**SOUTH SIDE  
QUEENSWAY WASTE  
MANAGEMENT SITE,  
LLANWERN STEELWORKS**

**2016 Annual Review of  
Environmental  
Monitoring**

*Report Number 1555r2v1d0117*

**January 2017**

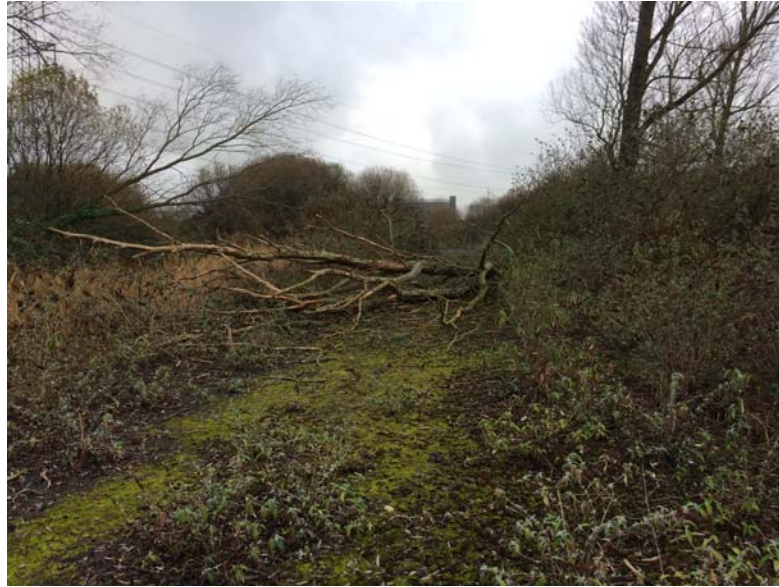
Plate 1. Fallen tree blocking access track

- Safe access to the surface water sampling points needs to be improved. Given that vegetation growth is inevitable, routine maintenance and signage would be beneficial.
- A large tree has fallen across the path of the access track on the southern side of the site. This prevents vehicular access to the southwestern monitoring points.

- Consideration could be given to preventing public access to the site and wider SSQ area.
