This form will report compliance with your permit as determined by an NRW officer

Site	Materials Recovery and Energy Centre			Permit Ref	BJ5775IF		
Operator/ Permit holder	Neath Port Talbot (Recycling) Ltd						
Date	10 October 2013			Time in	10:00	Out	13:45
What parts of the permit were assessed	See Below						
Assessment	Choose an item.	EPR Activity:	Installation	X	Waste Op	Water Discharge	
Recipient's name/position	Kevin Stewart / Health and Safety						
Officer's name	Karen Dunn			Date issued		30 October 2013

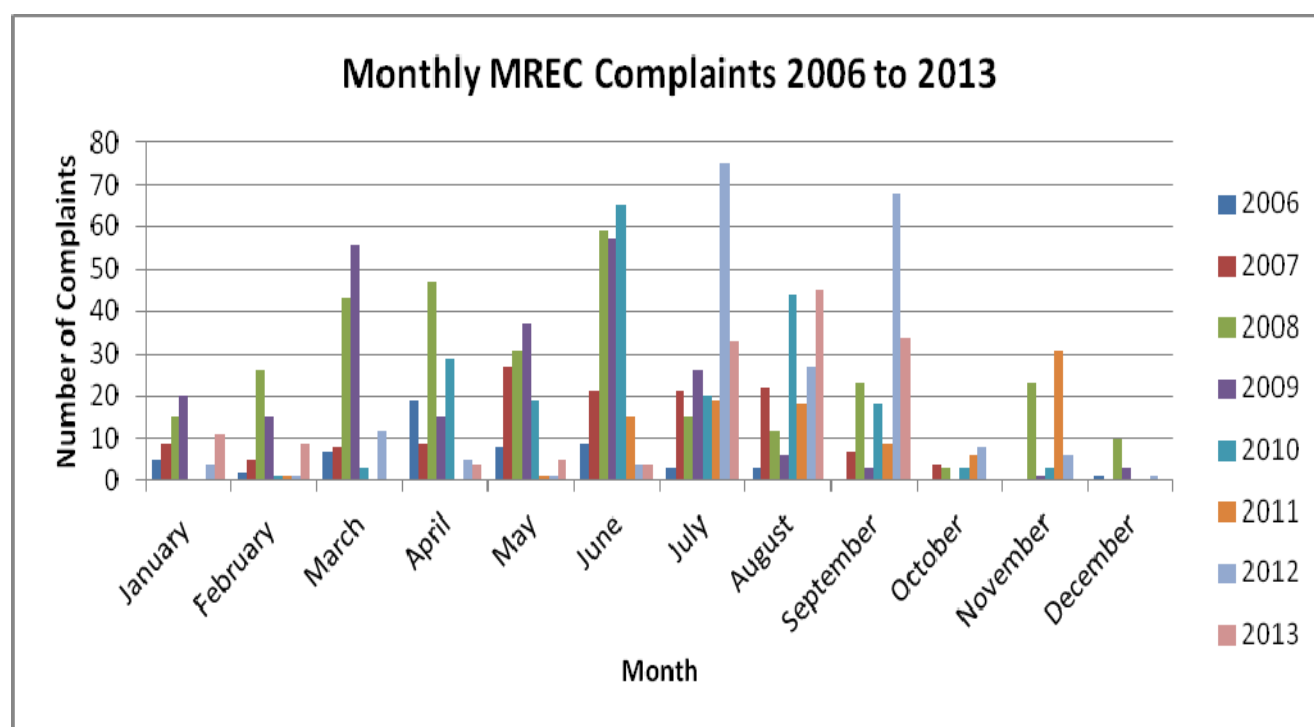
The numbers of complaints in recent months have increased significantly from June 2013. The graph below shows the number of monthly complaints received by the regulator from 2006 to 2013. The graph was compiled to make comparisons in order to better understand the scale of the odour issue over the last few months.

From the graph the number of complaints in July and September of 2012 and 2013 were greater than in the last 5 years. This is of significant concern to NRW as odour from the plant has been detected off-site by the regulator and this situation needs to improve as a priority. Although it is recognised in Odour Management Guidance H4 that there are a number of reasons why complaints are received about a site the data is a useful source of information to help understand a problem. KD enquired if the operator trends the complaint data they receive and KS was able to show a similar graph which is shared regularly at board level.

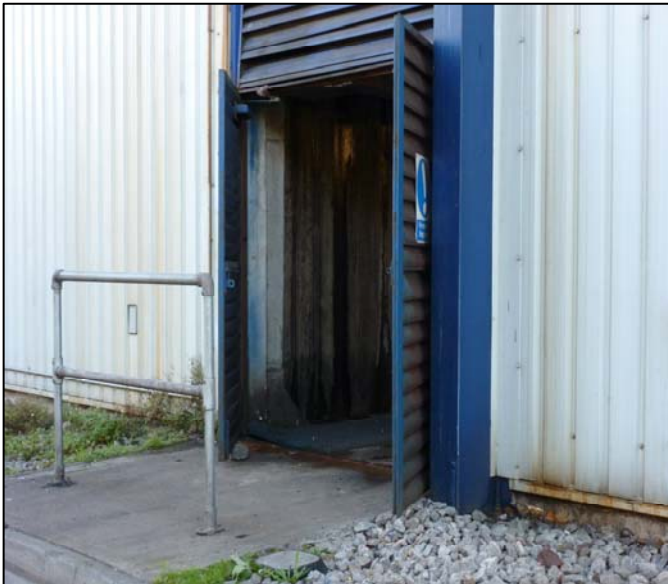
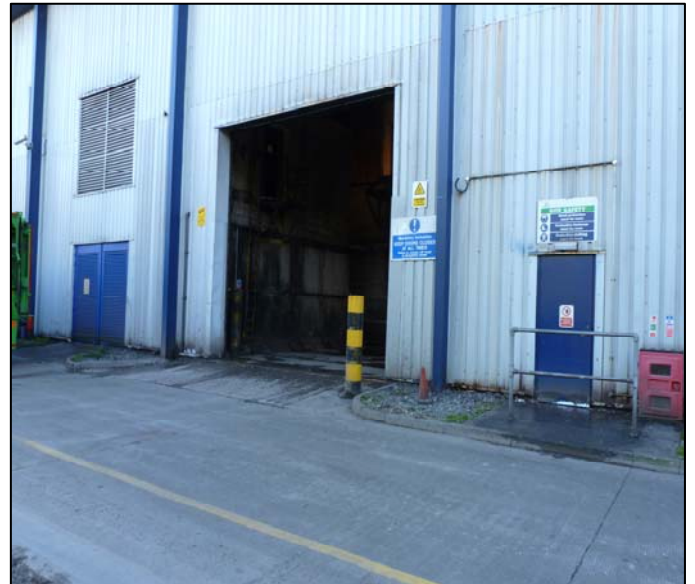
On leaving the processing hall two further doors on the northern side of the building were open. One of the doors had been propped open with a stone despite notices to keep them closed. KR used his radio to notify staff to rectify the matter and the doors were then closed. One of the operatives stated that they had been opened to dry out the building and water was evident on the floor of the entrance to these doors.

The photographs below were taken of open doors on the northern side of the site.

Action: Operator to investigate the root cause of the open doors on the fuel preparation sections of the building and to provide the findings to the NRW.

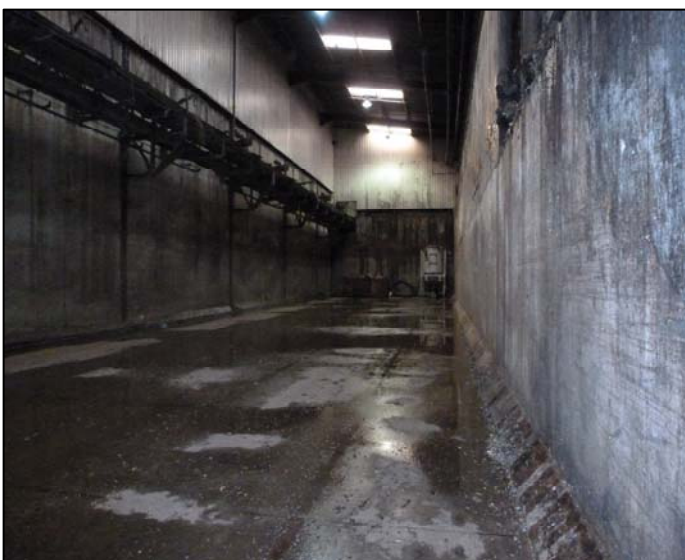
The photograph opposite was taken inside the RDF store. The store was empty following the change in status of the waste to energy plant. Water was evident on the floor of the store due to high humidity in the building.

It is understood that the operator has also been exploring improved air extraction rates in the processing / fuel preparation area of the plant.

Action: Operator to also provide an update on the timeline for the proposed improvements on the air extraction in the processing /fuel preparation area of the plant.

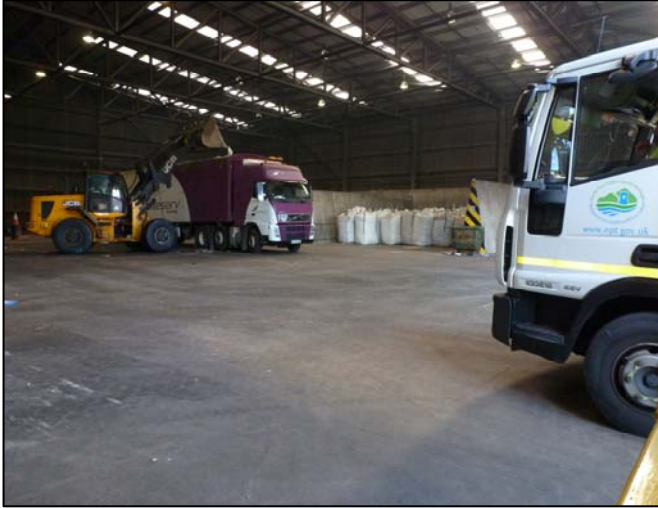
During this visit the transfer building for recovered recyclables was visually inspected from the entrance barrier due to vehicle loading at the time. Vehicles were queuing to tip in the building while a Siteserv lorry was being loaded with plastics. Bags of waste could be seen in one of the bays which KR said was paper waste that was being used for mixing with the RDF.

Following this audit KD cross-referenced the areas listed in the above condition against the relevant site plan. The areas corresponded to different locations on site. This is a non-compliance of the permit which has incurred a Category 3 score against condition 2.1.1 Table S1.1. Furthermore there appears to be an increase in the activity in this section of the site probably as a result of increased waste recycling.

Action: Operator to undertake a review of the recovered recyclables activities on site against the agreed permit activities and to provide a copy of it to NRW.

Recommendation: Depending on the outcome of the above review, should operations have changed from those previously agreed, a permit variation may be required.

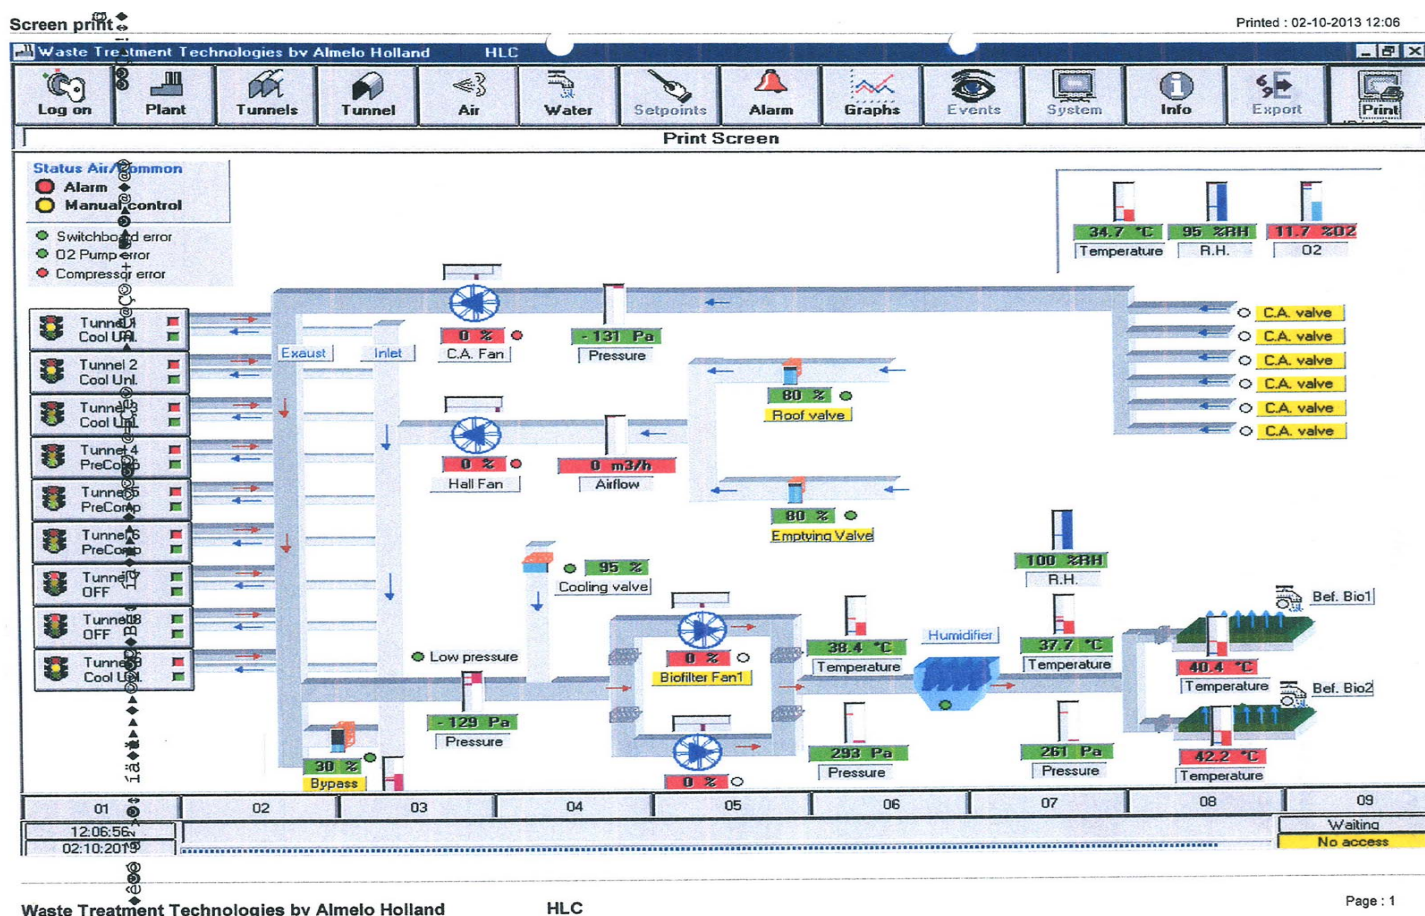
Screen Print of the WTT System from 2-10-2013

On review of the print out from the WTT system there appeared to be a number of occasions when the fans were at 0% this would suggest that the system is down. A print out from the day of the visit also stated the airflow was at 0m³/h and the fans were all at 0%.

Action: Operator to explain why the fans and airflow shows 0% on the WTT system.

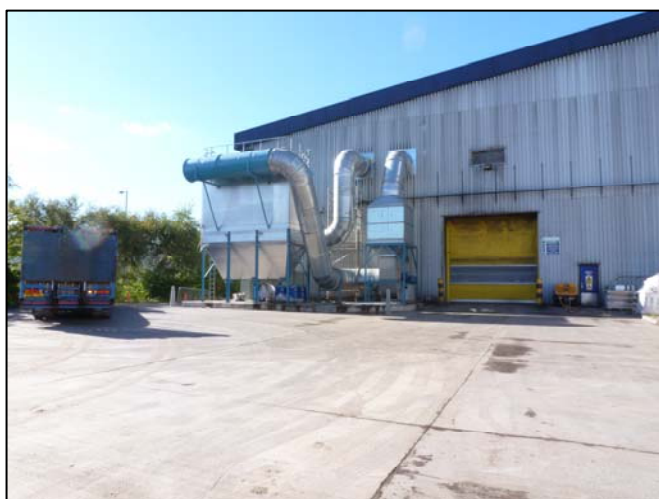
The photograph opposite was taken of the new de-duster unit installed on the fuel prep area. The installation of the new de-duster unit was a health and safety requirement in this area and was subject to planning. NRW as statutory consultees on the planning permission had recommended that a variation would be required to the

permit for an additional emission point. However the operator directed the stack back into the building. KD asked if the emissions from the de-duster have been ducted into the bio-filter as particles can block the media rendering it ineffective. Improvement Condition 9.48 on the bio-filter states:
