## Schedule 5 - Notification

| Name of operator | SCA Hygiene UK Ltd |
| Location of Facility | Chester Road, Flint CH6 5PU |

# Level 3 fire

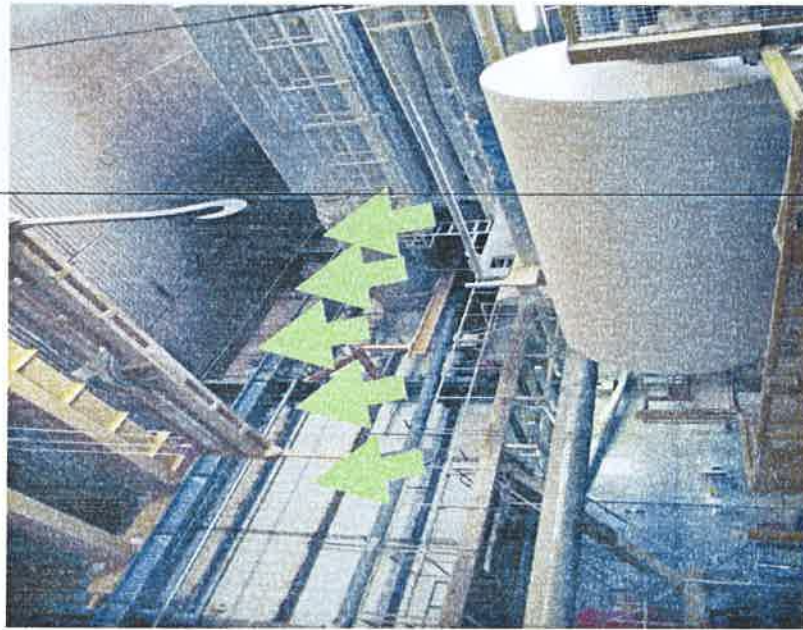
## Location of Incident:

Paper Production – PM 1

Whilst running the sheet, a length of tissue disappeared from the yankee at the dry end up into the hoods. This resulted in a fire which was quickly extinguished by the operators. However hot spots became evident on machine hall roof, so the fire service were called to deal with these and to further monitor the area.

Tissue paper / plugged paper in the hoods

Blade holder let the sheet pass the blade which resulted in the hoods being plugged

Maintain technical systems (here: blade holder)

Investigating root cause esp. re-ignition on hall-roof ongoing

Investigate added fire protection for machine hall roof

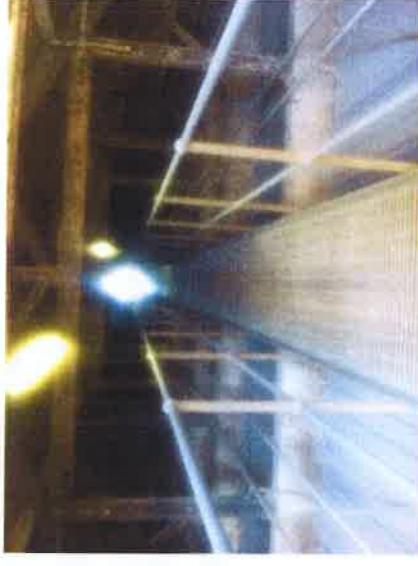
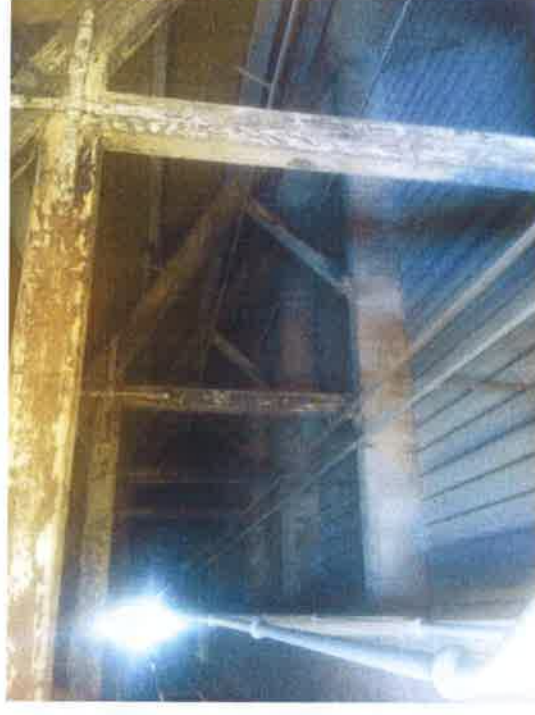
# Current fire protection on roof

- False ceiling in place made by non-combustible material
- Both areas (floor and ceiling are protected by sprinklers even within the false ceiling
- Nevertheless hot spots became evident on machine hall roof.

✓ non combustible material for roof and false ceiling

✗ Be careful with insulation that can collect dust and then “become combustible”. We have 2 companies looking at dust / fire prevention measures. Our initial proposal has been approved by Tony Wellington.

✗ Important to minimize damage from fires and to prevent fires is of course good housekeeping. Therefore a slightly overpressure in the system could prevent from piles. Housekeeping and cleaning regime is good, and continuous improvement is ongoing. The roof space is cleaned / vacuumed every 5/6 weeks. **Pressure system is being considered, and we will look into it should it prove to be necessary after implementing our initial proposal.**
