L.E.V THOROUGH EXAMINATION AND TEST IN ACCORDANCE TO HSG 258							
Customer Name & Address		Date of Test		11 July 2018			
Bimeda Telsol Ltd		Order Number		Commissioning			
23-24 Colomendy Ind Est		Contact Name		Ian Hardy			
Rhyl Road		Telephone					
Denbigh		Mobile					
LL16 5TA		Fax					
		Email					
The LEV System is Classified as				PASSED			
LEV Number	FFDT110718-1	LEV Type		Extraction Canopy			
Serial No	FF LEV3	LEV Location		Rear of Kiln			
Description		Part Detail		Passed	Comments		
Extraction Fan/Unit		Fan Engineering-FE47307		PASSED	420BL100 - 5.5Kw		
Mainline Ductwork		300mm 400mm		PASSED			
Drop Ductwork		N/A					
System Couplings		N/A					
System Hose		N/A					
System Funnels		N/A					
System Filters		HEPA 13			H7 Prefilters		
Specials (If Any)		Filter box mounted o/s, canopy i/s			Flame retardent Clear curtain.		
Fan Rotation		correct					
Type of Airborne Contaminant	Duct Size	Velocity Pressure at Inlet	Static Pressure at Inlet	Static Pressure at Outlet	Volume Flow at Inlet

LEV Report

Fume Extraction System-Kiln Room

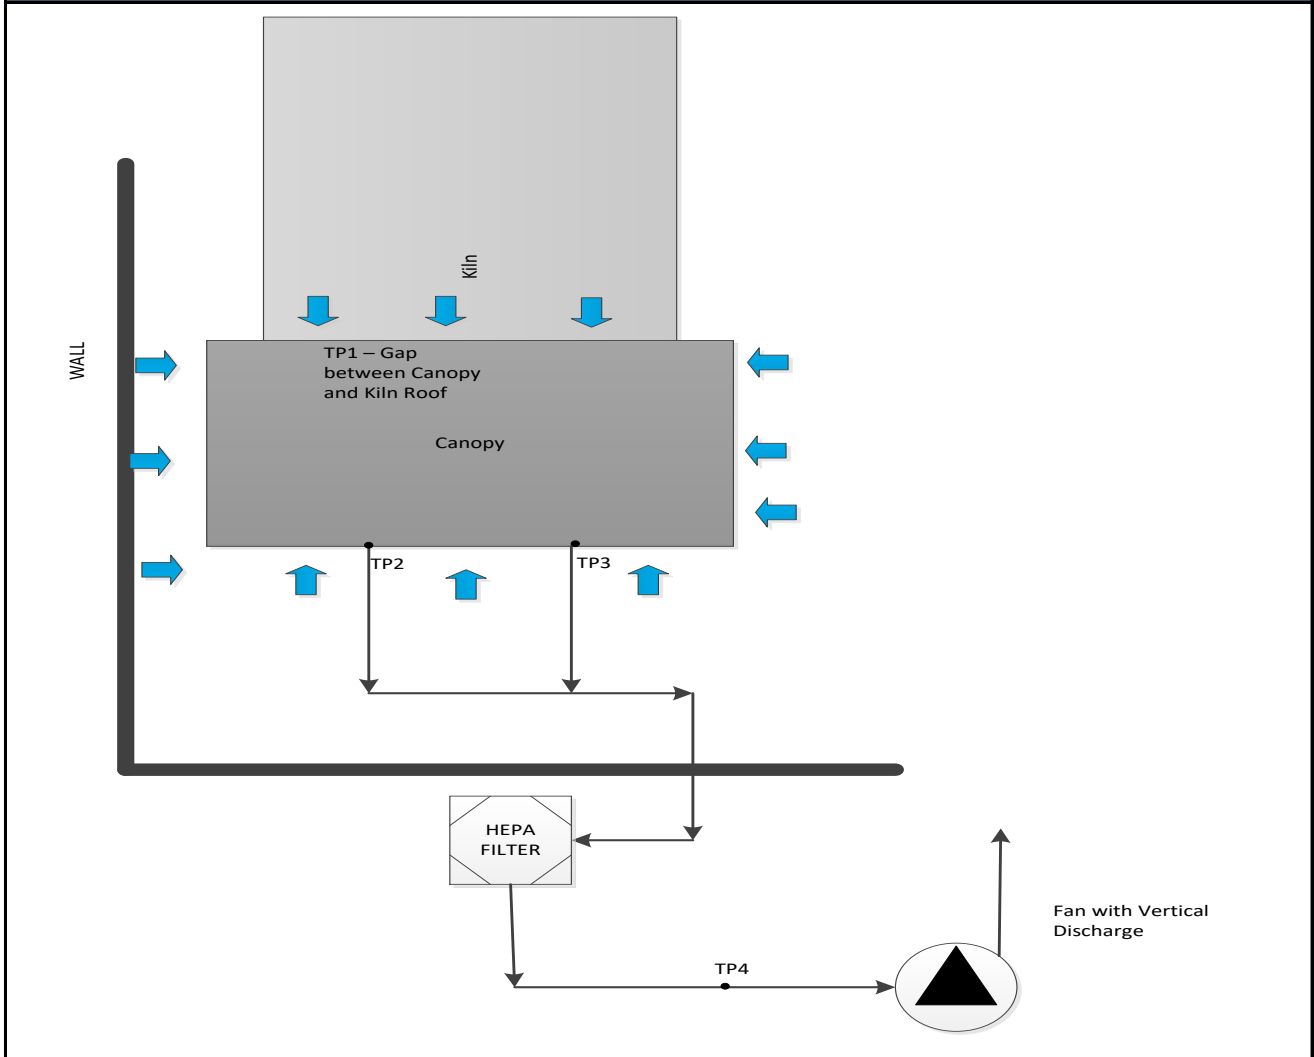
SCHEMATIC PLAN OF LEV

The system was visually examined and a simple line drawing of the system can be found within this LEV record file.
