## **Natural Resources Wales Technical Review Of Landfill Gas Management Systems**

12<sup>th</sup> November 2013

**Permit No: EAWML37207**

### **Brookhill Landfill Gas Review and Methane Emissions Survey**

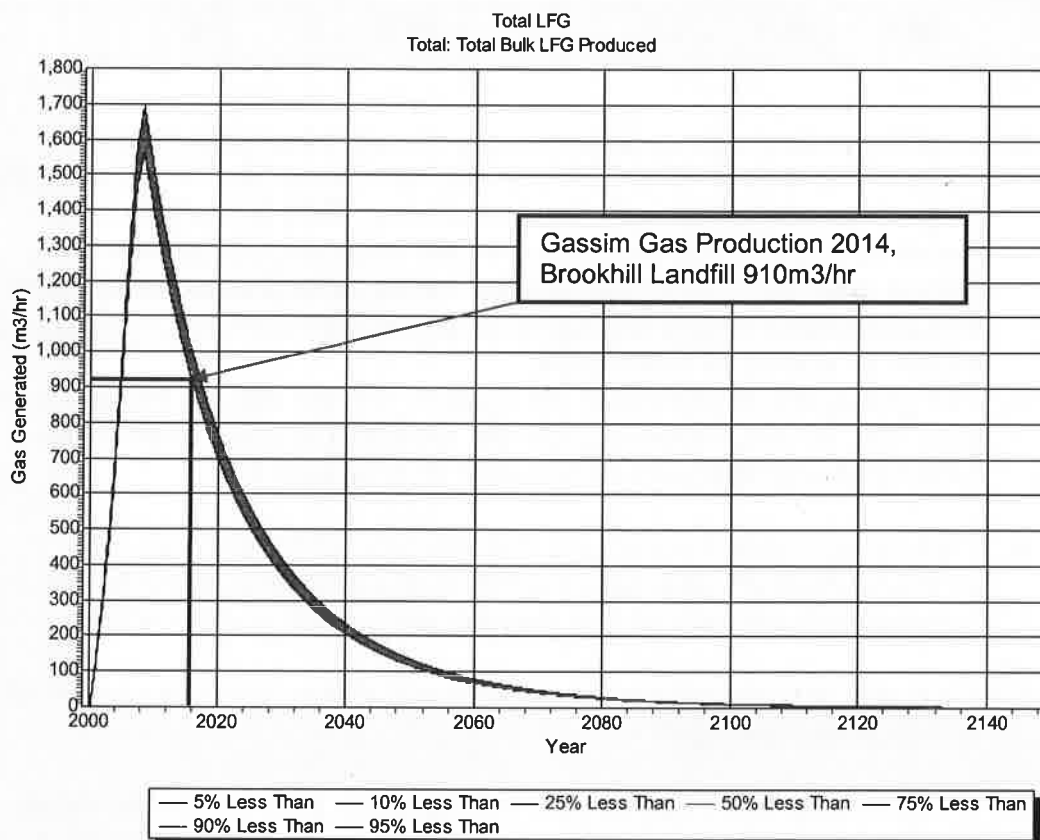
**Figure 1 Brookhill Gassim Model**

Figure 1 below shows the bulk gas generation curve produced using the Operator's data in Gassim, NRW's preferred gas production modelling tool. The modelled waste input is around 1.5 million tonnes of HCl waste (composition being around 60% domestic, 40% commercial so it is very biodegradable). The main issues are numbered as follows;

1. The moisture content is run 'Average' rather than 'Wet'. This may mean that the gas production rate has been underestimated as all of North Wales is designated as wet or super wet as far as Gassim modelling is concerned. We do recognise however that the site has been capped for some time.
2. The site has accepted a total of approximately 1.5 million tonnes of waste. At a range of 6m<sup>3</sup>-10m<sup>3</sup>, of gas/tonne per year this equates to 1027m<sup>3</sup>/hr-1712m<sup>3</sup>/hr at this point in time. The lower of these figures is 117m<sup>3</sup>/hr more than the Gassim estimate of 910m<sup>3</sup>/hr. For the sake of circumspection the lowest figure has been used for calculation of extraction efficiency.

3. The gas extraction rate at the site on the day of the audit was 420m<sup>3</sup>/hr @ 50% CH<sub>4</sub> (see results table below). This means extraction efficiency at the site is likely to be in the order of 46%. Using the lower figure in Gassim (run average for moisture content).

4. This extraction efficiency is unacceptable at a capped landfill of this nature with relatively recently tipped active waste. Reference LFTGNO3 (Landfill Technical Guidance Note) which recommends a target efficiency of 85%.

5. Taking 85% of the total Gassim estimate for gas production at this time would give a gas collection rate of 774 m<sup>3</sup>/hr a deficit of 353m<sup>3</sup>/hr.

6. The findings of the audit concur with the serious under extraction of gas at the site as demonstrated above, this situation must be remediated quickly in order to comply with the requirements of the Landfill Directive and the Welsh Governments Climate Change Programme.
