## Brookhill Landfill Site

## Leachate and Landfill Gas Management Review and Audit

**Document Reference:** 1850.4.FCC.ÅKS.JDM.A0

February 2014

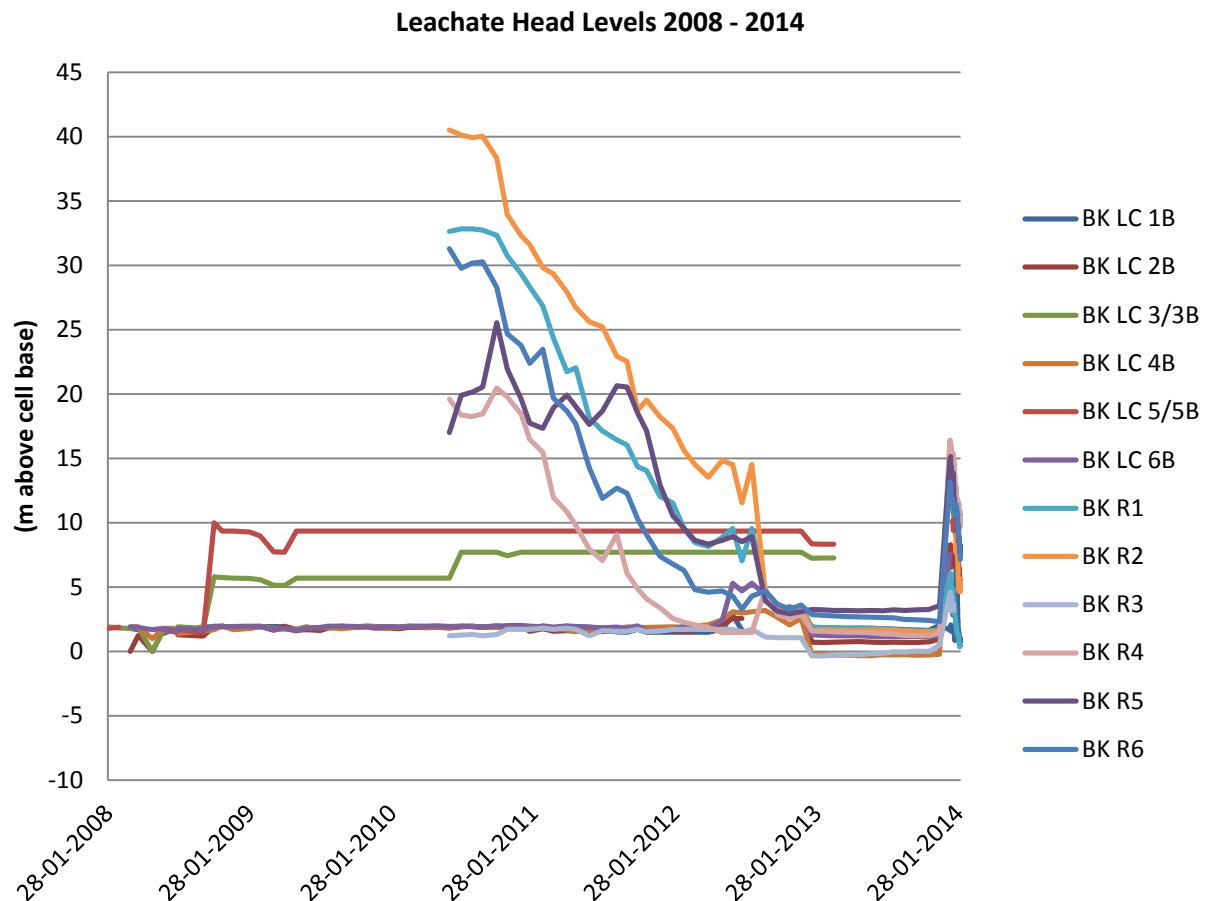
**Figure 1: Leachate Head Levels recorded at Brookhill between 2008 and 2014.**

2.6.10 Figure 1 displays a generally decreasing trend in leachate head level within the monitoring points between 2008 and the end of 2013, when all but R5 and R6 were recorded as being below their respective trigger limits.

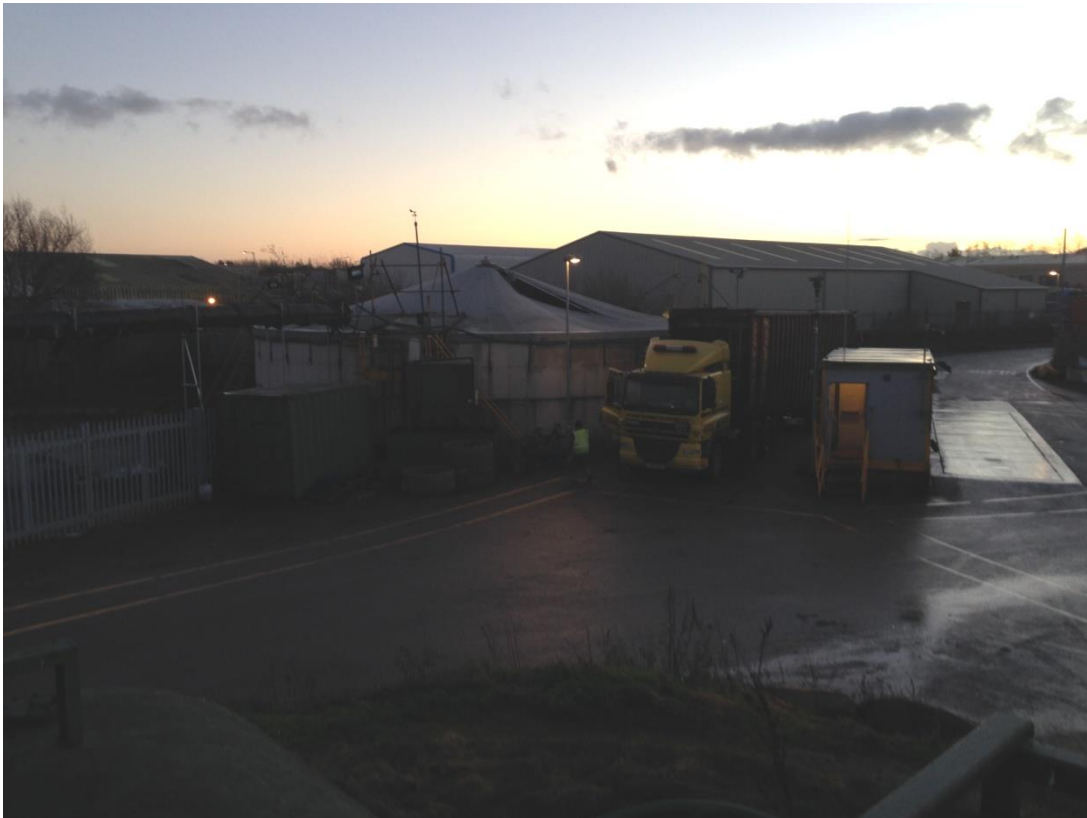
**Plate 7**

- 2.4.3 During the autumn of 2013, storm winds and rain caused a tear in the existing LTP roof (see plate 7, Appendix 2), which increased the heat losses. FCC will attempt a repair to this damage.

- 2.5.5 The leachate treatment plant is fundamentally a robust plant and an asset to the council, however, its maintenance has been neglected. The roof leak and lack of insulation is also affecting the leachate treatment performance plant during the colder winter period. In our opinion, the leachate treatment plant would benefit from the installation of an insulated roof (or similar).

| <b>Plate No.</b> | <b>Description</b> |
|---|---|
| <b>7</b> | Sequential Batch Reactor with Damaged Roof |

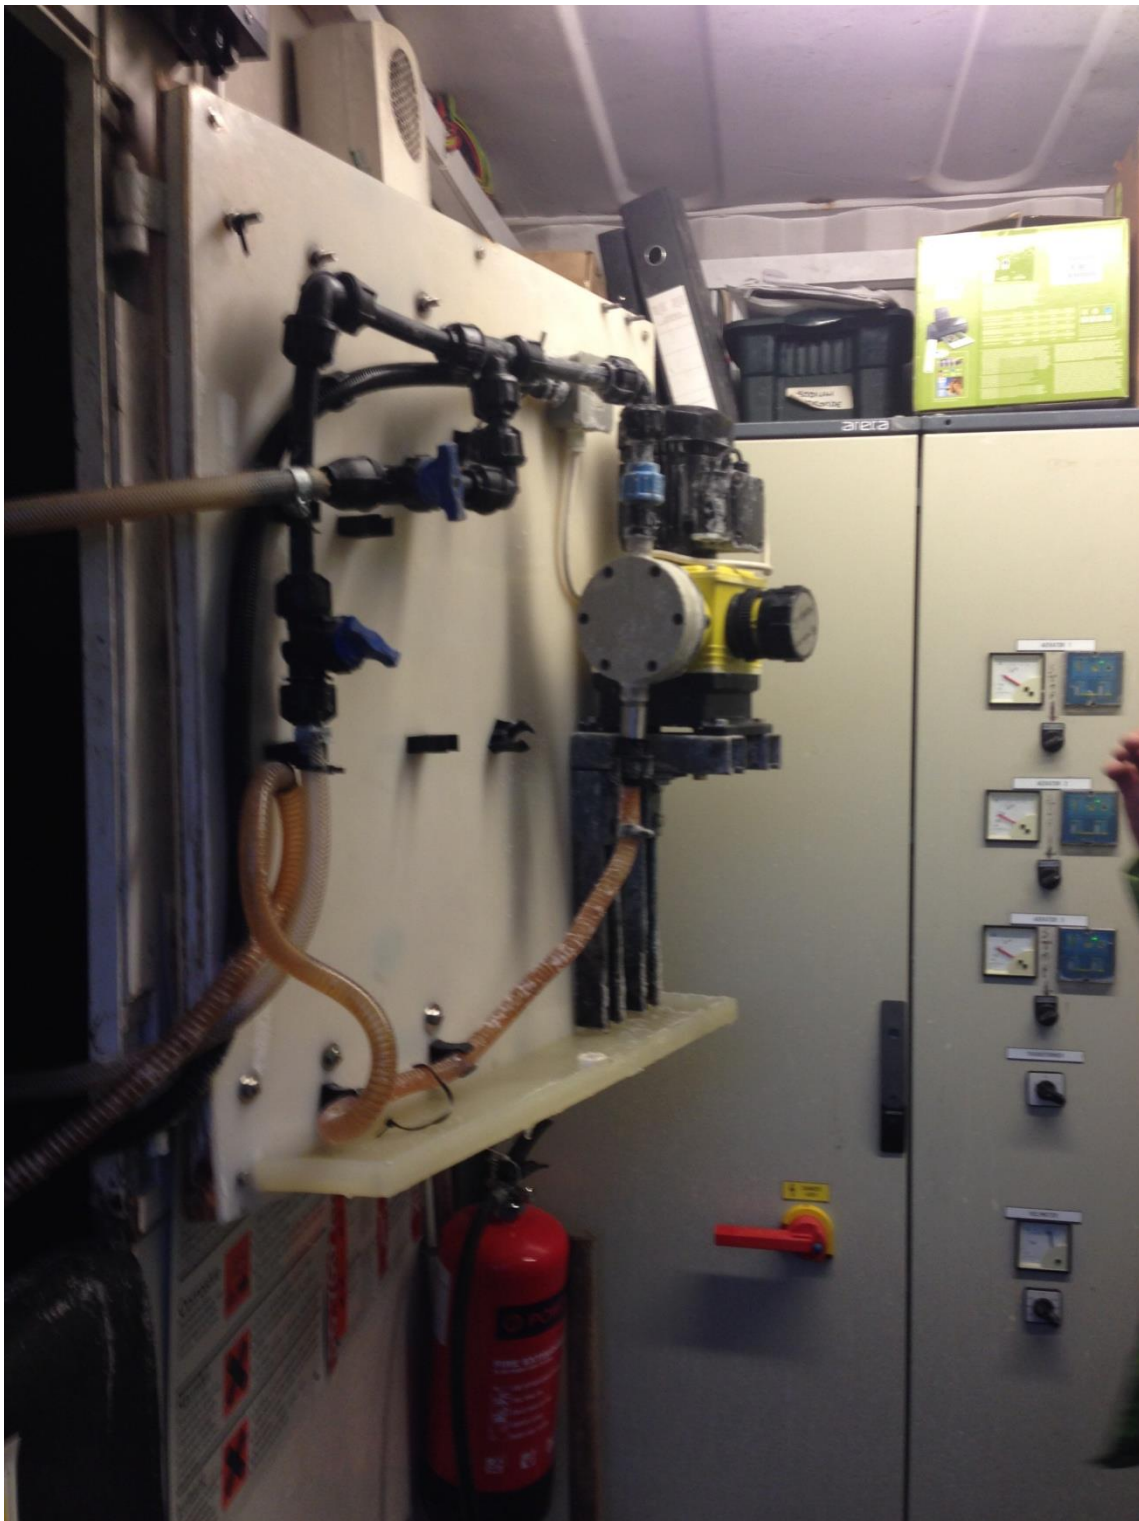
Plate 11

| <b>Plate No.</b> | <b>Description</b> |
|---|---|
| <b>11</b> | Sodium Hydroxide Pump Leak |

- 4.2.2 The sodium hydroxide spill in the control should be cleaned up immediately and damaged floor panels removed. The sodium hydroxide pumping system should be repaired, and the air lock in the system removed. It is not only a health hazard, but also detrimental to the leachate treatment if the sodium hydroxide dosing cannot be relied upon.

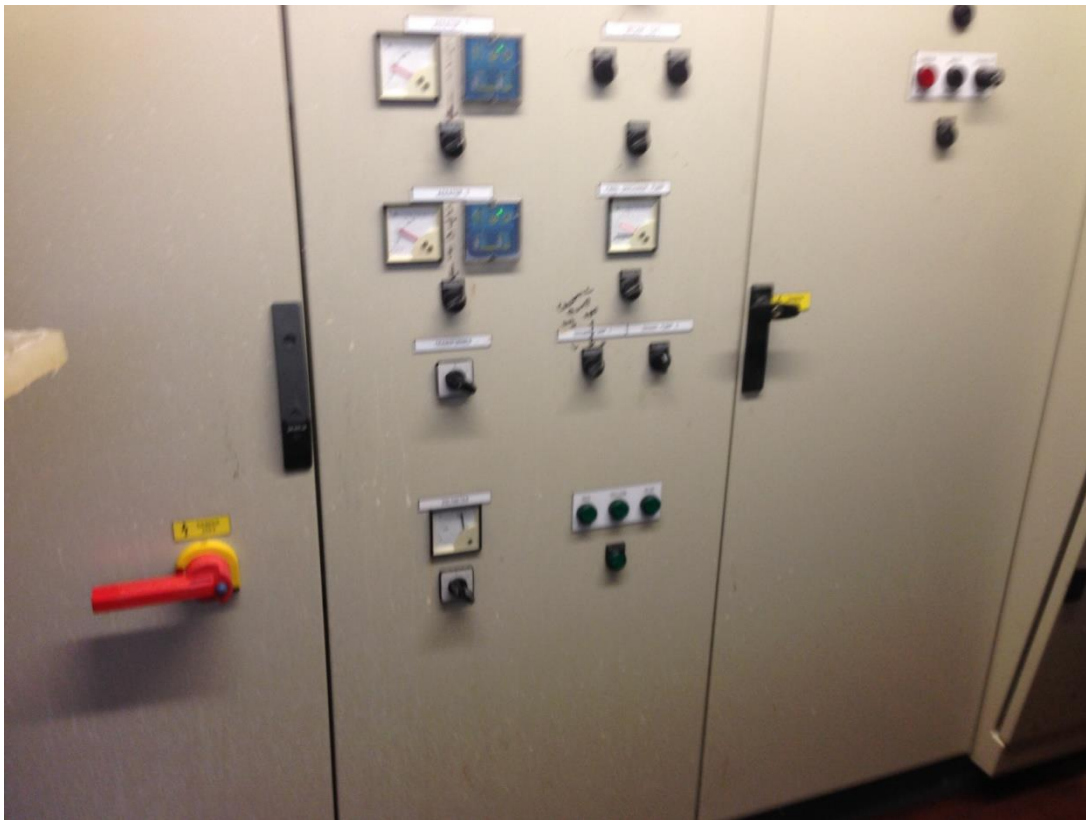
Plate 12

| <b>Plate No.</b> | <b>Description</b> |
|---|---|
| <b>12</b> | Sodium Hydroxide Leaking onto Control Panel |

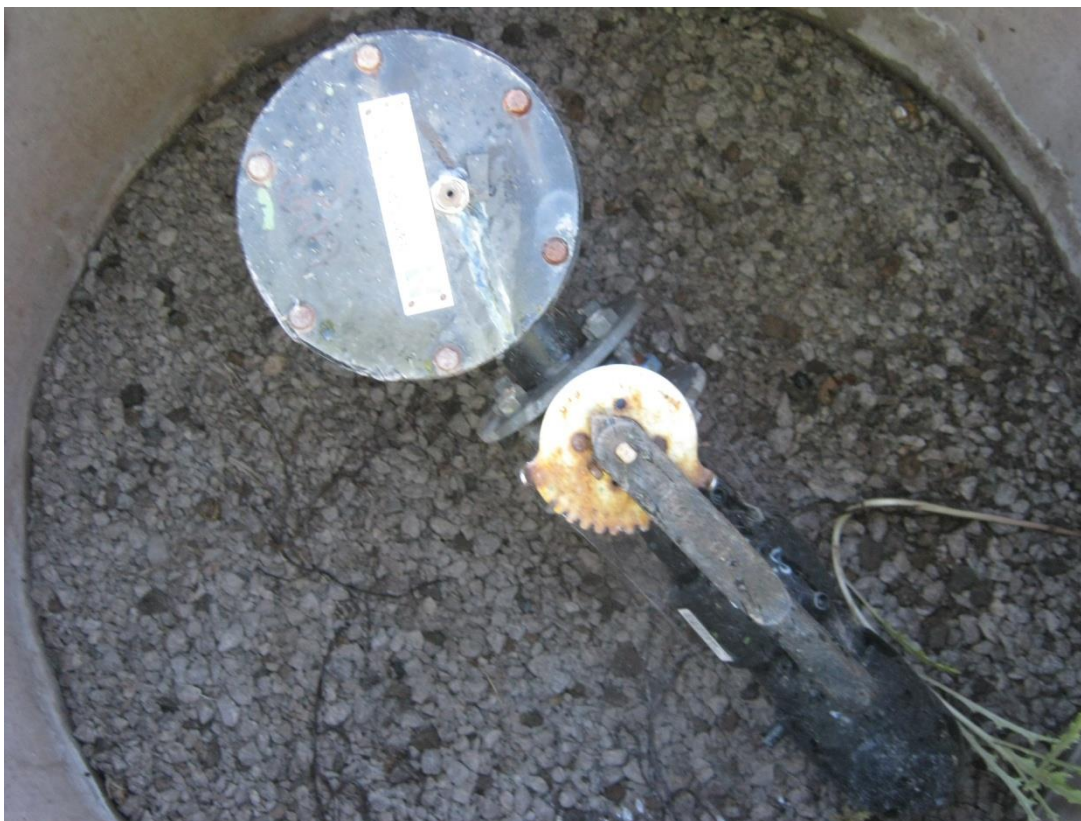
**Plate 3**

- 3.5.3 The valves at GV2, GV3, GV5, GV19, GV23 and GV26 were rusted, but otherwise these wells were also all in good condition with no visible damage. See Photographic Log in Appendix 3.

| GEX Well | Condition of Wellhead | Pipe Circ. (cm) | Condition of Pipework | VP at Wellhead (%) | VP (%) at Manifold | Seconds | CH4 | CO2 | O2 | Bal | H2S | CO | RP |
|---|---|---|---|---|---|---|---|---|---|---|---|---|---|
| GV3 | Ok. Rusted Valve. Photo 3. | 63 | Good | 100 | 100 | 30 | - | - | - | - | - | - | - |

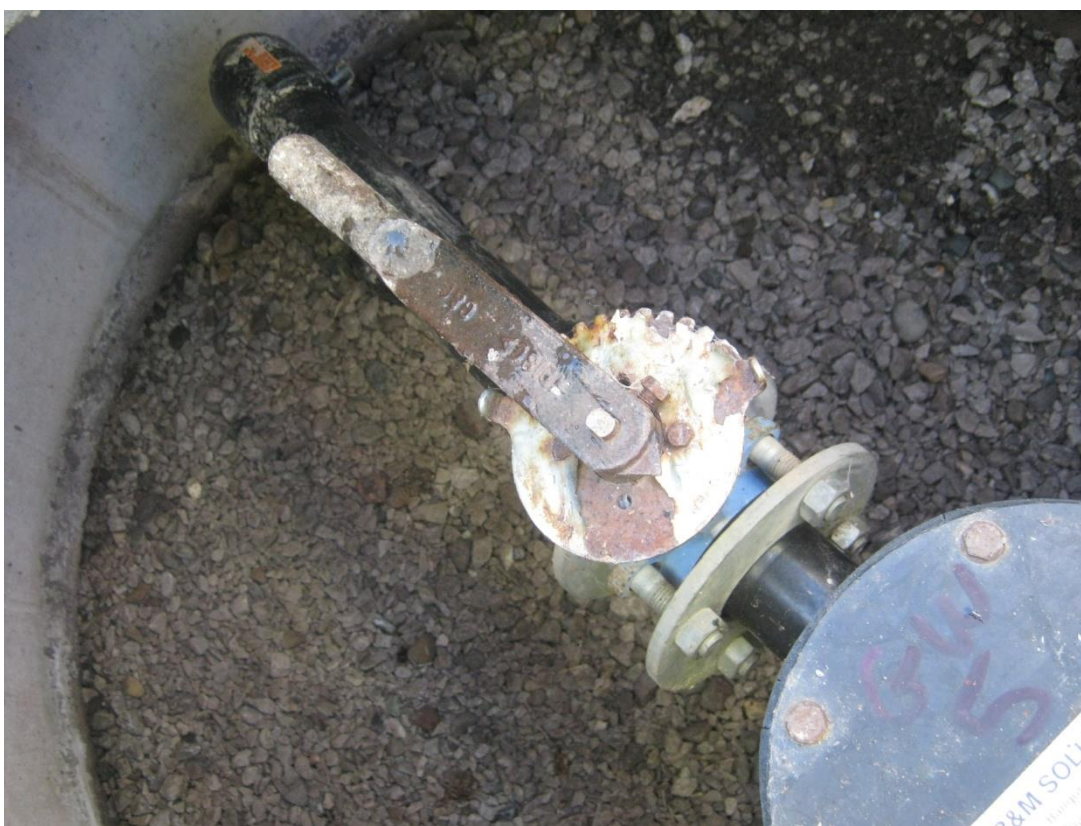
**Plate 4**

| GEX Well | Condition of Wellhead | Pipe Circ. (cm) | Condition of Pipework | VP at Wellhead (%) | VP (%) at Manifold | Seconds | CH4 | CO2 | O2 | Bal | H2S | CO | RP |
|---|---|---|---|---|---|---|---|---|---|---|---|---|---|
| GV5+R1 | GV5 Good. Rusted valve. Photo 4. R1 Good. Tefen valve sticks. | 63 | Good | 100 | 50 | 30 | 60.6 | 39.9 | 0.2 | 0.0 | 70 | 4 | R1: -14.23 |

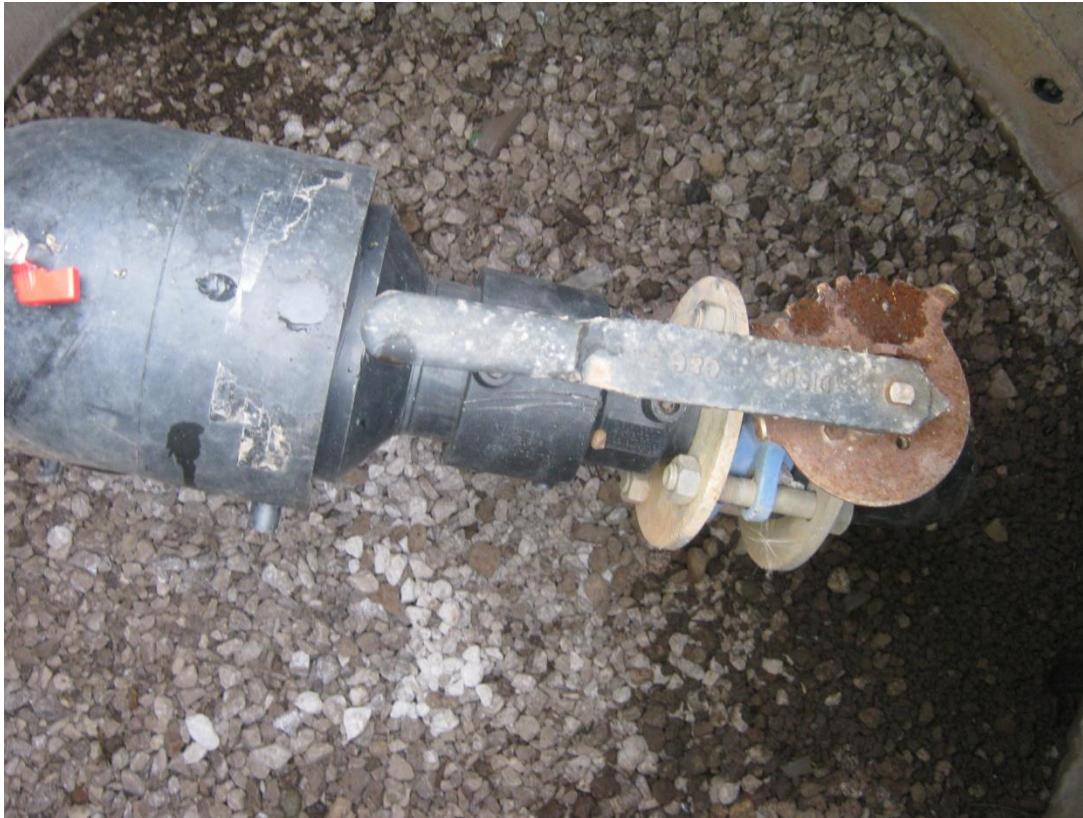
**Plate 7**

| GEX Well | Condition of Wellhead | Pipe Circ. (cm) | Condition of Pipework | VP at Wellhead (%) | VP (%) at Manifold | Seconds | CH4 | CO2 | O2 | Bal | H2S | CO | RP |
|---|---|---|---|---|---|---|---|---|---|---|---|---|---|
| GV23 | Ok. Rusted valve. Photo 7. | 63 | Good | 100 | - | 30 | 58.8 | 42.3 | 1.4 | 0.0 | 127 | 8 | -15.93 |

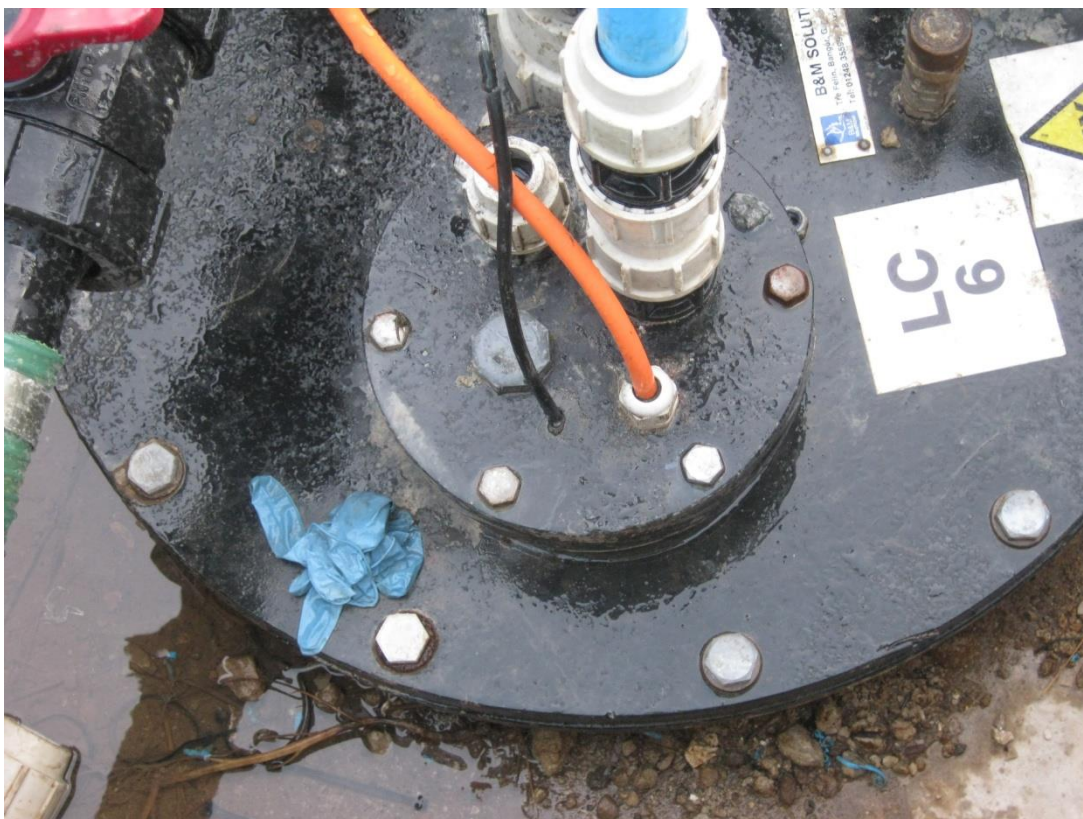
**Plate 8**

3.6.6 Landfill gas leaks were noted at R5, LC2b, LC4 and LC6. LC6 was determined to be leaking from an aperture created for the pump cable, as displayed in Plate of 8 of the Photographic Log in Appendix 3.

- 3.7.5 In October 2013, NRW found that leachate sump LC2b had loose fittings on head-works allowing gas to escape. In January 2014, LC2b was again found to have a gas leak, with strong landfill gas odour within the chamber. Gas leaks were also noted at R5, LC4 and LC6. LC6 was leaking from an aperture created for the pump cable.

- 4.2.9 Individual point sources, for example at GV8 and at leachate wells R5, LC2b, LC4 and LC6 should be repaired immediately, to limit oxygen ingress and maximise gas extraction.

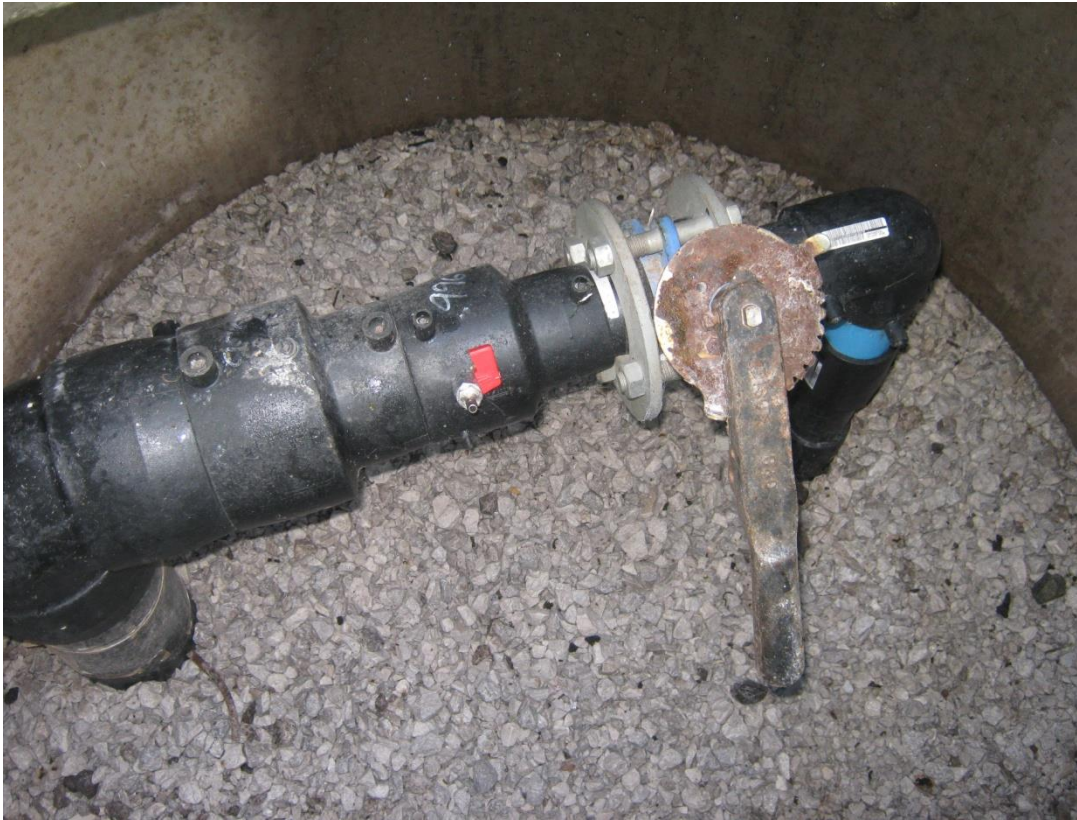
**Plate 9**

| GEX Well | Condition of Wellhead | Pipe Circ. (cm) | Condition of Pipework | VP at Wellhead (%) | VP (%) at Manifold | Seconds | CH4 | CO2 | O2 | Bal | H2S | CO | RP |
|---|---|---|---|---|---|---|---|---|---|---|---|---|---|
| GV26/A | Ok. Rusted valve. Photo 9. | 63 | Good | 0 | - | 30 | - | - | - | - | - | - | - |
