| Site | Tata Steel Port Talbot steelworks | Permit Ref | BL7108IM (as amended) |
| Date | 16 June 2015 | Time in | 09.30 Out 16.30 |
| Assessment | EPR - inspection | EPR Activity: | Installation X Waste Op Water Discharge |

| | <b>EPR Compliance Assessment Report</b> | Report ID: 5915 | |

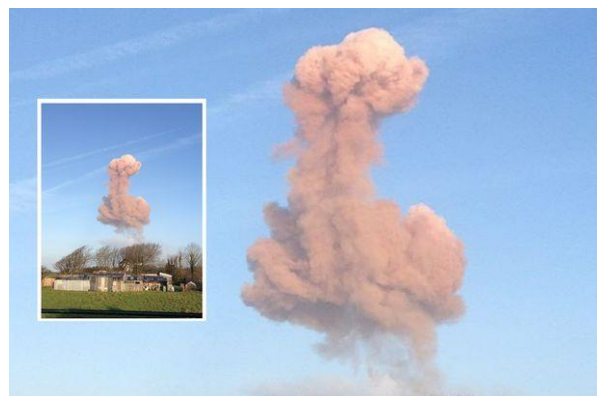
On Saturday 24 January 2015 NRW received a number of complaints about a release from the steelworks. The source of this release coincided with an event while plating molten iron within the steelworks. CAR Form 5854 contains details of NRW's initial investigation which concluded that ground water was not a contributor or source of the water that caused this event. During this visit we viewed video footage of the molten iron pour from the torpedo into plating pit number 3. The photograph shows the release above the steelworks from this plating operation. There appeared to be no discernible effect of this event on the air quality monitors around the steelworks.

The video showed the pour from the torpedo took around 15 minutes to complete. NRW understands the pour should take 30 minutes; at this rate the iron moves slowly enough to allow any moisture to evaporate in front of the advancing metal. After 8 minutes the hot metal reached the end of pit 3 with little release/fume visible. After 12 minutes the far end of the pit started to fume, then boiled and finally erupted like a volcano scattering molten metal into the air that rained down in front of the camera and the 'igloo'. Tata's initial report into this event suggests that damp slag had been used to prepare pit 3, but this cannot be confirmed. Tata showed us a photo of the pit 7 days before it was used and this showed a pool of water visible towards the far end of the pit. Pit 3 was prepared and dressed with slag by Harsco prior to the event although it is not clear how any standing water was dealt with during this process. What is clear is that the eruption took place in the same part of pit 3 where the standing water had been 7 days earlier.

Twelve actions were identified by Tata Steel when they and Harsco personnel investigated this event.

In NRW's view, the most likely causes of the plating release on 24/01/15 were a torpedo pour that was too fast and the presence of water in the plating pit. No discernible effect of the event could be seen on the air quality monitors around the steelworks. According to the Harsco procedure/work instruction, the pouring of molten iron and the maintenance and preparation of the pit are the responsibility of Harsco Metals. The permits for Tata Steel and Harsco Metals need to be reviewed and updated to correctly reflect this arrangement. NRW believes a meeting with both companies present would be the most appropriate way of progressing the necessary permit changes and the inspecting officers will contact the relevant personnel to arrange this.
