**This form will report compliance with your permit as determined by an NRW officer**

| Site | Tata Steel Port Talbot steelworks | Permit Ref | BL7108IM (as amended) |
| Date | 10 July 2014 | Time in | 09.30 Out 11.30 |
| What parts of the permit were assessed | Blast Furnace No.4 bleeder valve event 3 July 2014<br>See below for details of assessment | | |

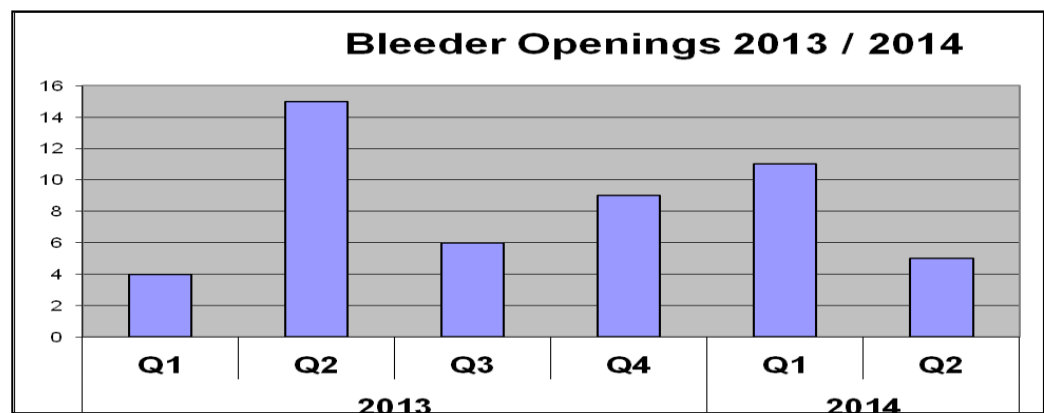
We have begun to examine this event on 03/07/14 in the context of wider blast furnace environmental performance since Q1 of 2013. The frequency of bleeder openings is slightly less this quarter compared to previous levels. The high levels seen in Q2 2013 were due to problems with a temporary lining used to commission No.4 Furnace.
