| Site | Tata Steel Port Talbot steelworks | | | | Permit Ref | BL7108IM (as amended) | | |
| Date | 11 March 2015 | | | | Time in | 09.30 | Out | 11.30 |
| Assessment | EPR - inspection | EPR Activity: | Installation | X | Waste Op | | Water Discharge | |

| | <b>EPR Compliance Assessment Report</b> | Report ID: 5854 | |

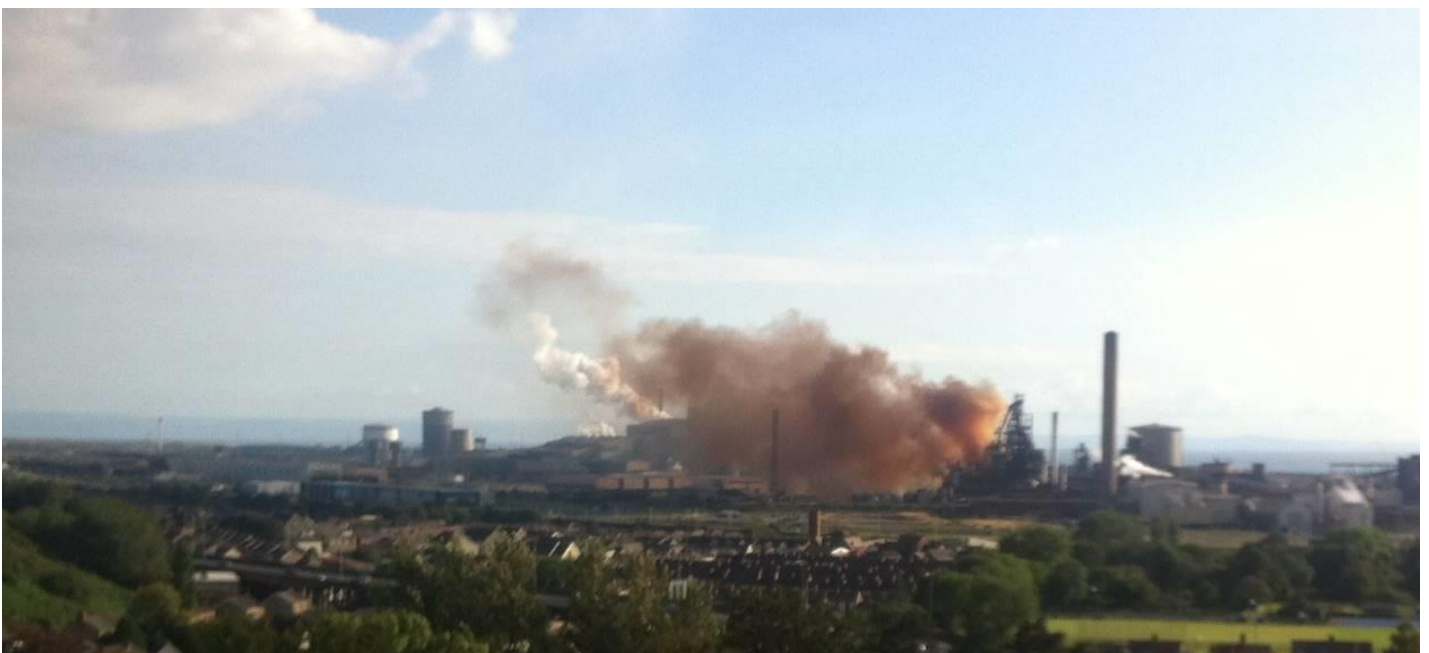
On 15 August 2014 the east taphole at Blast Furnace No. 4 was casting when it suddenly failed and broke up. When the taphole manipulator cover was removed there was a large release of smoke and fumes. Tata attempted to quickly plug the taphole with clay, but halfway through this procedure a fault with the remote clay gun occurred resulting in a failure to close the taphole and a prolonged emission from the cast house. While the furnace wind was reduced, the cast house operators resorted to a hard-wired system with a direct connection to the clay gun and succeeded in plugging the taphole and stopping the emission.

The switch gear, relays and circuits for the taphole equipment has to be close to the clay guns and this case is located in a sub-station basement near the slag cooling pits. Tata believes that there was ingress of sulphurous gases and water that corroded the copper switches in the relays and made them ineffective. As a result the remote control clay gun equipment had a power failure that meant the taphole could not be injected with clay to close it. The ingress problem appears to have also intermittently affected the circuits for the skip and hoist on No. 4 furnace.

We have recorded a **Compliance Classification Scheme (CCS) score of 3** in response to the unauthorised release from Blast Furnace No.4 cast house on 15 August 2014 (see photo below). The identified root cause for the failure to maintain the clay gun control circuitry has also been scored as a **CCS3**. Both scores have been recorded under **CCS reference 239007**.

As a result of these findings Tata has replaced all the connections with conformally-coated copper ones, rather than original copper versions, in case there is a sulphurous gas or moisture ingress again. The company has also installed a pumping/fan system to prevent water and gas ingress and to keep the basement under positive air pressure. Air-conditioning has been added to improve the environment around the clay gun relays and circuits. A standard maintenance regime is now in place for the sub-station basement area. Finally, all panel connections have been re-made and network connections upgraded with additional redundancy built in.

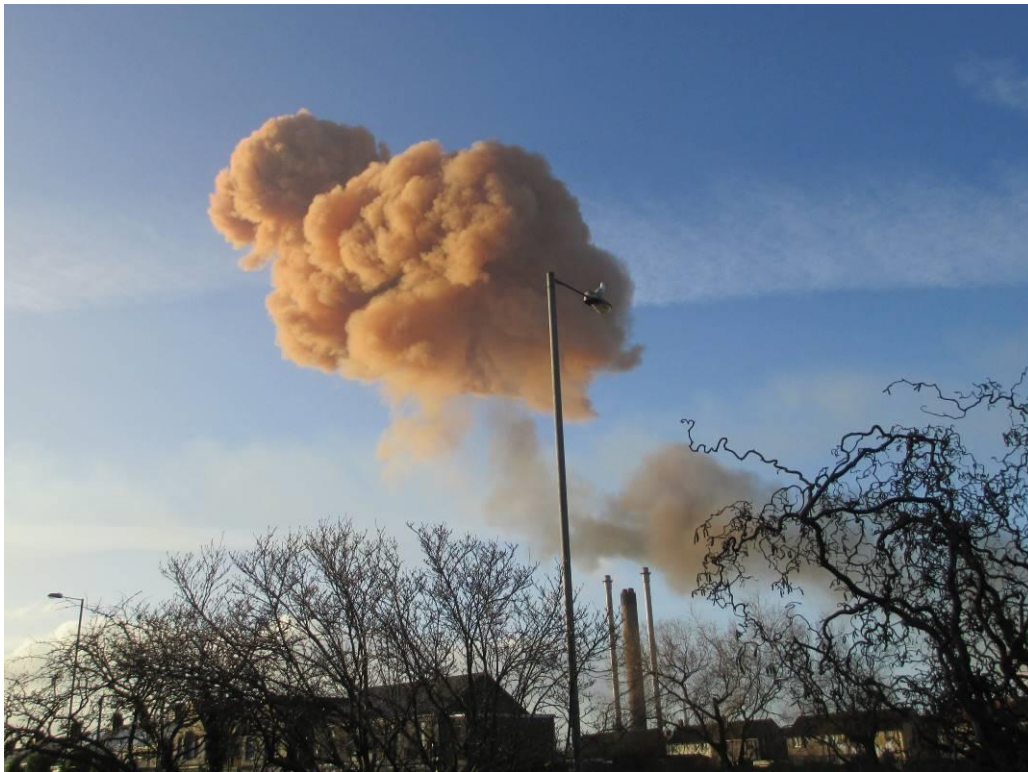
On 24 January 2015 molten iron was being poured and plated at pit number 3. At approximately 0930hrs a violent reaction occurred towards the end of the pour sending a sudden release of smoke and fumes into the air. Pouring was immediately halted. The emission resulted in a highly visible smoke cloud above the steelworks (see photo below).

Reactions of this nature can occur when pockets of water within the plating pit become trapped under the advancing molten metal, rapidly superheating the water into steam which then erupts through the surface of the metal and releases fumes.

There was heavy rain the week before the event although there was no high tide at the time. The proximity of ground water to molten metal is believed to increase the risk of having explosions and releases from the plating pit. This observation comes from work carried out on similar operations and incidents in Belgium and Holland. At Port Talbot it is recognised that the tide can influence the level of ground water. On 26 January 2015 the ground water was measured at around 2.5 m below the bottom of pit 3. Work in Belgium suggests that if the ground water is less than 1.7 m from molten metal this can create problems. Based on this information a high ground water level is unlikely to be the cause of this event.

There is some evidence that the wrong (wet) slag could have been used to build the pit. A tundish was being replaced around this time and the slag that should have been used for this replacement could have been used as a base of pit 3. There is also some anecdotal evidence that there was some standing water in the pit before the pour started, but the pits are always inspected by Harsco Metals before pouring. Also the molten metal from the pour had reached the end of the pit when the reaction took place. This might be an indication that the pour was too fast and any water present could not evaporate quickly enough in front of the advancing metal.

Before NRW can reach a final conclusion on the root cause(s) of this event, the potential causes identified above need to be explored with Tata Steel and Harsco Metals personnel. Video footage of the pour into pit 3 on 24 January 2015 also needs to be viewed by the inspecting officers. A follow-up visit will be undertaken to progress our investigations.
