## Compliance Assessment Report

**Report ID:**  
**CAR\_NRW0026307**

| Site | Port Talbot Steel Works EPR/BL7108IM | Permit Ref | BL7108IM | | |

To carry out a joint initial investigation into the events, causes and investigation into the power loss experienced at Tata Steel on 11/2/16 and to decide if the event is a major accident and COMAH and if there are implications under EPR.

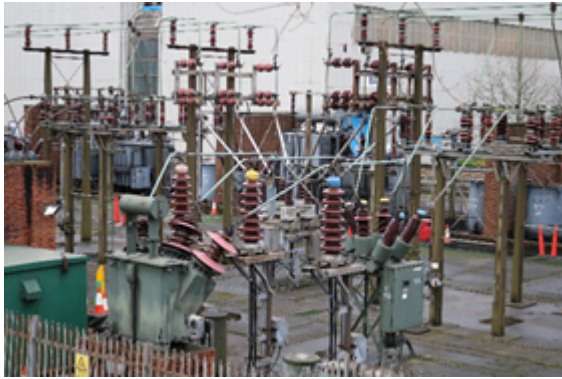
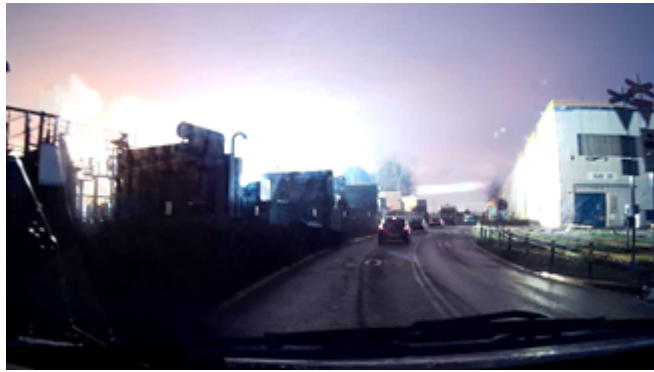
Tata's investigation concluded that there was a partial power loss caused by two separate flash overs at the Grange and Cefn Gwrgam substations. Heavy rain a few days earlier caused salt to build up on the substation insulators and the damp weather on the day then helped make the 'connection' across the insulators and then led to the flashovers.

The left hand photo shows the substation and the insulators and the right hand photo is of same substation showing the flashover

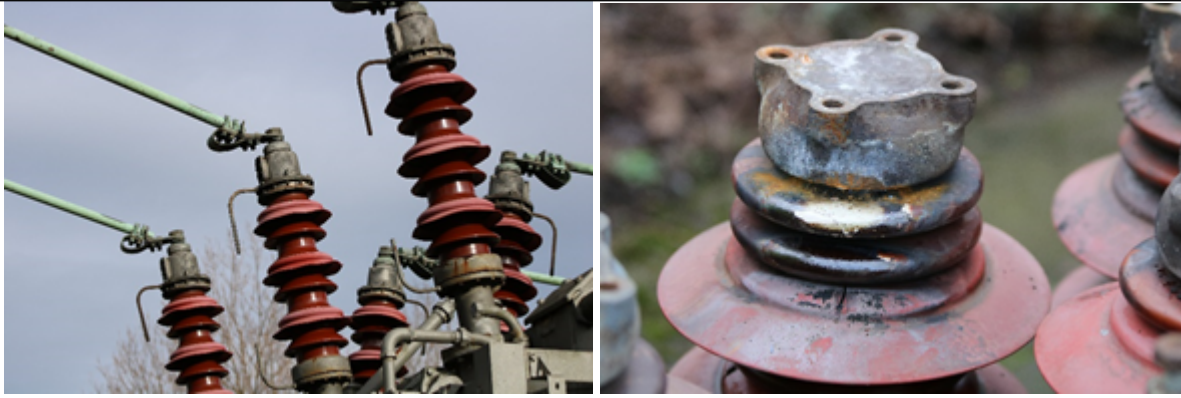
The cause of the flashover has been attributed to a sea salt build up on the insulators, then drying onto the ceramics followed by mist leading to formation of a conductive pathway across the insulators. Western Power use a three yearly maintenance of their insulators and Tata carry out annual washing and inspection of their insulators. A total of eleven insulators were replaced (by Western Power), six Western Power 'owned' ones and the remaindered inside the Tata Steel areas of responsibility and some others were cleaned. There were reports that similar flashovers happened elsewhere along the coast near Swansea.

The left hand photo shows the insulators and the right hand photo shows an insulator after a flashover.

Tata are looking at two things to avoid this problem. Firstly they are replacing the insulators with new insulators with coatings to minimise the risk of salt build up. Secondly they are funding a University project to attempt to predict when a flash over could occur based on insulator leakage, and voltage loss across the insulator with on-line monitoring. Tata need to, if they are not already in the maintenance system, a replacement plan for the insulators.

| Criteria Ref. | CCS Category | Action required/advised | Due Date |
|---|---|---|---|
| B5 | X | Tata needs to produce a replacement plan for its electrical insulators at both substations if these components are not already programmed into Tata's maintenance system. | 30/12/2016 |
