## EPR Compliance Assessment Report

Report ID: 6128

| Site | Llysonnen Mill | | | | Permit Ref | EP3034GS | | | |
| Operator / Permit Holder | Wynnstay Group PLC | | | | | | | | |

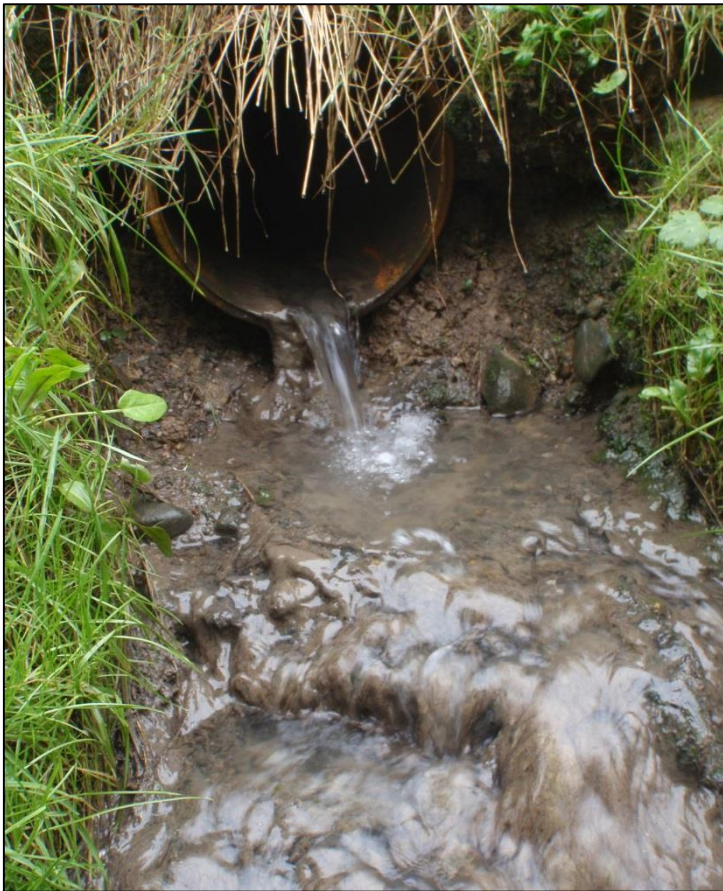
During our site investigation following the pollution event of 10 February 2016 we observed fungus (consistent with nutrient enrichment caused by the presence of untreated sewage) along the bed and banks of the perimeter ditch which ultimately discharges to the watercourse to the East of the permitted area (see photograph 1 & 2 below). The sewage fungus was present downstream of the main office septic tank overflow outfall\* but absent above it. This strongly indicates that the overflow of the septic tank serving the main office has not been sealed up and continues to have a polluting impact on the receiving watercourse.

Photo 1: Sewage fungus discharging from main office septic tank overflow outfall.

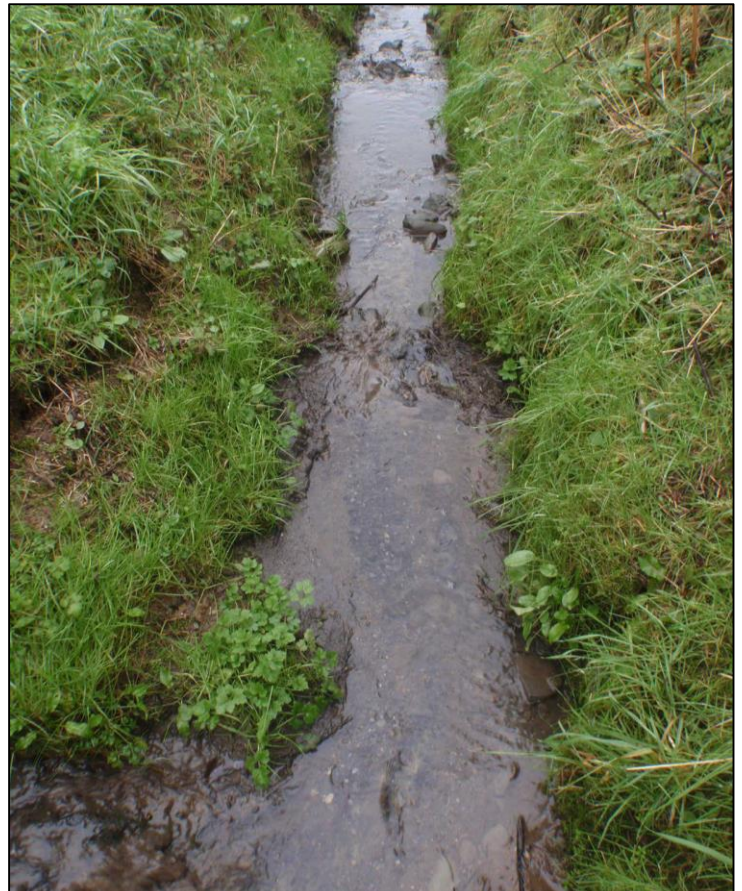
Photo 2: Sewage fungus along the bed and bank of the perimeter ditch downstream of the main office septic tank overflow outfall.

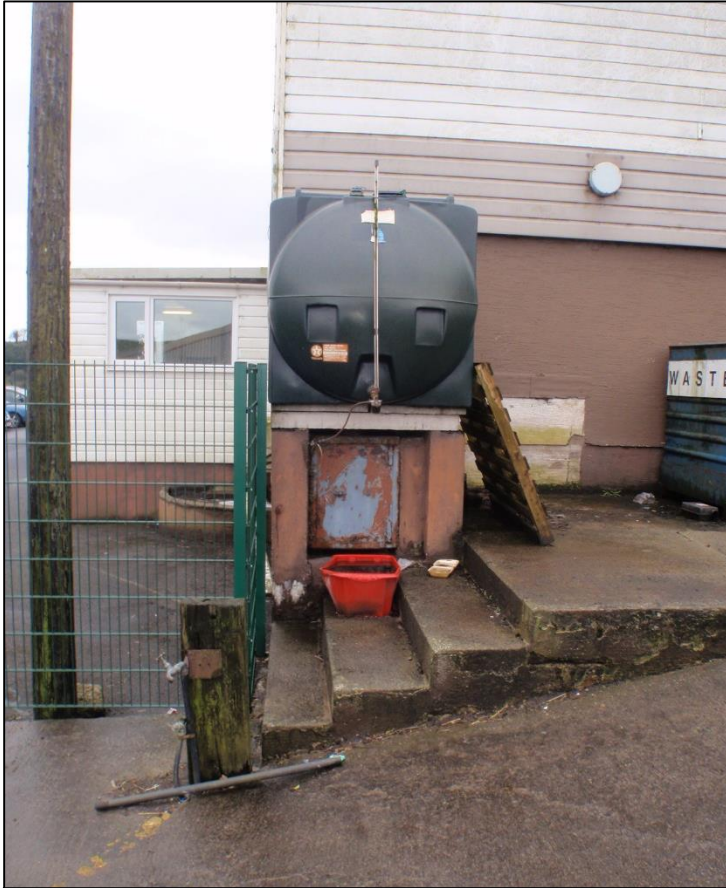
Section 2.3.2 of the May 2011 report makes the recommendation that the fuel oil tank adjacent to the main office (see photo 3) be placed in secondary containment. This recommendation has not been acted upon. The tank is positioned close to the main vehicular access and egress route and is at a higher risk of being struck and potentially breached. Given the uncertainties with regards to the surface water drainage network in this area an alternative siting should be considered.

Photo 3: Fuel oil tank adjacent to the main office not served by secondary containment

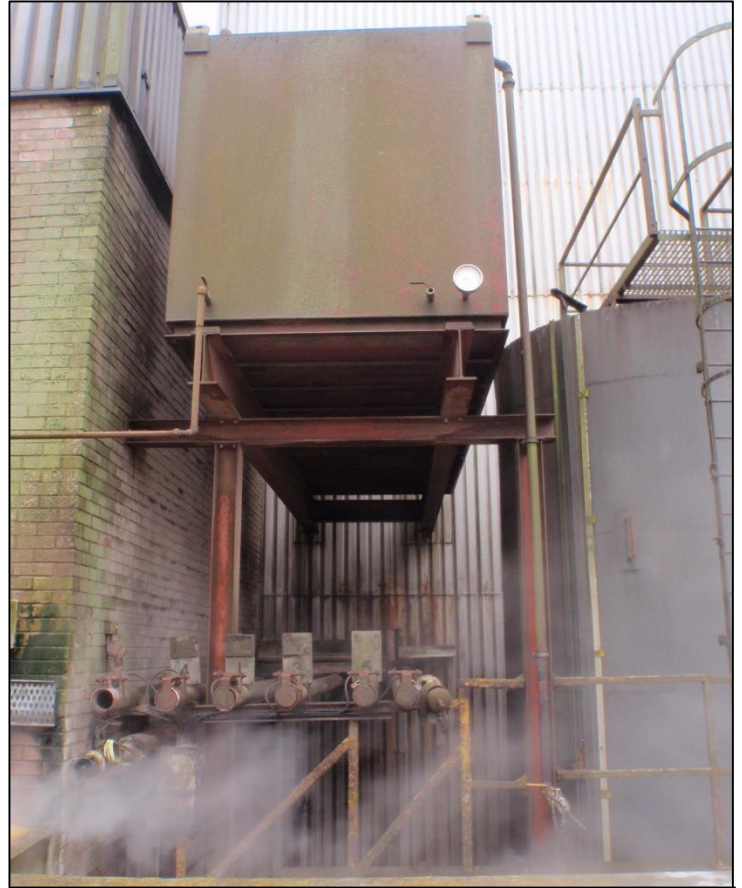
Photo 4: Fuel oil tank adjacent to the site workshop not served by secondary containment.

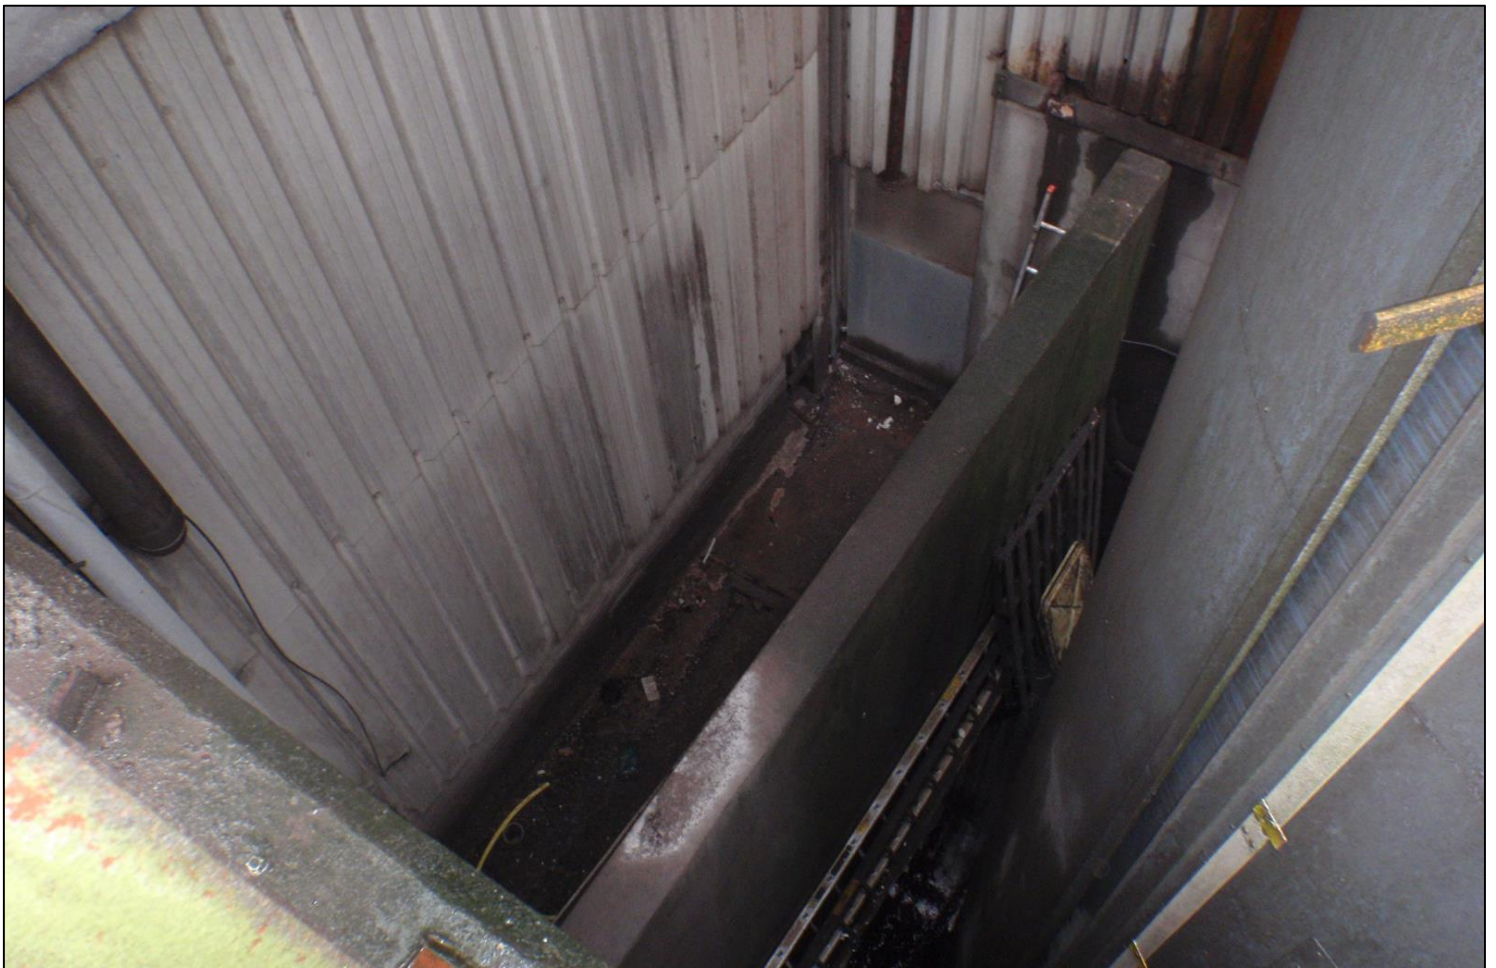
Photo 5: Below the fuel oil tank a partially rendered breeze block partition wall has been constructed. The fuel oil tank is positioned to the left of the partition wall, outside the bunded area. Any leaks (acute or chronic) from the fuel oil tank are therefore not captured by the bund and are able to escape.

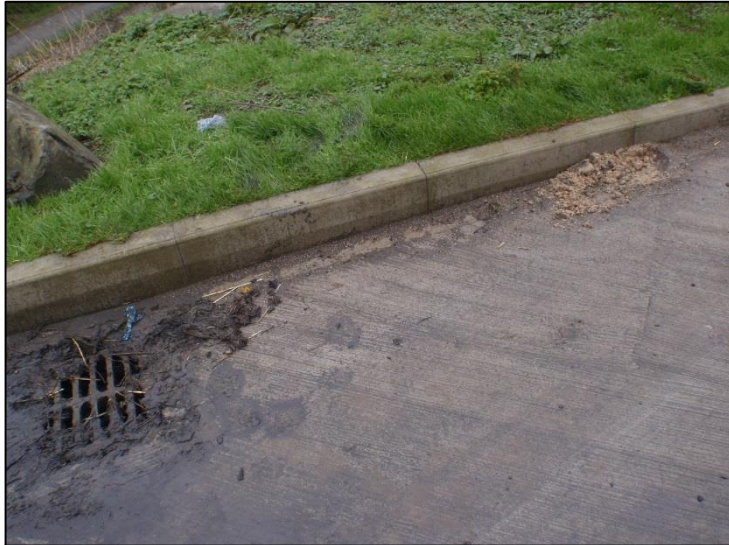
During our investigation following the pollution event on 10 February 2016 we identified general poor house-keeping across the operational area. Several spills of raw materials were observed across the site (see photo X). The soluble nature of this material will be contributing to potentially high BOD and nutrient enrichment in the surface water system. Evidence of enrichment in the form of fungus was found at many of the outfalls from the surface water drainage system (see photo X). The house keeping at the raw material feed delivery area was particularly poor with raw material fines covering every surface and 'caking' much of the integral infrastructure. Poor housekeeping will also contribute to fugitive emissions and the potential for odours.

Photo X: raw material spillage near surface water drainage gully as a result of poor house-keeping arrangements.

*Recommendation: Housekeeping procedures should be described in the Environment Management System including the recording of actions (e.g. daily/weekly checks). Records will be scrutinised during routine audits moving forward.*

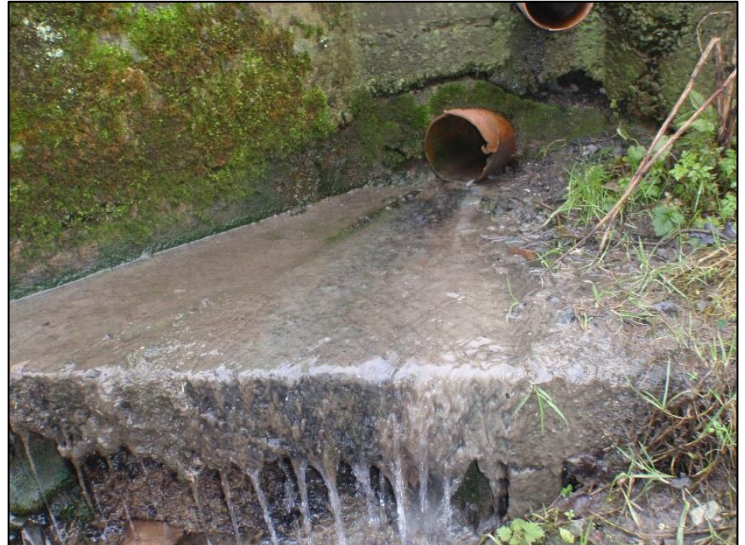
Photo X: Fungus in the vicinity of a discharging surface water drainage outfall.
