| | <b>EPR Compliance Assessment Report</b> | Report ID: 5265 |
| Site | Llysonnen Mill | Permit Ref EP3034GS |
| Operator/ Permit holder | Wynnstay Group PLC | |
| Date | 24 September 2013 | Time in 10:00 Out 12:30 |

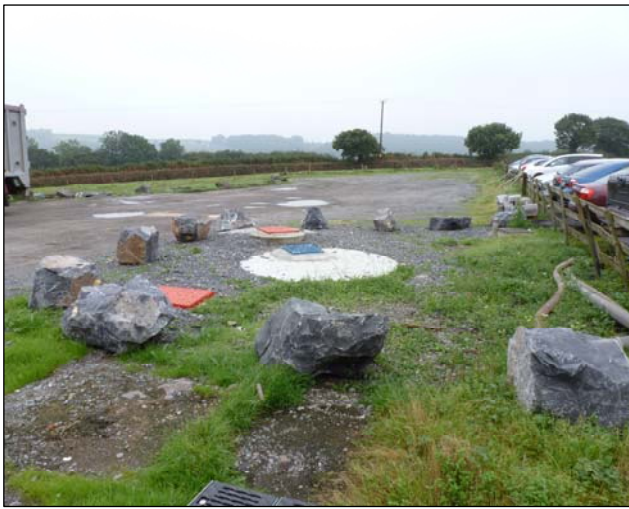
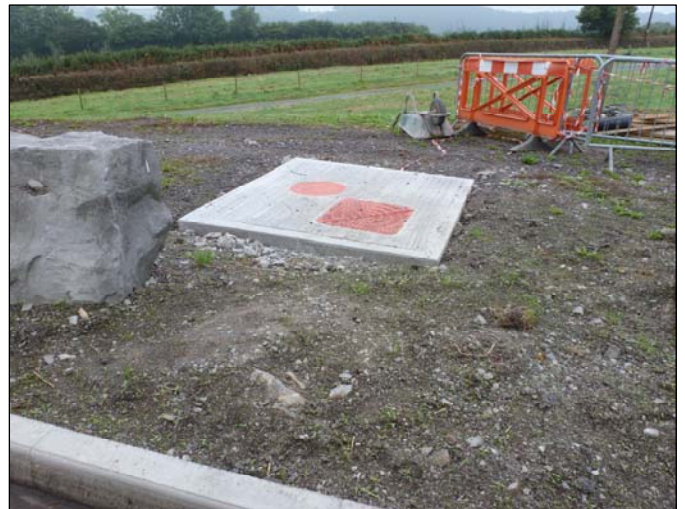
The photographs above were taken of the drainage works that have been undertaken closest to the site office. The clean surface water from the site office has been directed to the drain above left and the foul from that building goes to the sealed cesspit above right. Since the last visit improvements on the site drainage had clearly taken place and this should help with the long standing issue of elevated biological oxygen demand (BOD) on the discharge from the site.

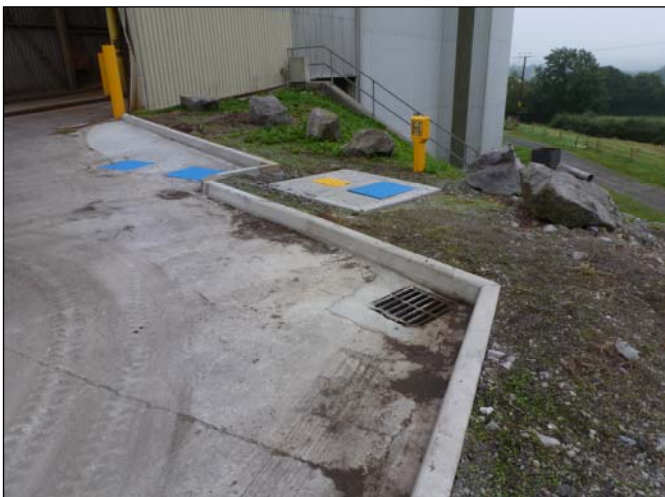
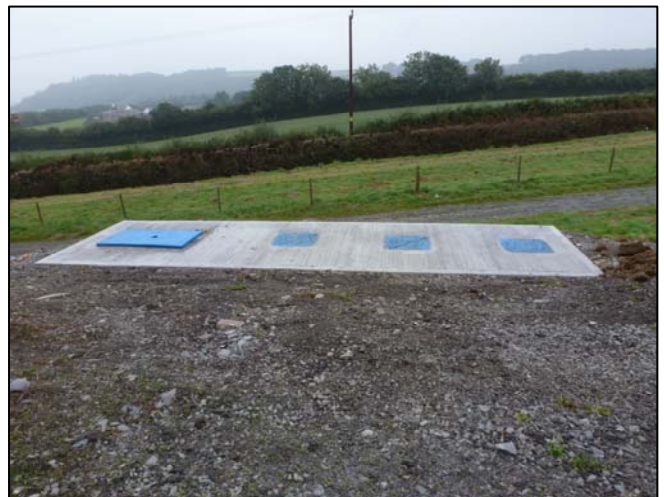
The photographs above were taken of the area close to the raw material intake, the interceptor had been colour coded and a concrete plinth installed to help with the continued maintenance. The photograph to the left shows the mains water to the site (yellow), newly installed kerbing and a new drain. This improvement work at the site will facilitate with the separation of clean from any contaminated surface water run-off in the yard.

**Action:** Operator to provide an up dated copy of the revised drainage plan following the completion of the improvement works on the site drainage.

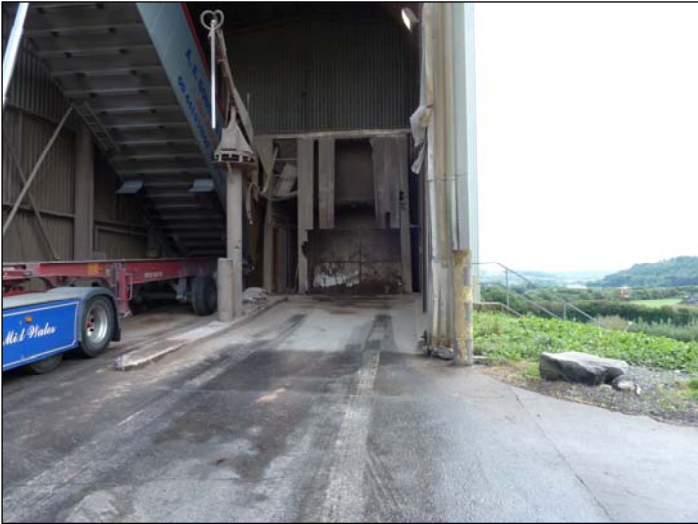
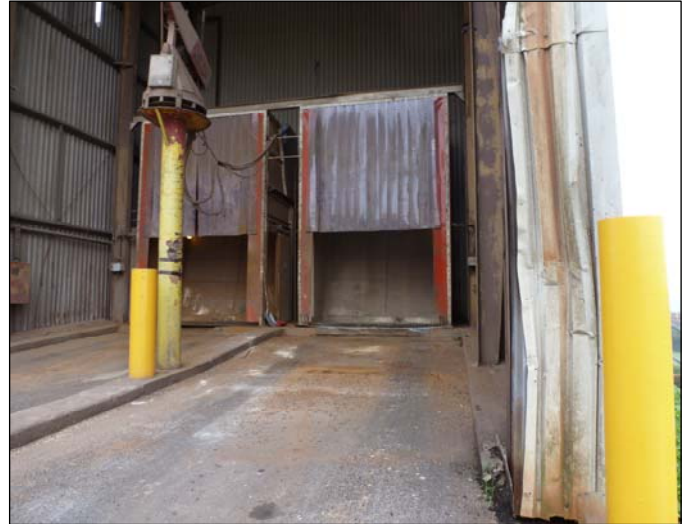
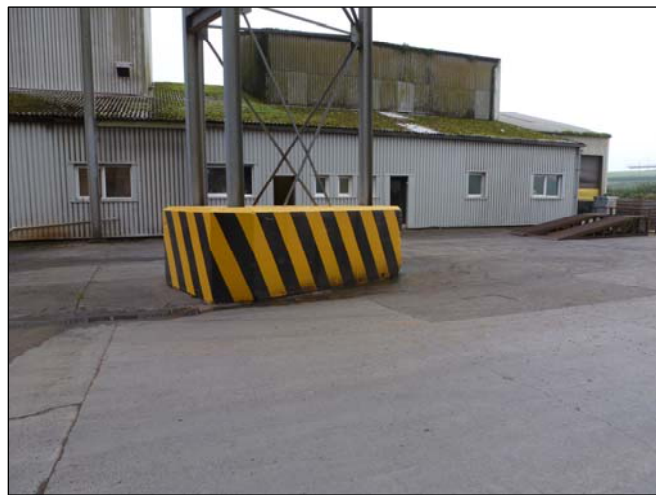
### Raw Material Intake 1 and 2

The photograph below left was taken during the site visit on the 21 September 2012 at that time damage was evident on the extraction curtain and dust could be seen in the bays. The photograph below right was taken during this visit and the difference on the bulk delivery raw intake bays was immediately noticeable. The bollards preventing damage to the building had been painted; the extraction system had been replaced including the plastic curtains to direct any dust into the abatement unit. The self cleaning of the extraction system was witnessed during the visit where loose feed is dislodged back down through the rubble separators for internal transfer to the appropriate silos or storage bins. New cameras have also been installed in the bay providing better management of a delivery from the main control room. The operator explained that drivers are also asked to use their grain 'socks' on their vehicles when making a delivery and this was sign posted in the control room.

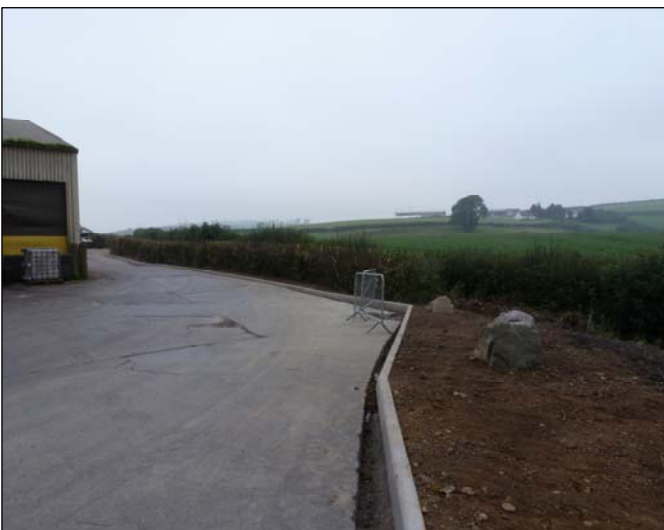
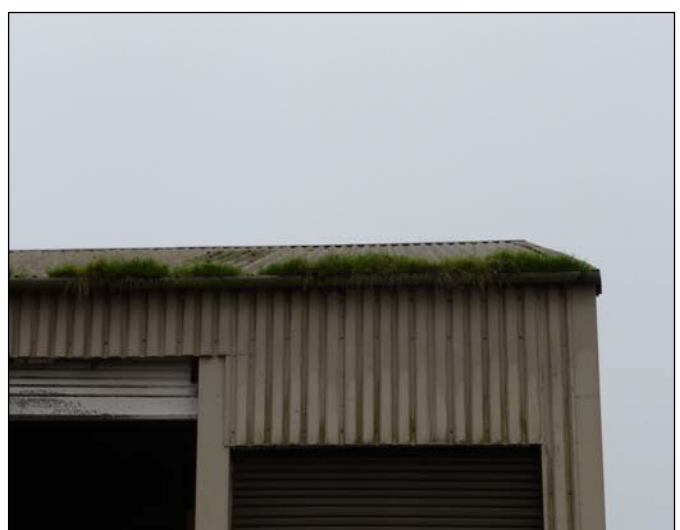
Drainage works to the north east corner of the site can be seen in the photograph below left with kerbing and a new surface water drain was under construction at the time of the visit. The drainage work has clearly made a positive difference to the site. There was some further maintenance work yet to be done to separate the clean water from the buildings in this location. HJ explained that a platform would be required to clean out the gutters which had some significant vegetation growth in them and this can be seen in the photograph below right.

A discussion was held with the operator regarding the drainage ditch and cesspit that serves the staff canteen in this location of the site. At the time of the visit the level alarm on the cesspit was going and HJ explained that it is alarming far too frequently (weekly basis). HJ stated that the cesspit may be filling up too quickly as it might have had a soak away associated with it or clean water is still entering the foul system. Investigatory work is on-going at the mill as part of the completion of the drainage works in order to determine the root cause of the foul drainage problem in this area.

**Action:** Operator to complete investigation and drainage work to ascertain the foul drainage problem concerning the cesspit that serves the staff canteen as this may be the root cause of the on-going issue concerning the high BOD in the discharge from W1.

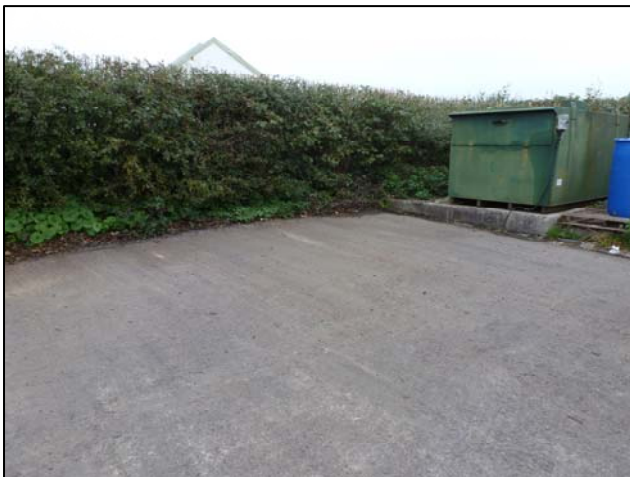
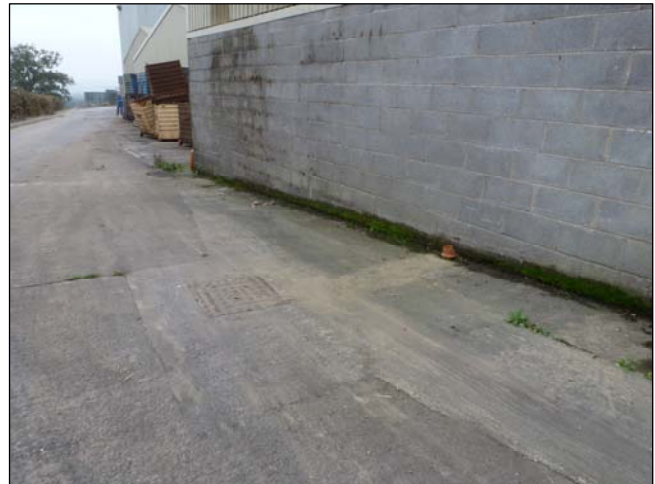
House-keeping on the site was good and this was evident along the northern boundary of the site with wastes having been removed from the drainage area around the fuel tank in the NW corner of the site. KD enquired about the drainage along the northern boundary as it was understood that an interceptor was present in this location and telemetry was due to be installed (CAR reference 4807). HJ explained that drainage investigations were not yet complete in this part of the site.

The photograph above left shows the fuel tank in the north west corner of the site. The photograph above right was taken of what was understood to be an oil interceptor and pipe-work for proposed telemetry on the building wall.

**Action:** Operator to provide clarity on the drainage in the NW corner of the site through the submission of an updated map on completion of the work.

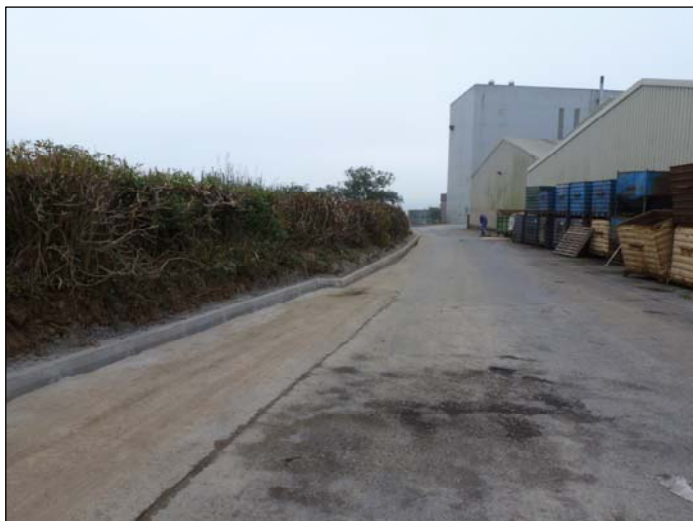
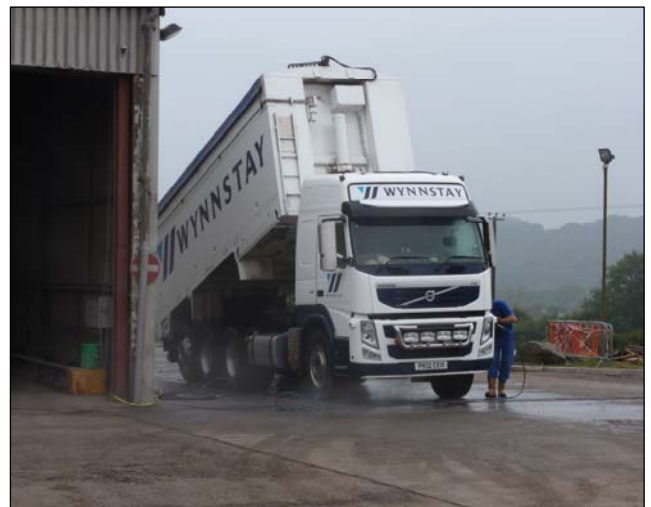
The photograph below left shows the improved kerbing and site boundary providing improved surface water management from the site

Progressing along the western boundary KD enquired about the site warehouse and a brief visit of this section was made. From the entrance to the warehouse a Wynnstay lorry was seen to be utilising the vehicle wash and this can be seen in the photograph above right

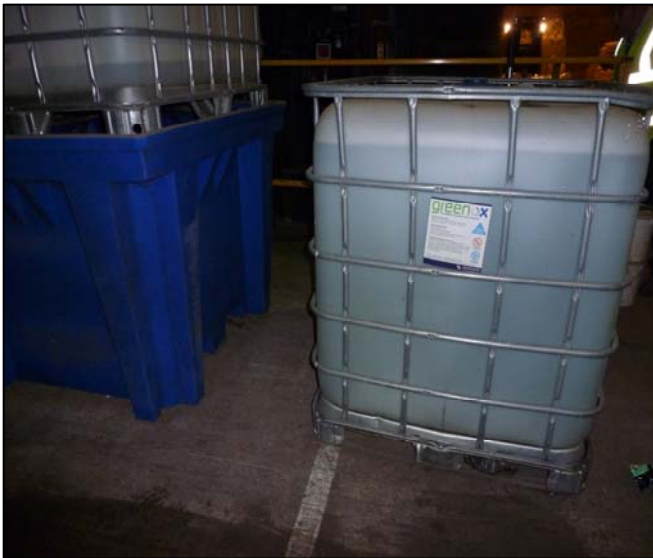
Housekeeping within the warehouse was also good however a full Integrated Bulk Container (IBC) of 'Adblue' was on the floor in the top part of the building. The IBC had been placed next to an almost empty one that was on a drip tray. KD progressed down the ramp from the top section of the warehouse to identify where the 'Adblue' would drain if compromised. There is a drain close to the bottom of the ramp within the warehouse however it was unclear if it was a surface water drain. Diesel Exhaust Fluid (DEF) commonly referred to as 'Adblue' can be extremely pollution to the aquatic environment as it will cause de-oxygenation of a water body.

The photograph opposite was taken of the full replacement IBC of Adblue on the floor of the warehouse next to the drip tray.

**Recommendation:** Operator to review Environment Agency Pollution Prevention Guidance (PPG) 26 'Drums and Integrated Bulk Containers' <http://www.environment-agency.gov.uk/business/topics/pollution/39083.aspx>

**Recommendation:** Operator to review the containment of liquids within the warehouse and in particular the storage of 'Adblue' in relation to any surface water drains. Operator to consider the use of the building to act as containment i.e. through kerbing, 'sleeping policeman' etc

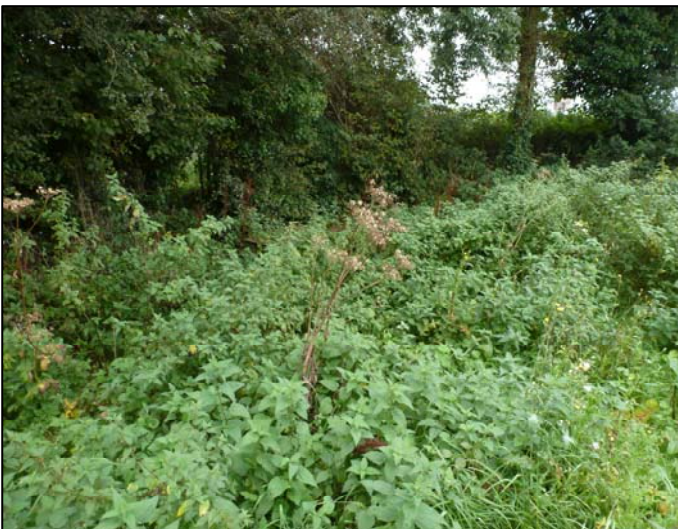
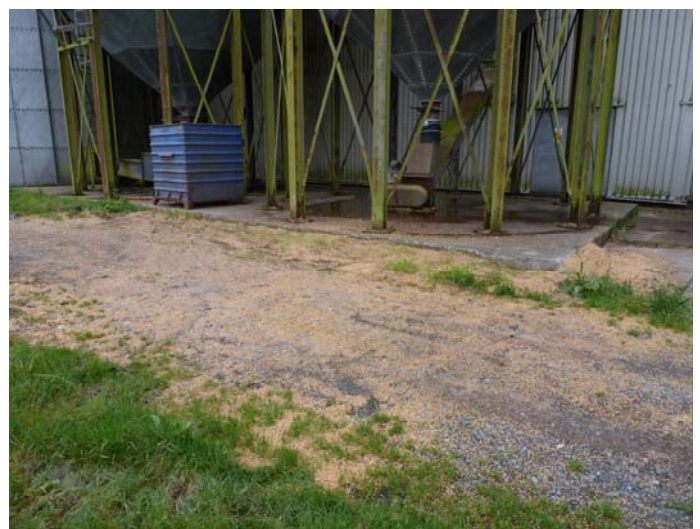
The visit progressed to sample point W1 in the eastern corner of the site, SC accompanied KD in this area. The sample point was overgrown making access difficult. As mentioned on previous visits the sample point needs to meet monitoring technical guidance note M18 <http://www.environment-agency.gov.uk/business/regulation/31831.aspx>. The sample point should be permanently labelled to ensure that staff are clear where to take the sample and it is truly representative of the discharge from the site. It was considered that the assessment of the sample point during this visit was non-compliant with permit condition 3.5.4 and has incurred a category 3 score. The photograph below left was taken of the overgrown sample location.

**Action:** Operator to review sample point (W1) at the Wynnstay mill to ensure compliance with permit condition 3.5.4.

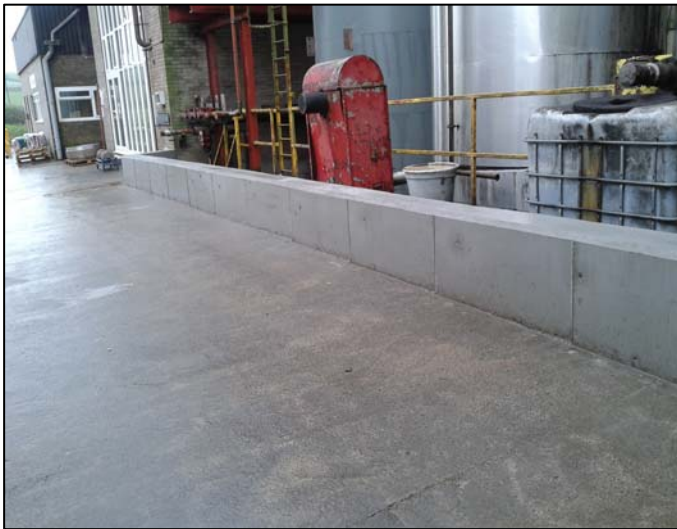
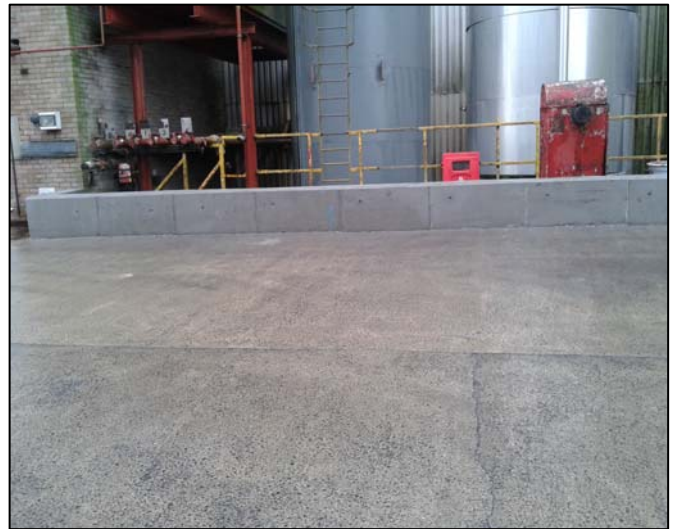
During the site visit the HJ informed KD of the proposal to improve the bund to the molasses and fat storage tanks. During the write up of this report the photographs below of improvements made to the delivery area and bund on the tank farm were sent to KD. This work forms part of the completion of the drainage work and improved surface water management system on site.
