## 1. General information

| Location Plan: | | St. Ishmael Sea Wall | |
| | | Assessment Date: 29/07/2020 | |
| | | CARRS Exam ID: | 2960028 |

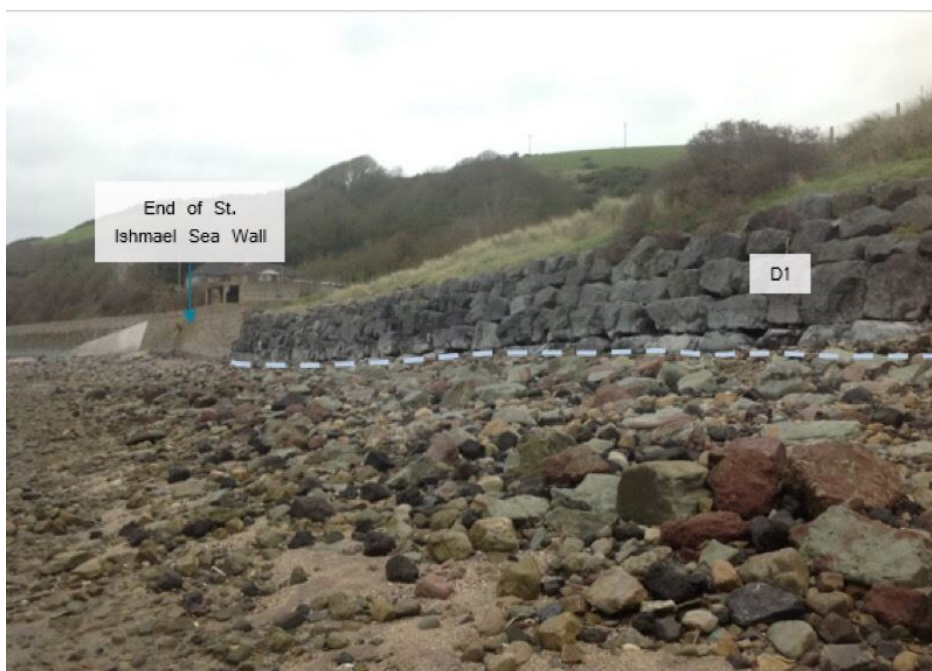
**Photo number: 23**

Adjacent asset of unknown ownership protecting the railway. Some sections have minimal coastal protection and appear vulnerable. No change between 2014 and 2020 inspections.

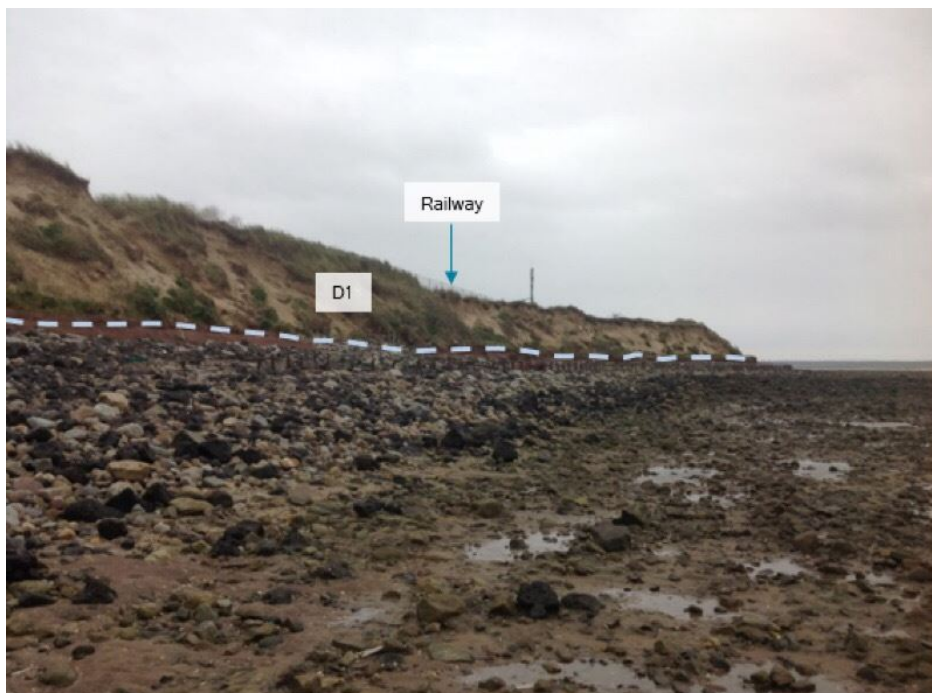
**Photo number: 24**

Adjacent asset of unknown ownership protecting the railway. Some sections have minimal coastal protection and appear vulnerable. No change between 2014 and 2020 inspections.

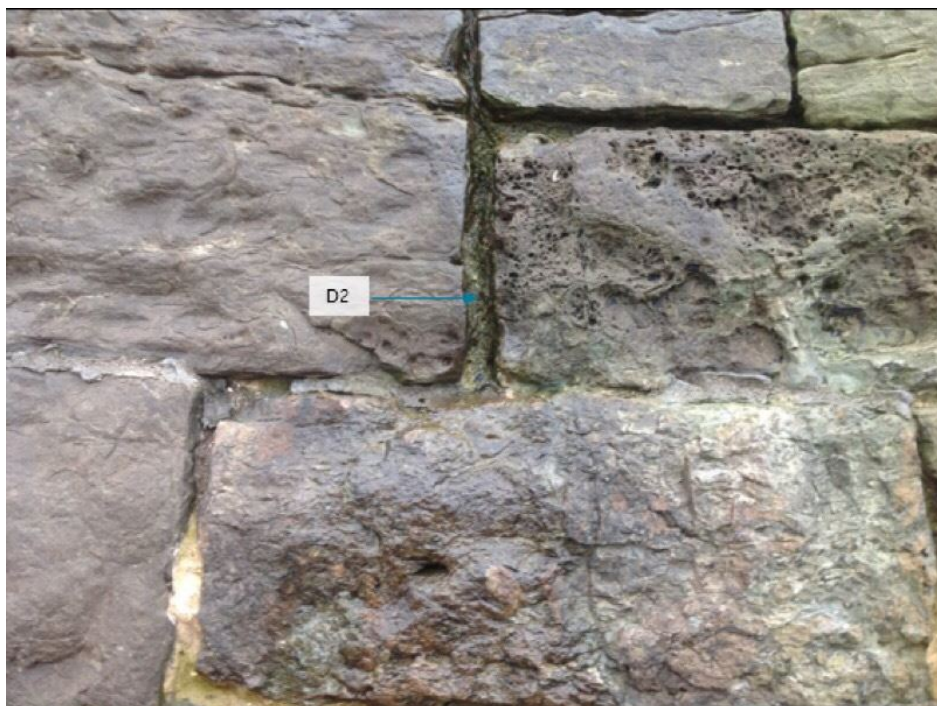
**Photo number: 25**

| Defect Ref No. | Defect Location (NGR) | Major Element | Minor Element | Photo Ref | Severity | Probability | Risk Score | Below MHWS | Defect Description | Recommendations | Defect Priority |
|---|---|---|---|---|---|---|---|---|---|---|---|
| D2 | 236200, 208300 | Wall | Parapet/Capping | 25, 26, 46, 47 | 2 | 3 | 6 | True | Open joints, if left unrepaired further deterioration is expected. No change between 2014 and 2020 inspections. | Repoint missing and worn mortar between masonry units. | 5 |

**Description:** Open joints, if left unrepaired further deterioration is expected. No change between 2014 and 2020 inspections.

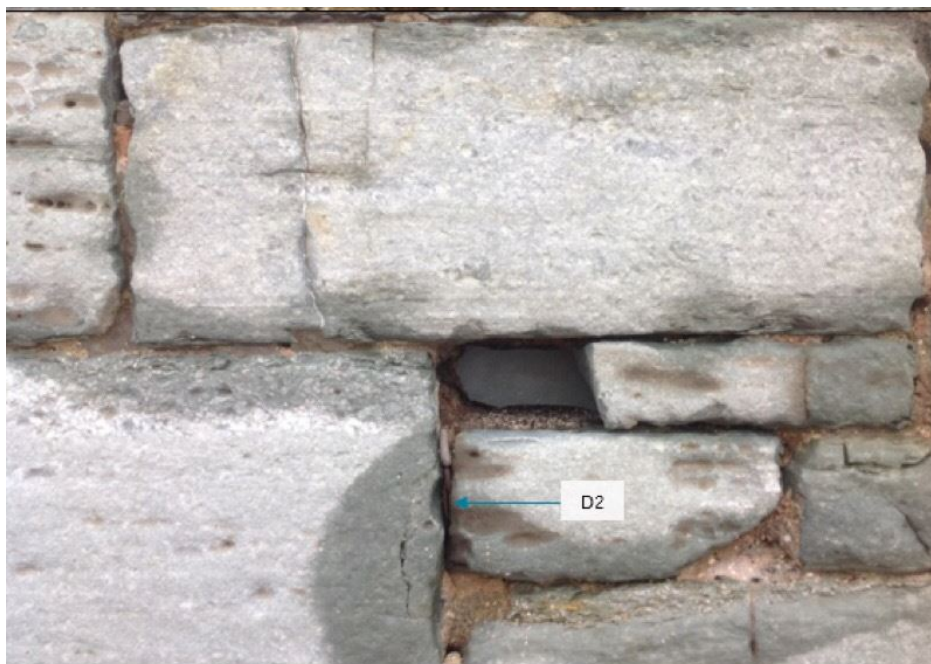
**Section A**  
**Parapet/Capping**  
**Defect Ref: D2**  
**Description:** Open joints, if left unrepaired further deterioration is expected. No change between 2014 and 2020 inspections.  
**Photo number: 26**

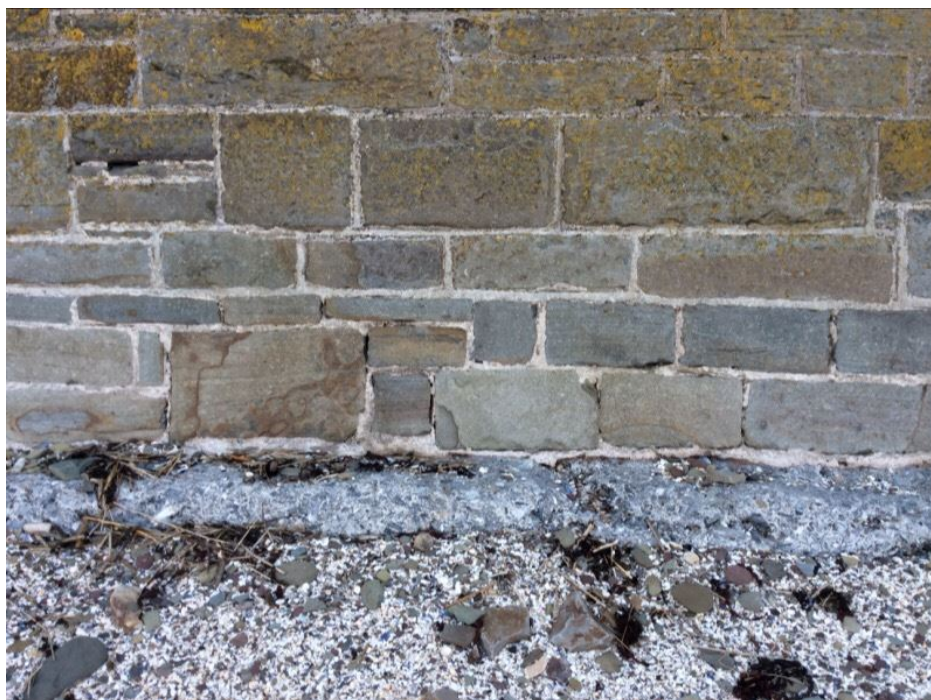
**Section A**  
**Parapet/Capping**  
**Defect Ref: D2**  
**Description:** Open joints, if left unrepaired further deterioration is expected. No change between 2014 and 2020 inspections.  
**Photo number: 46**

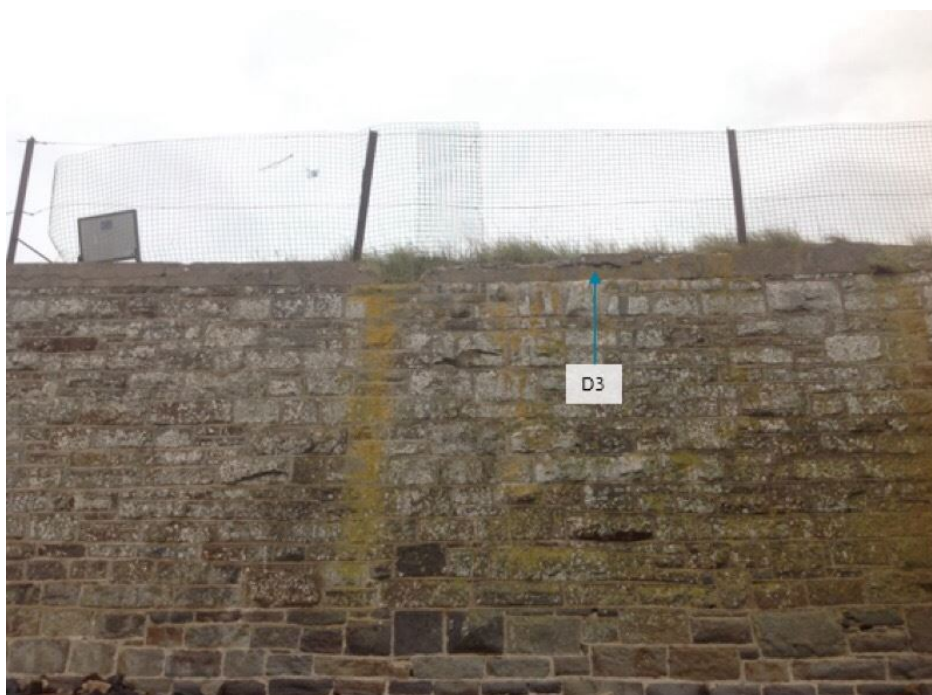
**Photo number: 27**

| Defect Ref No. | Defect Location (NGR) | Major Element | Minor Element | Photo Ref | Severity | Probability | Risk Score | Below MHWS | Defect Description | Recommendations | Defect Priority |
|---|---|---|---|---|---|---|---|---|---|---|---|
| D3 | 236192, 208210 | Embankment | Capping Wall | 27, 48 | 2 | 3 | 6 | False | Cracks in capping beam, if left unrepaired further deterioration is expected. No change between 2014 and 2020 inspections. | Replace capping beam. | 7 |

**Description:** Cracks in capping beam, if left unrepaired further deterioration is expected. No change between 2014 and 2020 inspections.

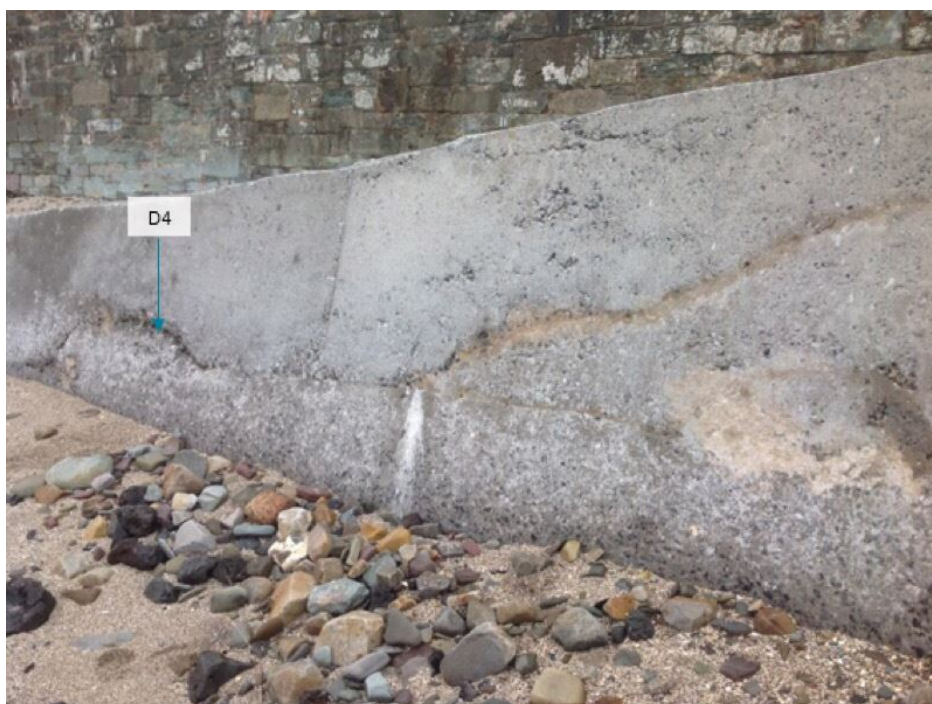
**Photo number: 28**

| Defect Ref No. | Defect Location (NGR) | Major Element | Minor Element | Photo Ref | Severity | Probability | Risk Score | Below MHWS | Defect Description | Recommendations | Defect Priority |
|---|---|---|---|---|---|---|---|---|---|---|---|
| D4 | 236187, 208259 | Wall | Wall section | 28, 49 | 2 | 2 | 4 | True | Spalling concrete access ramp. No change between 2014 and 2020 inspections. | Monitor and consider repairing damaged and exposed sections. | 9 |

**Description:** Spalling concrete access ramp. No change between 2014 and 2020 inspections.

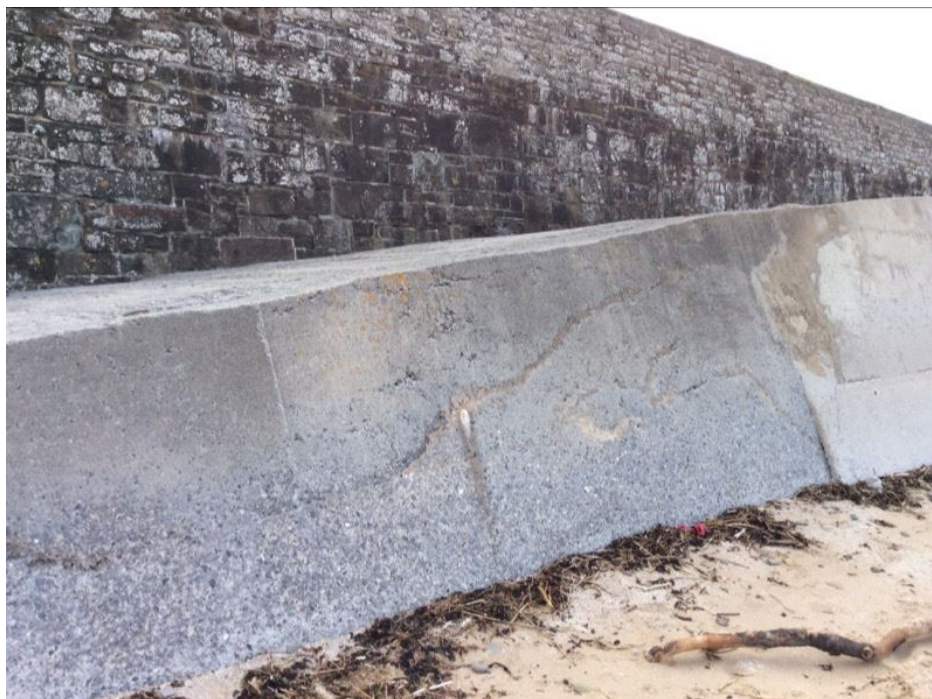
**Section A**  
**Wall section**  
**Defect Ref: D4**  
**Description:** Spalling concrete access ramp. No change between 2014 and 2020 inspections.  
**Photo number: 49**

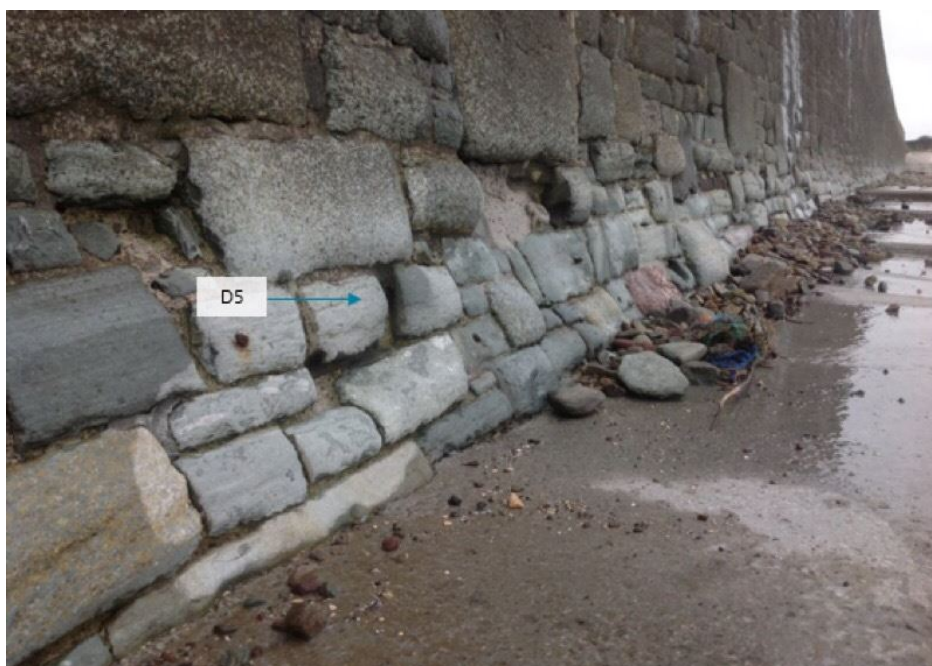
| Defect Ref No. | Defect Location (NGR) | Major Element | Minor Element | Photo Ref | Severity | Probability | Risk Score | Below MHWS | Defect Description | Recommendations | Defect Priority |
|---|---|---|---|---|---|---|---|---|---|---|---|
| D5 | 236200, 208300 | Wall | Wall section | 29, 52 | 2 | 2 | 4 | True | Erosion of masonry. Long term deterioration of the structure, further exposing joints. Between 2014 and 2020, a minor increase in weathering of the masonry has been observed. | Monitor the deterioration of masonry blocks as part of annual maintenance plan. | 8 |

**Section A**  
**Wall section**  
**Defect Ref: D5**  
**Description:** Erosion of masonry. Long term deterioration of the structure, further exposing joints. Between 2014 and 2020, a minor increase in weathering of the masonry has been observed.  
**Photo number: 29**

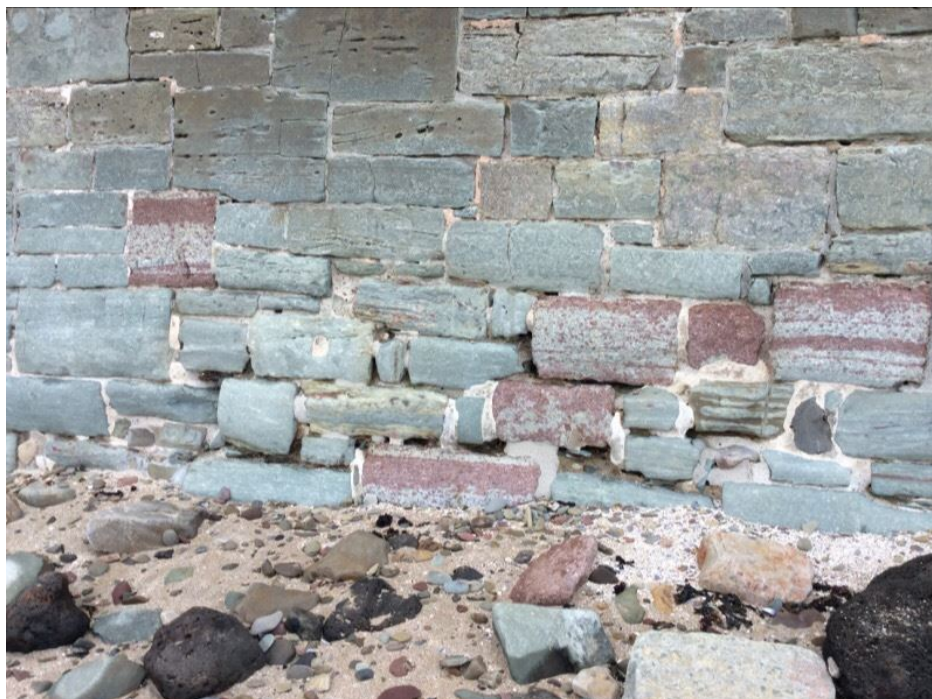
**Section A**  
**Wall section**  
**Defect Ref: D5**  
**Description:** Erosion of masonry. Long term deterioration of the structure, further exposing joints. Between 2014 and 2020, a minor increase in weathering of the masonry has been observed.  
**Photo number: 52**

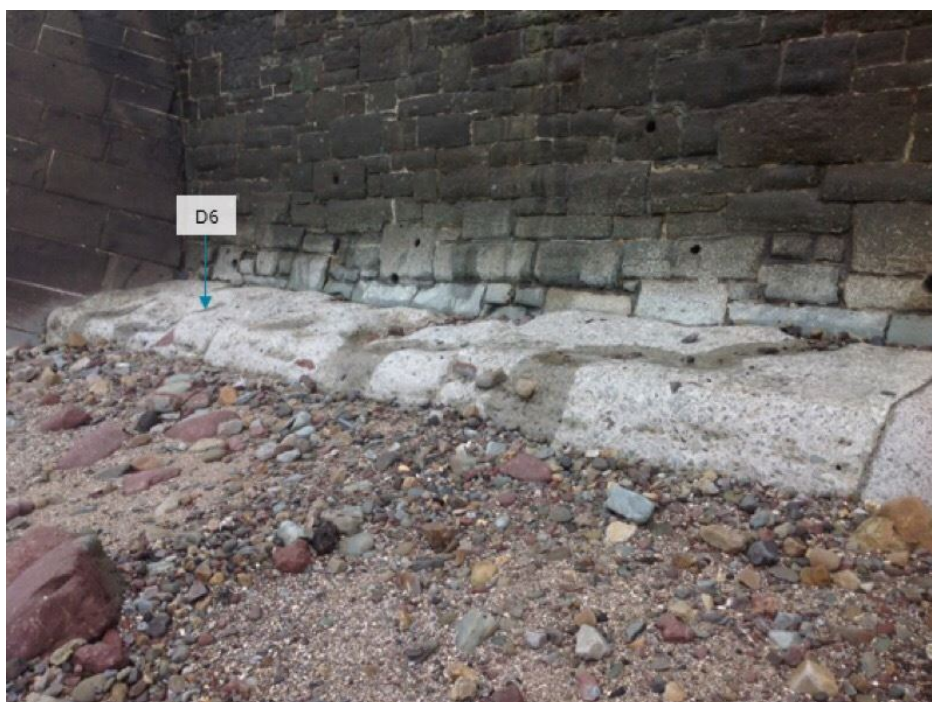
| Defect Ref No. | Defect Location (NGR) | Major Element | Minor Element | Photo Ref | Severity | Probability | Risk Score | Below MHWS | Defect Description | Recommendations | Defect Priority |
|---|---|---|---|---|---|---|---|---|---|---|---|
| D6 | 236152, 208434 | Wall | Wall Apron | 30, 55 | 2 | 2 | 4 | True | Sections of the concrete apron are showing signs of significant deterioration. No change between 2014 and 2020 inspections. | Consider replacing apron sections. | 4 |

**Section A**  
**Wall Apron**  
**Defect Ref: D6**  
**Description:** Sections of the concrete apron are showing signs of significant deterioration. No change between 2014 and 2020 inspections.  
**Photo number: 30**

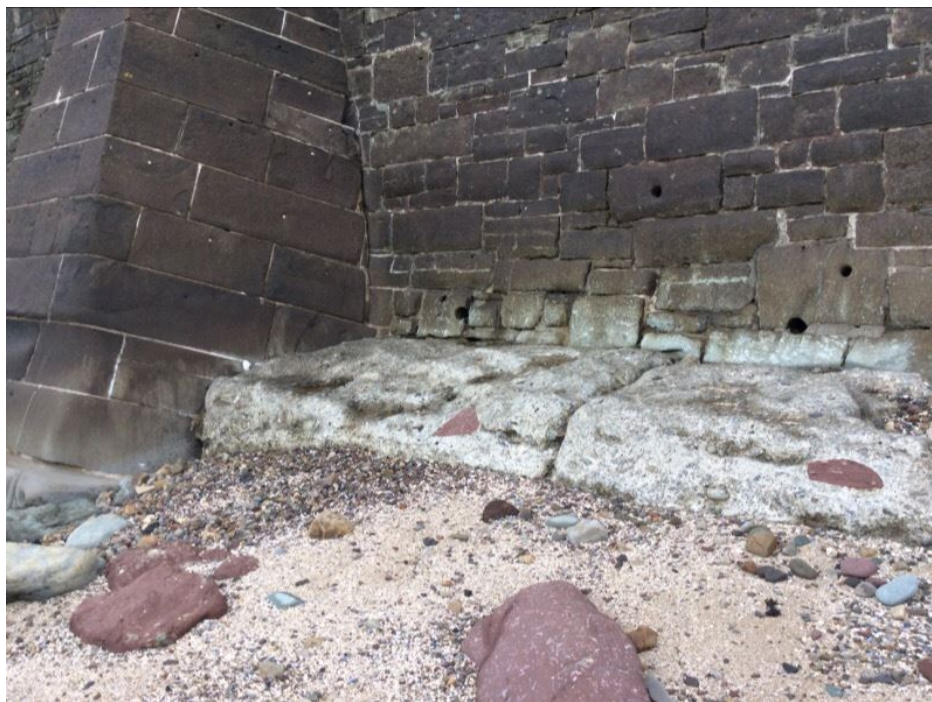
**Section A**  
**Wall Apron**  
**Defect Ref: D6**  
**Description:**  
Sections of the concrete apron are showing signs of significant deterioration. No change between 2014 and 2020 inspections.  
**Photo number: 55**

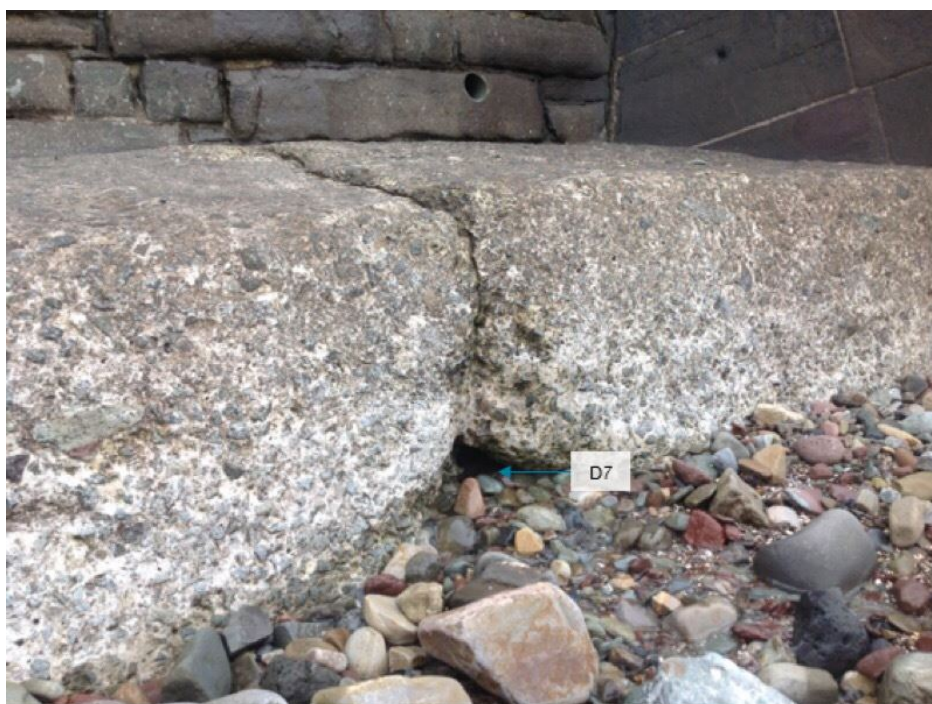
| Defect Ref No. | Defect Location (NGR) | Major Element | Minor Element | Photo Ref | Severity | Probability | Risk Score | Below MHWS | Defect Description | Recommendations | Defect Priority |
|---|---|---|---|---|---|---|---|---|---|---|---|
| D7 | 236150, 208447 | Wall | Wall Apron | 31, 56, 57 | 4 | 4 | 16 | True | Drainage flow passing under apron. Between 2014 and 2020, a large increase in drainage flow under the apron was observed (1m by 300*300). | Repair and fill damaged apron. Provide additional drainage in the base of the wall. | 2 |

**Section A**  
**Wall Apron**  
**Defect Ref: D7**  
**Description:**  
Drainage flow passing under apron. Between 2014 and 2020, a large increase in drainage flow under the apron was observed (1m by 300\*300).  
**Photo number: 31**

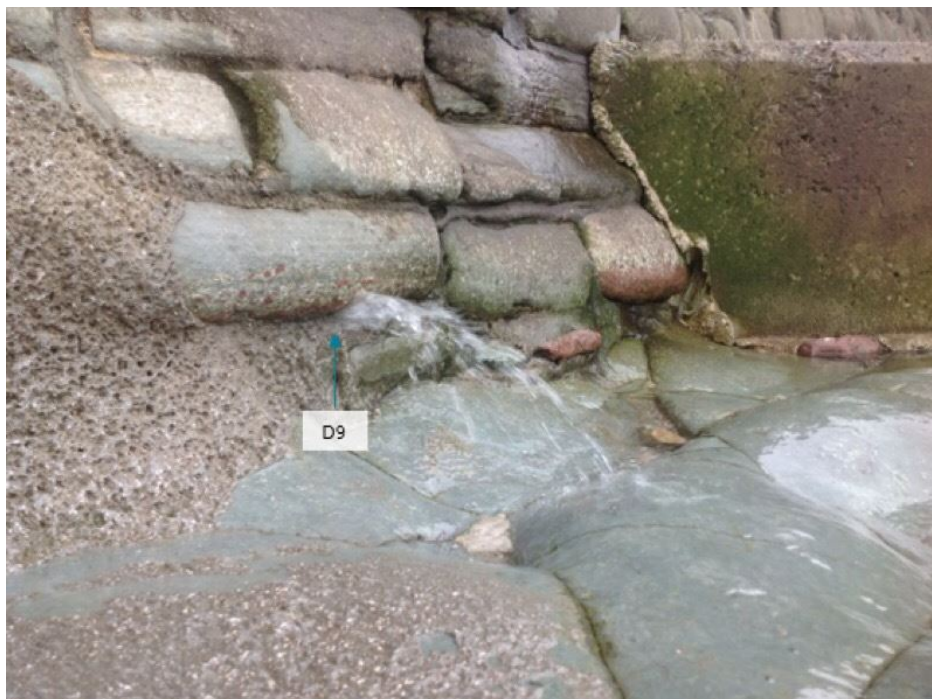
**Photo number: 33**

| Defect Ref No. | Defect Location (NGR) | Major Element | Minor Element | Photo Ref | Severity | Probability | Risk Score | Below MHWS | Defect Description | Recommendations | Defect Priority |
|---|---|---|---|---|---|---|---|---|---|---|---|
| D9 | 236142, 208480 | Wall | Wall section | 33, 59 | 1 | 2 | 2 | True | High pressure water draining through voids in sea wall. Between 2014 and 2020 the voids were repaired and visible water drainage was no longer present during the 2020 inspection. | Provide additional drainage capacity through the wall if none present with repair. | 11 |

**Description:** High pressure water draining through voids in sea wall. Between 2014 and 2020 the voids were repaired and visible water drainage was no longer present during the 2020 inspection.

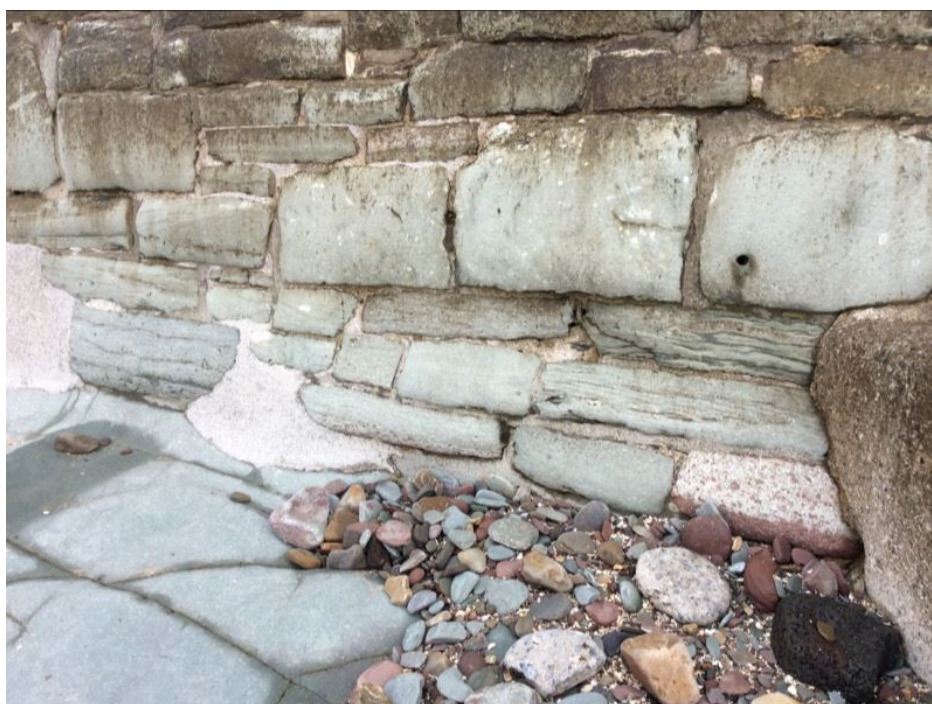
**Description:** High pressure water draining through voids in sea wall. Between 2014 and 2020 the voids were repaired and visible water drainage was no longer present during the 2020 inspection.

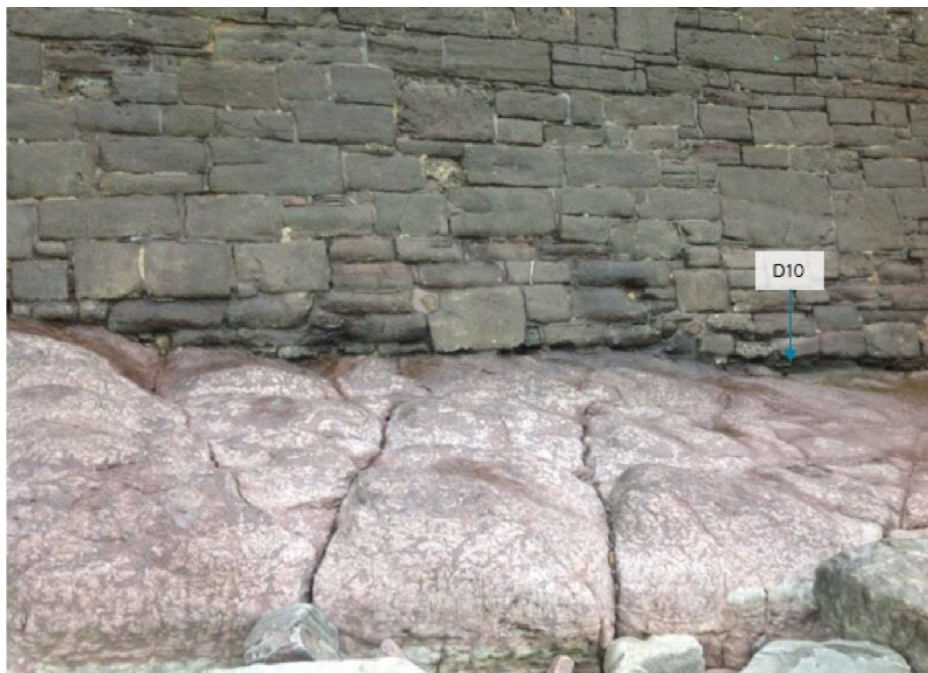
| Defect Ref No. | Defect Location (NGR) | Major Element | Minor Element | Photo Ref | Severity | Probability | Risk Score | Below MHWS | Defect Description | Recommendations | Defect Priority |
|---|---|---|---|---|---|---|---|---|---|---|---|
| D10 | 236130, 208520 | Wall | Wall section | 34 | 2 | 2 | 4 | True | Erosion at the connection between the sea wall and natural rock foundation. No change between 2014 and 2020, potentially due to protection afforded by rock armour in front of apron. | Repoint missing and worn mortar between masonry units. | 5 |

**Section A**  
**Wall section**  
**Defect Ref: D10**  
**Description:** Erosion at the connection between the sea wall and natural rock foundation. No change between 2014 and 2020, potentially due to protection afforded by rock armour in front of apron.  
**Photo number: 34**

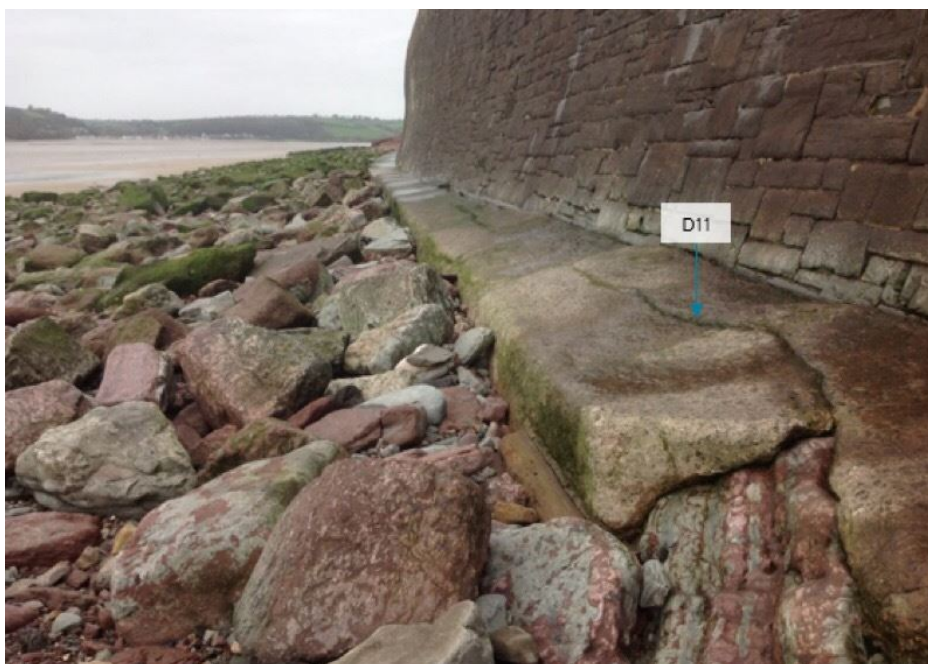
| Defect Ref No. | Defect Location (NGR) | Major Element | Minor Element | Photo Ref | Severity | Probability | Risk Score | Below MHWS | Defect Description | Recommendations | Defect Priority |
|---|---|---|---|---|---|---|---|---|---|---|---|
| D11 | 236112, 208623 | Wall | Wall Apron | 35 | 2 | 3 | 6 | True | Large fractures in concrete apron. No change between 2014 and 2020, potentially due to protection afforded by rock armour in front of apron. | Consider replacing apron sections. | 5 |

**Section A**  
**Wall Apron**  
**Defect Ref: D11**  
**Description:** Large fractures in concrete apron. No change between 2014 and 2020, potentially due to protection afforded by rock armour in front of apron.  
**Photo number: 35**

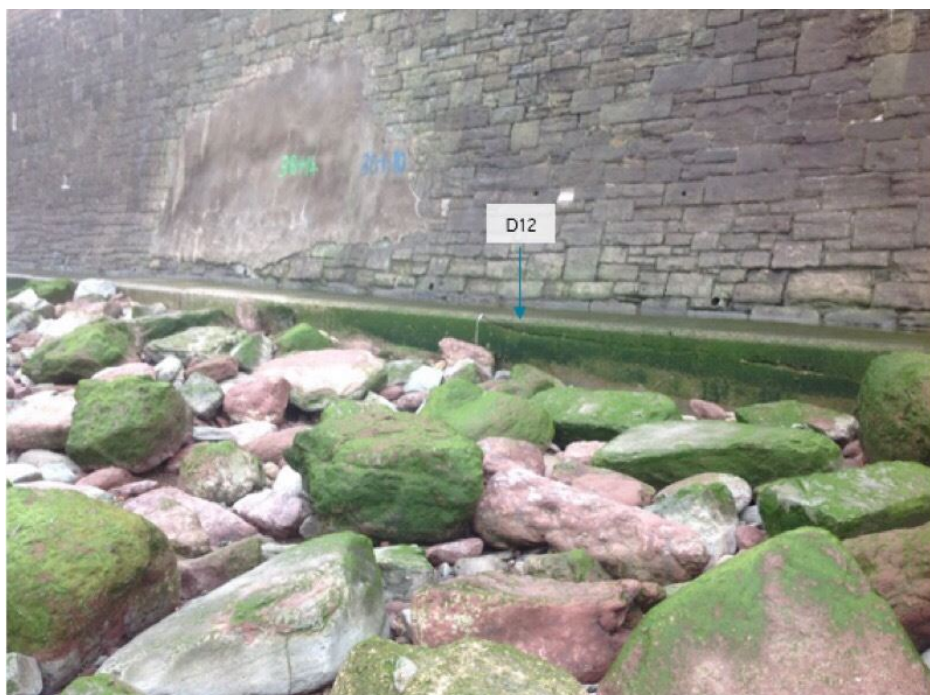
**Photo number: 36**

**Description:** Large accumulations of algae growing on wall apron. No change between 2014 and 2020, potentially due to protection afforded by rock armour in front of apron.

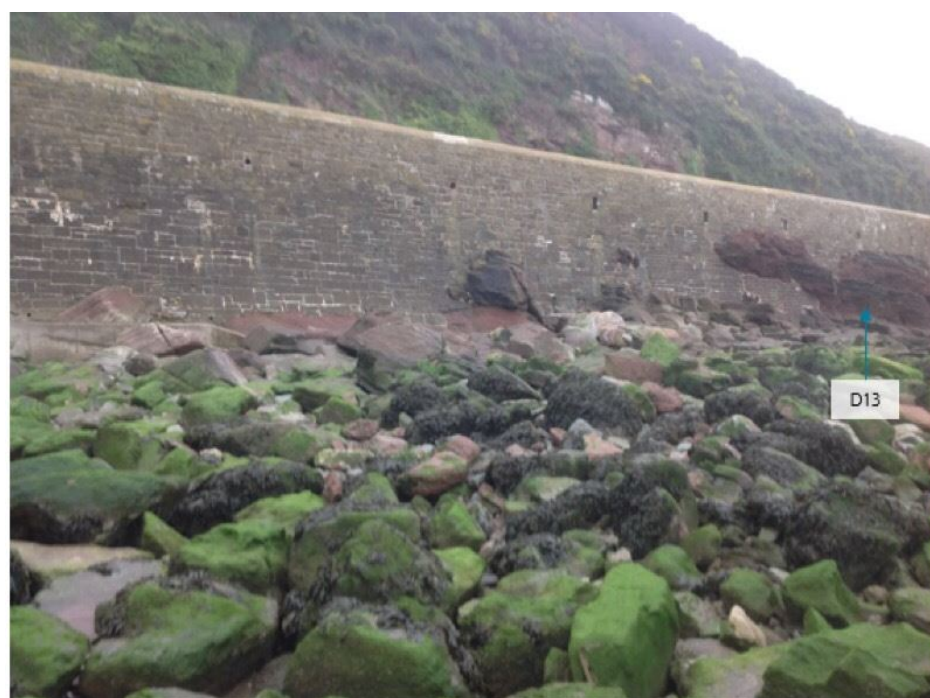
**Photo number: 38**

| Defect Ref No. | Defect Location (NGR) | Major Element | Minor Element | Photo Ref | Severity | Probability | Risk Score | Below MHWS | Defect Description | Recommendations | Defect Priority |
|---|---|---|---|---|---|---|---|---|---|---|---|
| D13 | 236200, 208300 | Wall | Wall section | 38, 63 | 2 | 2 | 4 | True | Erosion of the natural rock forming part of the sea wall. No change between 2014 and 2020 inspections. | Monitor and replace with a masonry or concrete face when it is no longer an effective defence. | 10 |

**Description:** Erosion of the natural rock forming part of the sea wall. No change between 2014 and 2020 inspections.

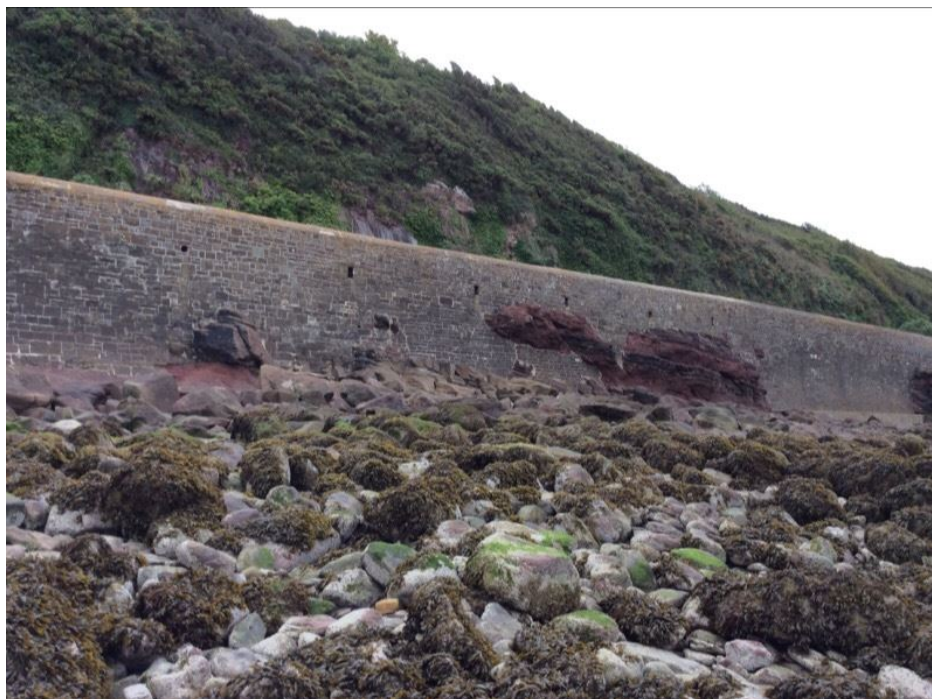
**Section A**  
**Wall section**  
**Defect Ref: D13**  
**Description:** Erosion of the natural rock forming part of the sea wall. No change between 2014 and 2020 inspections.  
**Photo number: 63**

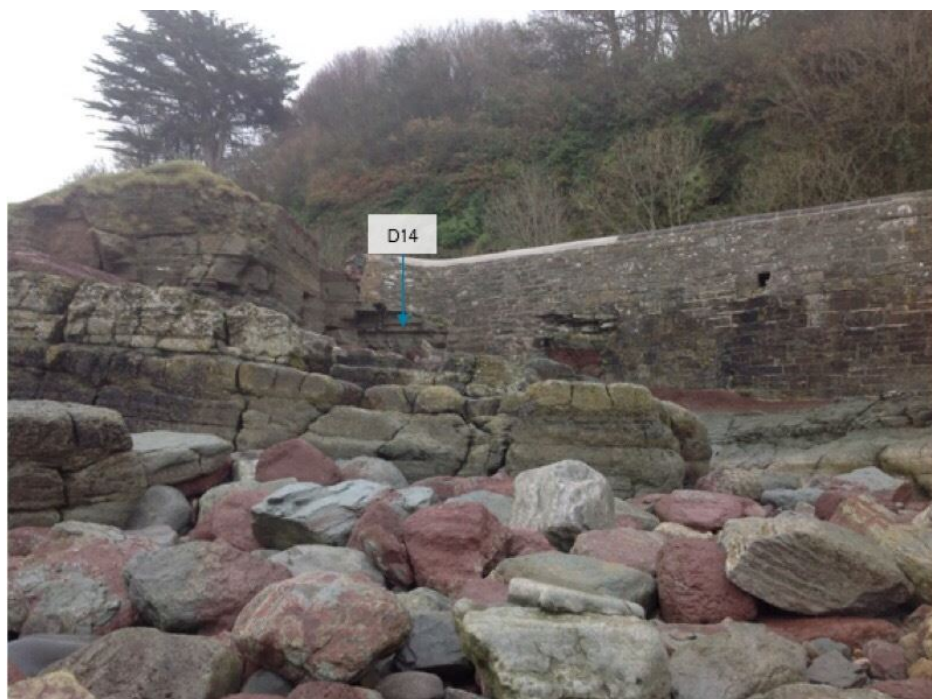
| Defect Ref No. | Defect Location (NGR) | Major Element | Minor Element | Photo Ref | Severity | Probability | Risk Score | Below MHWS | Defect Description | Recommendations | Defect Priority |
|---|---|---|---|---|---|---|---|---|---|---|---|
| D14 | 236189, 209256 | Wall | Wall section | 39, 65, 66, 67 | 1 | 2 | 2 | True | Poor tie-in with natural rock foundations. Between 2014 and 2020 the material has continued to separate from the foundations. | Repoint missing and worn mortar between masonry and natural foundation. Consider replacing tie in. | 5 |

**Section A**  
**Wall section**  
**Defect Ref: D14**  
**Description:** Poor tie-in with natural rock foundations. Between 2014 and 2020 the material has continued to separate from the foundations.  
**Photo number: 39**

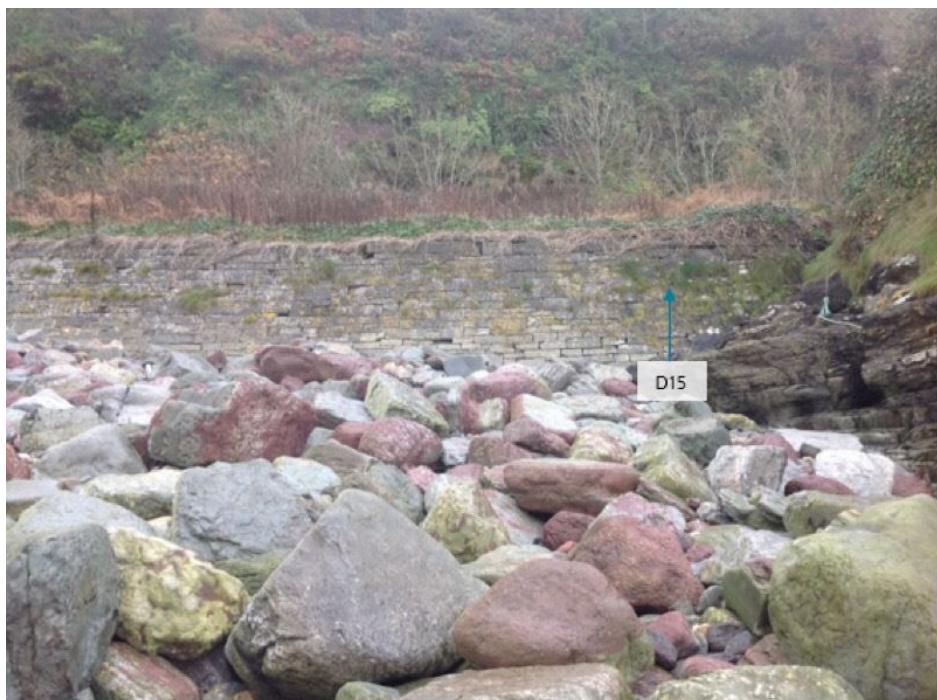
| Defect Ref No. | Defect Location (NGR) | Major Element | Minor Element | Photo Ref | Severity | Probability | Risk Score | Below MHWS | Defect Description | Recommendations | Defect Priority |
|---|---|---|---|---|---|---|---|---|---|---|---|
| D15 | N/A | Embankment | Capping Wall | 37, 68 | 2 | 2 | 4 | False | Vegetation growth could weaken embankment pitching and cause localised structural damage. Between 2014 and 2020 minor increases in vegetation growth were observed. | Remove vegetation, and repair any damage caused. | 6 |

**Description:** Vegetation growth could weaken embankment pitching and cause localised structural damage. Between 2014 and 2020 minor increases in vegetation growth were observed.  
**Photo number: 37**

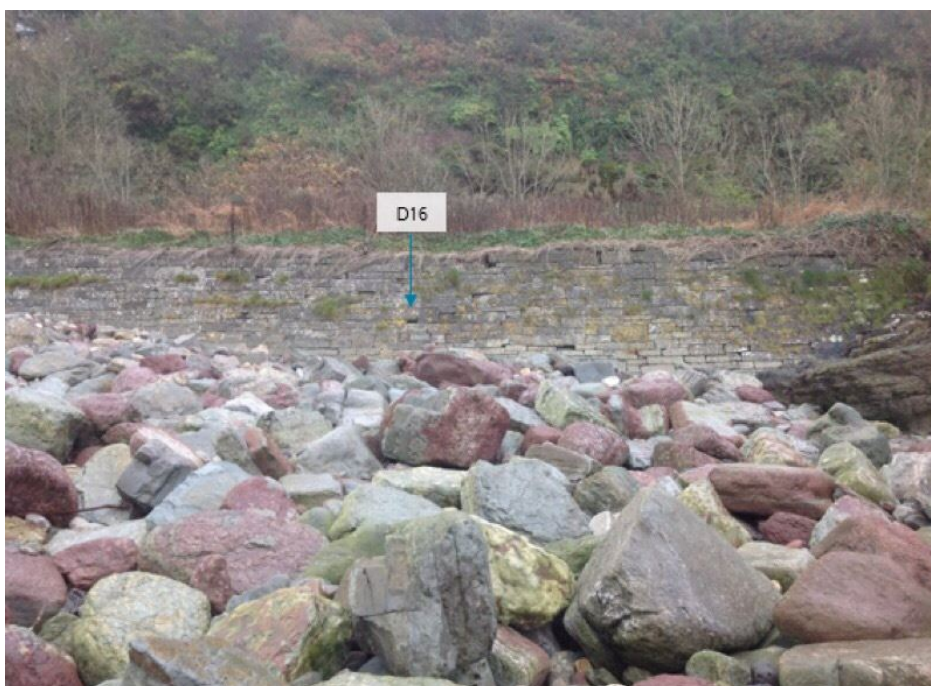
**Photo number: 40**

| Defect Ref No. | Defect Location (NGR) | Major Element | Minor Element | Photo Ref | Severity | Probability | Risk Score | Below MHWS | Defect Description | Recommendations | Defect Priority |
|---|---|---|---|---|---|---|---|---|---|---|---|
| D16 | 236200, 208300 | Wall | Wall section | 40, 64, 69 | 3 | 2 | 6 | True | Open joints, if left unrepaired further deterioration of the wall is expected. No change between 2014 and 2020 inspections. | Repair missing and worn pointing and extend rock armour protection. | 4 |

**Description:** Open joints, if left unrepaired further deterioration of the wall is expected. No change between 2014 and 2020 inspections.

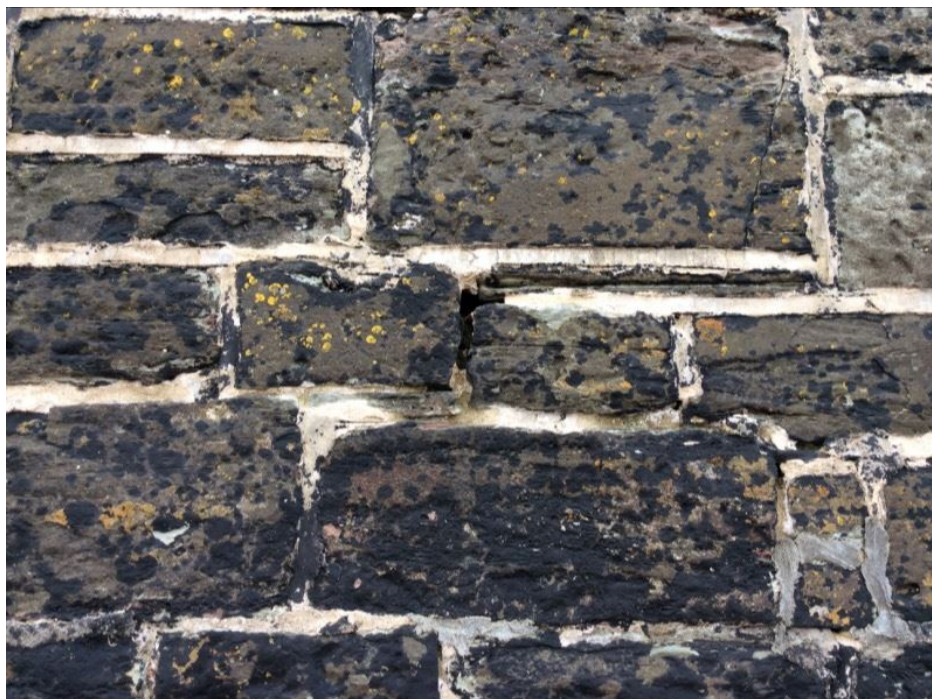
**Section A**  
**Wall section**  
**Defect Ref: D16**  
**Description:** Open joints, if left unrepaired further deterioration of the wall is expected. No change between 2014 and 2020 inspections.  
**Photo number: 64**

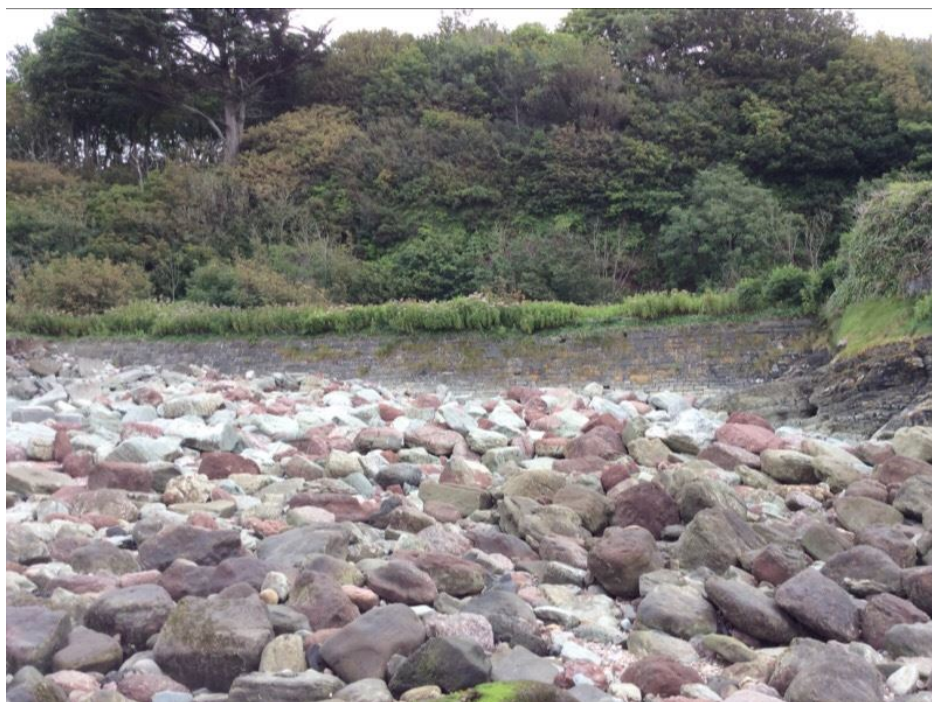
**Section A**  
**Wall section**  
**Defect Ref: D16**  
**Description:** Open joints, if left unrepaired further deterioration of the wall is expected. No change between 2014 and 2020 inspections.  
**Photo number: 69**

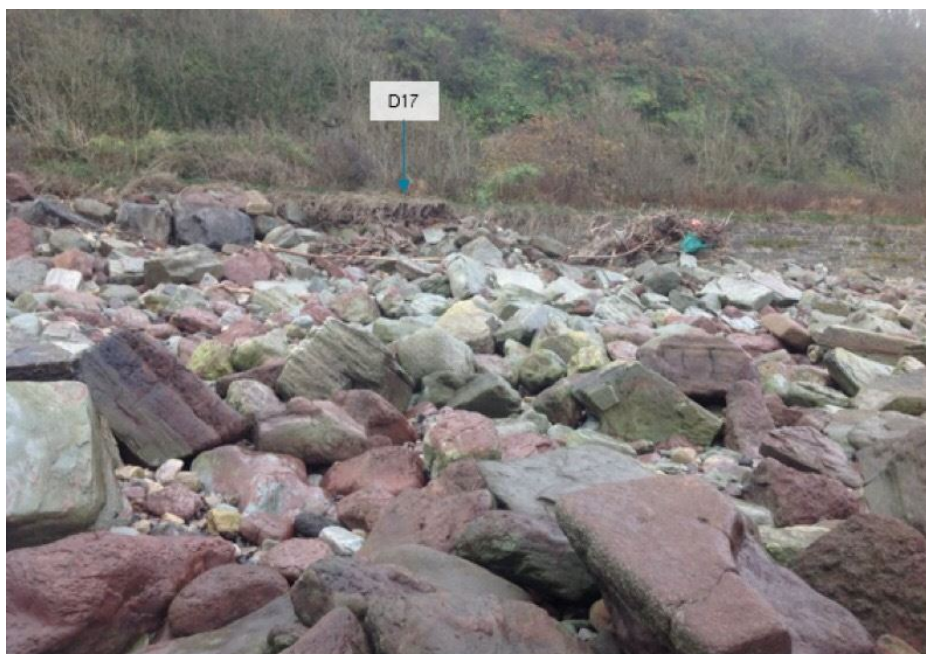
**Section A**  
**Wall Armour**  
**Defect Ref: D17**  
**Description:** Slope recession and poor tie-in. No change between 2014 and 2020 inspections (section B).  
**Photo number: 41**

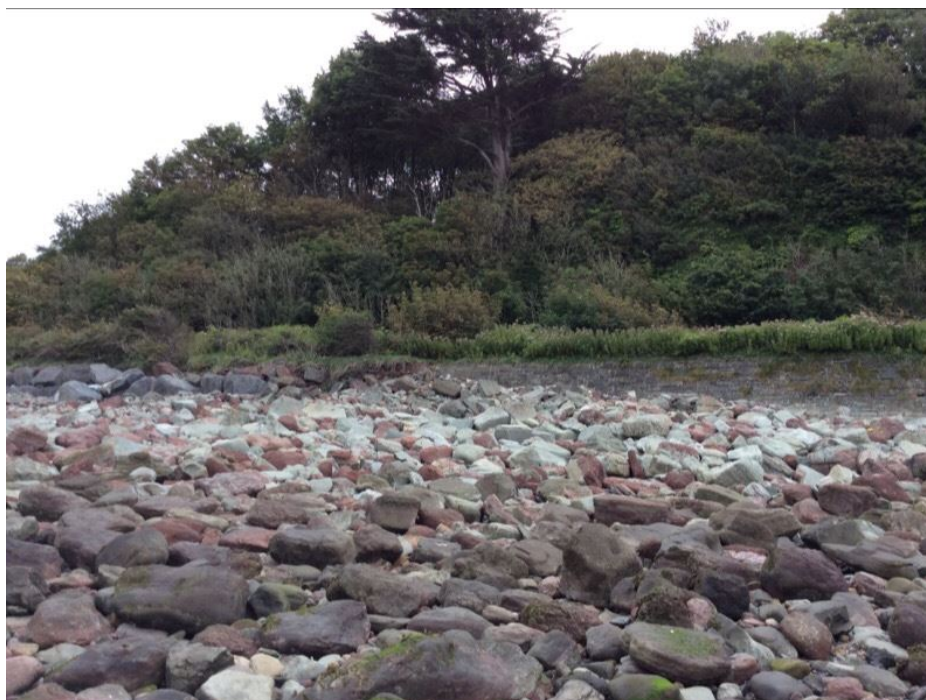
**Section A**  
**Wall Armour**  
**Defect Ref: D17**  
**Description:** Slope recession and poor tie-in. No change between 2014 and 2020 inspections (section B).  
**Photo number: 70**

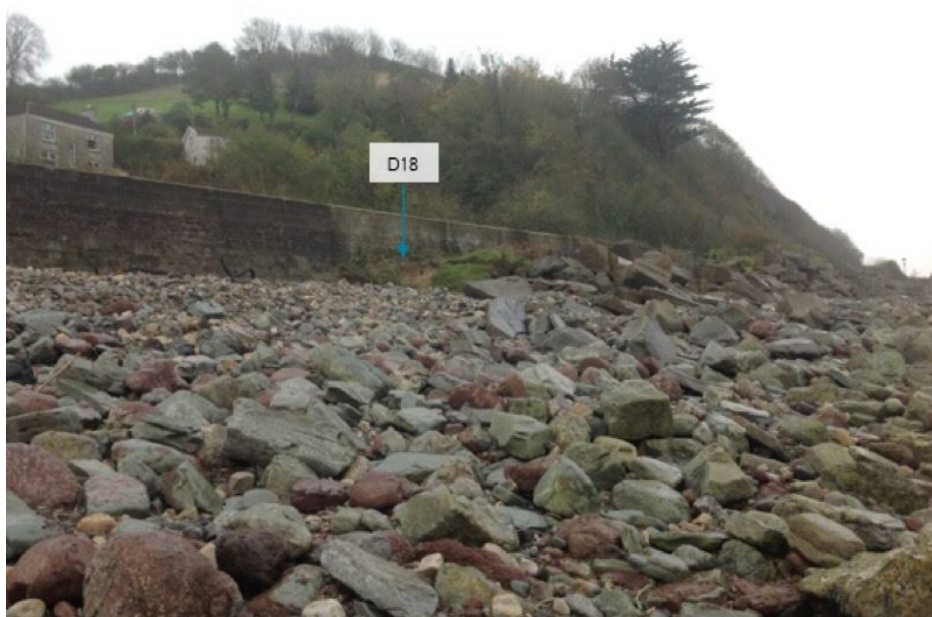
**Section A**  
**Wall Armour**  
**Defect Ref: D18**  
**Description:**  
Discontinuous rock armour/unprotected wall. No change between 2014 and 2020 inspections.  
**Photo number: 42**

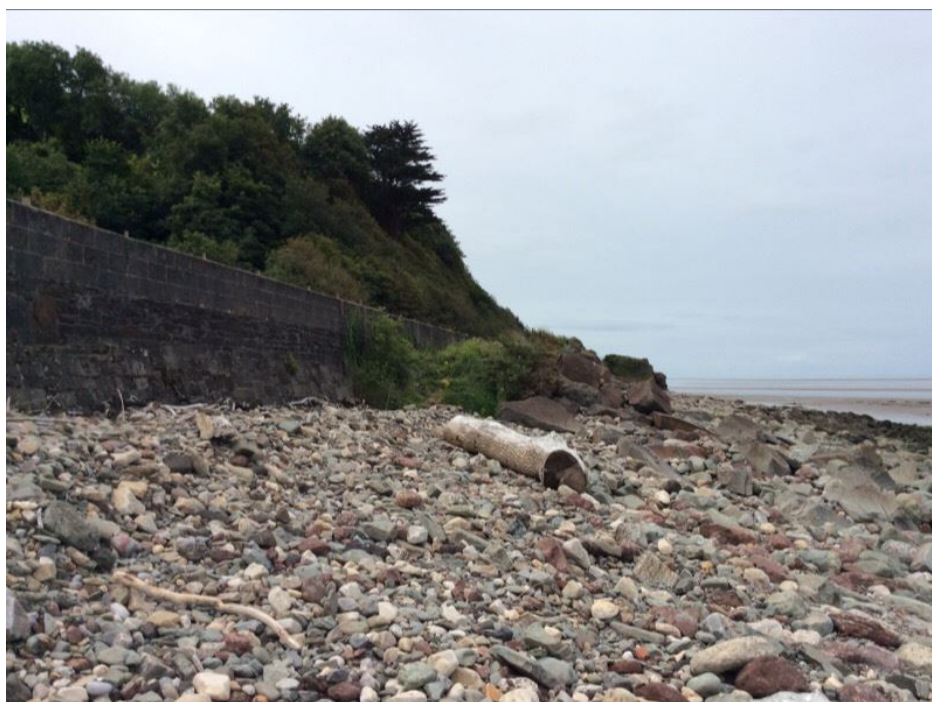
**Section A**  
**Wall Armour**  
**Defect Ref: D18**  
**Description:**  
Discontinuous rock armour/unprotected wall. No change between 2014 and 2020 inspections.  
**Photo number: 71**
