## 1. General information

| Location Plan: | | St. Ishmael Sea Wall | |
| | | Assessment Date: 29/07/2020 | |
| | | CARRS Exam ID: | 2960028 |

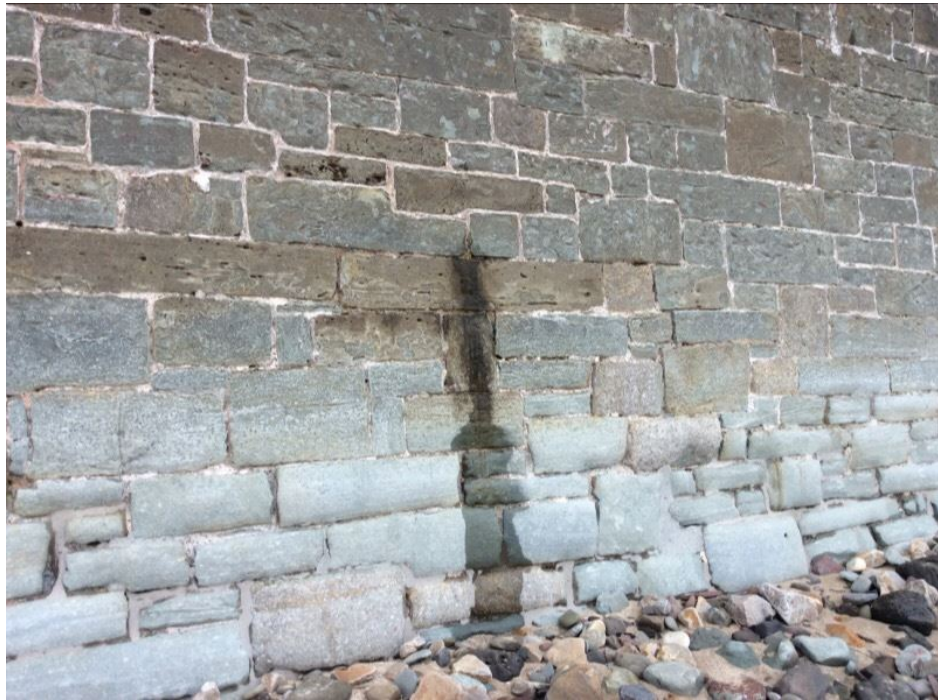
| Defect Ref No. | Defect Location (NGR) | Major Element | Minor Element | Photo Ref | Severity | Probability | Risk Score | Below MHWS | Defect Description | Recommendations | Defect Priority |
|---|---|---|---|---|---|---|---|---|---|---|---|
| D21 | N/A | Wall | Wall section | 53, 54 | 1 | 2 | 2 | True | New defect from 2020 inspection. Seepage through wall at 2 adjacent locations. If left unrepaired, further deterioration is expected. | Repair any failures/weaknesses in wall. Consider providing additional drainage at base of wall. | 7 |

**Section A**  
**Wall section**  
**Defect Ref: D21**  
**Description:** New defect from 2020 inspection. Seepage through wall at 2 adjacent locations. If left unrepaired, further deterioration is expected.  
**Photo number: 53**

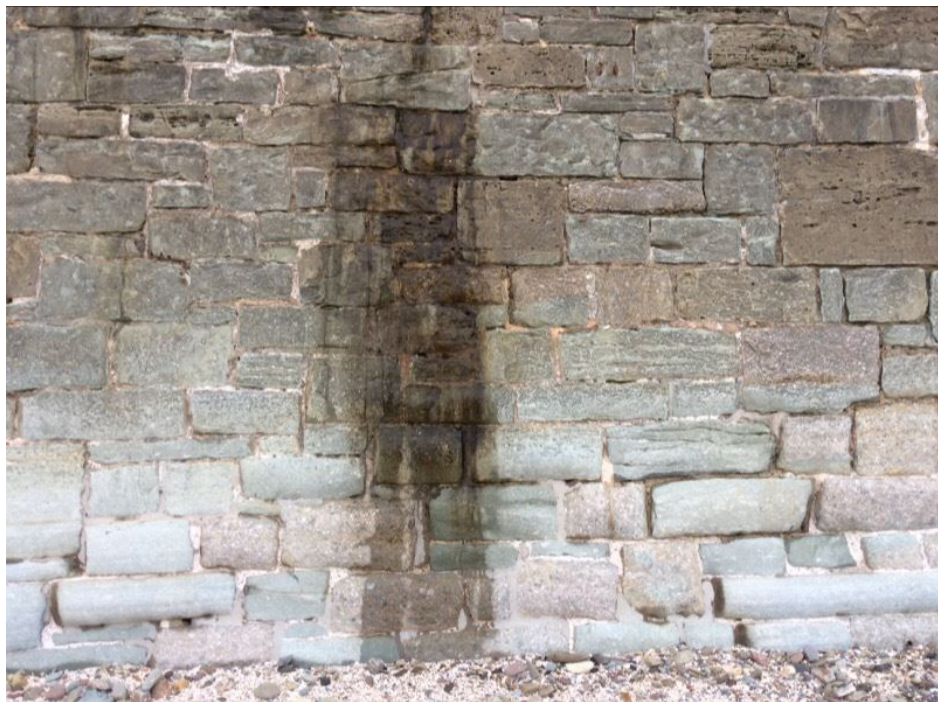
**Section A**  
**Wall section**  
**Defect Ref: D21**  
**Description:** New defect from 2020 inspection. Seepage through wall at 2 adjacent locations. If left unrepaired, further deterioration is expected.  
**Photo number: 54**
