## EPR Compliance Assessment Report

Report ID: BU0800IZ/0222488

| Site | LLANDDULAS LANDFILL SITE | | | Permit Ref | BU0800IZ | | |
| What parts of the permit were assessed | Landfill Gas Audit and review of new engineering. | | | | | | |

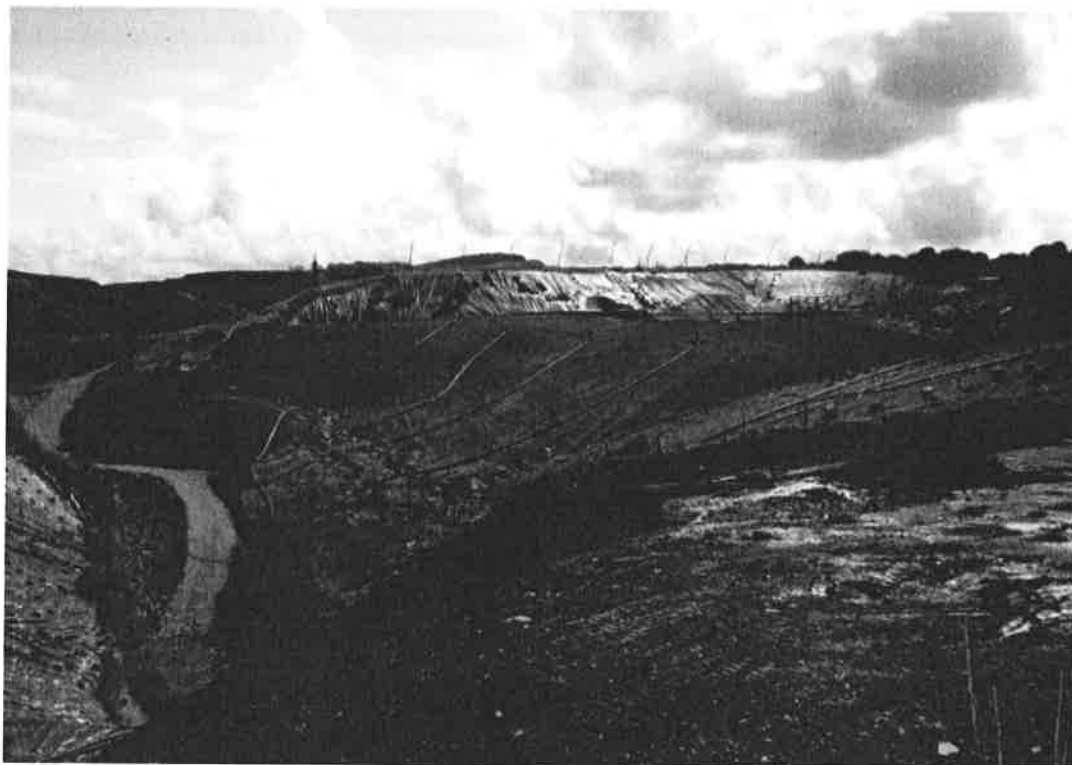
**New Gas Wells on NE Flank of Phase 3A North (pictured above)** – This gas infrastructure was installed during July 2014 following the completion of the permanent capping work to this area of the site. Gas mains and collection pipework have also been re-laid to accommodate this infrastructure with good falls to prevent condensate build up.

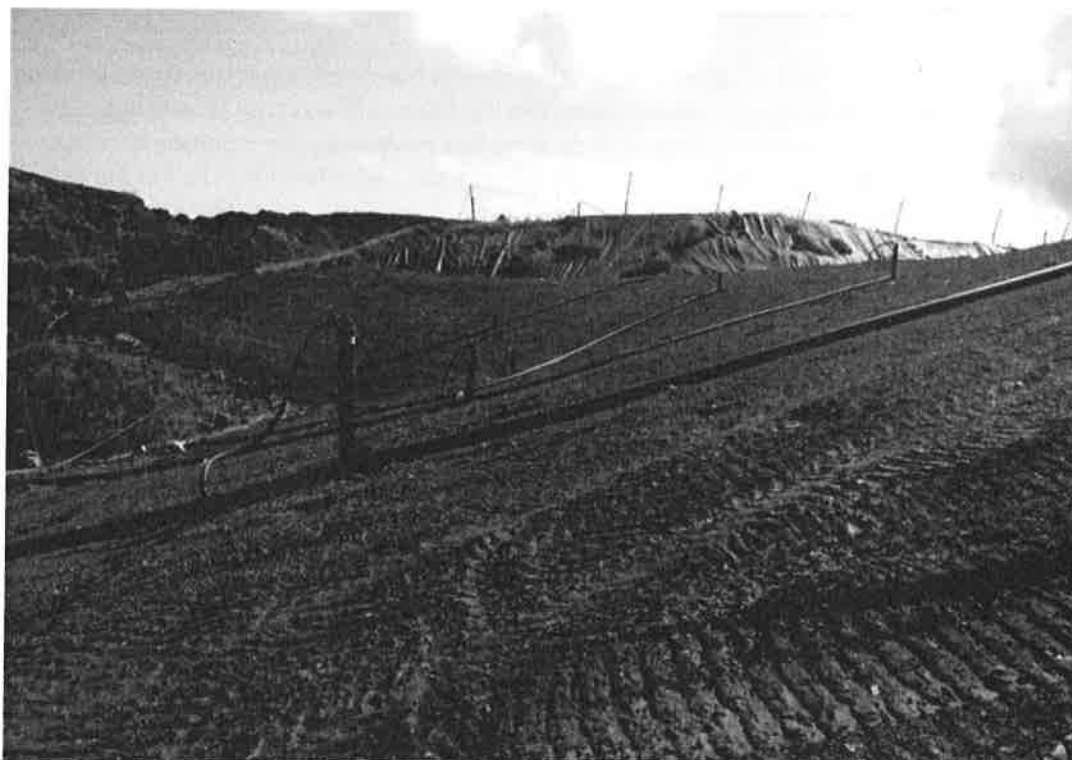
However, data gathered during the audit and a review of the CQA report submitted shows 10 of 12 recently installed gas wells are probably inhibited in their gas collection efficacy due to high water / perched leachate levels.

**Gas Well D284 (pictured above)** – This well was recorded under relatively high negative pressure (-77.49mb), 61.95 CH<sub>4</sub>, 40.1% CO<sub>2</sub> and H<sub>2</sub>S off the scale. These readings combined with the well location (towards the base of the flank) indicate that the well could already be inhibited by high liquid levels within the well. Drill logs submitted as part of the installation CQA show that there was a horizon of wet waste encountered during its installation and that the well was essentially full of liquid 24hrs after installation.

1. **Gas Well Dewatering** – Gas wells D268, D277, D278, D280, D281, D282, D284, D285, D286 & D287 should all be investigated for perched leachate / high liquid levels and dewatered to improve landfill gas collection as a matter of priority. All these wells should be re-dipped to determine current water levels and a plan for the pumping of these wells submitted.

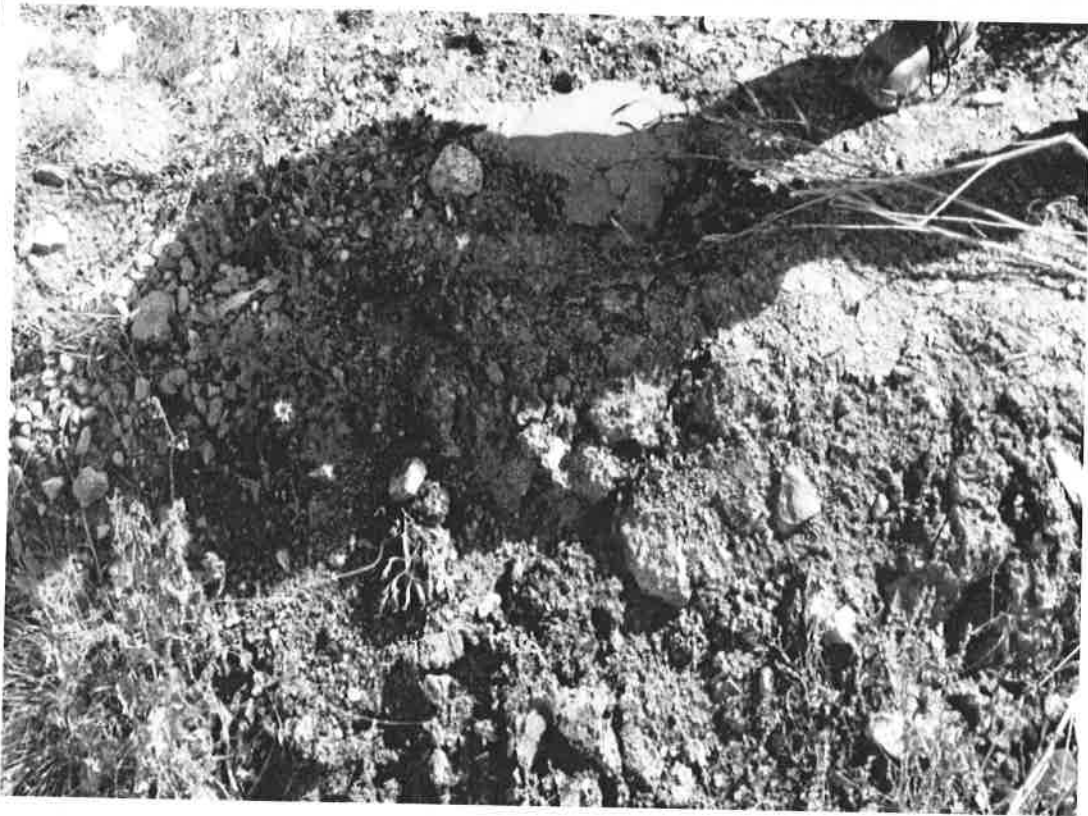
- Fugitive emissions of 5000ppm was recorded from the line of old pin wells adjacent to the haul road and close to gas well D264.
- Gas / Leachate infrastructure D268, LC3A, D269 & D272 all showed significant (>1000ppm) fugitive emissions from bentonite seals.

**Area adjacent to D264 / Line of Old Pin Wells (pictured above)** – Up to 5000ppm was recorded from the surface of the landfill this area. This suggests the gas infrastructure in the immediate vicinity is not performing optimally allowing surface emissions to be generated from the line of old pin wells that were located in this area.

3. **Fugitive Emissions on line of old pin wells** – Gas wells D264, D265 & D266 should be investigated as to whether they require de-silting to improve collection efficacy in this area. Temporary capping and/or re-bentoniting of the pin well boreholes should also be considered.
