**EAST WASTE  
MANAGEMENT SITE,  
LLANWERN STEELWORKS**

**PERMIT EAWML/30003**

**2020 Annual Review of  
Environmental  
Monitoring**

*Report Number 1995r1v1d0121*

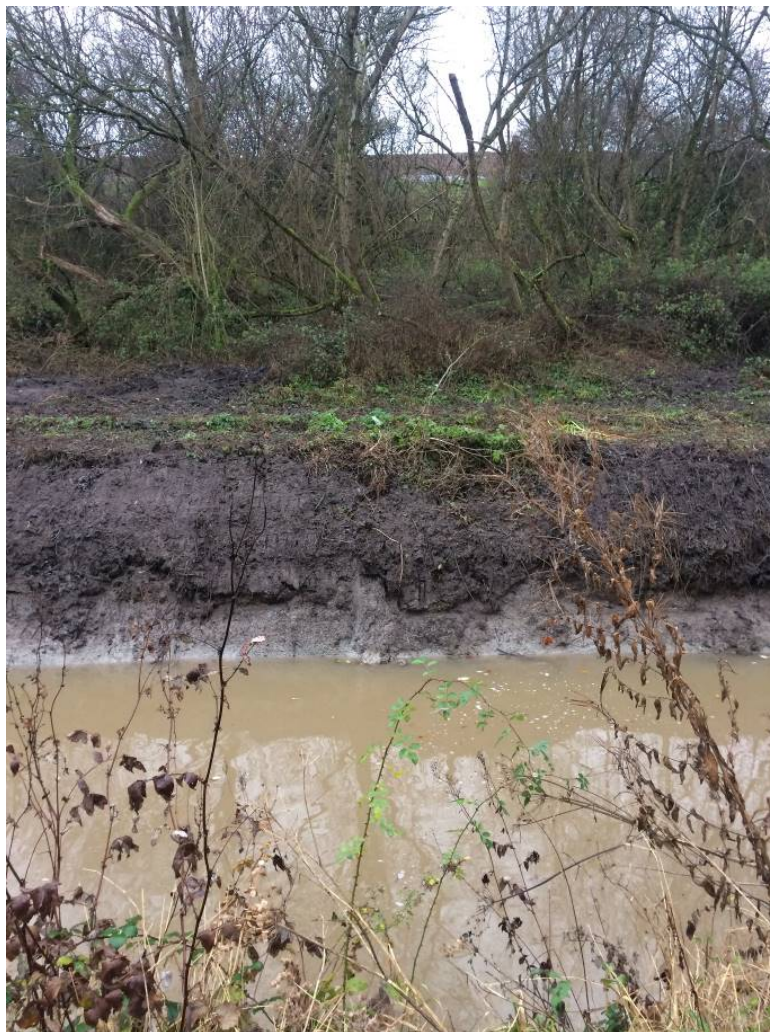
The latest monitoring data continues to indicate that upgradient and downgradient surface water chemistry is generally very similar. However, there are times when there are abrupt changes in several parameters including pH and alkalinity. Subtle differences in the concentration of sodium, potassium, chloride, sulphate and alkalinity (and other parameters) are sometimes apparent and as leachate has been observed along this flank and as the waste in the landfill is being exposed during the restoration works, this aspect of the monitoring programme should continue to be closely scrutinised. Recent inspection of the adjacent reen indicates that the reen is cut into low permeability deposits and that there are no obvious visual signs of staining indicative of leachate (see Plate 2). At this stage, there is no clear evidence that the reen quality is being impacted by the landfill.

**Plate 9-1 Reen flowing from right to left along eastern side of site. Landfill can be seen in background beyond tree.**

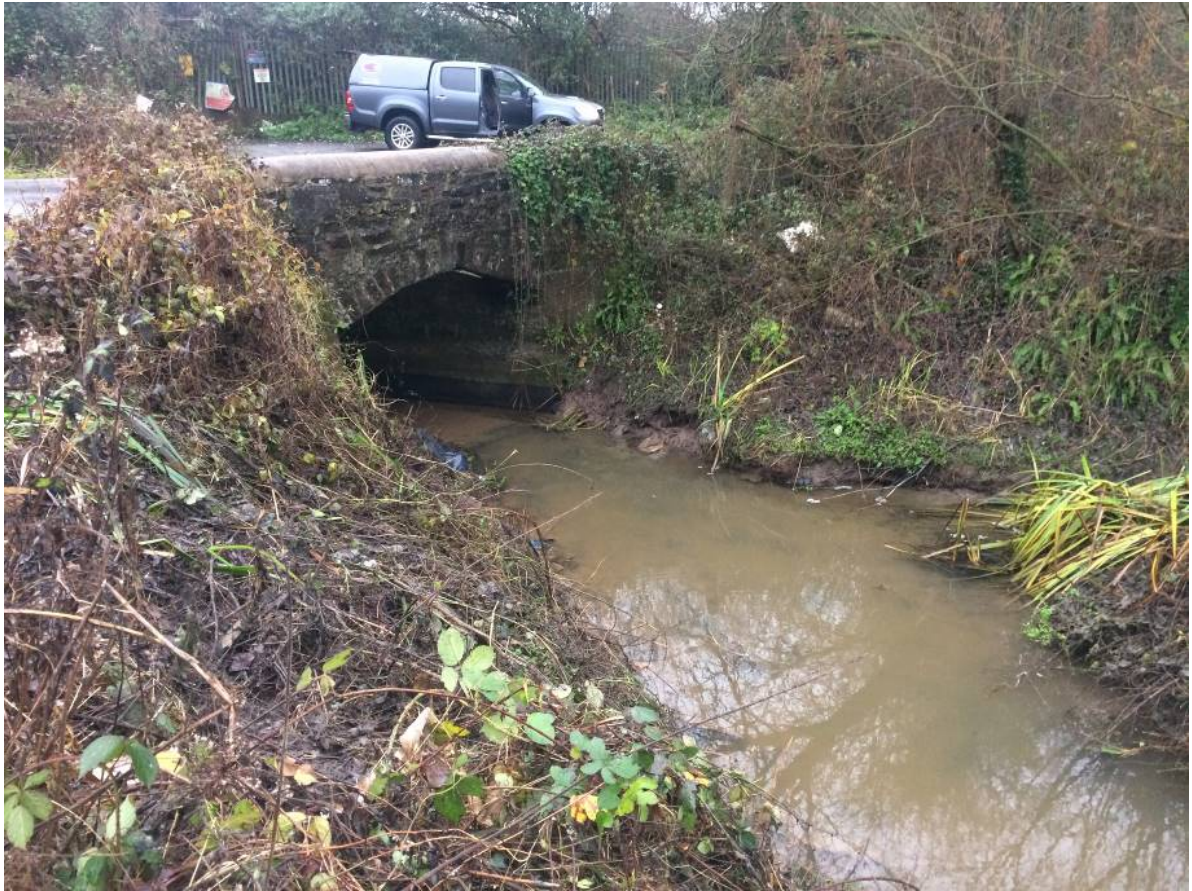
Continued scrutiny of upstream influences is also required as observations in December 2016 (see Plate 9-2) suggest that there are upstream sources of suspended solids.

**Plate 9-2 Suspended solids in surface water upstream of site**
