**EAST WASTE  
MANAGEMENT SITE,  
LLANWERN STEELWORKS**

**PERMIT EAWML/30003**

**2021 Annual Review of  
Environmental  
Monitoring**

*Report Number 2103r1v1d0122*

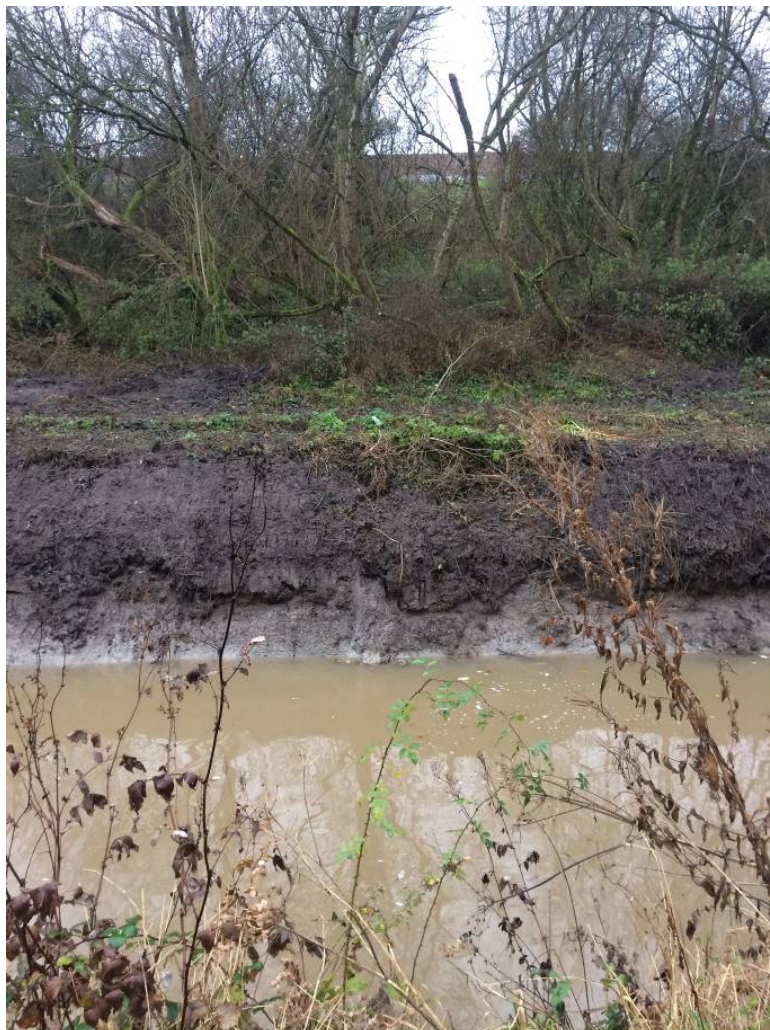
The latest monitoring data continues to indicate that upgradient and downgradient surface water chemistry is generally very similar. However, there are times when there are abrupt changes in several parameters including pH and alkalinity. Subtle differences in the concentration of sodium, potassium, chloride, sulphate and alkalinity (and other parameters) are sometimes apparent and as leachate has been observed along this flank and as the waste in the landfill is being exposed during the restoration works, this aspect of the monitoring programme should continue to be closely scrutinised. Recent inspection of the adjacent reen indicates that the reen is cut into low permeability deposits and that there are no obvious visual signs of staining indicative of leachate (see Plate 9-1). At this stage, there is no clear evidence that the reen quality is being impacted by the landfill.

**Plate 9-1 Reen flowing from right to left along eastern side of site. Landfill can be seen in background beyond tree.**

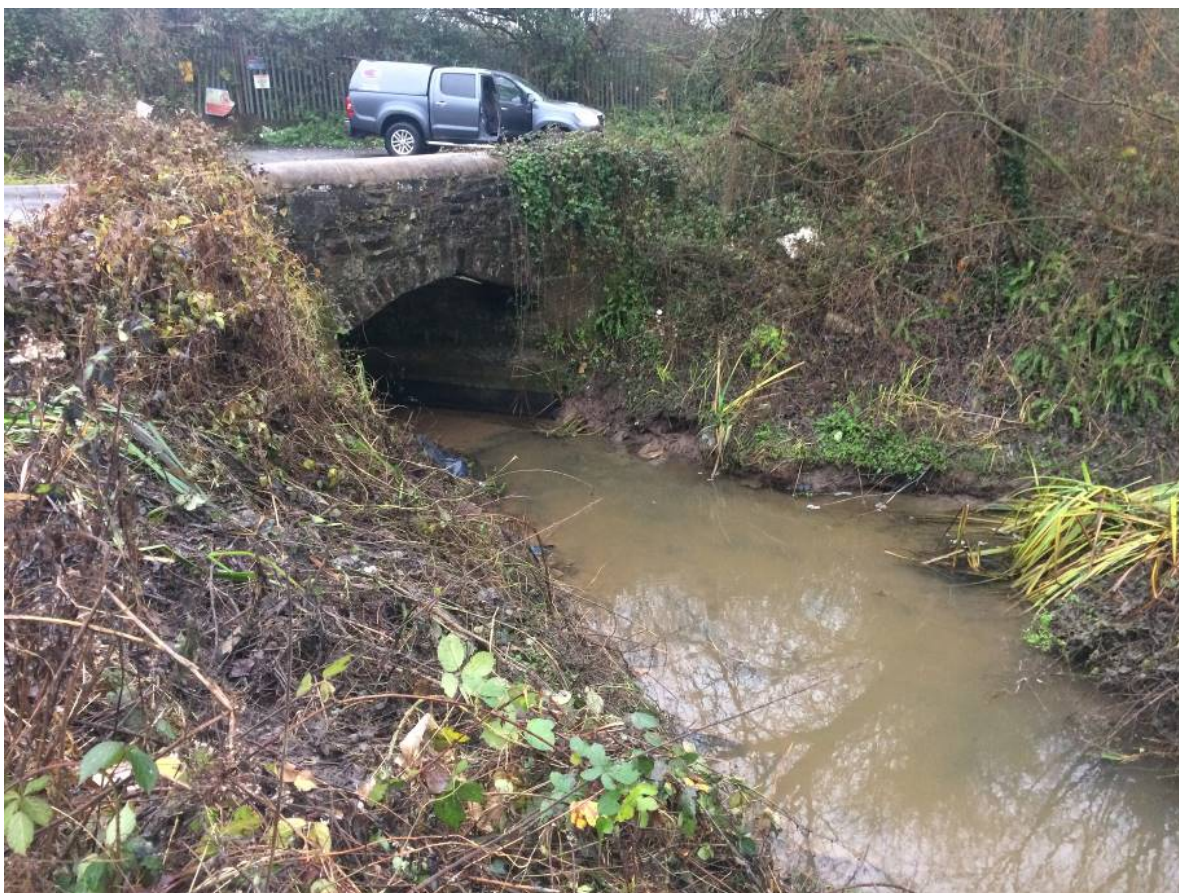
Continued scrutiny of upstream influences is also required as observations in December 2016 (see Plate 9-2) and on subsequent occasions, suggests that there are upstream sources of suspended solids. These also influence water chemistry downstream of the landfill.

**Plate 9-2 Suspended solids in surface water upstream of site**
