**SOUTH SIDE  
QUEENSWAY WASTE  
MANAGEMENT SITE,  
LLANWERN STEELWORKS**

**2021 Annual Review of  
Environmental  
Monitoring**

*Report Number 2103r2v1d0122*

**January 2022**

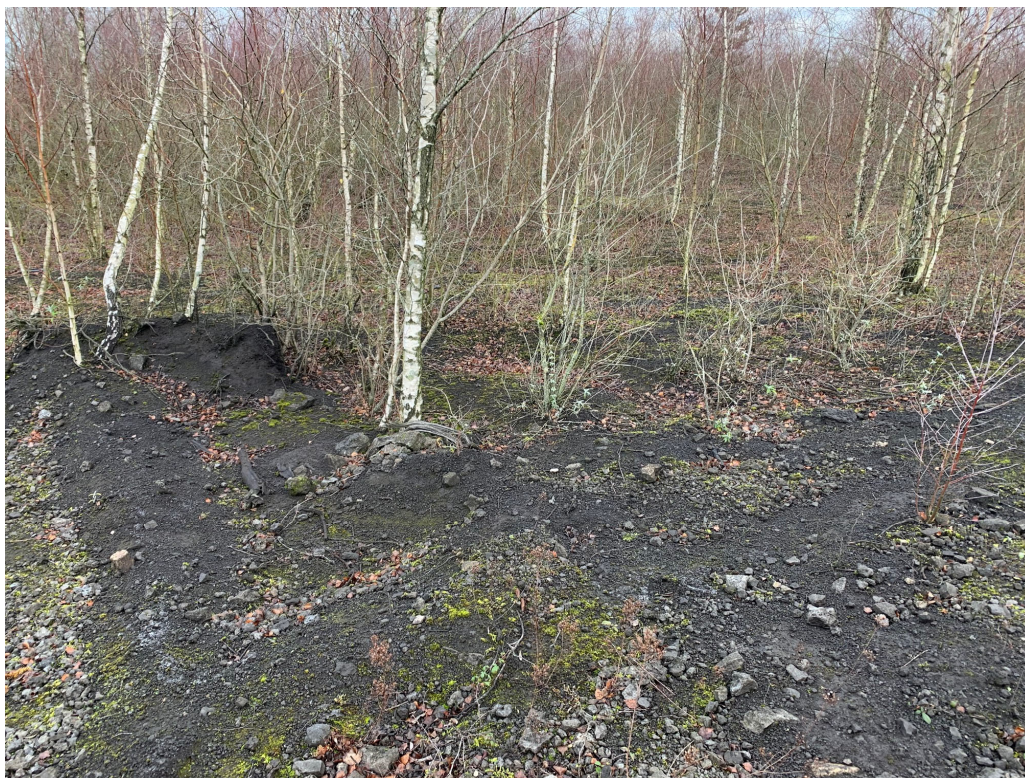
**Plate 3-1 Surface of Lagoon 12 in 2020**

As the lagoons are predicted to pose no significant risk to the aquatic environment and have been shown to be geotechnically stable, the restoration plan focussed on preventing the release of dust during dry conditions, improving the overall site aesthetics and ensuring that the surface water collection ditches are regularly maintained. As can be seen from Plates 3-1 and 3-2, both lagoons are currently partially naturally vegetated, with the vegetation at Lagoon 12 more advanced than Lagoon 25. Consequently, there have been no recorded issues regarding dust blow events. Therefore, there is no intention to disturb this habitat currently. Rather, the occurrence of dust release at both lagoons will be monitored and only, if necessary, will additional soil cover be placed. Such an approach will also benefit the appraisal of recovery operations, which is ongoing.

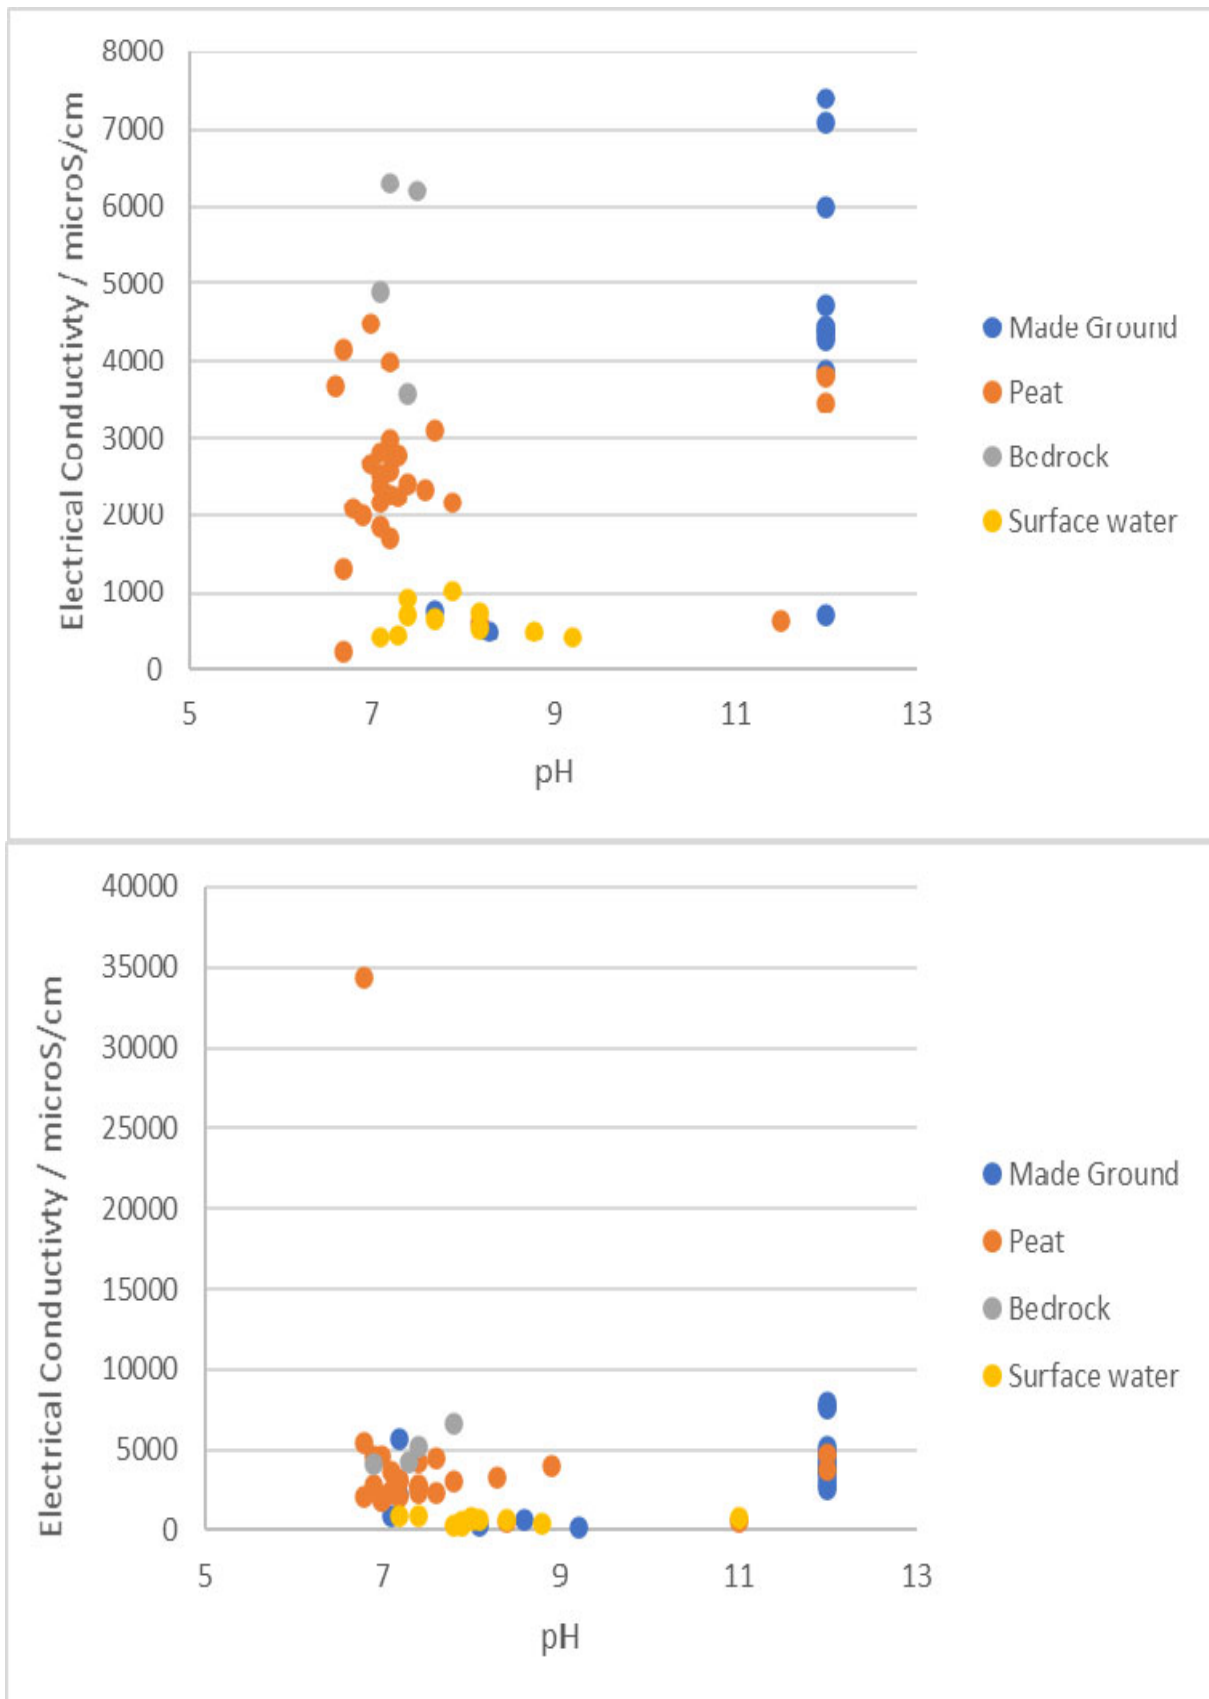
**Plate 5-1 pH and Electrical Conductivity during 2020 (top) and 2021 (bottom)**

Because of the highly alkaline pH, many non-hazardous and hazardous substances are sometimes below detection limits or at low concentrations in the groundwater recovered from the made ground. In recent years, hazardous substance cadmium has been detected on several occasions, and sometimes at elevated concentration. Chromium, copper, lead (and other metals) have also been found above their freshwater Environmental Quality Standards (EQS). In 2019, cadmium was only detected once, within the peat at BH18D, at 0.001 mg/l. In 2020, Cadmium was detected on several occasions but in 2021 it was only detected on one occasion, at BH203S, as illustrated in Plate 5-3. Some of the levels of hazardous and non-hazardous substances detected have historically breached freshwater Environmental Quality Standards (EQS), but the breaches are not persistent. Mercury was not detected in 2020 but lead and nickel, also hazardous substances were detected above their respective EQSs. In 2021, lead was the only inorganic hazardous substance detected; found above the EQS in the made ground on 2 occasions at two different wells (BH13S and BH203S). Iron and manganese were also found at elevated concentration in the made ground, peat and underlying peat. The occurrence of iron and manganese is most likely considered to be due to natural processes within each monitored lithology. All other parameters were below EQS.

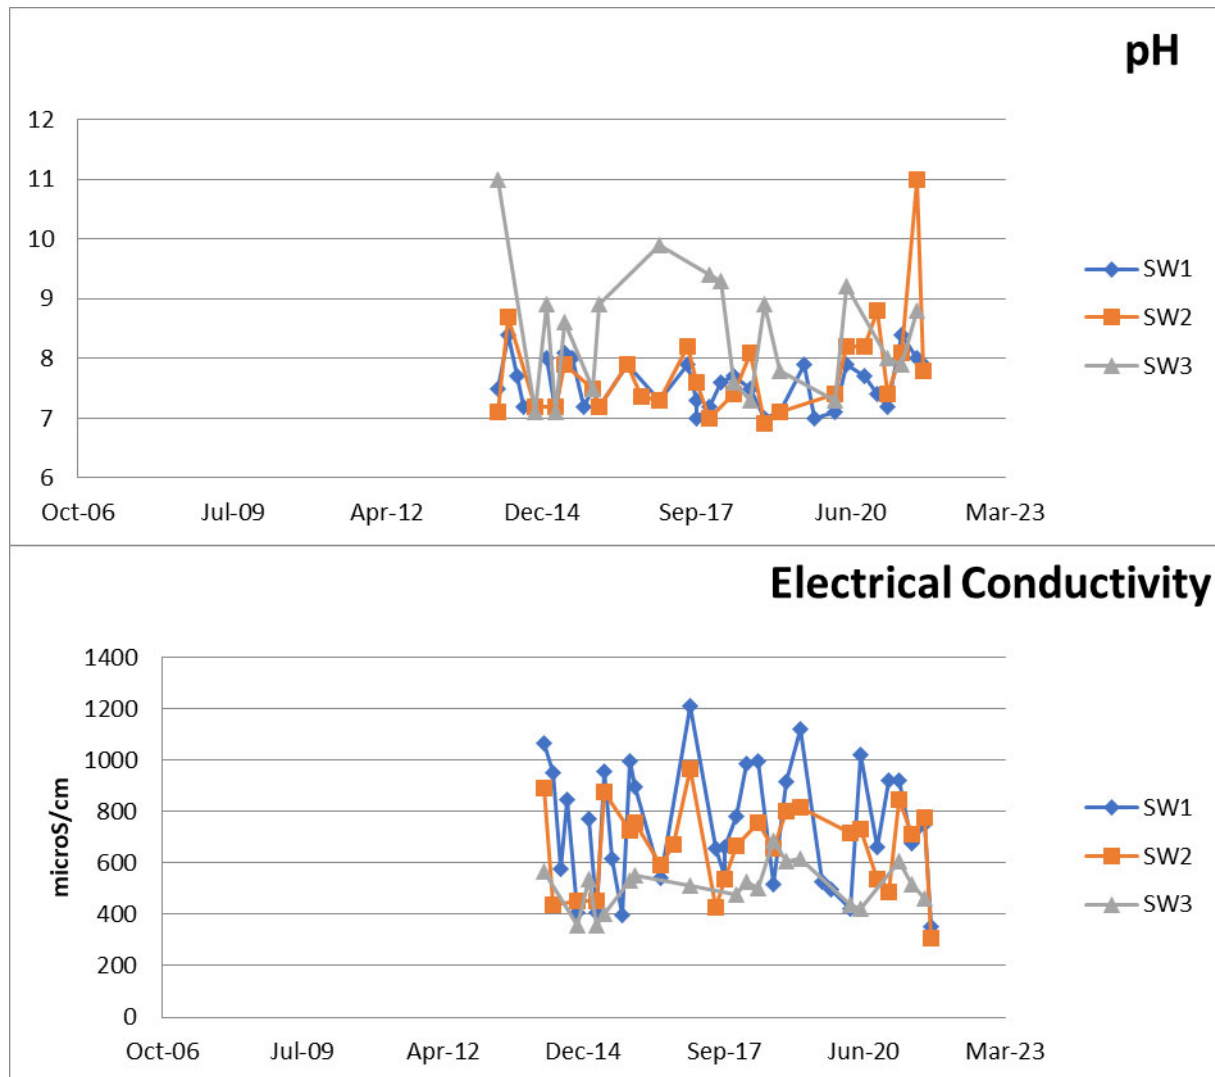
**Plate 6-1 Variations in surface water chemistry**

Surface water is typically circumneutral, moderately mineralised with low levels of non-hazardous and hazardous substances. There are sometimes short-term variations in trace metal concentrations but no persistent trends indicating deteriorating water quality. Some of the data trends may be influenced by the timing of sampling relative to ditch clearance and maintenance, as shown in Plate 6-2. During 2021, there were no breaches of the Annual Average EQS at any of the surface water monitoring points. In October 2021, some of the highest surface water levels observed were found at SW1 (compare Plates 6-2 and 6-3). This was due to significant rainfall in the preceding 24 hrs.

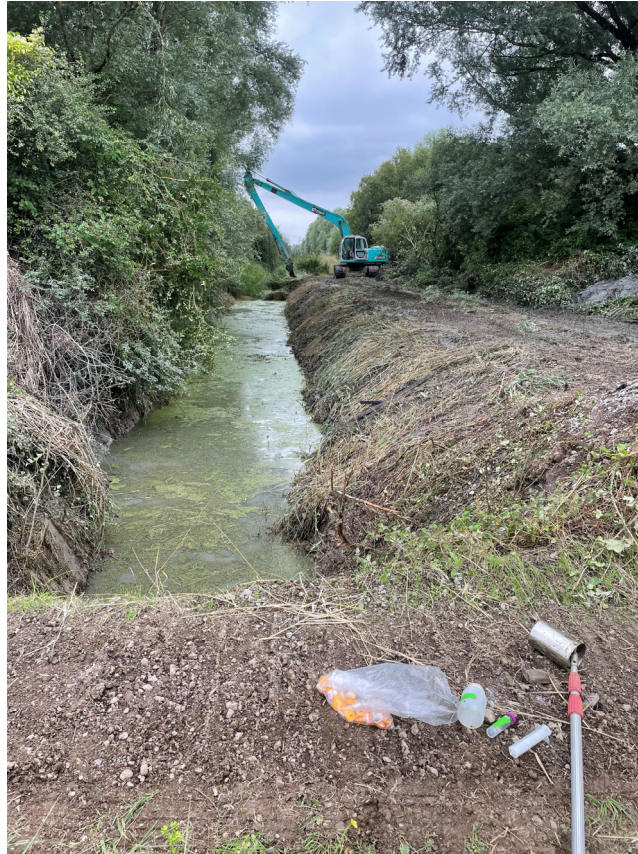
**Plate 6-2 Ditch maintenance during August 2021 sampling**

- Samples cannot always be collected from the surface water sample monitoring locations due to dense vegetation growth. This needs to be subject to preventative maintenance to ensure safe and timely access.
- Buddleia growth along the southern boundary sometimes limits access and monitoring, particularly during the summer months.
- In 2019, no sample was collected from BH24 as the headworks were found to have been destroyed. During 2020, further investigations located the well and a sample was collected, although the headworks remain damaged and require repair. Samples have been recovered from the damaged well in 2021 but plans are in place to replace this position in Q1 2022.
- With the drill rig on site to replace BH24, Tata also plans on replacing BH16, BH18 and BH205 as all have partly damaged headworks and require moving to allow for future redevelopment in the area.

- Safe access to the surface water sampling points needs to be improved. Given that vegetation growth is inevitable, routine maintenance and/or signage would be beneficial. Alternate sample positions could be considered and agreed with NRW, if necessary.
- Several of the headworks are open and not secure. The headworks at monitoring positions BH17, BH19, and BH201 need particular attention (as BH16, 18, 24 and 205 are to be replaced) due to inadvertent damage over the years.
- Buddleia growth along the southern boundary is limiting access and monitoring. The vehicular access route and monitoring positions should be routinely maintained.
