Inspection Details

Customer Name:	Sita UK Ltd
Customer Location:	Marlborough Road, Wrexham LL13 9RJ
Plant Reference:	Main Filter
Membership No:	N/A
Date:	Jul 24, 2014
Inspected By:	Rob Main
Order No:	TBC

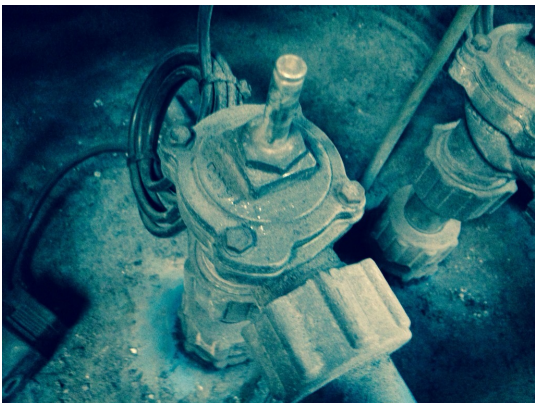
Item:	2 & 6
Details of Defects:	We discovered that No 12 valve did not activate, this was due to the plunger sticking within the valve.
	We also identified that many of the valve

couplings were passing air due to poor alignment, also Atmospheric air is being drawn into the clean side chamber via the down-let pipe orifice.

The differential transmitter is not working. Remove the old solenoid plunger and replace with new.

Adjust the coupling alignment to prevent air loss, currently the supply of a compressed pulsed air is reduced due to the leaks found ethics can result in poor cleaning and premature blinding.

Remove old sealant and reseal the valve down-let pipe orifice to prevent secondary atmospheric air being drawn into the clean side chamber, secondary cooler air being drawn in to the filter could lead corrosion, fugitive emission and premature bag fallers.

It was reported that a new Differential pressure transmitter was ordered from France, we recommend that this system is fitted and calibrated along side a manual differential pressure test.
High
