**Wrexham Lead Melting Emissions Failure Investigation****DATE :** 14<sup>th</sup> January 2015**AUTHOR:** Derick Forsyth (Health, Safety & Environment Manager)**REFERENCE:** Lead Melting –Environmental Permit YP3732LZ**SITE:** Prysmian Cables & Systems Ltd  
Oak Road  
Wrexham Industrial Estate  
Wrexham  
LL13 9PH**ABSTRACT:**

**Wrexham Lead Melting Emissions Failure Investigation****1.0 INTRODUCTION**

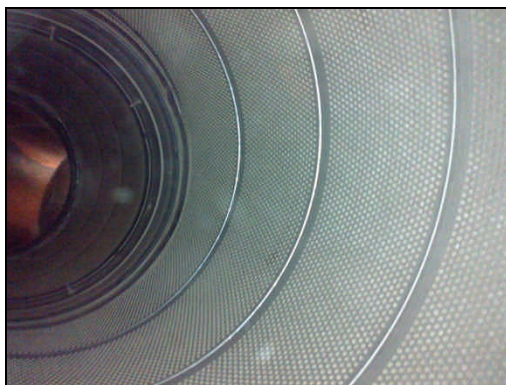
The Silencer fitted on the exit flow of the machine was inspected for operational condition and was found to be in good condition. The silencer is in-built to the LEV pipe work, and the Kemper engineer decided to vacuum clean the filter to remove any residual particles.

Internal picture of  
silencer

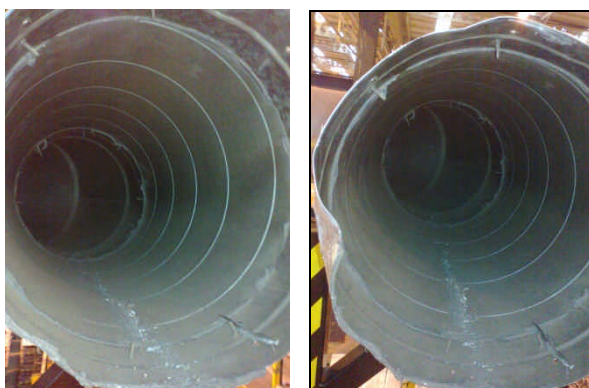
The LEV exhaust flue from the Kemper system was opened and inspected by the original installation contractor: Isaac's Ltd. The pipe was of a rolled construction which has ridges running along its length, and it was considered that these could be a catch for dust build up in the area used for the monitoring measurements. When the pipework was opened it was found that the original theory concerning the pipework being a trap for dust was founded. There was a small ridge that was found at the lowest point of the internal pipe which looked consistent with dust. This was vacuum cleaned.

Internal pictures of old pipework and ridge – note some residue from removal process

The inspection had shown that dust could become trapped in the section of pipe used for the monitoring and possibly give variable readings and so it was concluded to replace this section of pipe with one of a smooth design which will allow a clear flow of air and assist in avoiding build-up of dust over an elongated period of time. The replacement pipe was of the same aperture dimension as the previous pipe and the connection between the old and new pipe work is a sealed flange and with compression bolts.

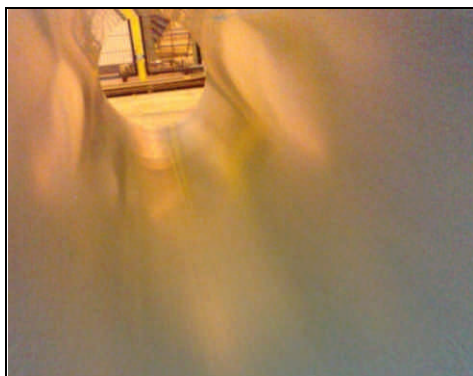
Internal picture of new pipework

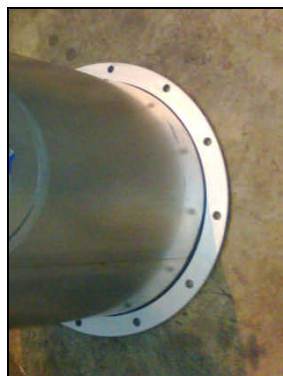
Flange connection

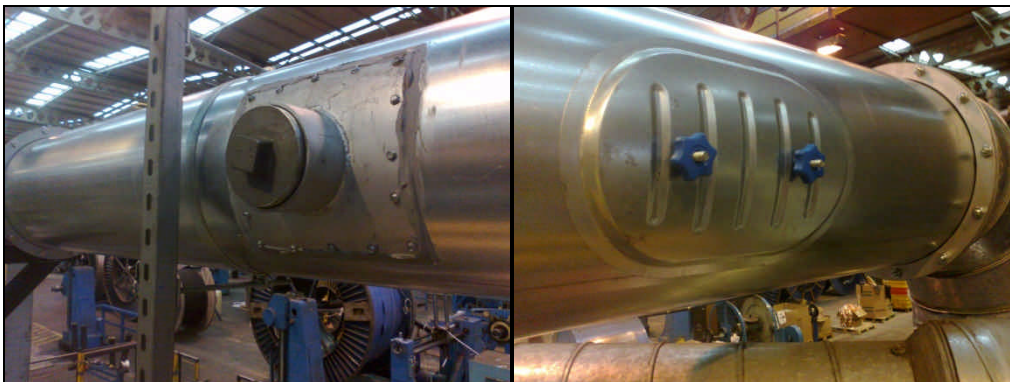
Sample port located in new pipework

New inspection hatch

The emissions sample port was removed from the old pipe and fitted into the new pipework. Also fitted into the new length of pipe is a service hatch which will allow for inspection of the internal pipework and, if required, the top of the Kemper system.

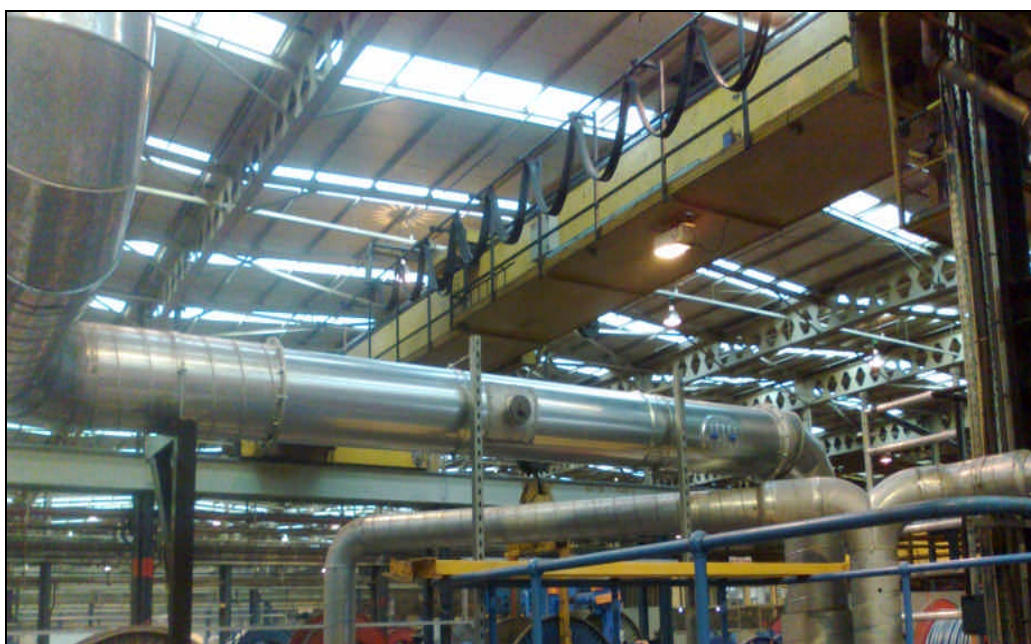
Picture of new pipework in position
