Schedule 6 - Notification

Permit Number	ZP3331LP
Name of operator	BHP Billiton Petroleum Ltd
Location of Installation	Talacre Holywell Flintshire CH8 9RD
Time and date of the detection

POINT OF AYR GAS TERMINAL
REPORT To Supplement Part B Notification to NATURAL RESOURCES WALES
TGU REBOILER REPAIR 31ST MAY 2013 to 7th JUNE 2013

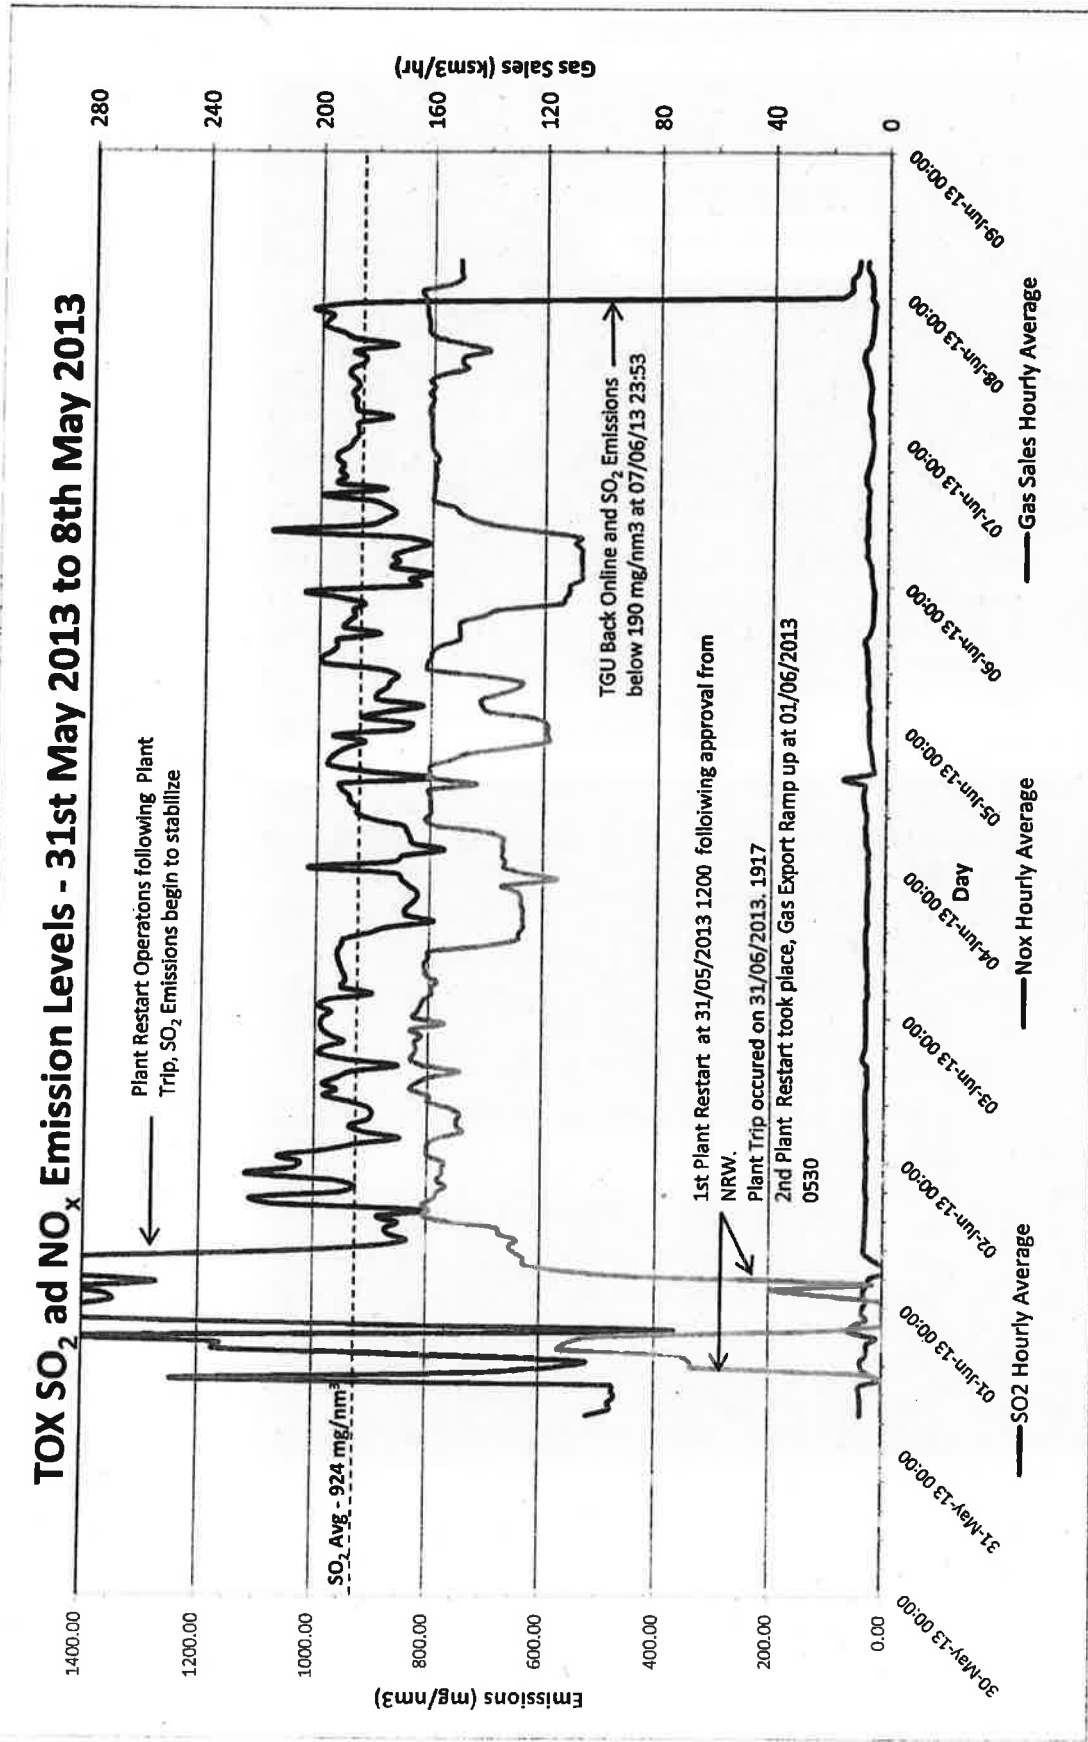
Attachment 1 – Trend of SO₂ and NO_x Emission Levels from 31st May 2013 to 8th May 2013

Once gas flow was restarted and the plant stabilized, SO₂ emissions reduced to within the predicted emissions range when the TGU wet section is offline, and stabilized at circa 1000 hrs on 01/06/13. The average SO₂ emission (hourly average) was estimated at 924 mg/nm³, peaking at 1120 mg/nm³ during the period the TGU wet section remained offline (refer to Attachment 1).

During the time the TGU Wet Section was offline, the NO_x emissions remained with the permitted PPC ELV of 120 mg/nm³ (refer to Attachment 1).
