United Kingdom Production Unit
Point of Ayr Terminal
Station Road
Talacre
CH8 9RD

POINT OF AYR GAS TERMINAL
REPORT To Supplement Part B Notification to NATURAL RESOURCES WALES
TGU REBOILER REPAIR 22nd AUGUST 2013 to 3rd OCTOBER 2013

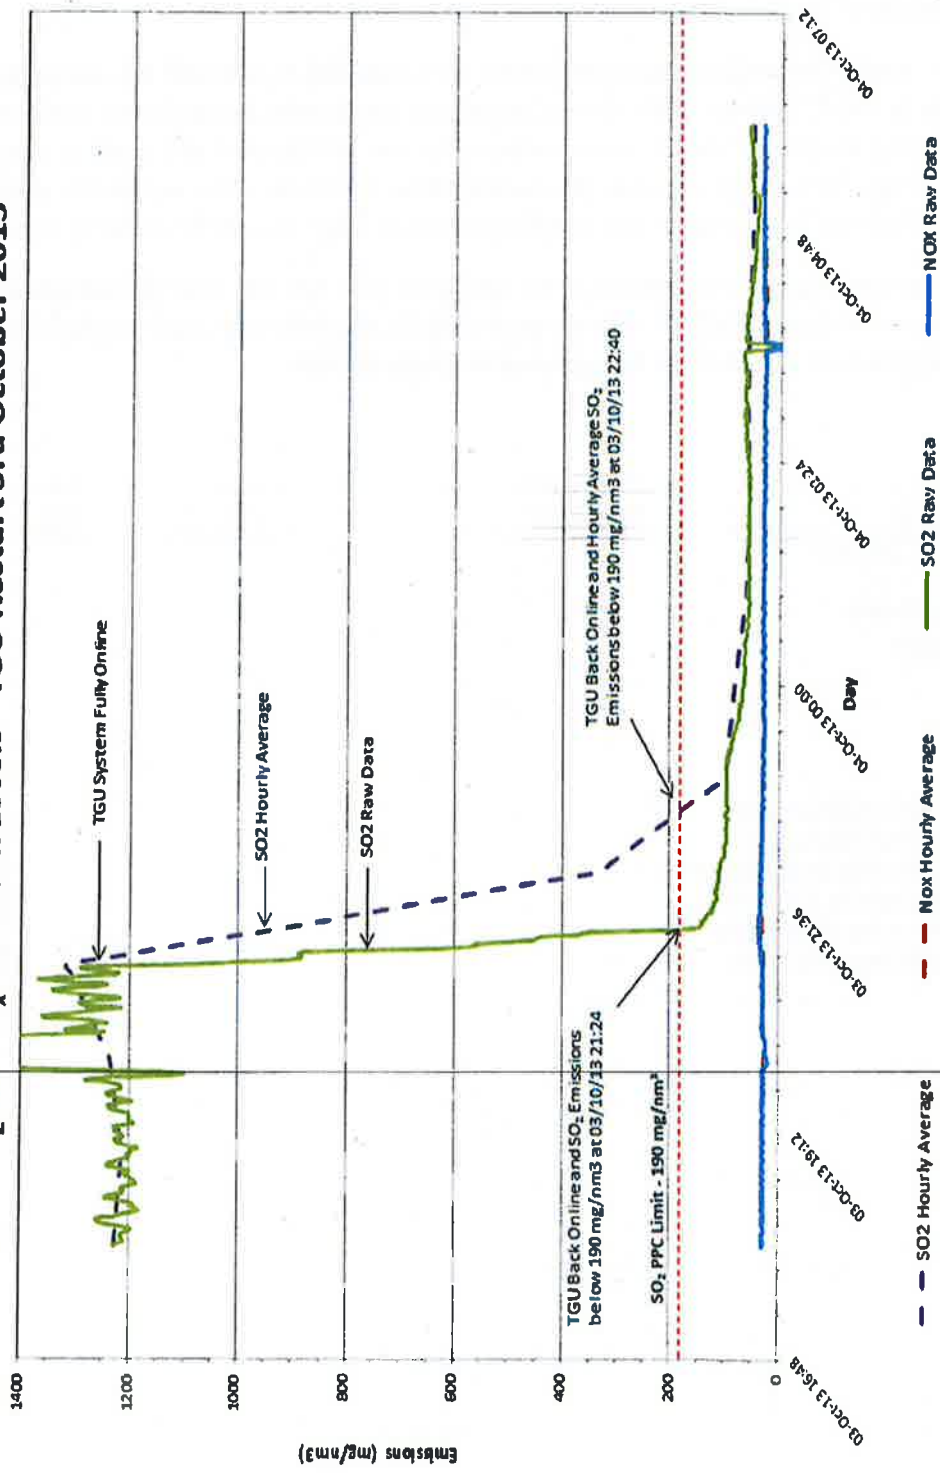
Attachment 1 – Trend of SO₂ and NO_x Emission Levels during TGU Restart 3rd October 2013

The Lean Rich Solvent Exchanger re-gasketed plates were returned to site and the exchanger subsequently re-installed in-situ on the 1st October 2013. The exchanger and piping were despaded and pressure tested on the 2nd October 2013. This allowed circulation to re-commence on the Tail Gas Unit and auxillary systems to be brought online. The Tail Gas Unit was fully online by the evening of the 3rd October 2013 and the SO₂ emissions were back in specification at 2130 hrs. The hourly average specification met its target at 2240 hrs (refer to Attachment 1).

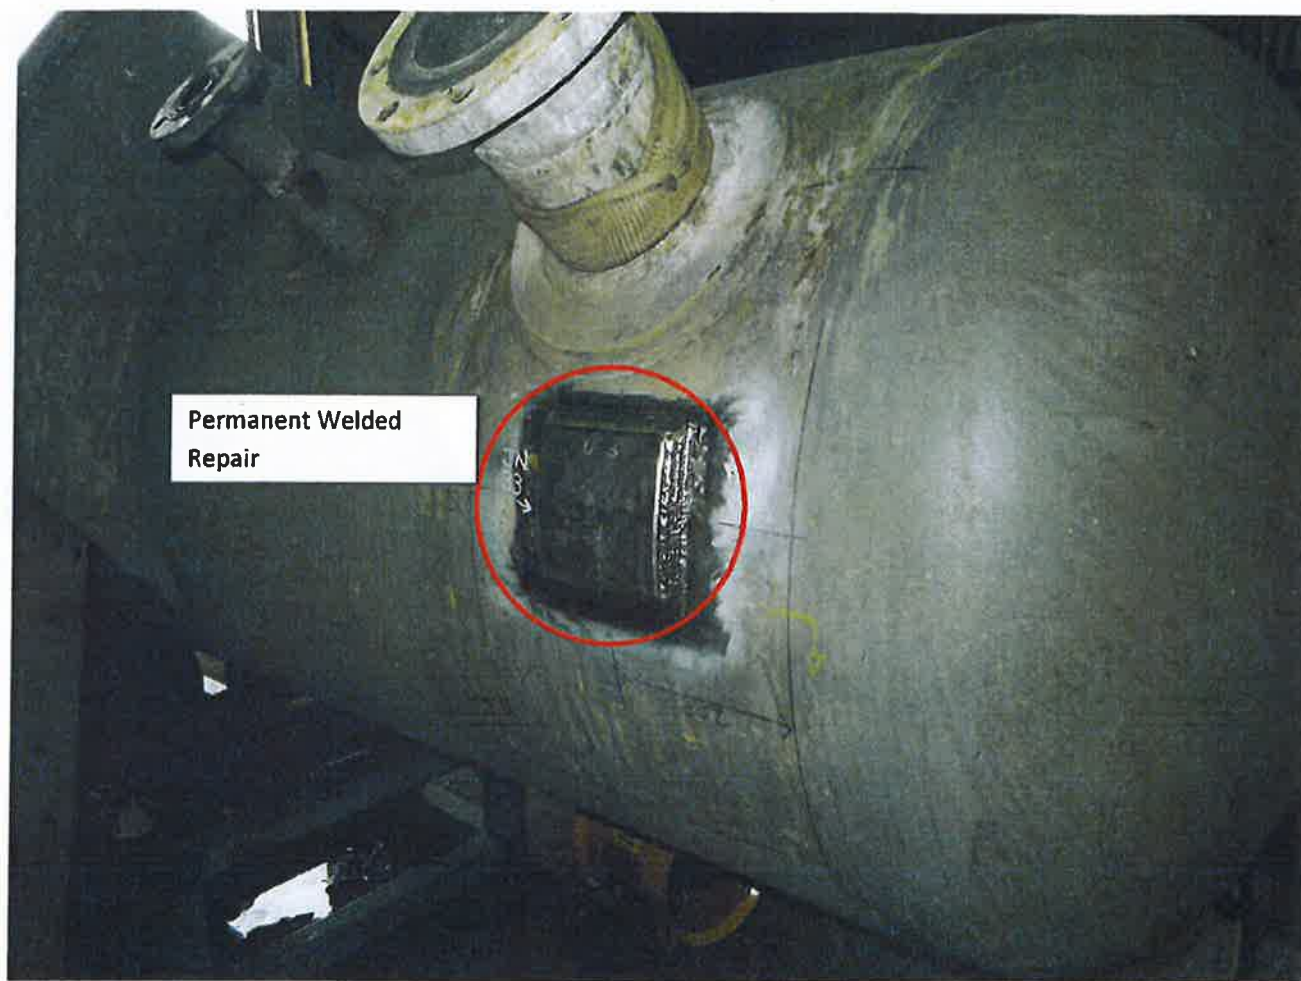
Attachment 2 – Permanent Repair of TGU Reboiler

At Fabricom's yard, the temporary Belzona repair was removed and the shell was further cleaned in preparation for the permanent welded repair. The exchanger was re-inspected and several additional areas of significant pitting corrosion were found which needed a Belzona repair internally. The welding was subsequently completed and post weld heat treatment carried out (refer to Attachment 2). A Belzona repair was applied due to the additional corrosion identified. Once the permanent repair solutions were completed the reboiler's shell and tube bundle was put back together and pressure tested. The exchanger was returned to site on the 16th September 2013.

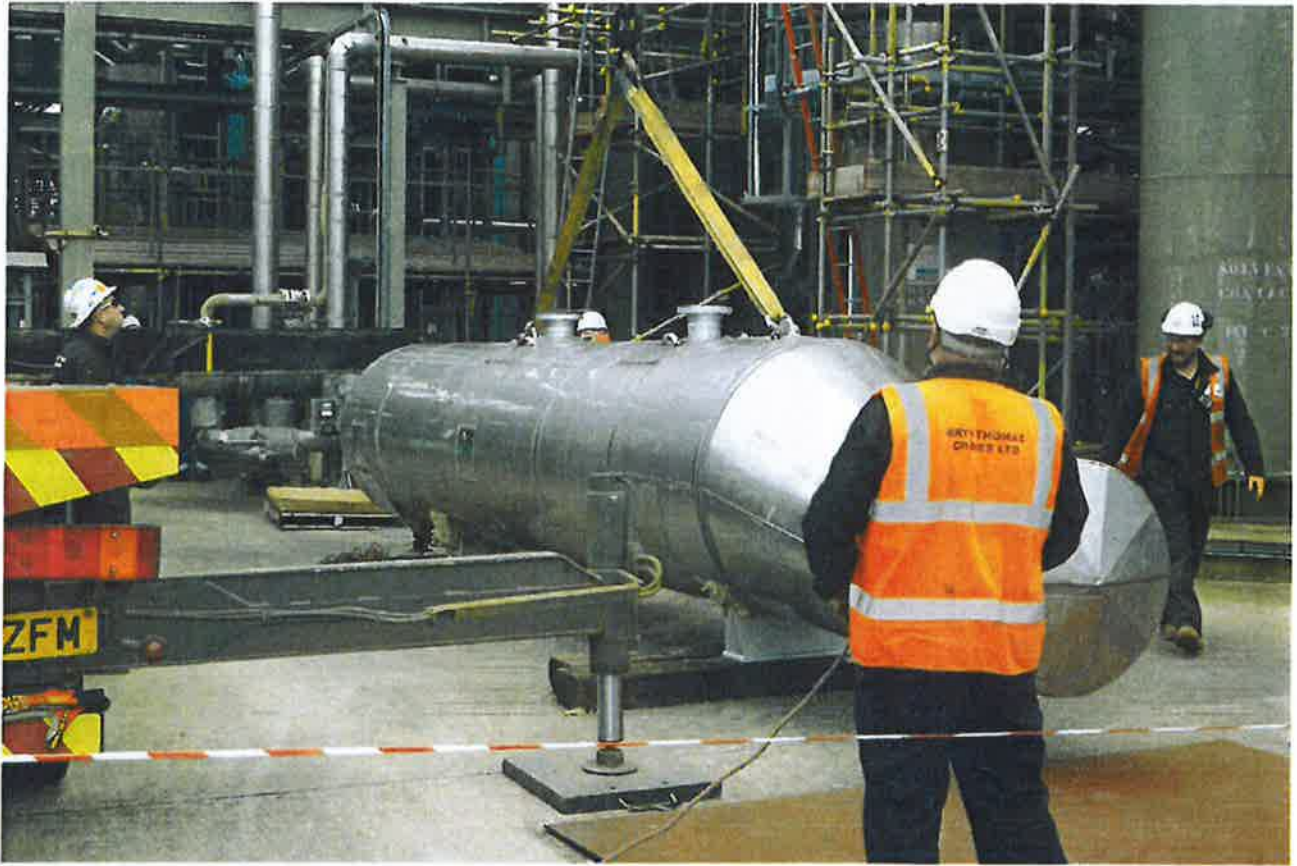
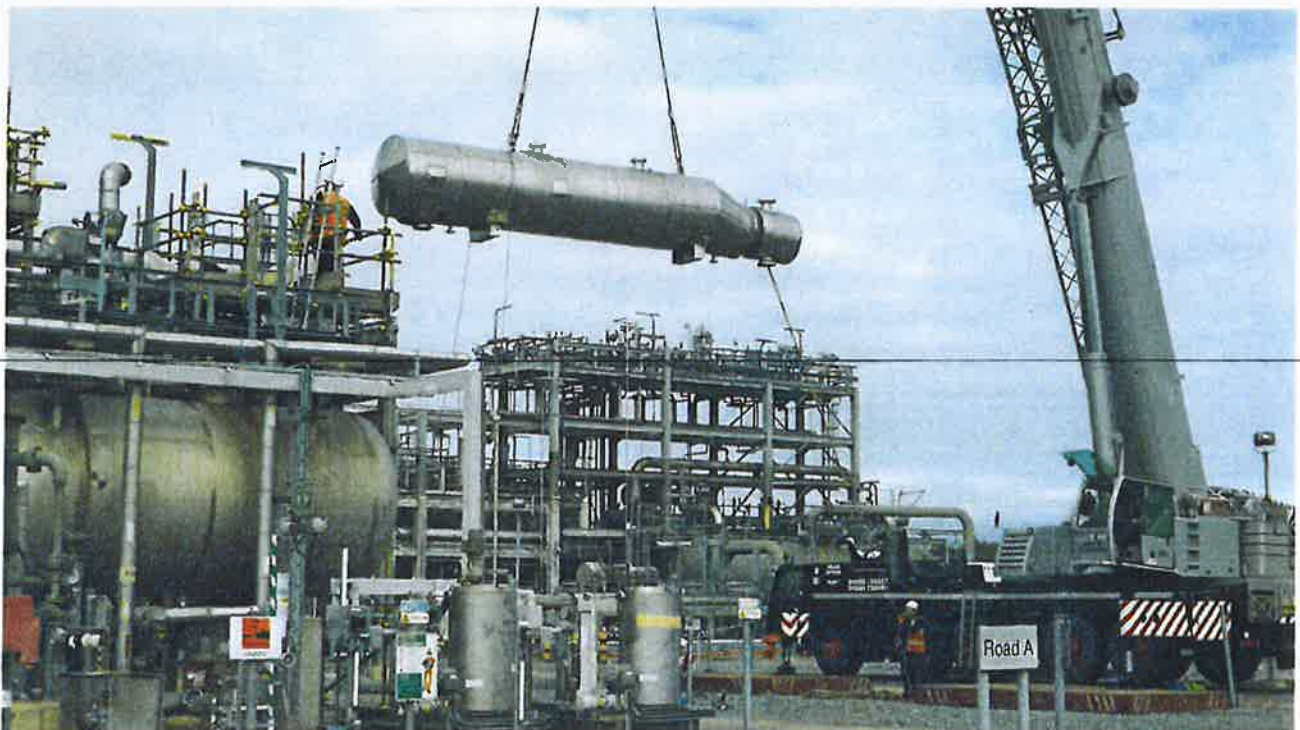
Attachment 3 – Lifting Operations of Solvent Regenerator Reboiler

The Tail Gas Unit was taken offline on the 22nd August 2013 in preparation for removal of the Solvent Regenerator Reboiler. The unit was subsequently washed, decontaminated, isolated and spaded before the exchanger was lifted on the 27th August 2013. The shell and tube bundle was separated onsite, cleaned and sent to Fabricom GDF Suez yard at Sandycroft, Flintshire for repair.

During the week of the 16th September the weather was not favorable due to high winds and rain and therefore the crane lift to return it to its final position could not be undertaken safely. This resulted in a potential delay to the reboiler's "Handover to Operations" date. A change in strategy was undertaken, where the insulation was completed at the ground level before it was lifted. The exchanger was lifted into place on the 20th September 2013 safely (refer to Attachment 3). The piping connections, despading and pressure testing were subsequently completed on the 26th September 2013.
