Project Name                                      2 Sisters Remedial

Start Date                                              19/06/2017

| Purpose: <b>Post inspection of repairs or renovations</b> | Flow Control: |

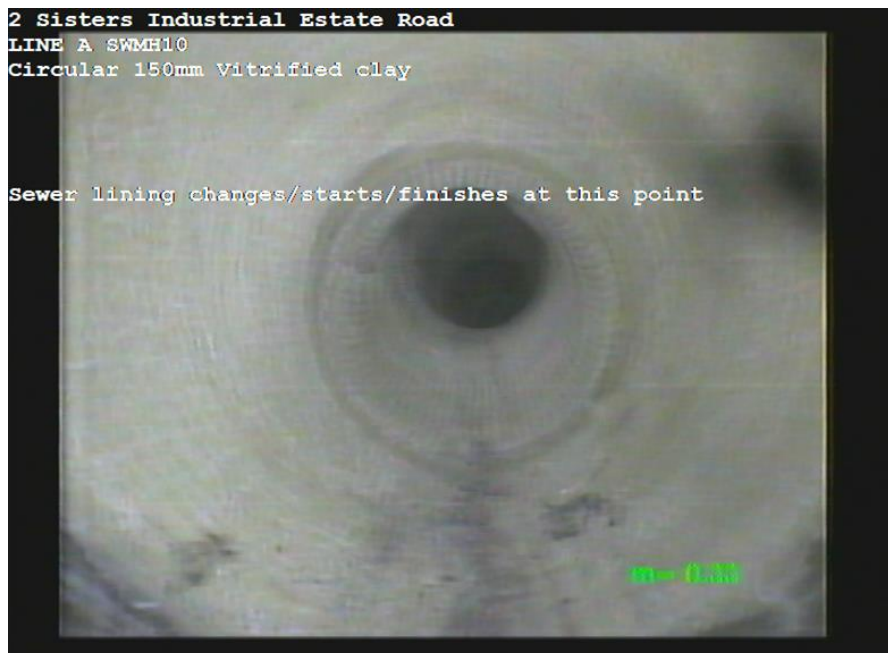
LINE AX\_1fbc1e05-b299-436a-9252-769fd5c77bff\_20170620\_114150\_457.jpg, 00:00:13, 0.33m  
Sewer lining changes/starts/finishes at this point

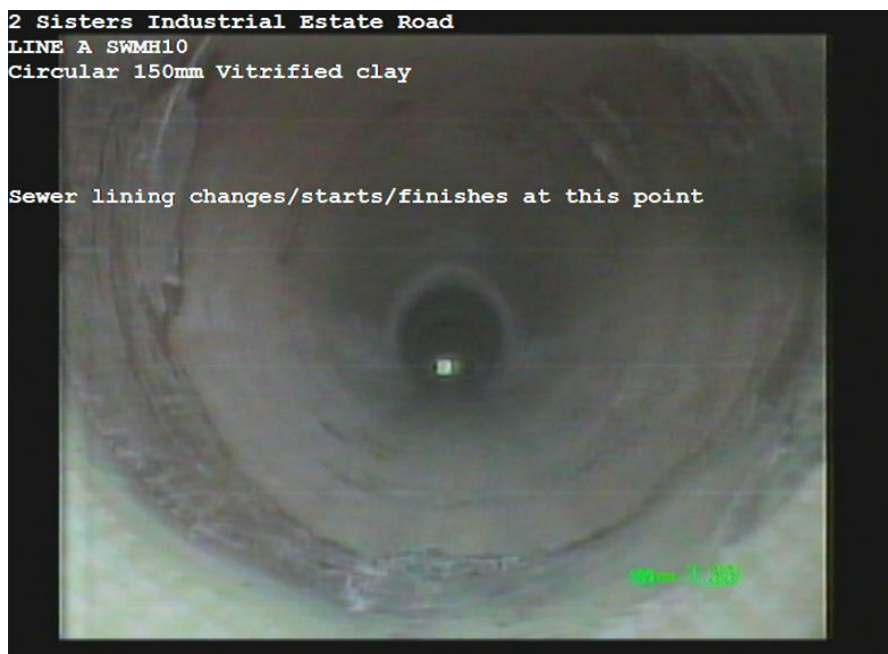
LINE AX\_84deb483-3fef-402f-b2ed-e27d9877b0ef\_20170620\_114232\_648.jpg, 00:00:34, 1.33m  
Sewer lining changes/starts/finishes at this point

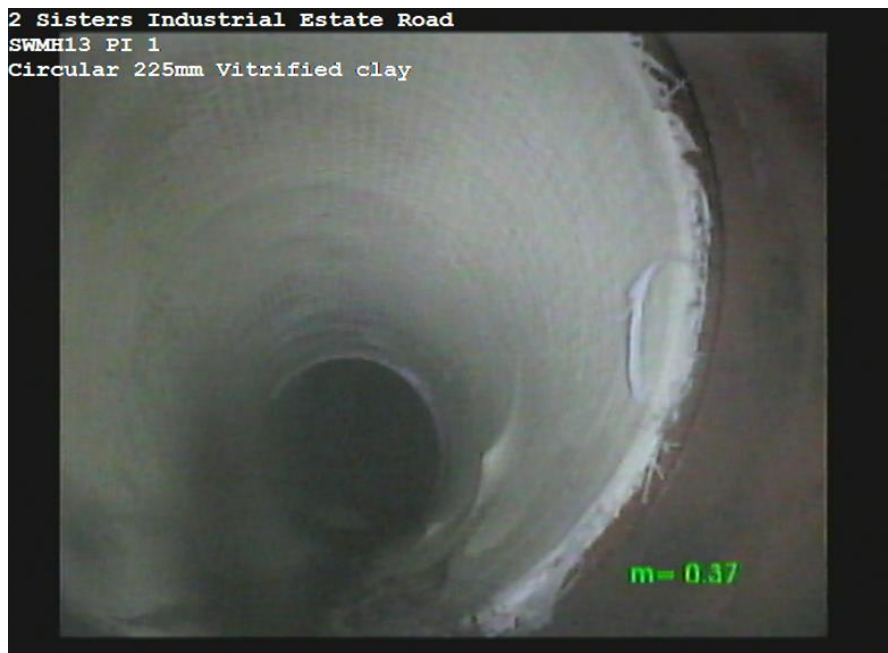
SWMH13X\_e7789cd4-cdb6-4824-87b5-772fc65de6b3\_20170620\_152211\_616.jpg, 00:00:00,  
0.37m  
Sewer lining changes/starts/finishes at this point

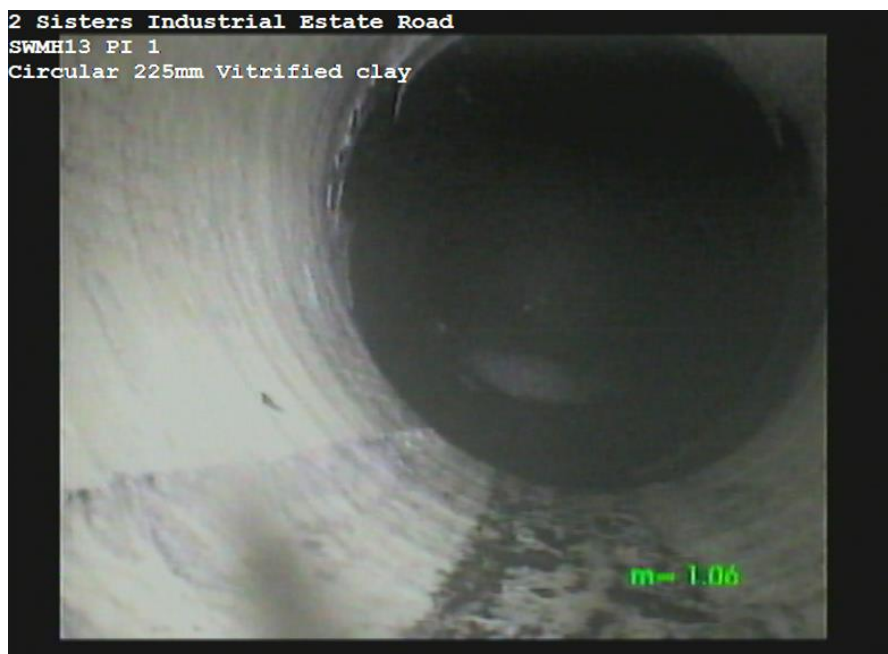
SWMH13X\_dd588aea-59b7-4d0f-a5c0-c70071613441\_20170620\_152341\_569.jpg, 00:01:03,  
1.06m  
Sewer lining changes/starts/finishes at this point

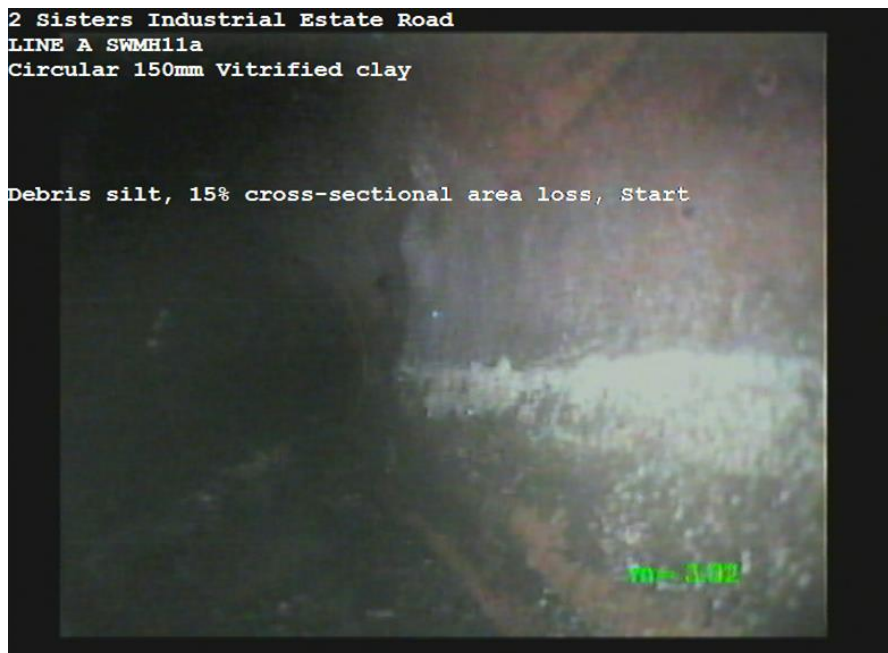
LINE AX\_9a7fae94-dcd1-4566-aeb6-42a98a2e9e10\_20170622\_064255\_270.jpg, 00:00:18,  
4.19m  
Debris silt, 15% cross-sectional area loss, Finish

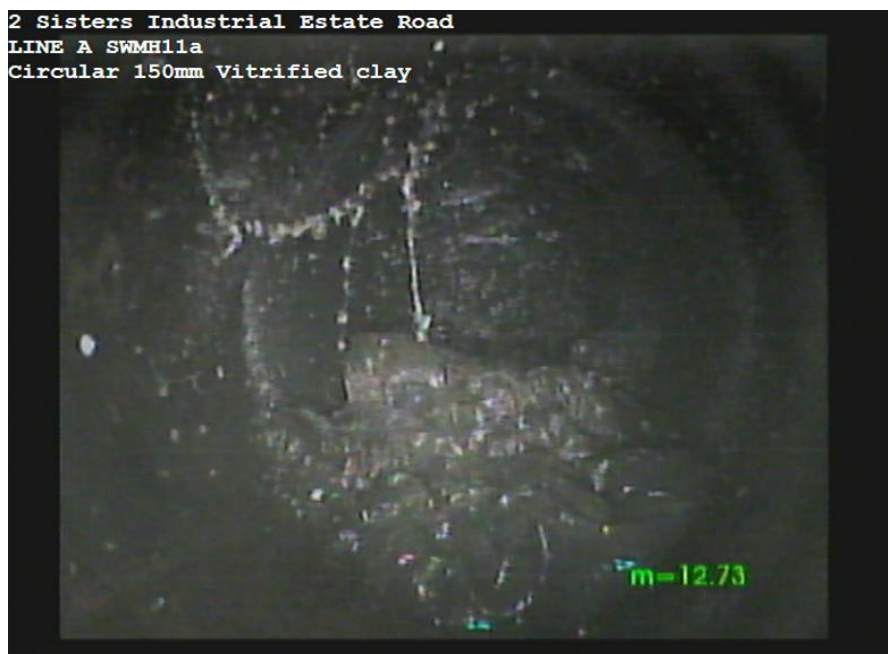
| Section | Pipe Ref | Grade | Description |
|---|---|---|---|
| 3 | LINE AX | 5 | Obstruction from 12 o'clock to 12 o'clock, 95% height loss |

LINE AX\_faa065e7-765e-4826-98de-115a3067a3d6\_20170622\_064632\_571.jpg, 00:01:49,  
12.73m  
Obstruction from 12 o'clock to 12 o'clock, 95% height loss

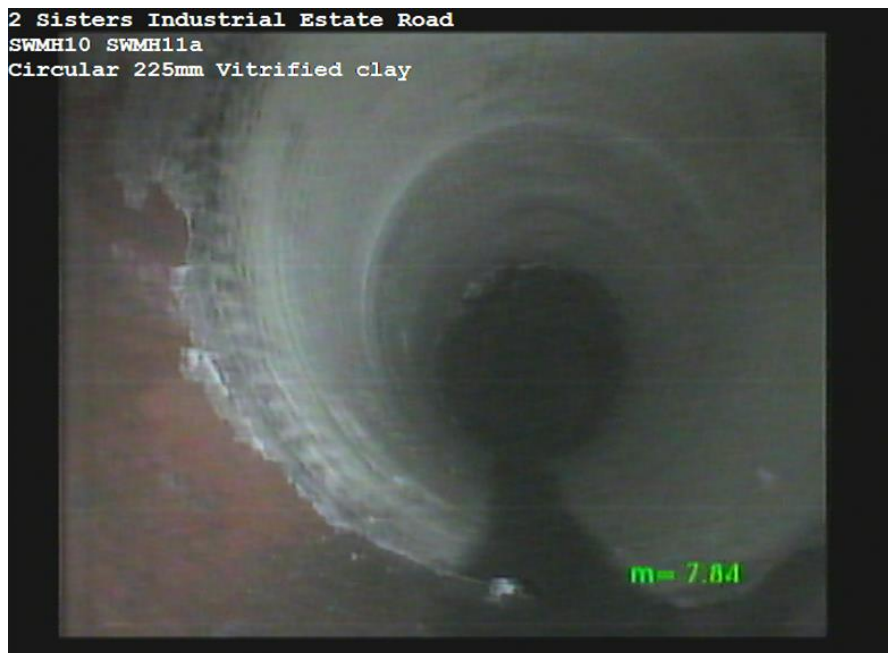
SWMH10X\_9aac5131-bd9b-41d0-89fb-81cbdd461637\_20170622\_065351\_994.jpg, 00:00:24,  
7.87m  
Sewer lining changes/starts/finishes at this point

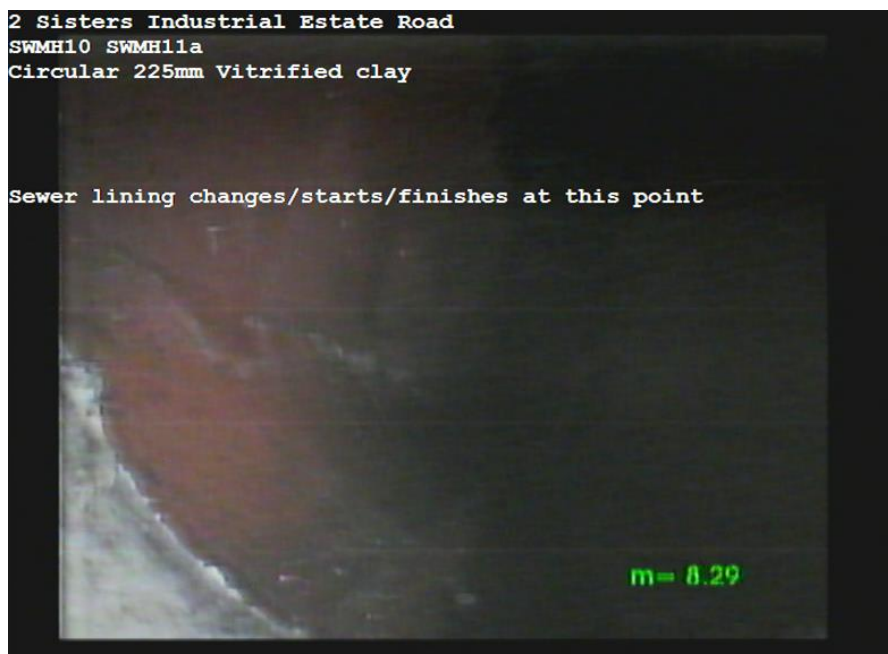
SWMH10X\_19661fd1-2b1b-4a3b-b90b-60378e9481a6\_20170622\_065335\_414.jpg, 00:00:40,  
8.29m  
Sewer lining changes/starts/finishes at this point

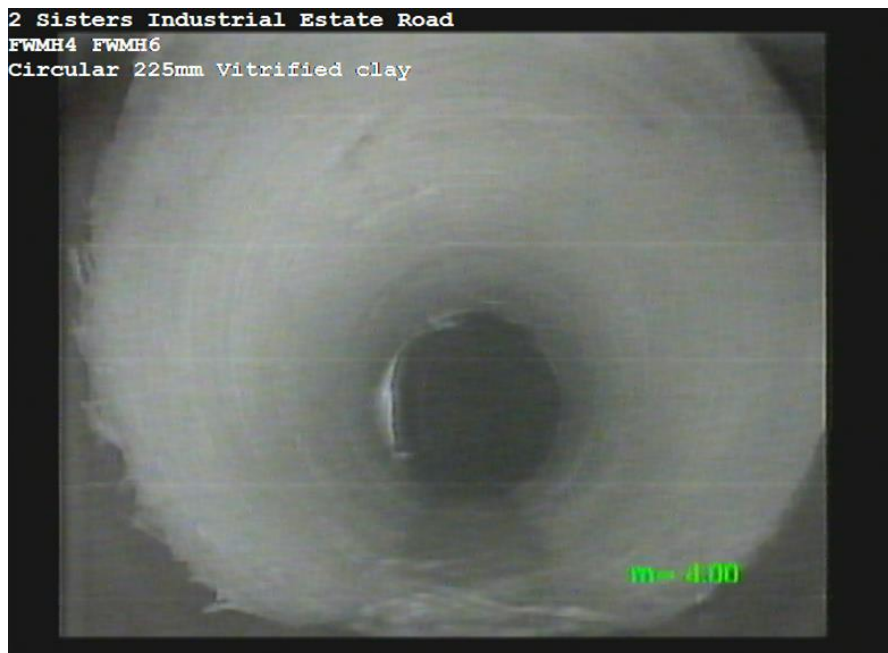
FWMH4X\_a5a4e1c0-3f41-46b2-a799-ba14cea9645c\_20170622\_124154\_329.jpg, 00:00:13,  
3.92m  
Sewer lining changes/starts/finishes at this point

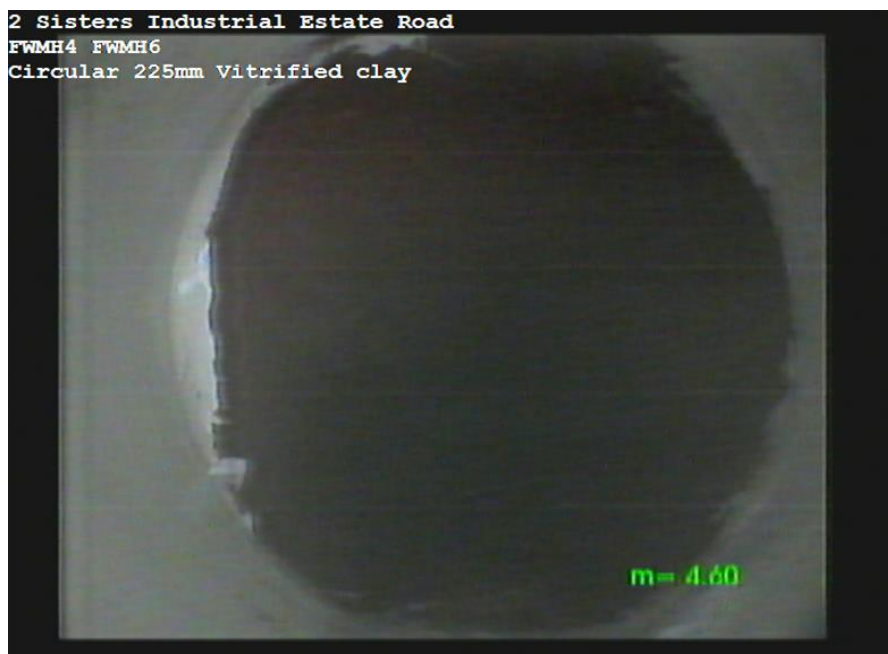
FWMH4X\_7d238d10-2c31-4056-ba13-b0f854e45c75\_20170622\_124209\_132.jpg, 00:00:28,  
4.67m  
Sewer lining changes/starts/finishes at this point

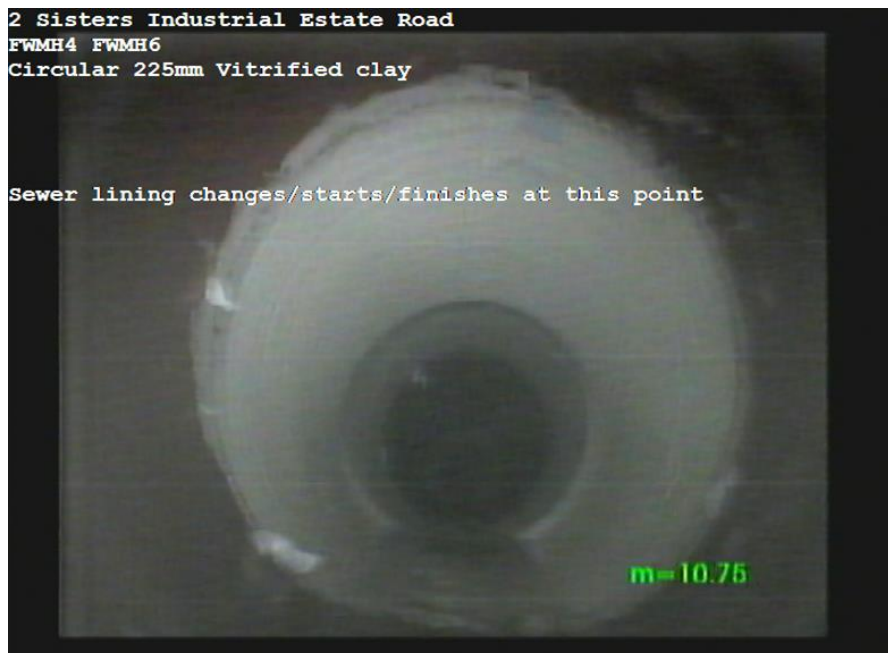
FWMH4X\_be5f6ca3-4b84-40f6-a85a-a5fcacce18b9\_20170622\_124309\_459.jpg, 00:01:39,  
10.75m  
Sewer lining changes/starts/finishes at this point

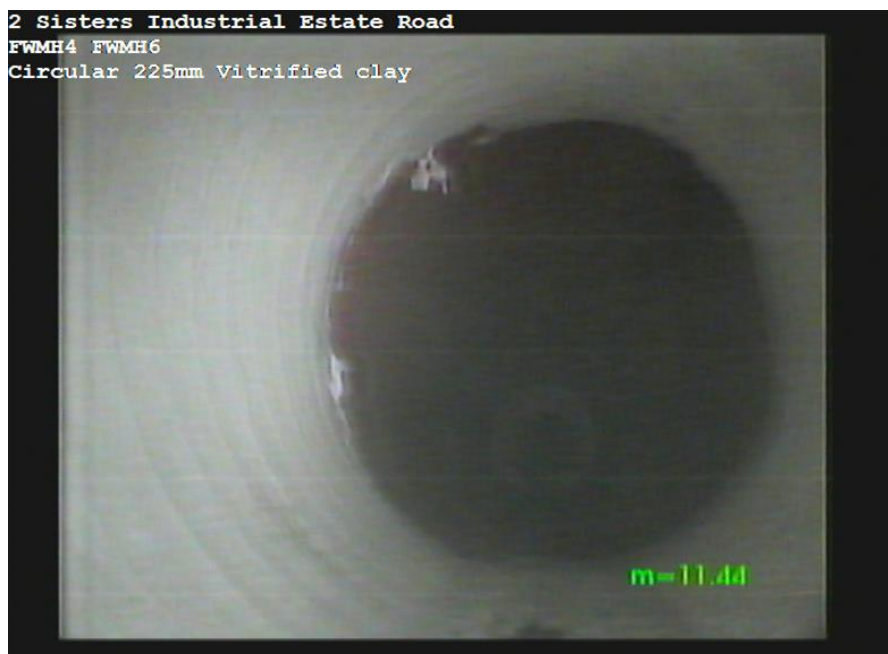
FWMH4X\_cf664817-d747-42e8-b4b5-289354077130\_20170622\_124352\_568.jpg, 00:02:01,  
11.44m  
Sewer lining changes/starts/finishes at this point

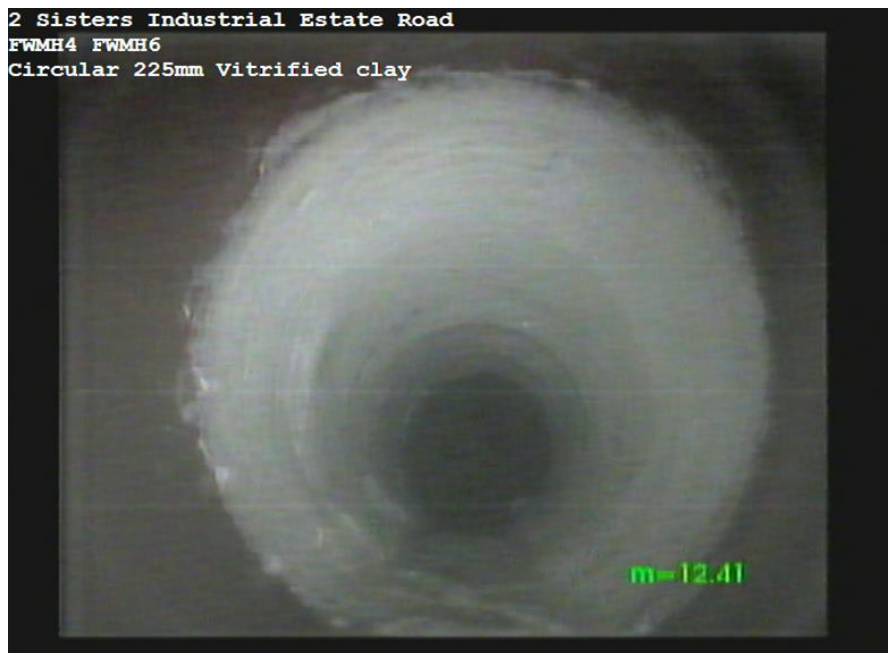
FWMH4X\_bd581432-5b32-4c72-bc3b-257f68d926cf\_20170622\_124544\_465.jpg, 00:02:20,  
12.44m  
Sewer lining changes/starts/finishes at this point

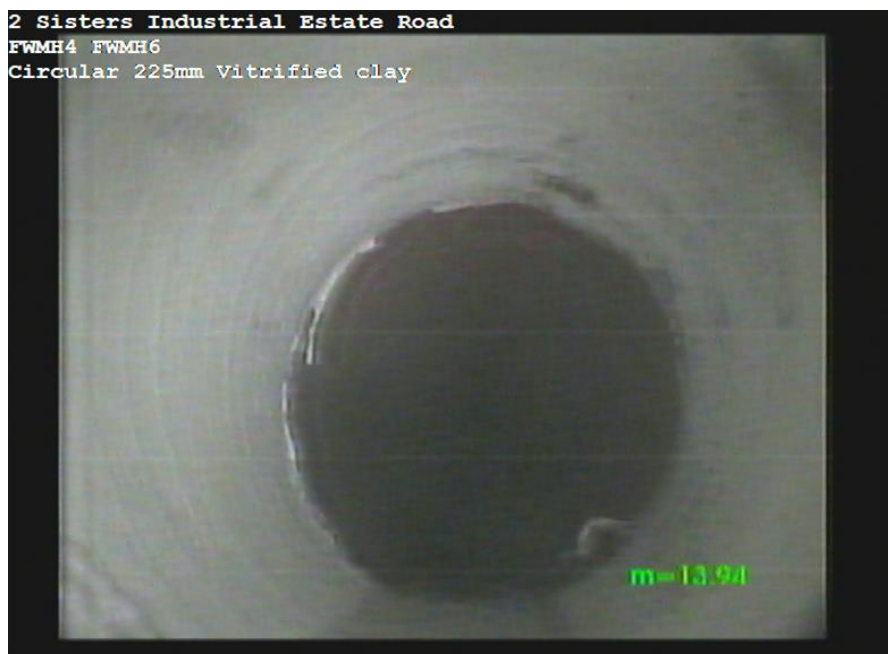
FWMH4X\_3f5d34cd-43b8-46bf-a341-98fa62b75929\_20170622\_124511\_205.jpg, 00:02:44,  
13.94m  
Sewer lining changes/starts/finishes at this point

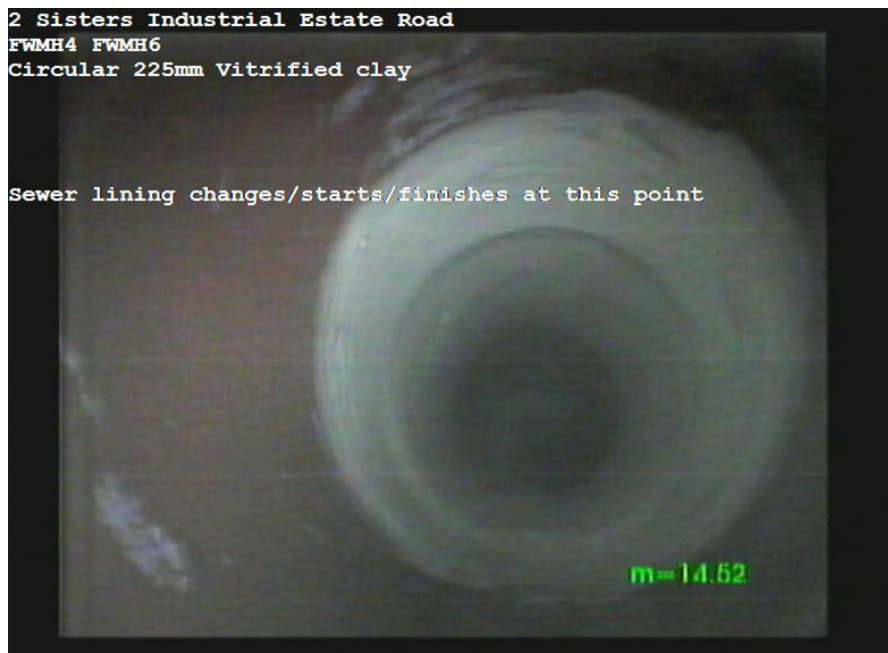
FWMH4X\_88a9eda9-8477-4c78-97fb-2801c5b99fe4\_20170622\_124623\_852.jpg, 00:03:43,  
14.52m  
Sewer lining changes/starts/finishes at this point

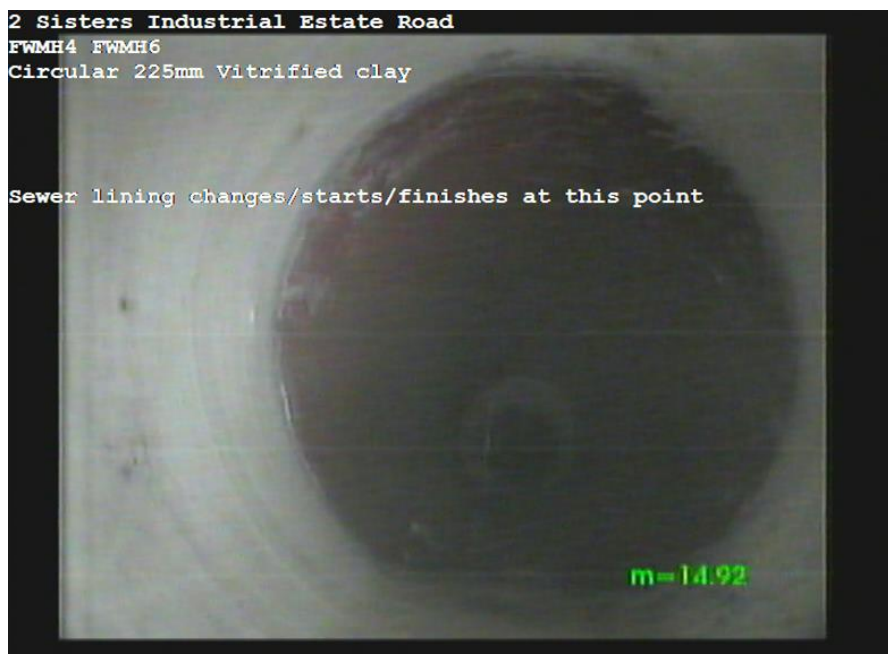
FWMH4X\_5235b1f3-41d3-47b2-aef3-8563609d1de4\_20170622\_124708\_162.jpg, 00:03:58,  
14.92m  
Sewer lining changes/starts/finishes at this point

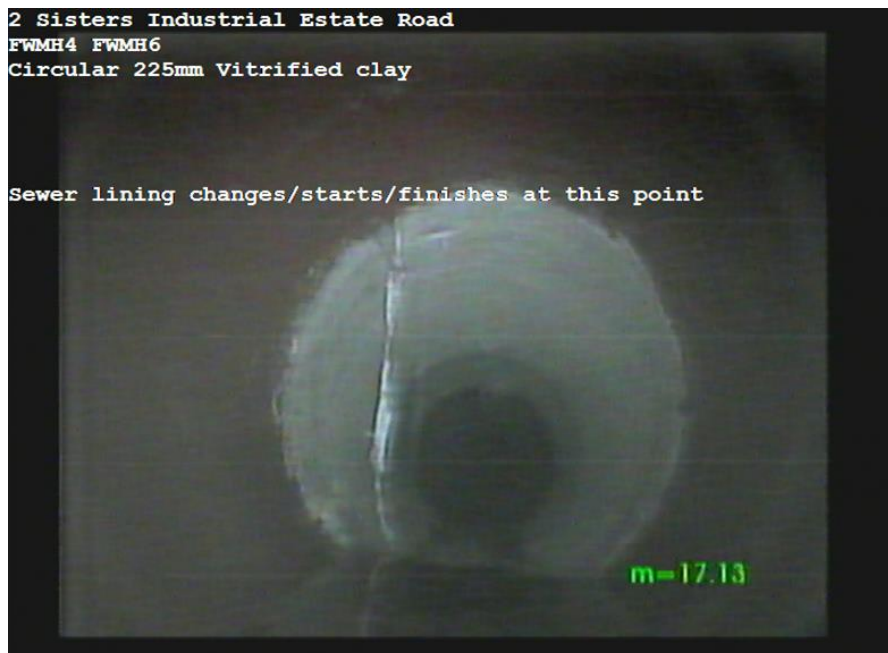
FWMH4X\_c92f4f40-966b-4dac-bea2-30dd2616dc94\_20170622\_124837\_089.jpg, 00:05:10, 17.13m  
Sewer lining changes/starts/finishes at this point

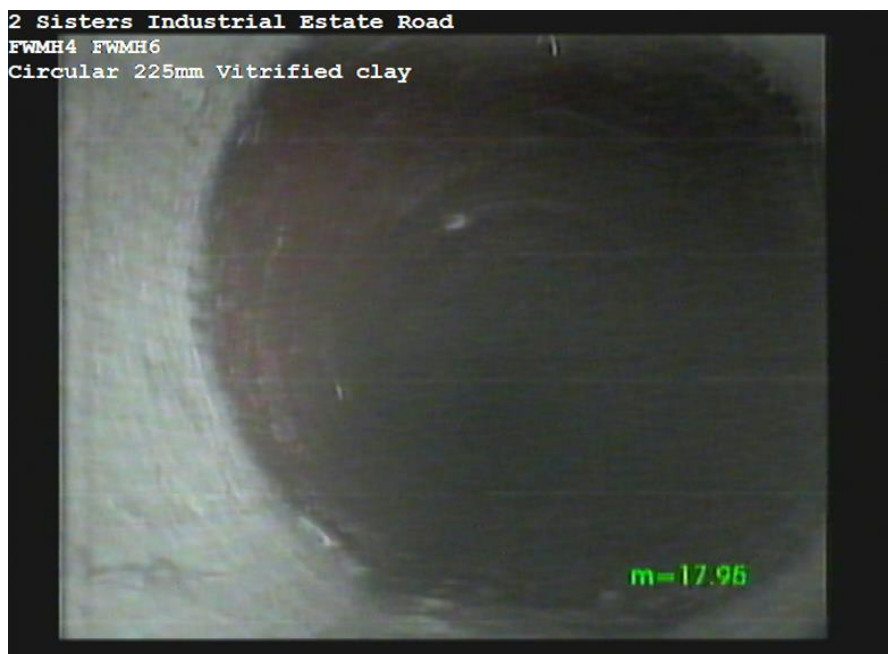
FWMH4X\_ed670d45-7678-48c9-b225-86665e92ac73\_20170622\_125005\_943.jpg, 00:05:32, 17.95m  
Sewer lining changes/starts/finishes at this point

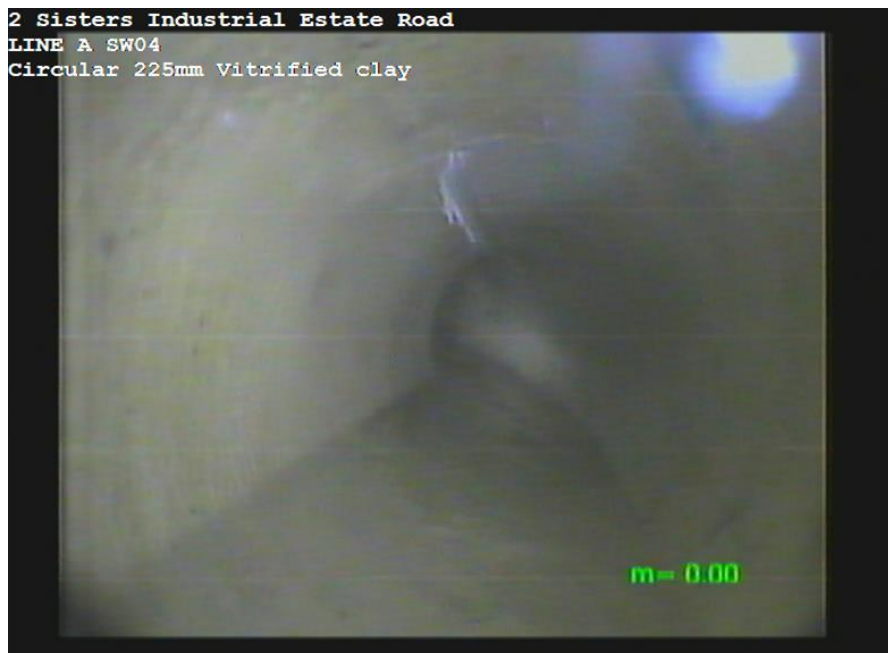
LINE AX\_10d967aa-013c-411f-940f-b1f16ea068d3\_20170622\_155832\_243.jpg, 00:00:00,  
0.01m  
Sewer lining changes/starts/finishes at this point

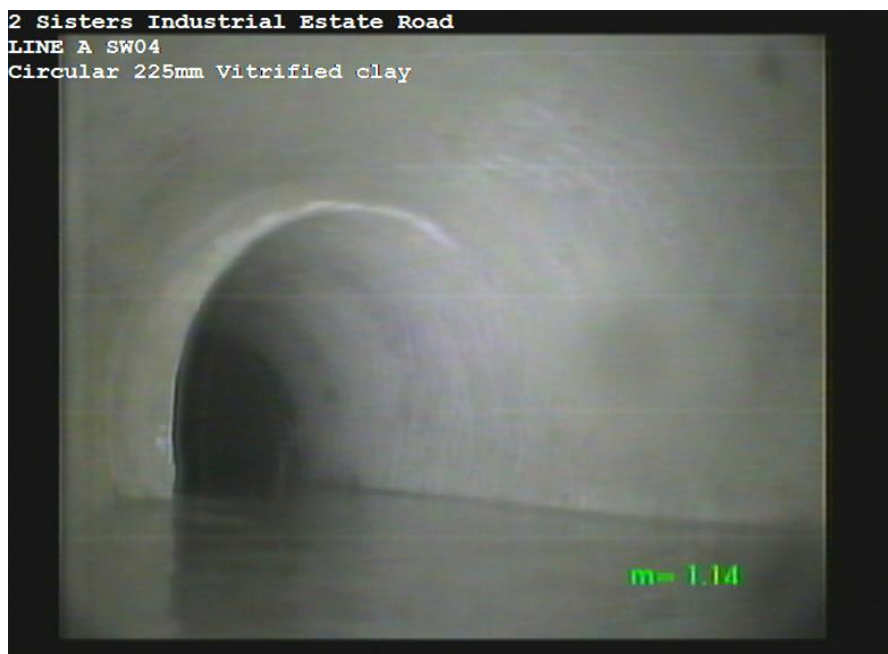
LINE AX\_977b7323-0c73-4586-91dc-48bb27dec19d\_20170622\_160013\_701.jpg, 00:00:55,  
1.14m  
Sewer lining changes/starts/finishes at this point

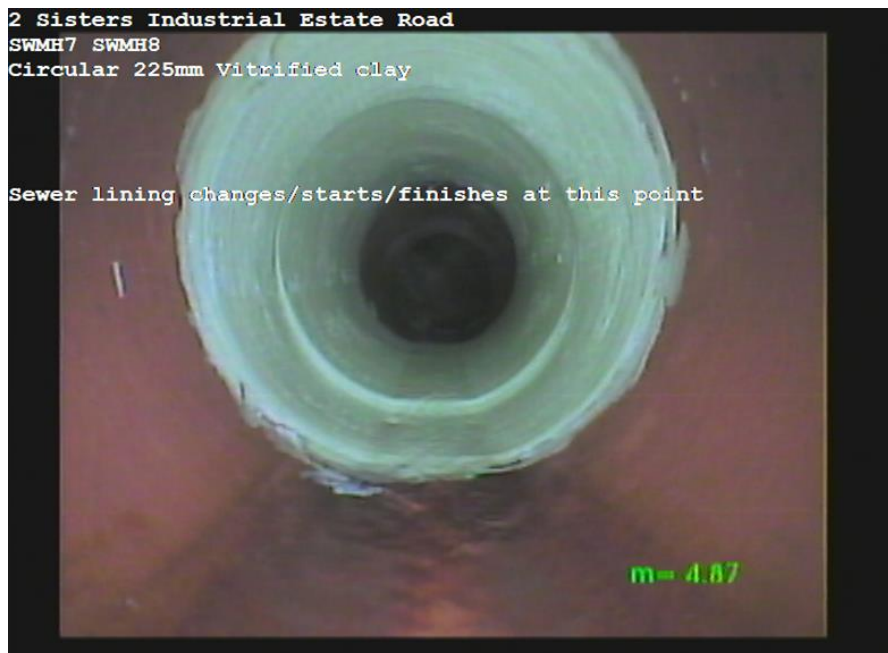
SWMH7X\_403ed8c3-5bb3-4782-8120-80dc687a1669\_20170622\_174835\_108.jpg, 00:00:38,  
4.87m  
Sewer lining changes/starts/finishes at this point

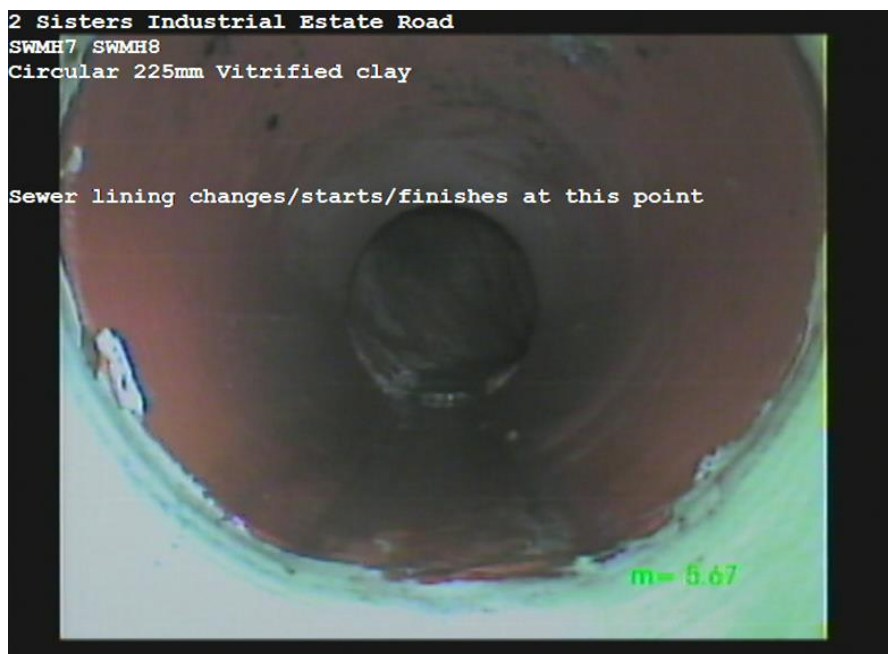
SWMH7X\_051899fe-31e4-47c8-bb6f-31994bfe1854\_20170622\_174924\_754.jpg, 00:01:04,  
5.67m  
Sewer lining changes/starts/finishes at this point

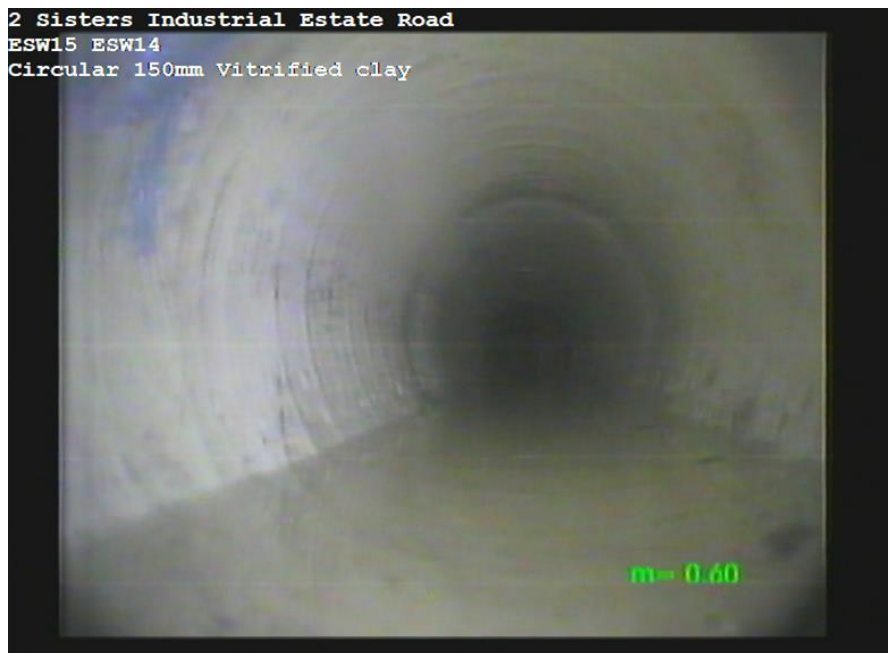
ESW15X\_3ec77f19-61bf-4152-aa76-f4e0fd1c5cb7\_20170623\_055005\_159.jpg, 00:00:00,  
0.60m  
Sewer lining changes/starts/finishes at this point

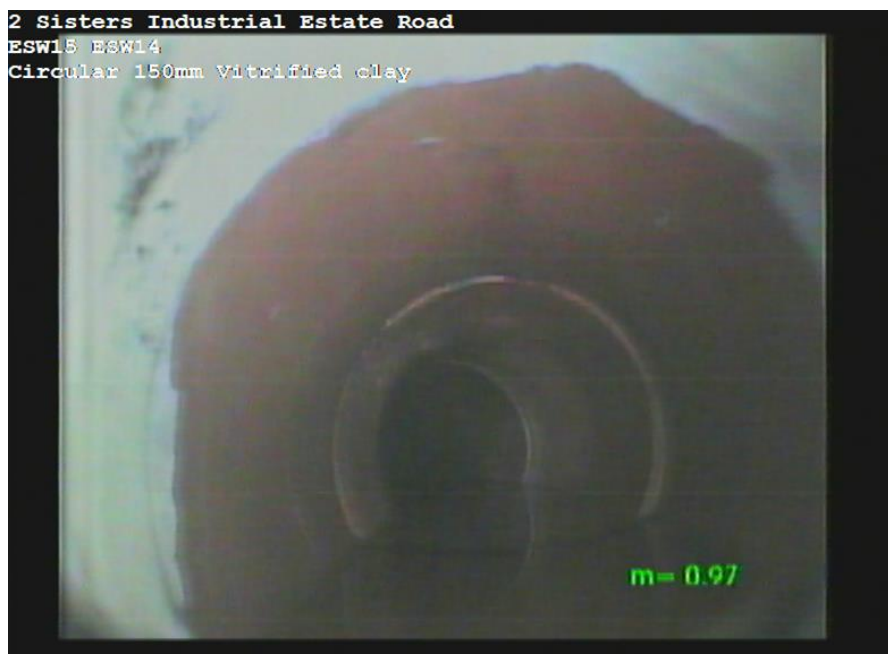
ESW15X\_6fe1855c-35e8-4c99-b2ea-e23cb511dbcc\_20170623\_055102\_253.jpg, 00:00:36,  
0.97m  
Sewer lining changes/starts/finishes at this point

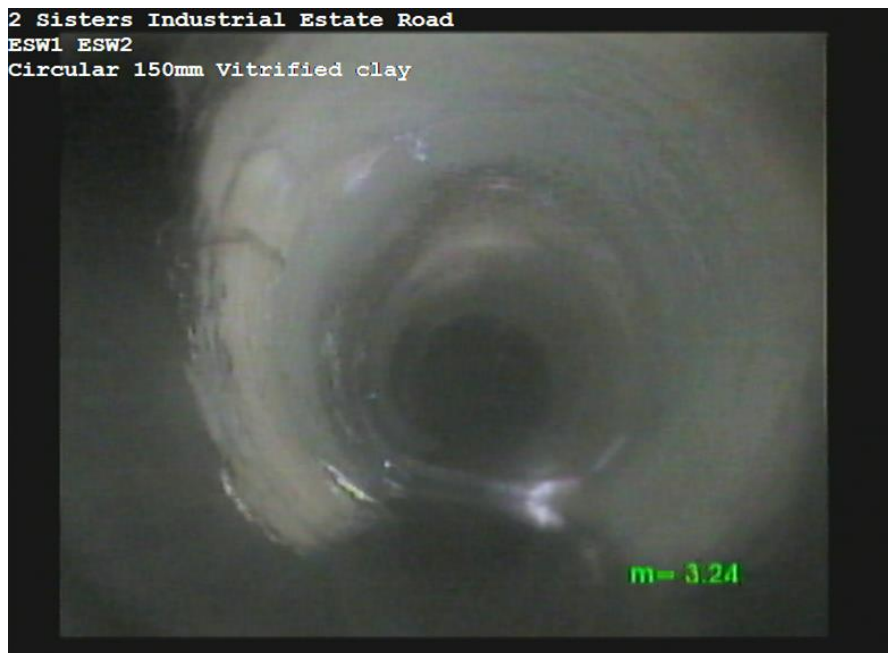
ESW1X\_4b29e6cd-490b-47bc-83e7-2f95f5e0d252\_20170623\_060337\_733.jpg, 00:00:22,  
3.24m  
Sewer lining changes/starts/finishes at this point

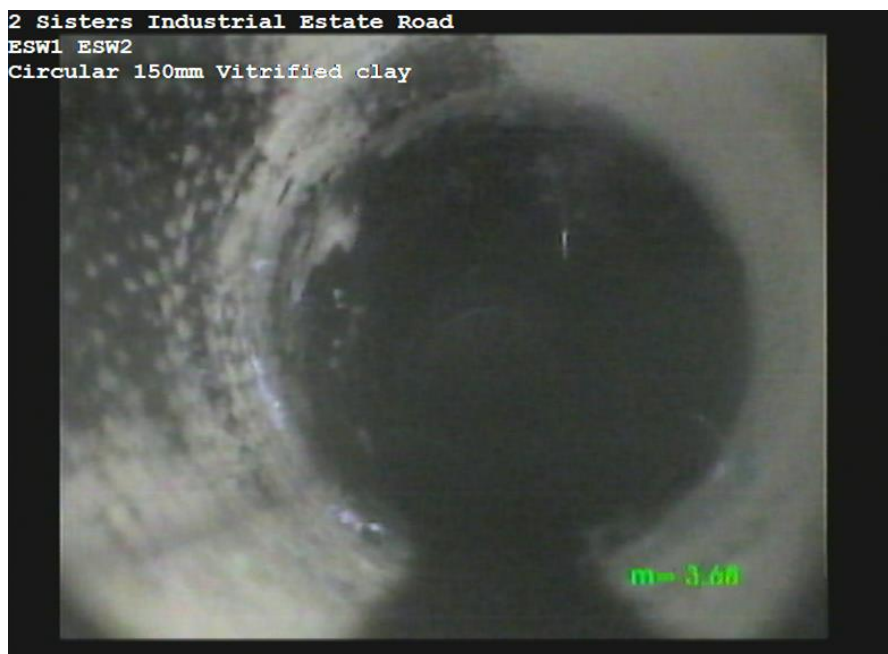
ESW1X\_700d08c7-09af-4d30-8327-ce8141aca2d9\_20170623\_060428\_381.jpg, 00:00:37,  
3.59m  
Sewer lining changes/starts/finishes at this point

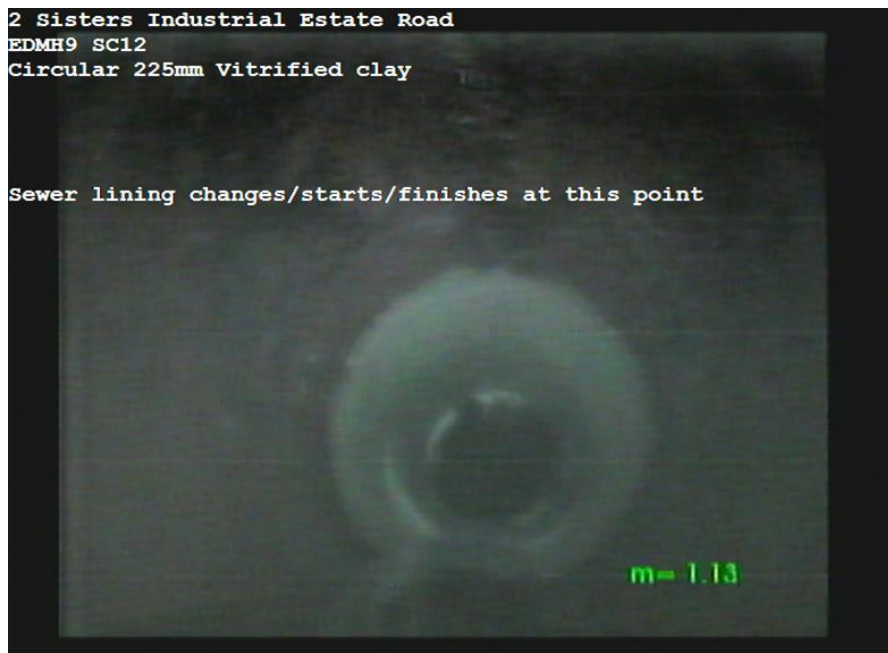
EDMH9X\_1028eca3-c83e-4294-9535-3f5dc0afc082\_20170623\_115430\_503.jpg, 00:00:14,  
1.11m  
Sewer lining changes/starts/finishes at this point

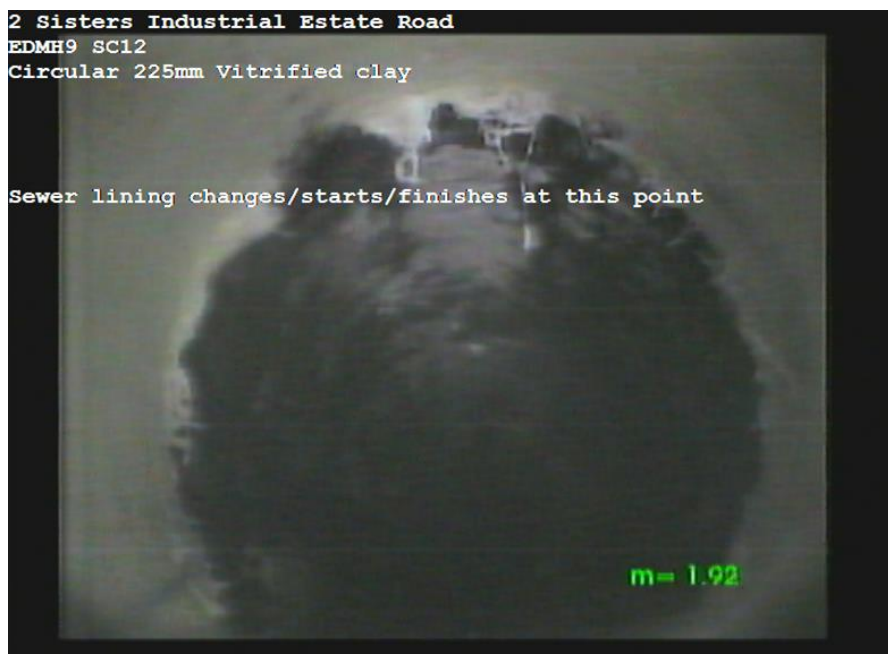
EDMH9X\_1c9921d1-9b57-4d02-b12d-2d46032187ea\_20170623\_115512\_696.jpg, 00:00:35,  
1.92m  
Sewer lining changes/starts/finishes at this point

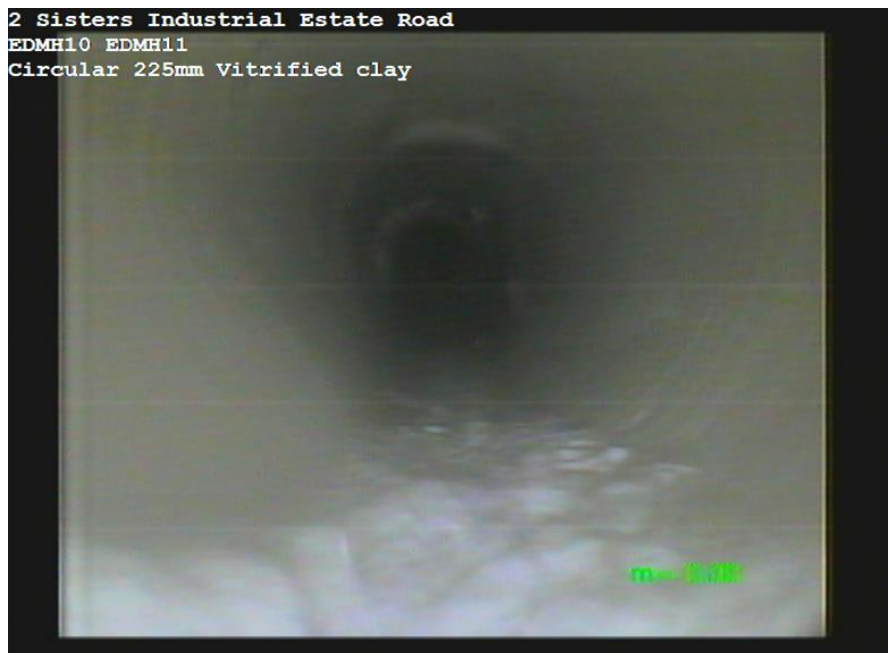
EDMH10X\_b9de2752-edb1-4100-80fb-94f571934139\_20170623\_122606\_461.jpg, 00:00:04,  
0.00m  
Sewer lining changes/starts/finishes at this point

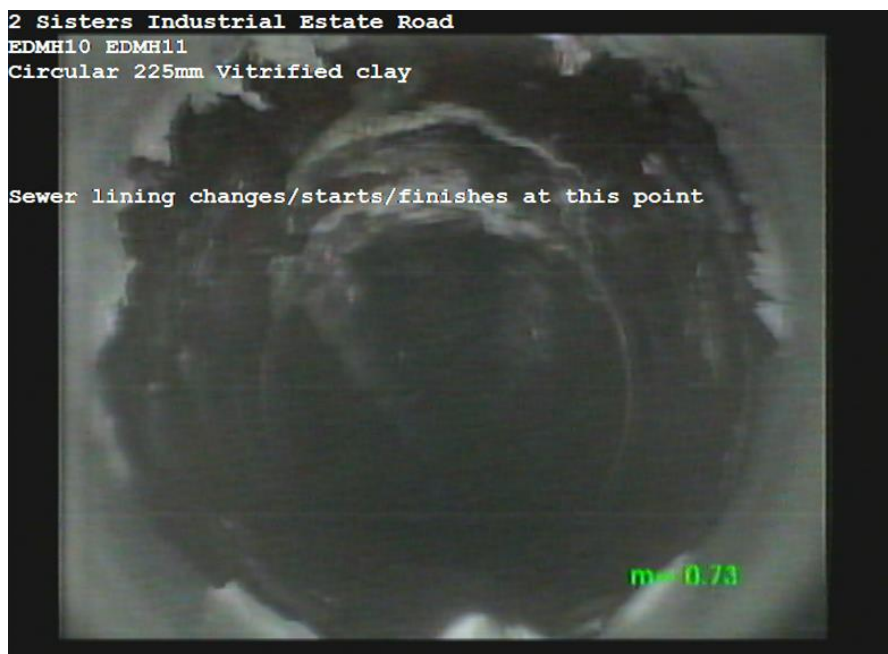
EDMH10X\_184e0cd9-7154-424c-9ab7-e700b0c67050\_20170623\_122308\_167.jpg, 00:00:25,  
0.73m  
Sewer lining changes/starts/finishes at this point

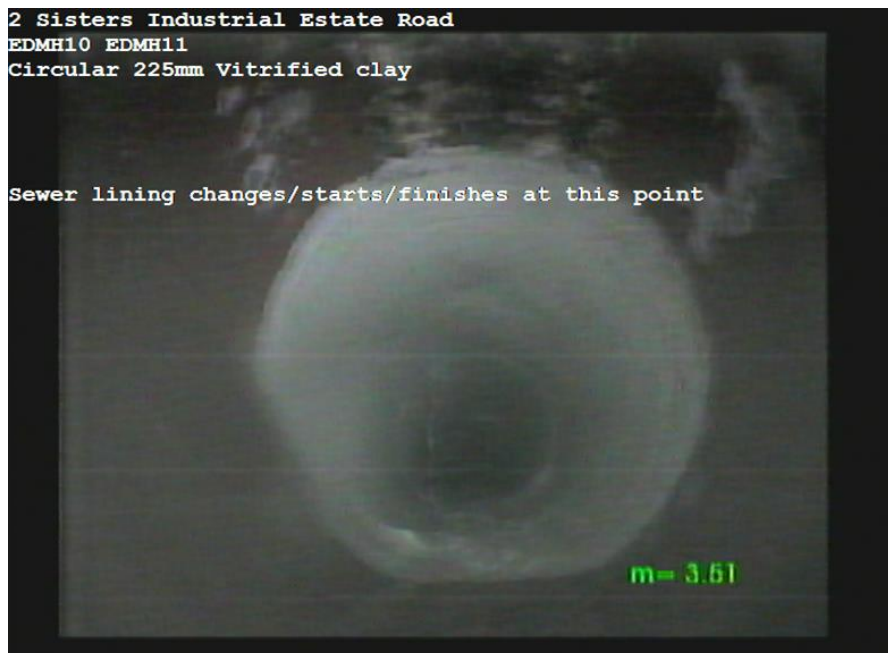
EDMH10X\_10becd6d-ca3b-47f4-b675-749b49a00ead\_20170623\_122402\_761.jpg, 00:00:58,  
3.51m  
Sewer lining changes/starts/finishes at this point

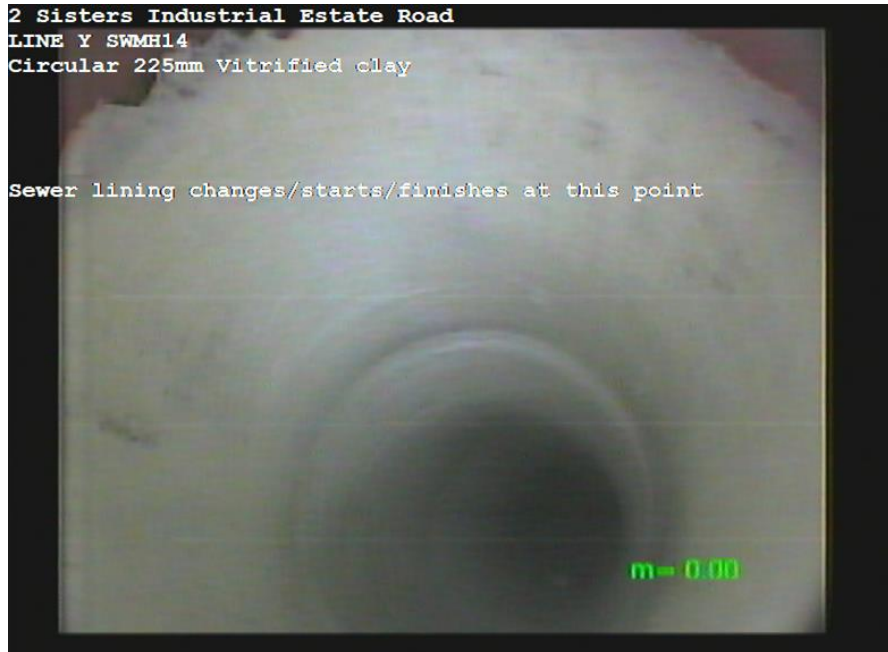
LINE YX\_021c3de1-5d3d-41df-b5ab-a3a3a360c7d1\_20170623\_133006\_960.jpg, 00:00:02,  
0.00m  
Sewer lining changes/starts/finishes at this point

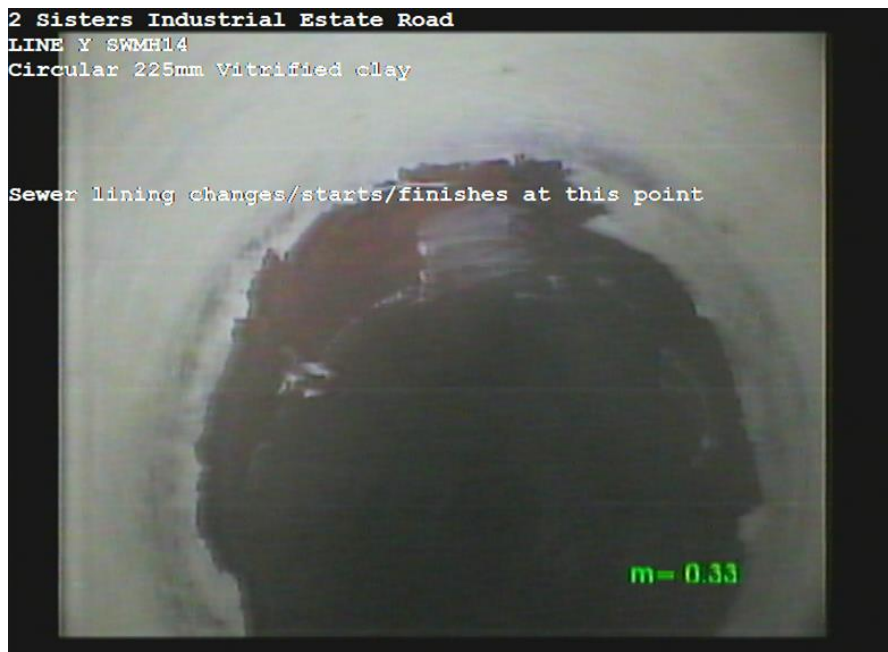
LINE YX\_0e3e7a11-6a3b-4479-8b92-bf6e4fb0f9d8\_20170623\_133045\_762.jpg, 00:00:24,  
0.33m  
Sewer lining changes/starts/finishes at this point

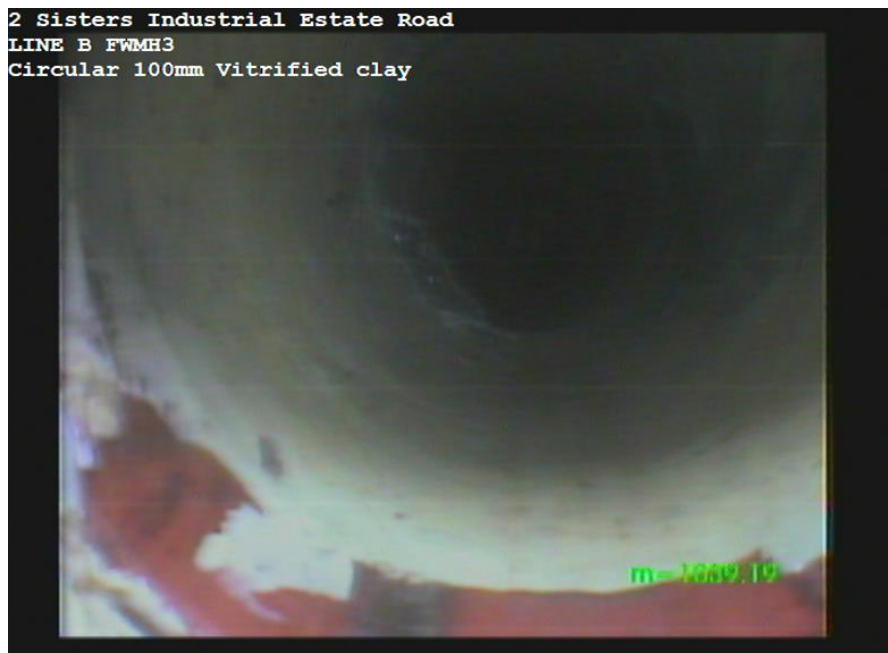
LINE BX\_98fe3b8d-390e-491a-974a-eccb7cfcdb41\_20170623\_134034\_080.jpg, 00:00:00, 0.01m  
Sewer lining changes/starts/finishes at this point

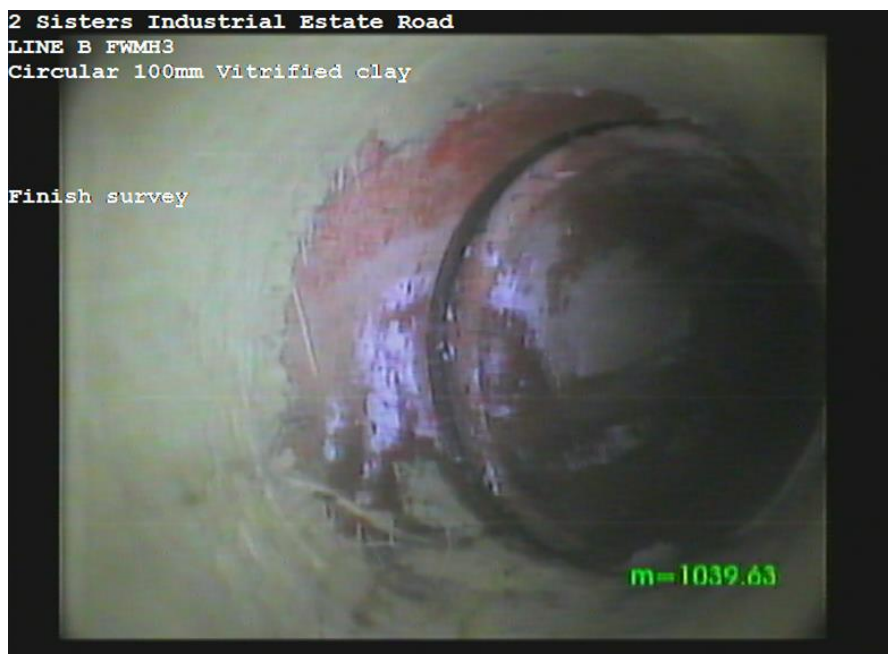
LINE BX\_f2997f23-f1f9-4459-bfec-56504196a0b0\_20170623\_134129\_319.jpg, 00:00:44, 0.35m  
Sewer lining changes/starts/finishes at this point

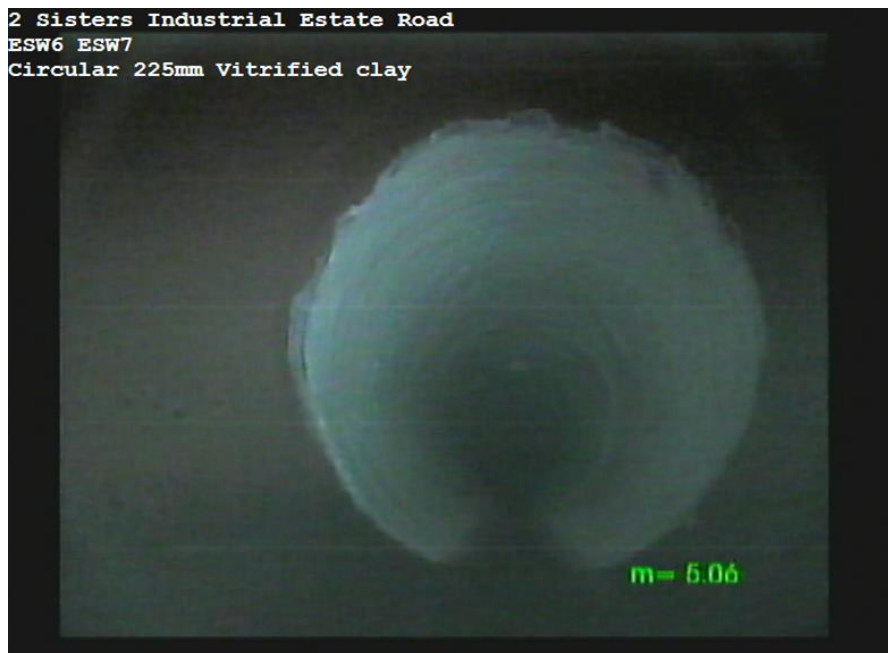
ESW6X\_137b160a-0fda-49b2-8dfa-3f02a1eb49f4\_20170623\_152309\_067.jpg, 00:00:24, 5.06m  
Sewer lining changes/starts/finishes at this point

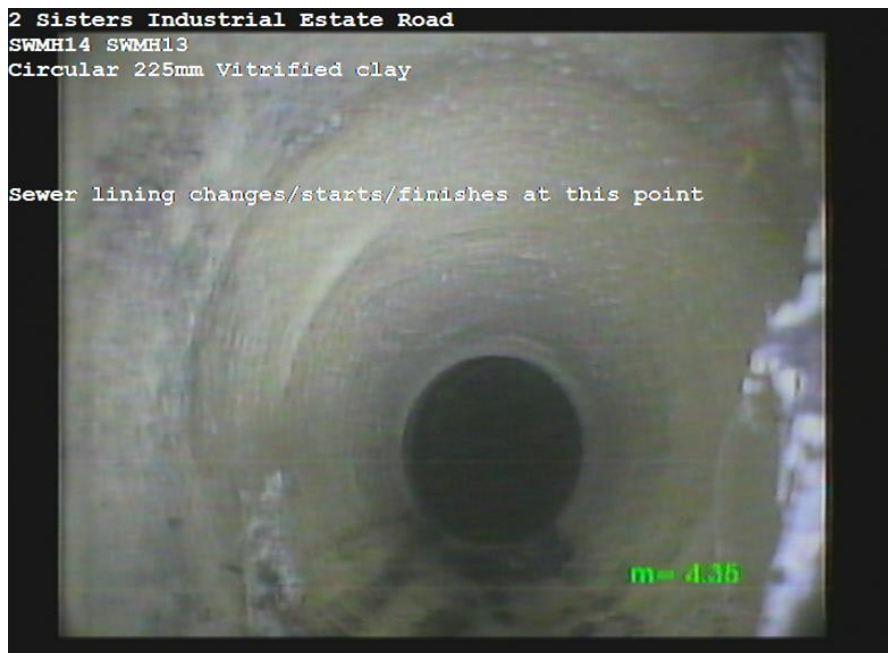
SWMH14X\_5ee8f9ab-a427-48ce-83c6-79fee2651629\_20170623\_153055\_237.jpg, 00:00:33,  
4.35m  
Sewer lining changes/starts/finishes at this point
