Project Name                                      2 Sisters Remedial

Start Date                                              19/06/2017

| Purpose: <b>Post inspection of repairs or renovations</b> | Flow Control: |

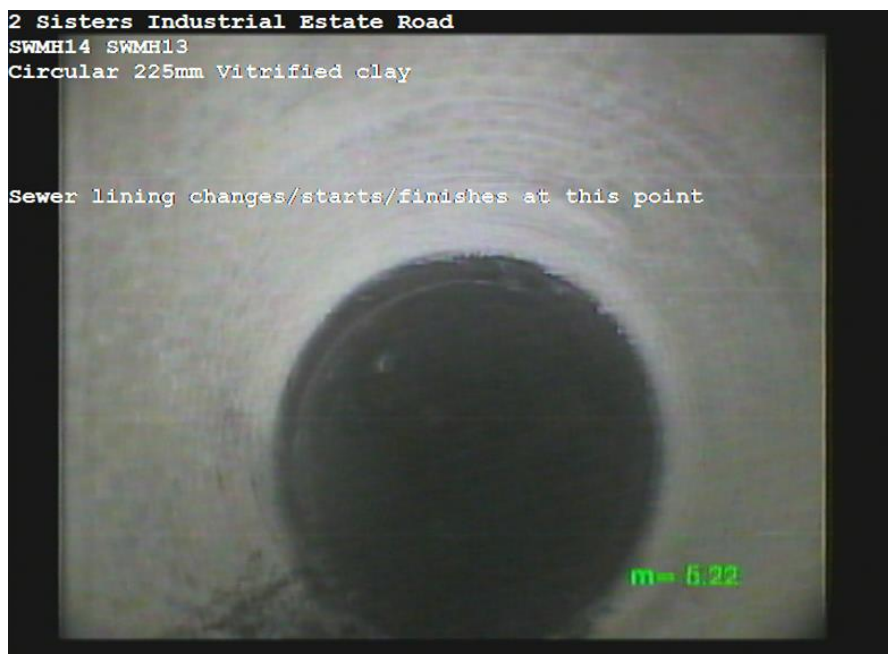
SWMH14X\_3cf4f22c-c7c9-4d10-aa1f-c9d3c18e2699\_20170623\_153243\_031.jpg, 00:01:51,  
5.22m  
Sewer lining changes/starts/finishes at this point

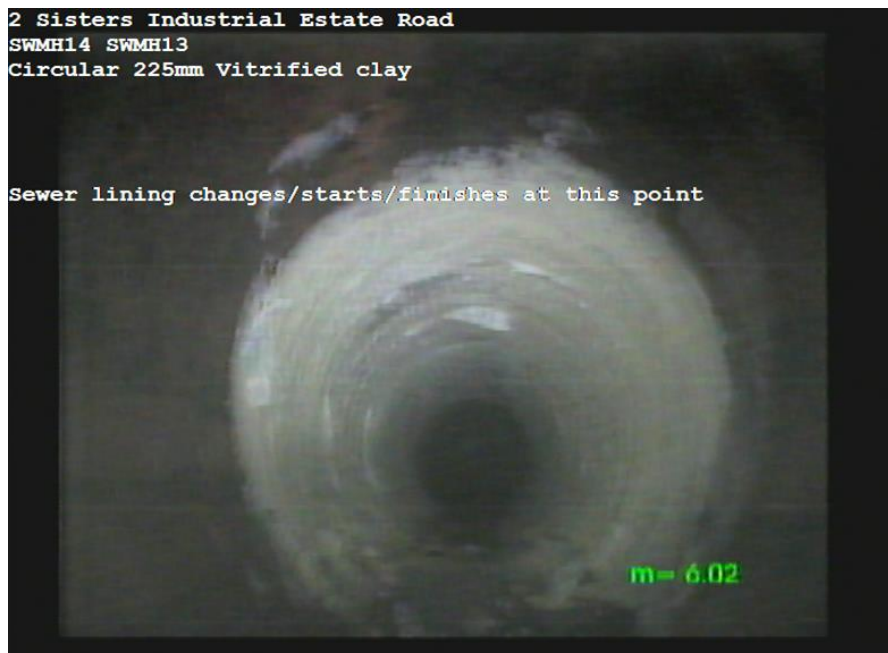
SWMH14X\_e0851588-5522-4343-9d17-d992fabaab4a\_20170623\_153331\_869.jpg, 00:02:19,  
5.94m  
Sewer lining changes/starts/finishes at this point

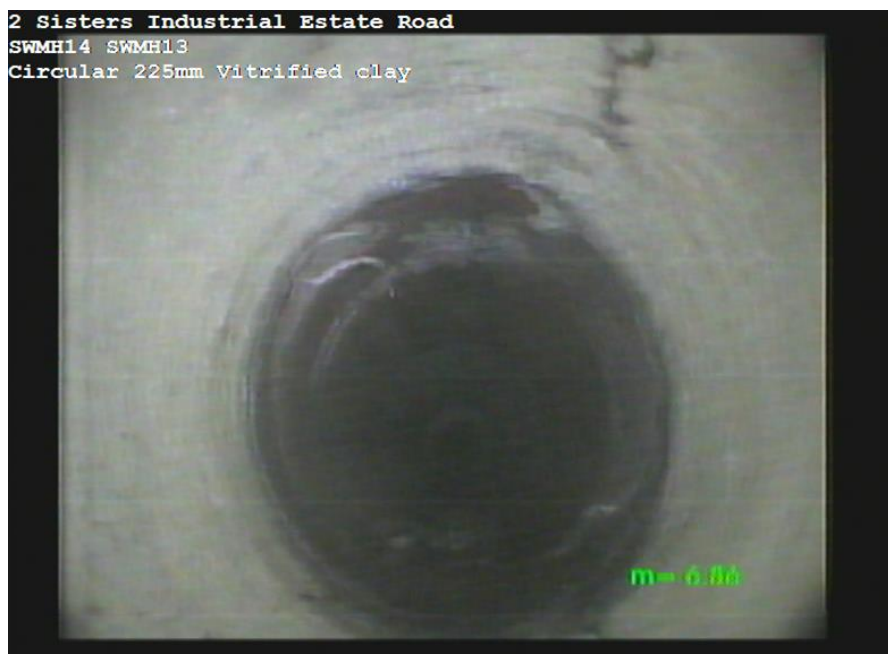
SWMH14X\_bc4eaccb-041a-4fe0-ace0-eca2422328ec\_20170623\_153408\_637.jpg, 00:02:38,  
6.87m  
Sewer lining changes/starts/finishes at this point

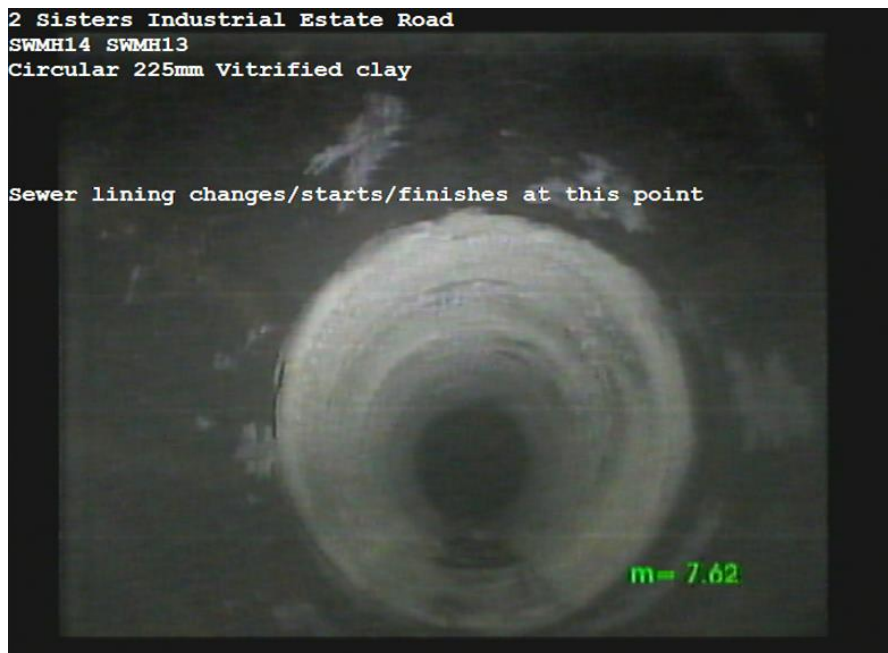
SWMH14X\_039edf5b-f555-4637-8925-239dbac8b440\_20170623\_153441\_115.jpg, 00:02:55,  
7.62m  
Sewer lining changes/starts/finishes at this point

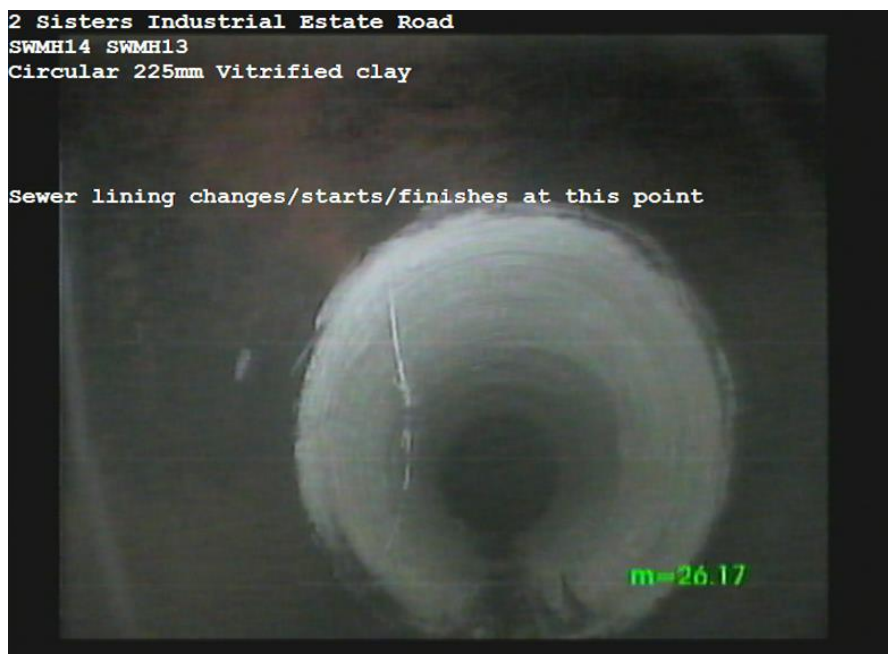
SWMH14X\_491e6763-f1d0-4a81-825a-773ee96bd826\_20170623\_153750\_342.jpg, 00:04:59,  
26.17m  
Sewer lining changes/starts/finishes at this point

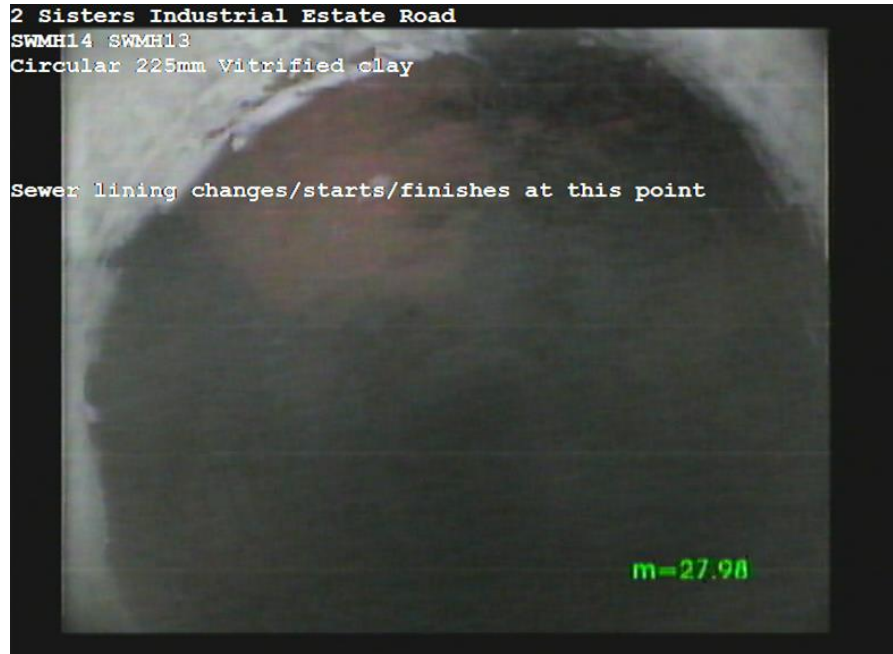
SWMH14X\_58a39c6a-91ba-4d30-a303-18e4979c10cb\_20170623\_153836\_690.jpg, 00:05:21,  
27.98m  
Sewer lining changes/starts/finishes at this point

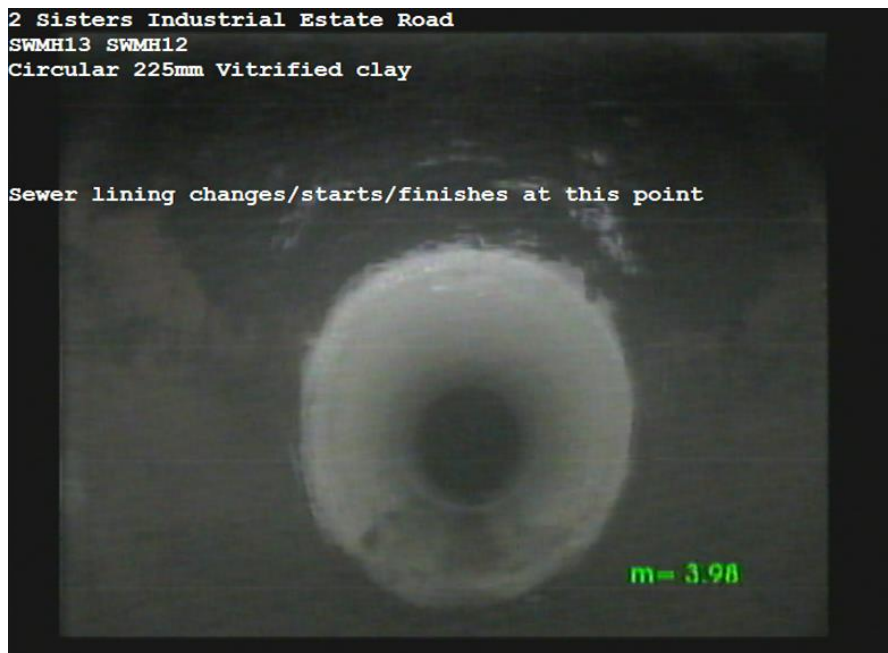
SWMH13X\_8cb6fbfa-99dc-4d21-a428-313d3db1b8f1\_20170623\_154227\_380.jpg, 00:06:32,  
3.98m  
Sewer lining changes/starts/finishes at this point

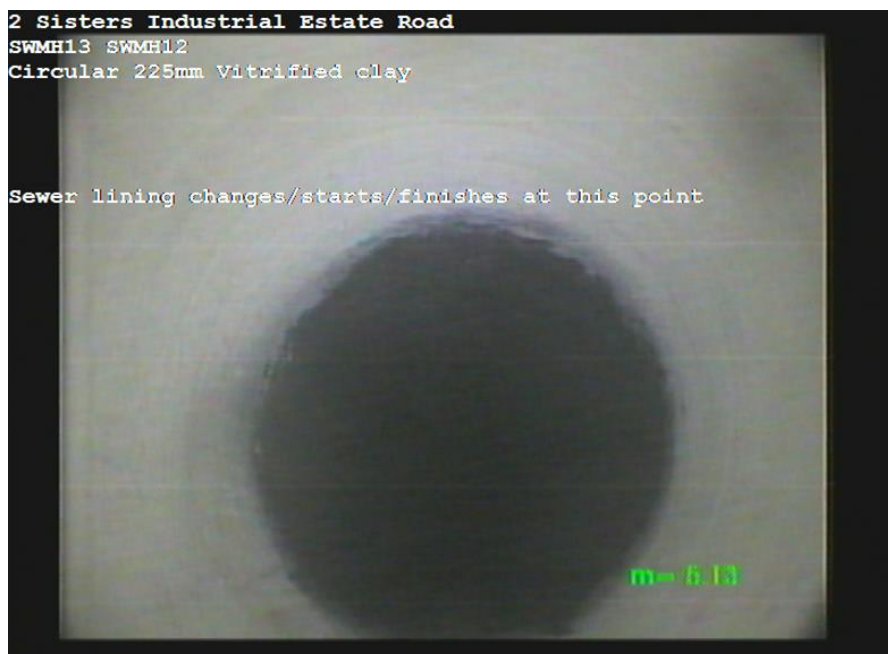
SWMH13X\_5f5bbc2f-0c8b-4f0e-badc-9bf328a41d29\_20170623\_154327\_385.jpg, 00:00:16,  
5.13m  
Sewer lining changes/starts/finishes at this point

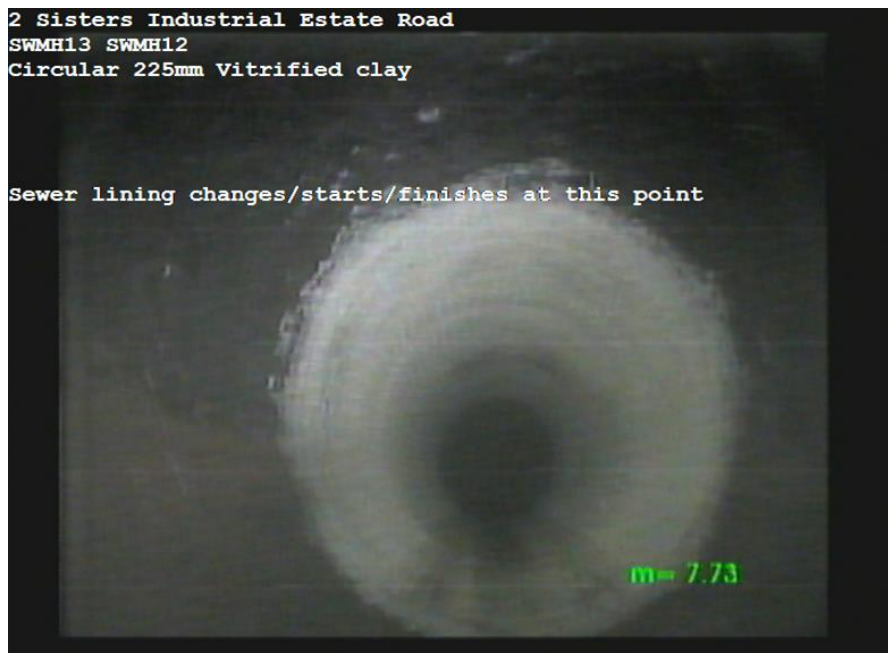
SWMH13X\_bd16db54-2aa8-43dd-975d-c54e5d65a4a8\_20170623\_154422\_191.jpg, 00:00:49,  
7.73m  
Sewer lining changes/starts/finishes at this point

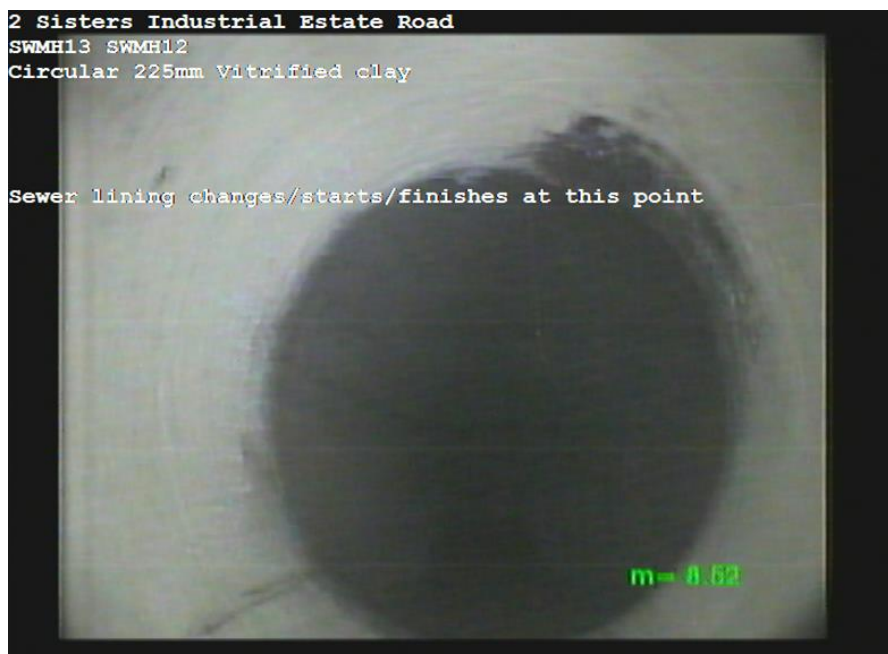
SWMH13X\_4f7a62b8-330c-4daf-a230-443930e307f4\_20170623\_154503\_096.jpg, 00:01:02,  
8.53m  
Sewer lining changes/starts/finishes at this point

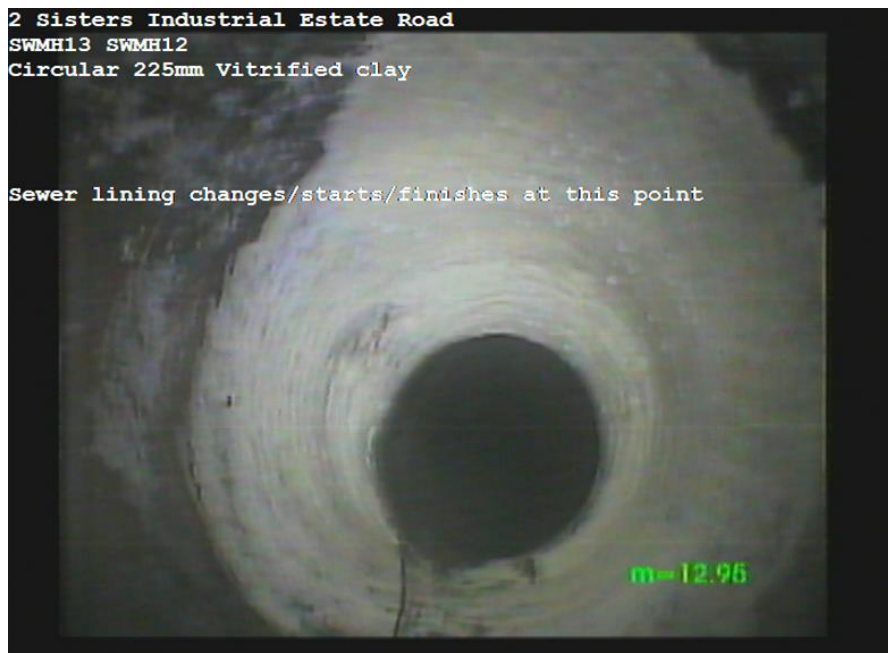
SWMH13X\_bacebbe2-a1fc-441e-b5a9-b96c6fbb4217\_20170623\_154609\_181.jpg, 00:01:34,  
12.95m  
Sewer lining changes/starts/finishes at this point

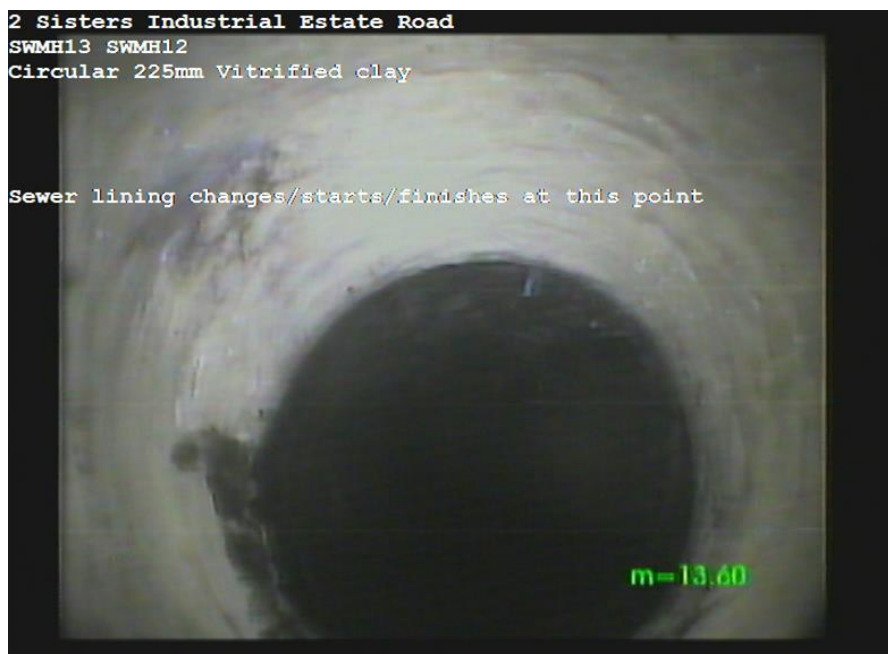
SWMH13X\_08acc3c8-6cf6-41b0-aeae-9900846d65c2\_20170623\_154717\_579.jpg, 00:01:51,  
13.60m  
Sewer lining changes/starts/finishes at this point

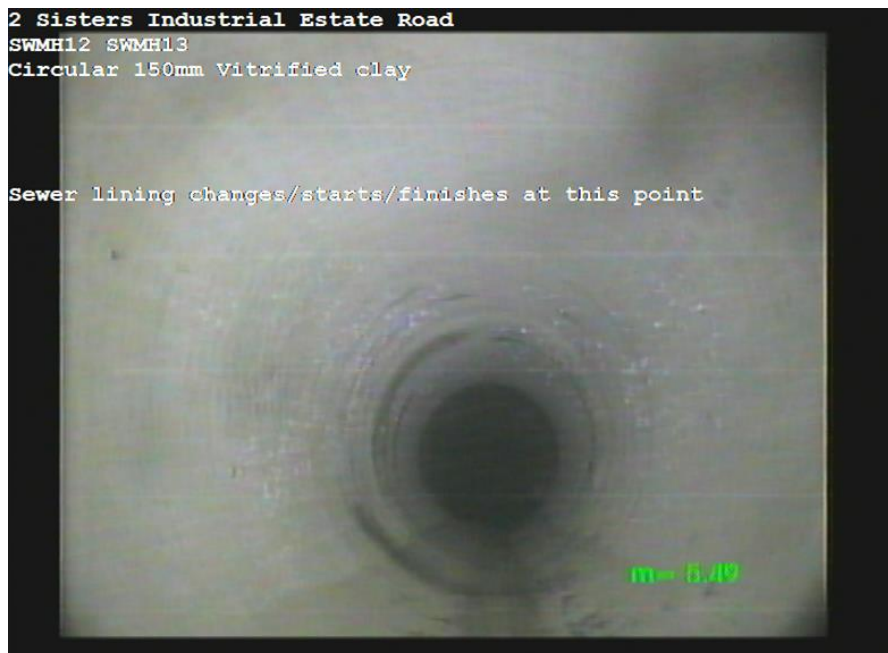
SWMH12X\_f37b4eed-09d8-4083-824e-31aa07f8e42c\_20170623\_155844\_389.jpg, 00:02:33,  
5.49m  
Sewer lining changes/starts/finishes at this point

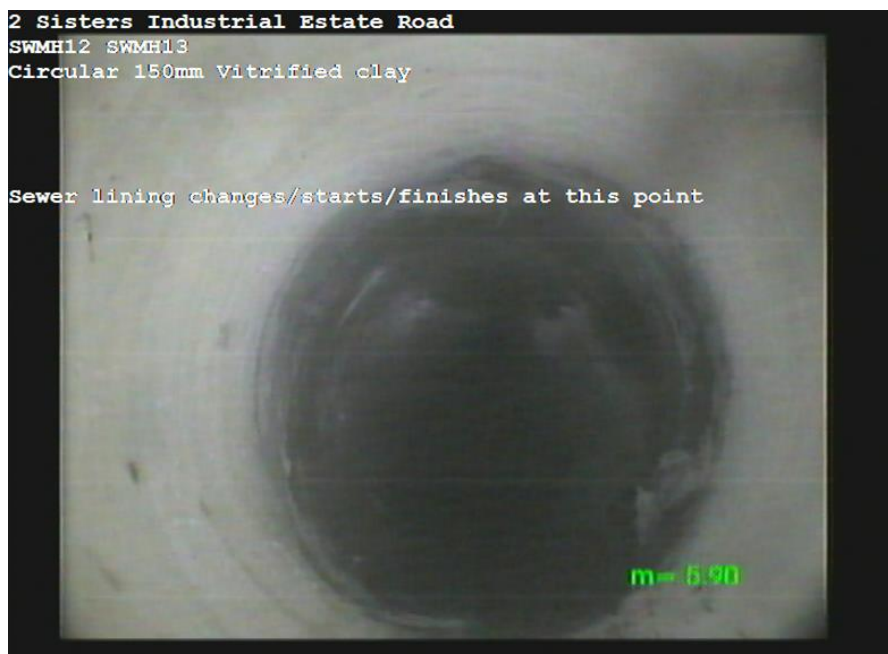
SWMH12X\_81ab399a-8ae1-4155-81d9-0ddff52074c4\_20170623\_155928\_081.jpg, 00:00:00,  
5.90m  
Sewer lining changes/starts/finishes at this point

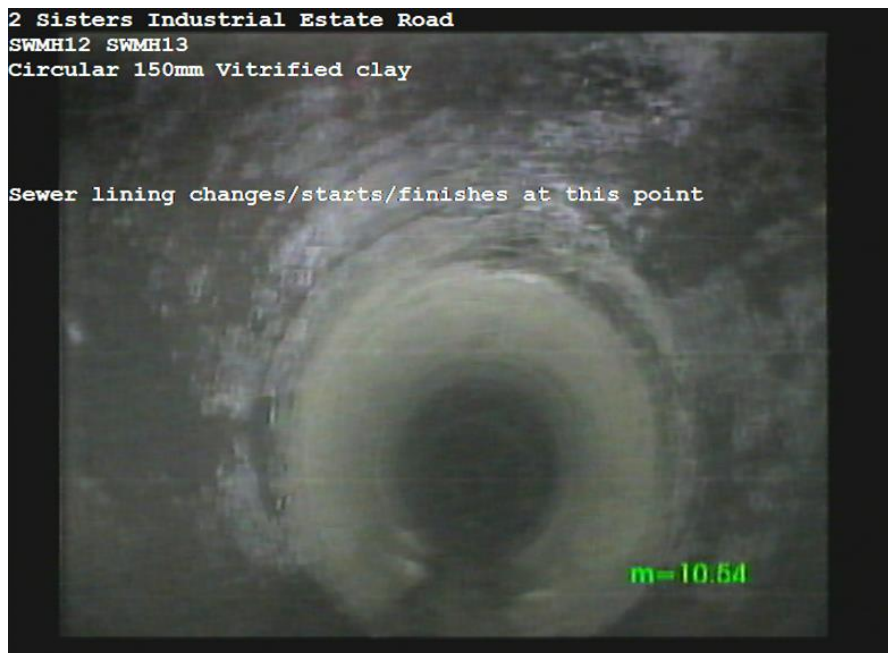
SWMH12X\_aec8aa87-c7b4-47b6-9bc8-d217bd1f5245\_20170623\_160021\_820.jpg, 00:00:19,  
10.54m  
Sewer lining changes/starts/finishes at this point

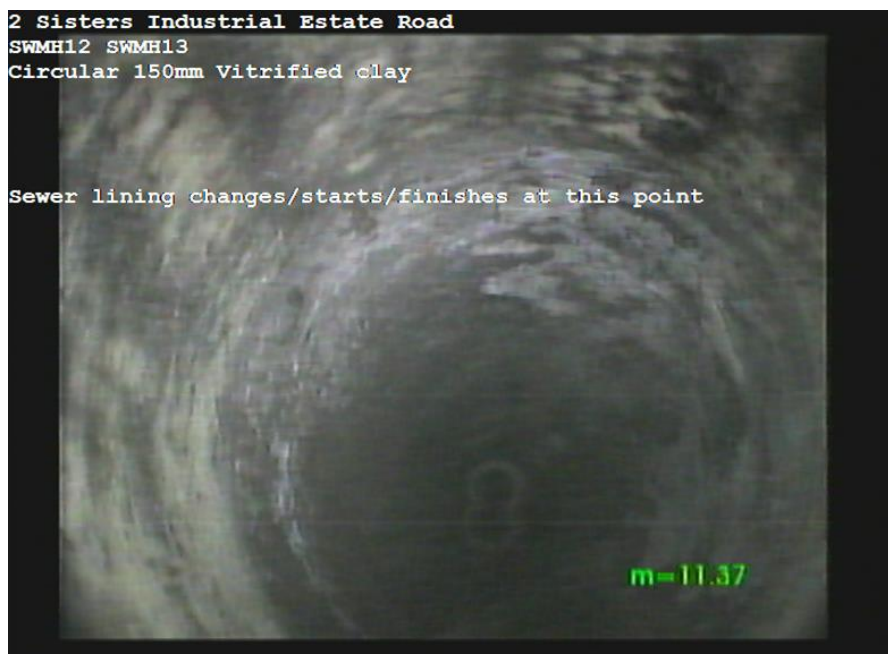
SWMH12X\_075f19c8-260a-4442-bee9-583696bc34d0\_20170623\_160120\_183.jpg, 00:00:44,  
11.37m  
Sewer lining changes/starts/finishes at this point

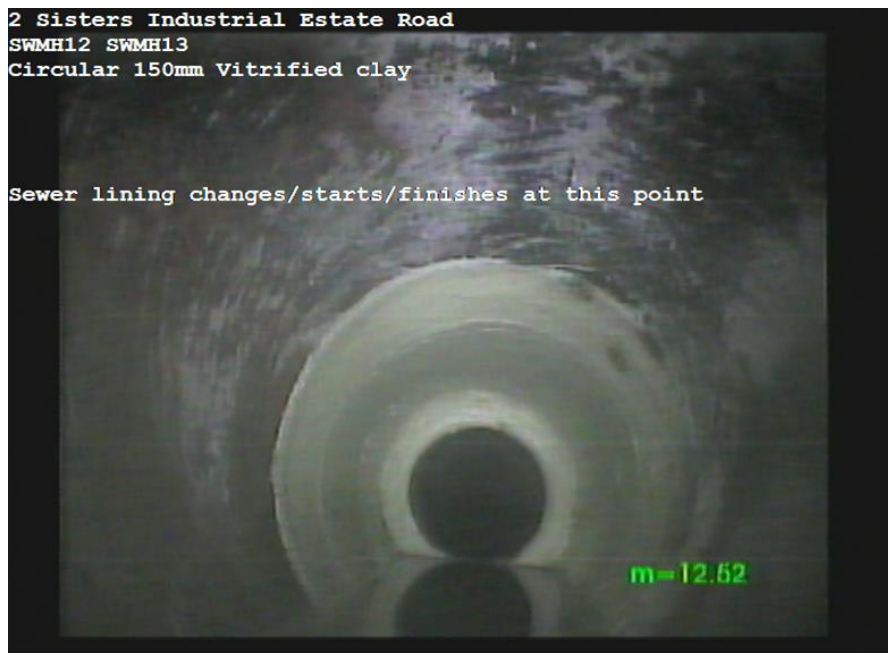
SWMH12X\_d05aedic9-15cb-41da-85b7-c522af7caab4\_20170623\_160227\_720.jpg, 00:01:30,  
12.52m  
Sewer lining changes/starts/finishes at this point

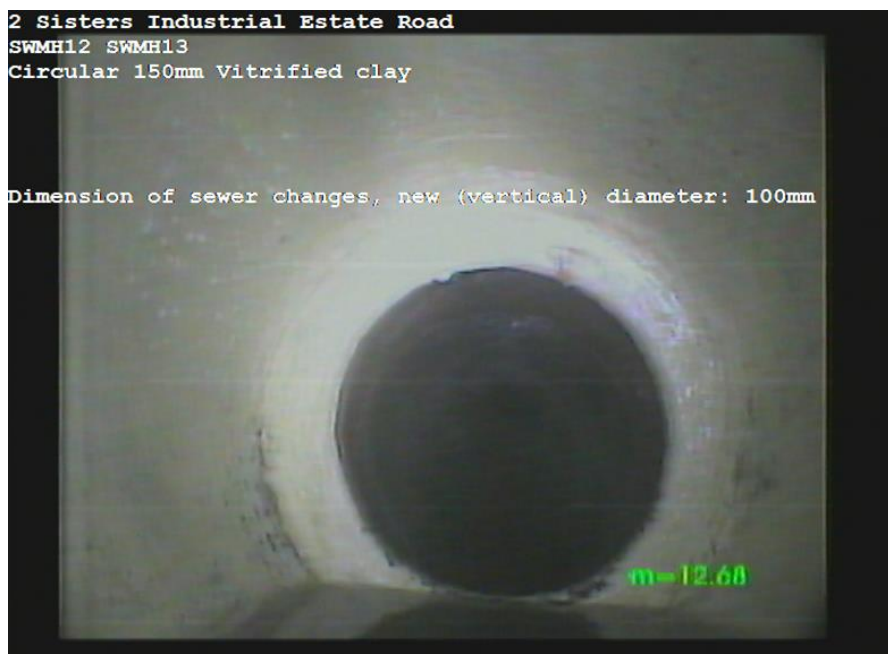
SWMH12X\_c8d34e41-a42c-494e-8bee-21741b3b94a9\_20170623\_160421\_393.jpg, 00:02:01,  
12.68m  
Dimension of sewer changes, new (vertical) diameter: 100mm

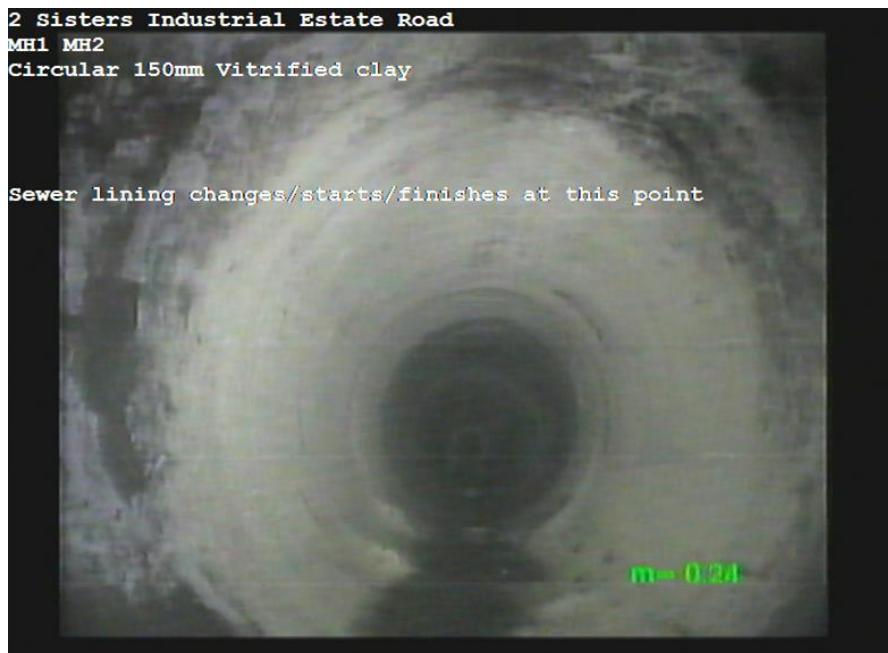
MH1X\_1d1fd957-b692-47b7-a99a-d8147e191c6d\_20170623\_160803\_390.jpg, 00:02:11, 0.25m  
Sewer lining changes/starts/finishes at this point

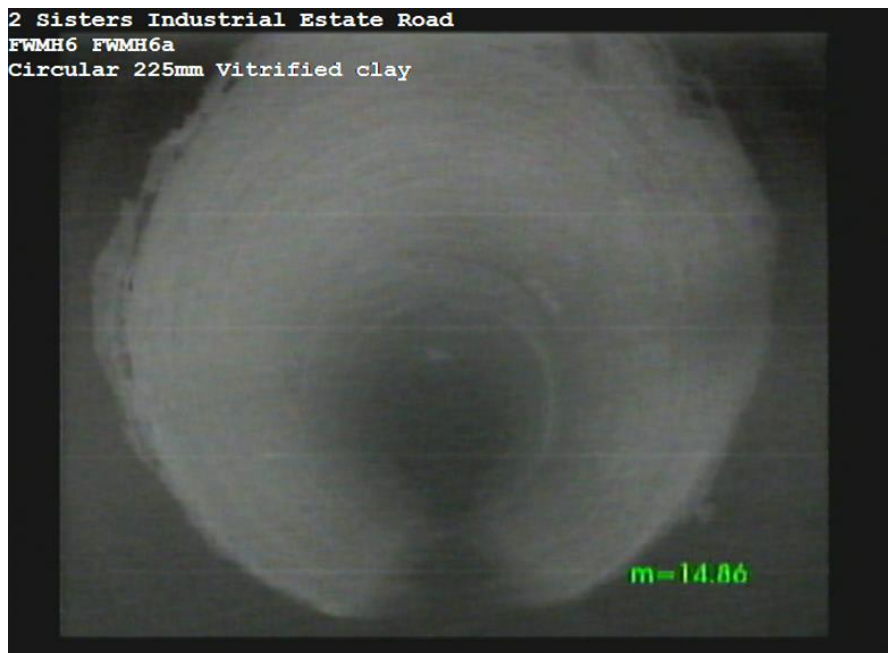
FWMH6X\_dfcc0f2a-afa2-4db1-bc94-2e6f148f5554\_20170623\_161706\_052.jpg, 00:02:11,  
14.86m  
Sewer lining changes/starts/finishes at this point
