EPR Compliance Assessment Report

Report ID: PP3139GB/0217317

Site	Hafod Quarry Landfill	Permit Ref	PP3139GB
Operator/ Permit holder	Cory Environmental (Central) Ltd		
Date	02/07/2014	Time in	10:00
What parts of the permit were assessed	Natural Resources Wales Gas Audit 2-3 July 2014	Out	16:00
Assessment	Audit	EPR Activity:	Installation X Waste Op Water Discharge
Recipient's name/position	Ian Craven - Site manager		
Officer's name	Tony Roberts, Tyrone Ward, Neil Herbert	Date issued	18/08/2014

Natural Resources Wales Technical Review Of Landfill Gas Management Systems

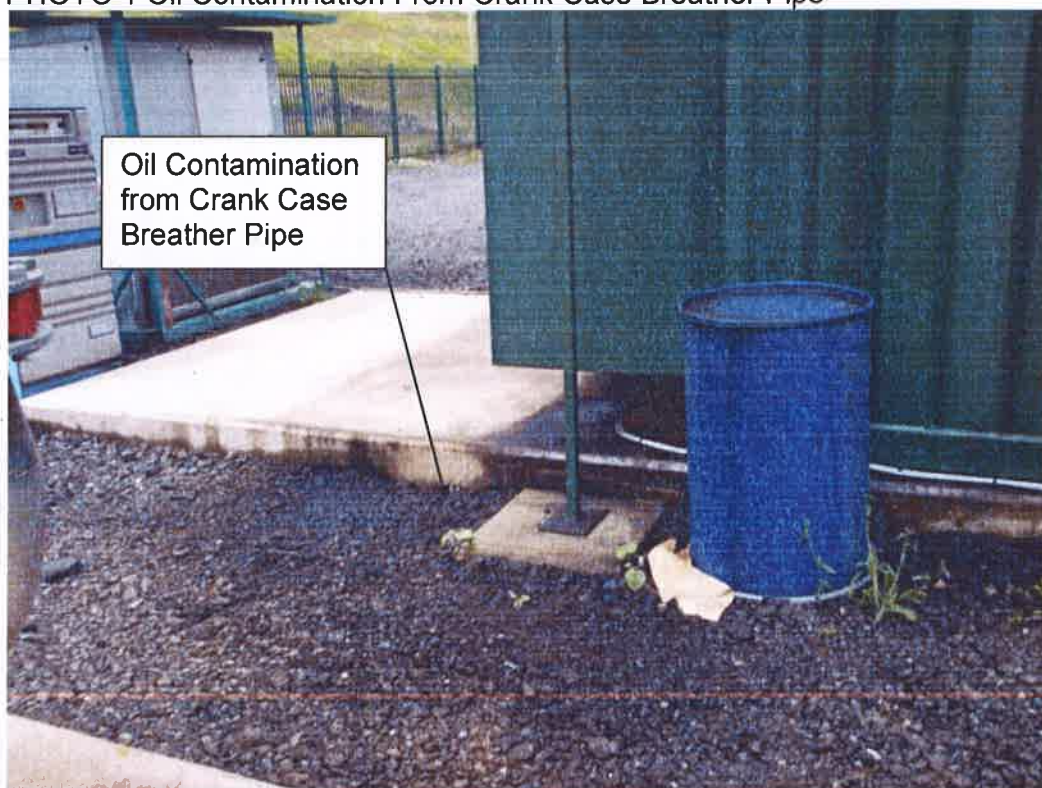
PHOTO 1 Oil Contamination From Crank Case Breather Pipe

3. Oil was noted on the stone close to the gas engine housing which was coming from the crank case breather. This is to be re-routed back through the engine in the near future. It was noted that by the second morning of the audit the contaminated material had been removed and

replaced with railway ballast. Thank you for the swift response to this issue.

On the CAT 3516 engines the crankcase emissions are sucked from the engine via a fixed pump which then sends the emissions to the exhaust via a Vokes filter unit. Since the audit the filters have been replaced and secondary containment installed to catch any possible residue entering the outside of the genset.. In addition to the removal of any contaminated stone, the side of the genset container has also been thoroughly cleaned of any oil/dirt residue.

ACTION 2. Please explain if this is best practice, as many of the engines at sites regulated by NRW re-route the crank case breather discharge back into the engine for combustion.

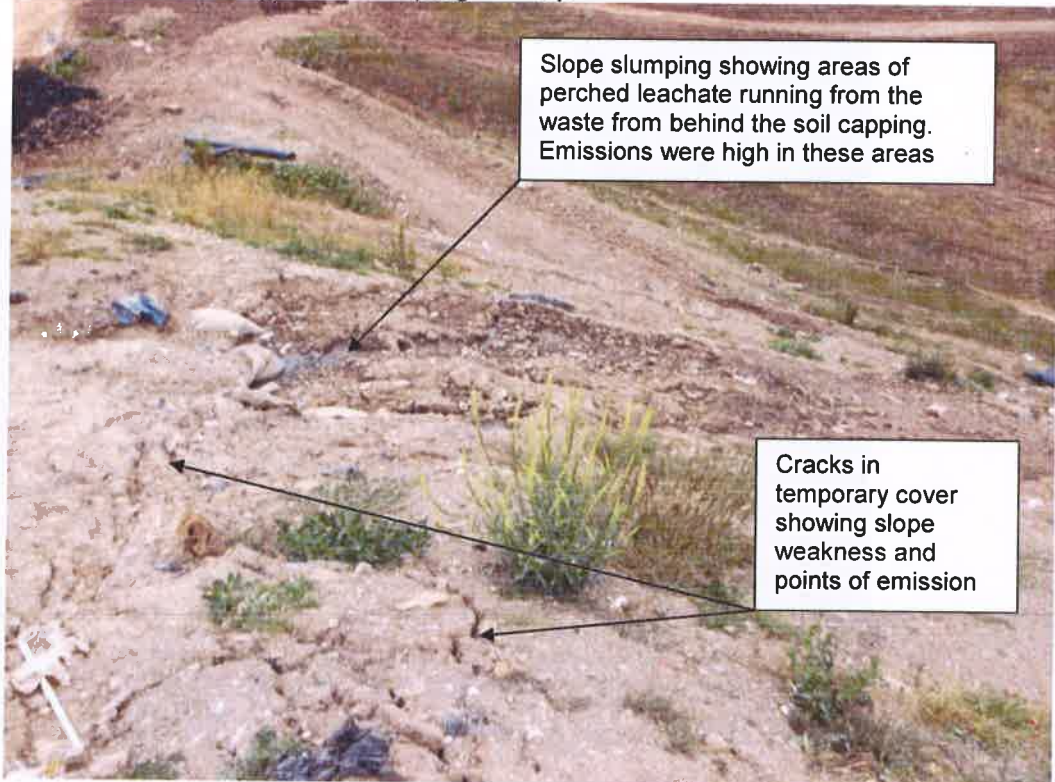
PHOTO 2: Cracking and Slumping of Slope

4. The site in cross section showed numerous weeps indicating perching of leachate at discrete levels in the waste. **ACTION: all wells and well logs should be checked for perching and where required and possible, pumps should be installed by the 31st October 2014.**
5. High emissions were noted from some defects in the placed geo-membrane. All folds/ creases/Boot detail. (See emissions survey)
ACTION: These should be patched as soon as possible but no later than during the next phase of temporary capping.

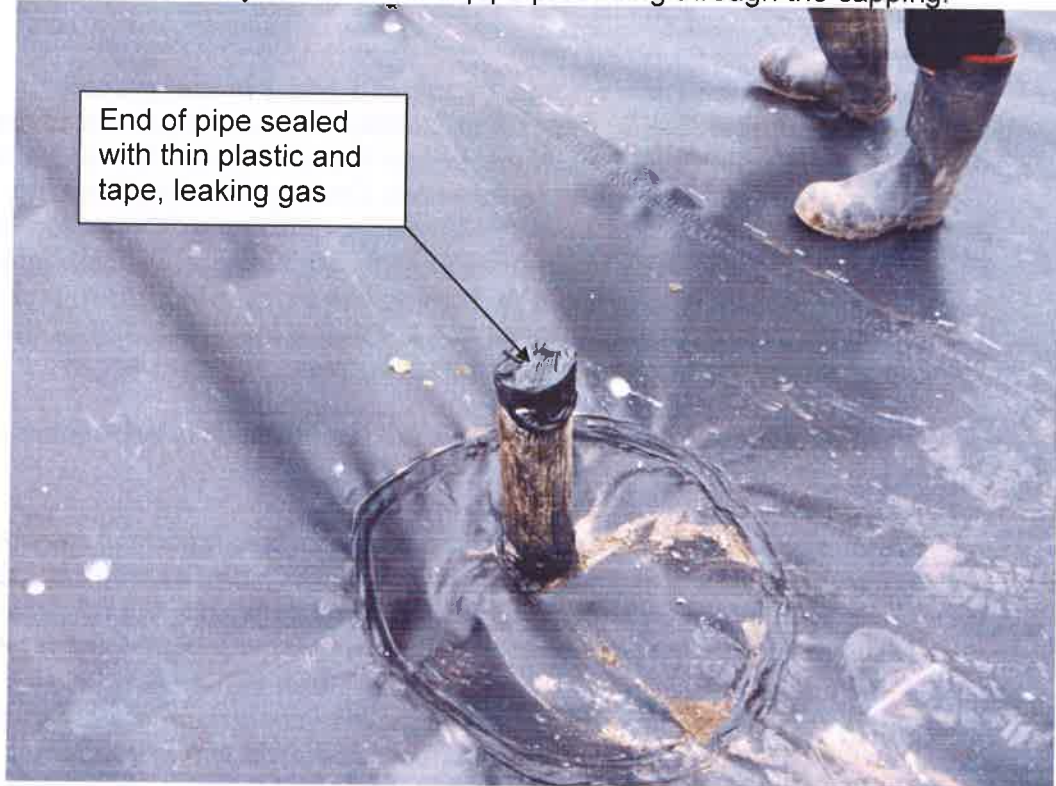
PHOTO 4 : Poorly sealed vertical pipe protruding through the capping.

7. Emissions were detected in discrete areas on the new plastic temporary capping and several pipes which were protruding through the cap were sealed with tape which was leaking. (see photo below)

ACTION: End caps should be fitted ASAP

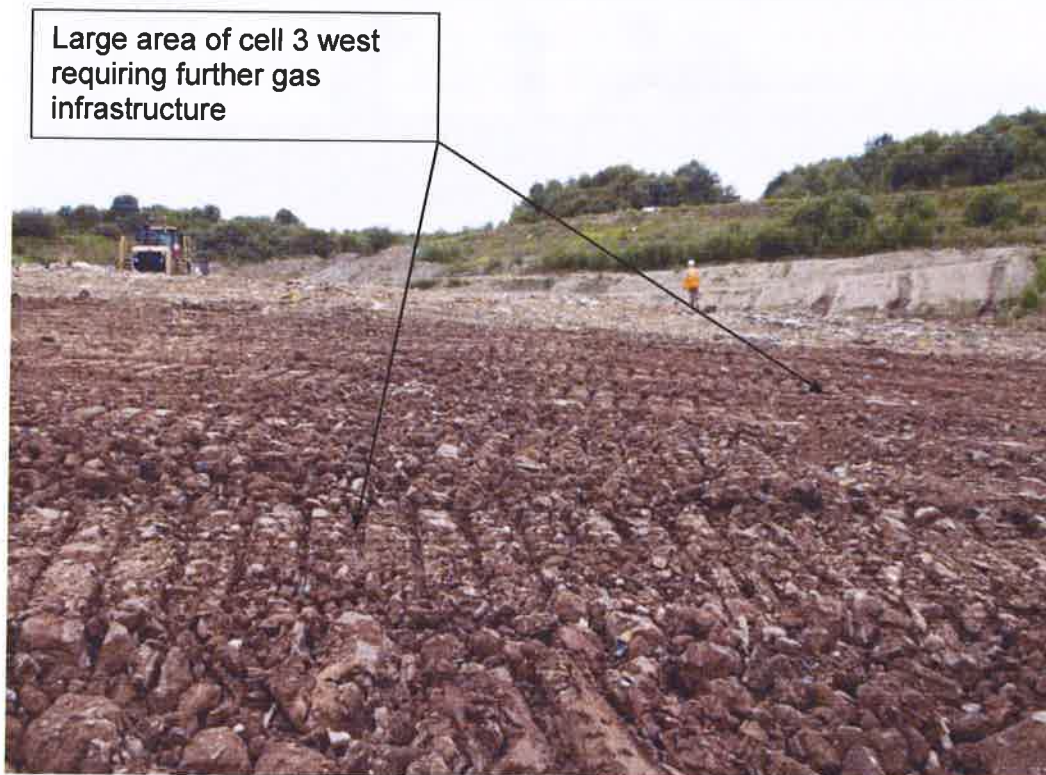
PHOTO 6 : Areas Of Landfill With Little Apparent Gas Infrastructure.

16. There appeared to be a lack of well coverage in the newly tipped and covered areas on the Western side of the slope of phase three.
ACTION: Install extraction infrastructure by the 31st October 2014.

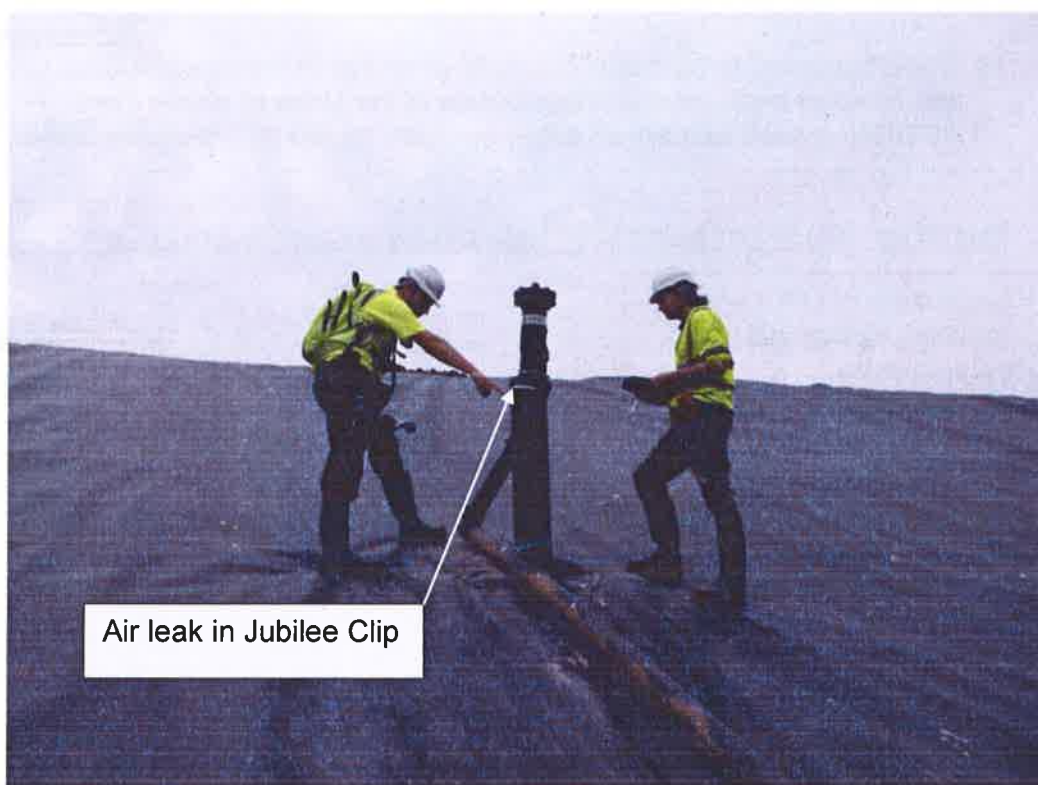
PHOTO 7: Air Leak in Well Head Coupling

17. Air leaks were noted on some of the well couplings.

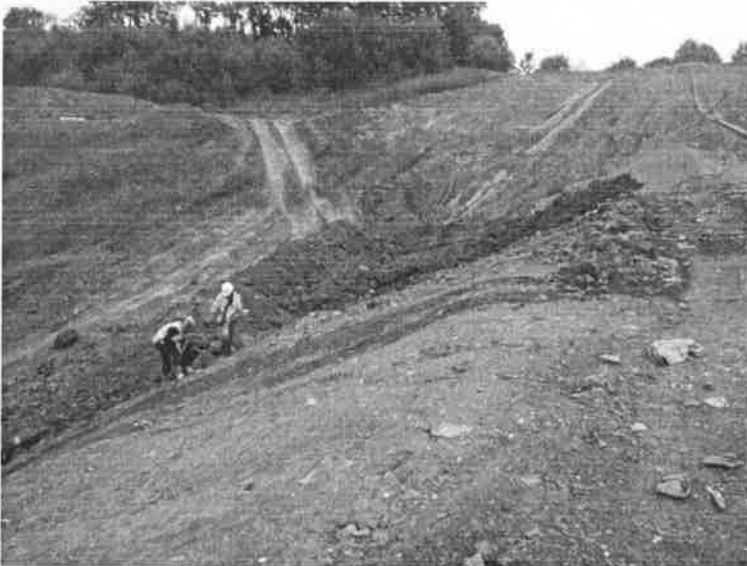
Photograph 1.1:- North Flank Cell 3,
Eastern section. Showing area of flank
in process of being regraded

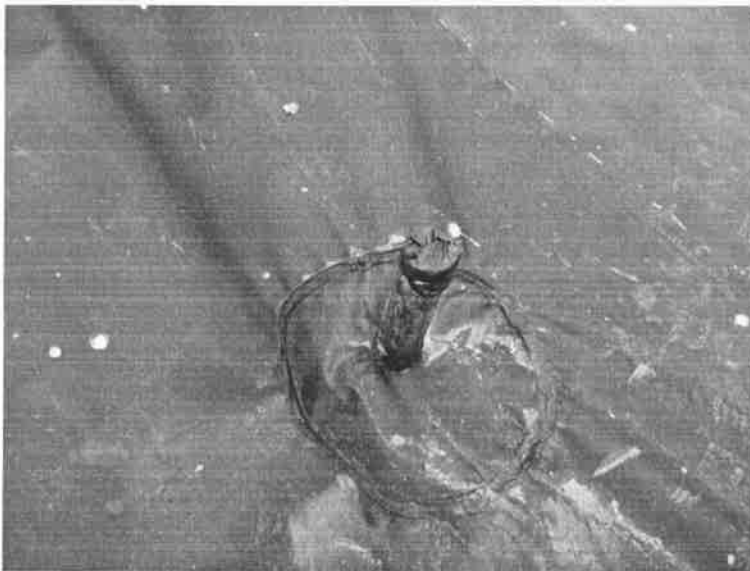
Photograph 1.2. Showing well sealed
with gaffer tape.

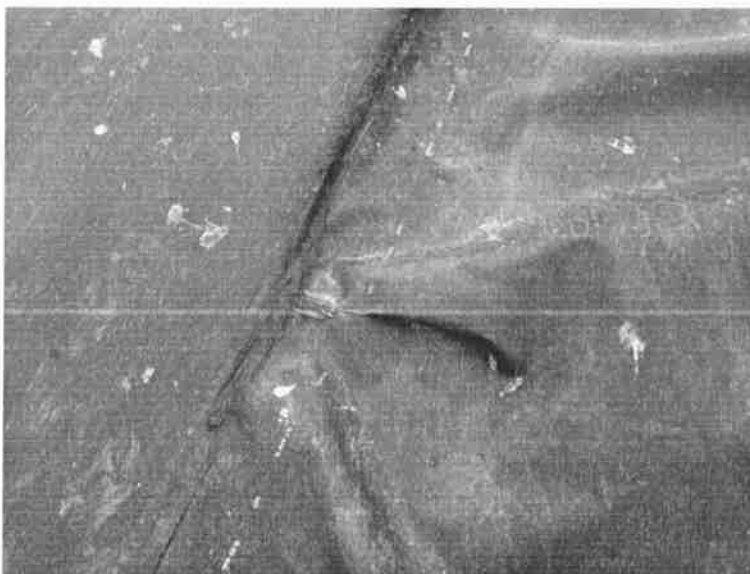
- High emissions from areas of the flank which has not been capped, even with reworked regulation layer (intermediate cover).
- High emissions noted from some defects in the placed geomembrane. All folds/ creases ("fishmouth") should be patched during the next phase of temporary capping.

Photograph 1.3:- leak in
geomembrane folds.

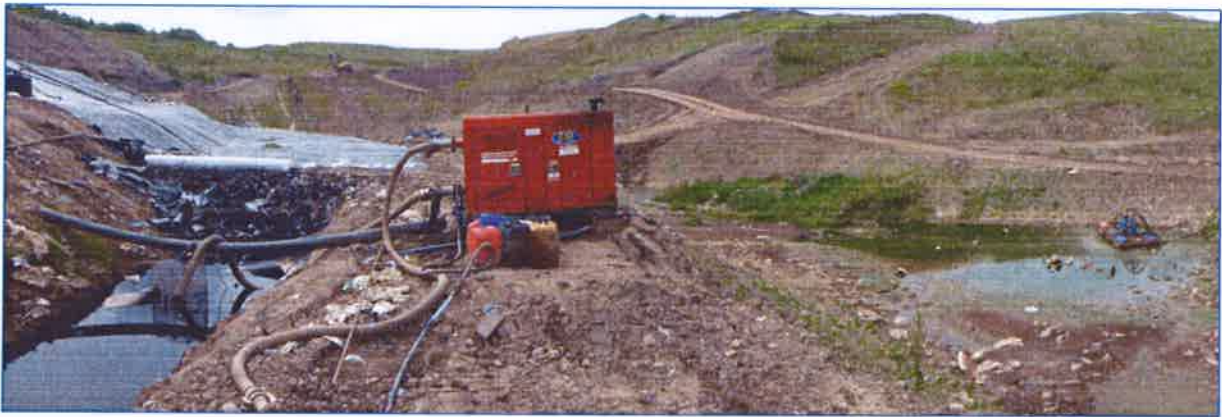
- Gas pressure high along toe of cell 3 North (e.g. leachate sump) indicating that gas collection not wholly effective.
- Methane rich gas detected outside containment bund. Source of gas needs to be established (e.g. coal or landfill)

Photograph 1.5 showing (from left to right) the leachate sump, the containment bund and surface water sump. Methane rich gas bubbling in both the leachate sump and surface water sump.
