EPR Compliance Assessment Report

Report ID: PP3139GB/0197525

Site	Hafod Quarry Landfill			Permit Ref	PP3139GB		
Operator/ Permit holder	Cory Environmental (Central) Ltd						
Date	26/11/13 & 12/12/2013			Time in	10:05	Out	14:45
What parts of the permit were assessed	Landfill gas system and emissions audit.						
Assessment	Audit	EPR Activity:	Installation	X	Waste Op	Water Discharge	
Recipient's name/position	Ian Craven / NW Area Manager						
Officer's name	Aled Zachary			Date issued	20/01/2014

Methane Emissions Survey Sheet

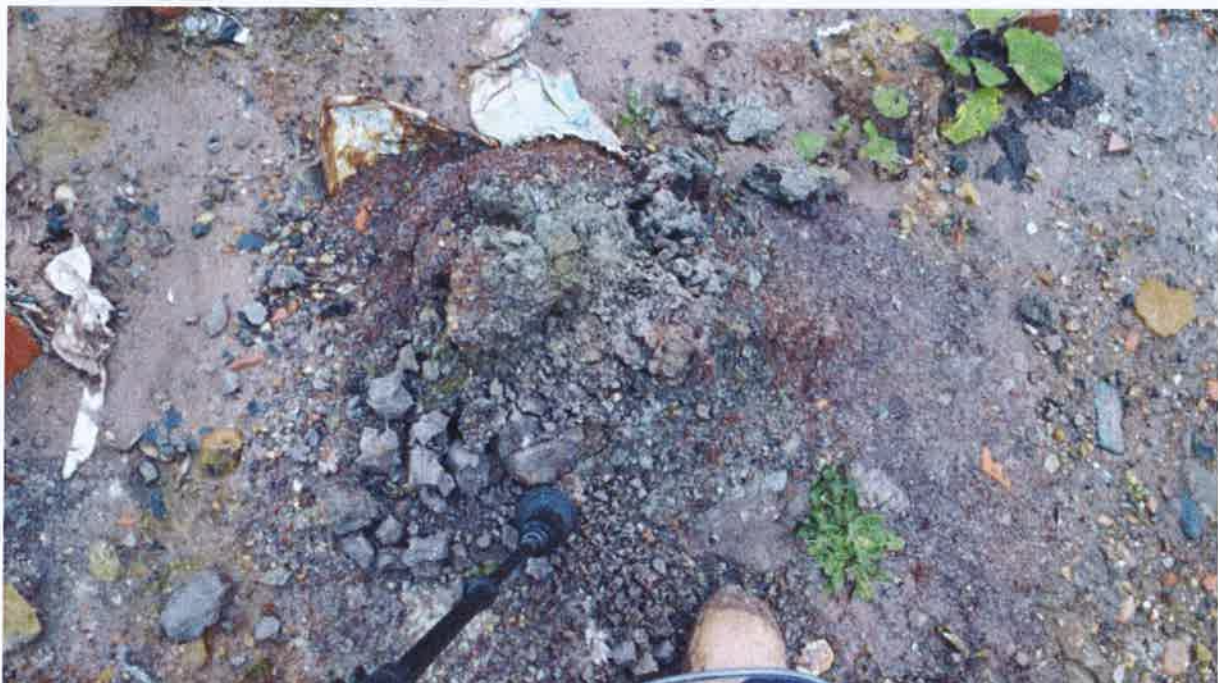
Findings – High levels of fugitive landfill gas emissions were recorded on the northern flank of Cell 3, around a number of gas wells and from all leachate extraction and monitoring points sampled. The levels of ambient emissions recorded on the flank of cell 3 indicate a significant proportion of landfill gas is going un-collected at present.

Emissions on flank of Cell 3, Point 5, Photo 01:

1. Action is required to reduce the level of fugitive emissions from the Northern Flank of Cell 3. Positive gas pressure indicates a lack of gas control, which should be addressed urgently to reduce the health and safety risk from H₂S alongside the potential for nuisance from odour. Temporary capping of this flank or increasing the amount of deep gas extraction infrastructure in this Cell should be investigated as a matter of urgency.

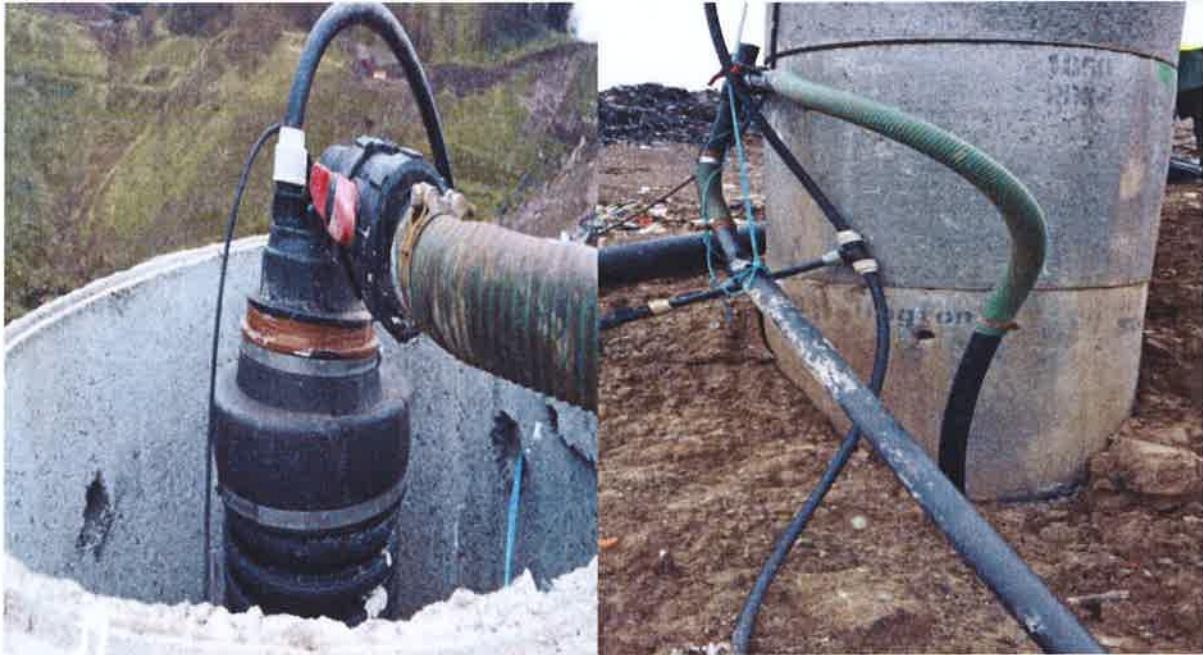
Point ref.	Methane Reading	Feature and / or Grid Reference	Description / Comment
8	10%	SJ3092745439	Emission from LEACHATE TOWER half way down the main flank of Cell 3. NOTE: Air is being drawn into the gas system at the well head jubilee clip and through the brown tape at the juncture of the well head and the tower PHOTOS 02 & 03. The KOP condensate return in this area was also discharging directly onto the flank. This area was very odorous.
9	120-200ppm	SJ3092445383	Reading taken in trenched waste close to the Leachate well in question. (Temporal variation in odour and gas readings). NOTE: Unattached well in this area. PHOTO 04.
10	50ppm	SJ3096745434	
11	100ppm	SJ3097045426	Black surface standing leachate at the edge of the working face. This area was very odorous. Gas was noted bubbling through leachate.
12	100ppm	SJ3097845441	A very strange white and green coloured precipitate was noted running down the flank in various places in this area. It may be useful to test this discharge. PHOTO 05

Landfill gas emissions from Leachate tower LMP2, Point 8, Photos 02 & 03:

3. Leachate extraction towers should be resealed with bentonite or plastic boot seals to prevent fugitive emissions. Consideration should also be given to "nested" wells in their vicinity to reduce emissions. Side Wall risers should be sealed to prevent fugitive emissions. A small amount of direct gas extraction may be required to reduce emissions from this infrastructure.

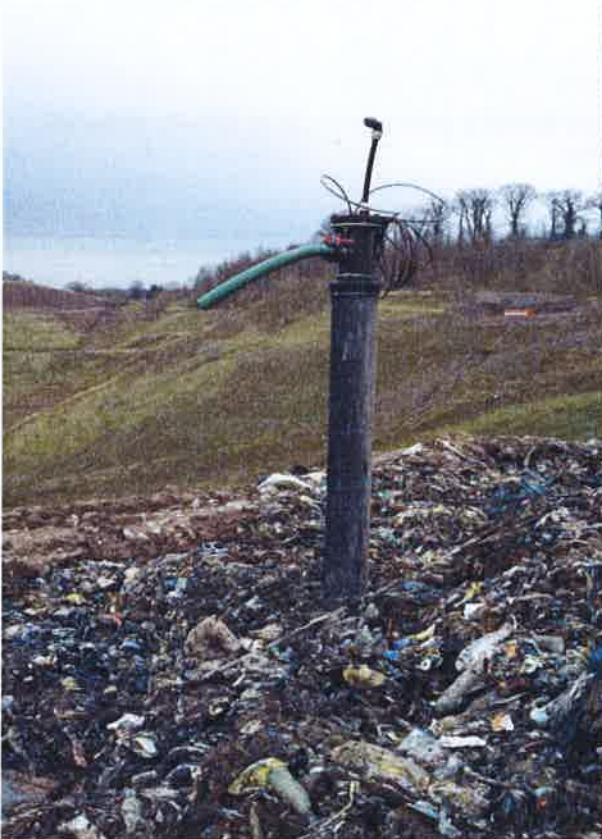
Unattached gas well, Point 9, Photo 04:

2. A full review of current gas extraction infrastructure should be carried out including whether gas wells require dewatering or investment in replacement wells. Dip data for all wells should be supplied to NRW within 2 weeks of this report. The data should include depth to base, depth to slotting and depth to water. CCTV surveys are very helpful in establishing the condition of gas wells and should be considered as part of reviewing the gas infrastructure.

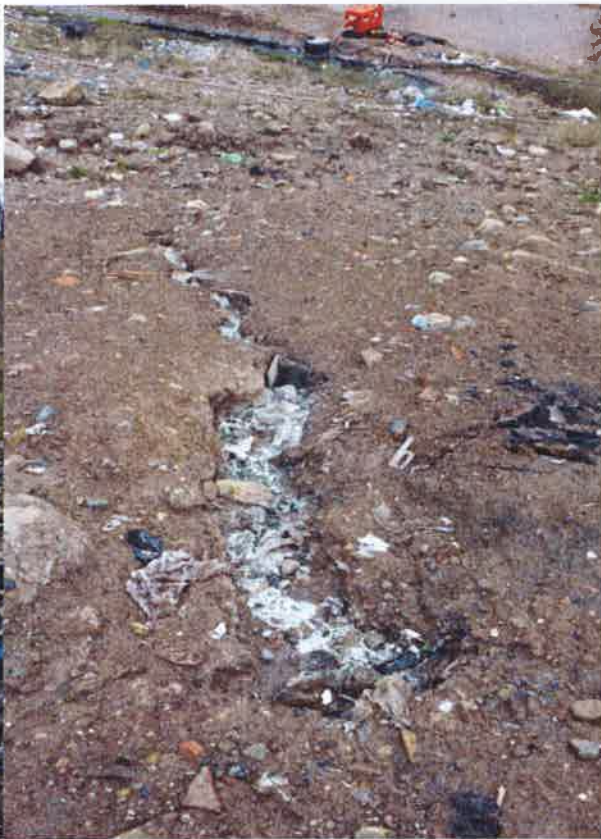
Precipitate / leachate on flank, Point 12, Photo 05:

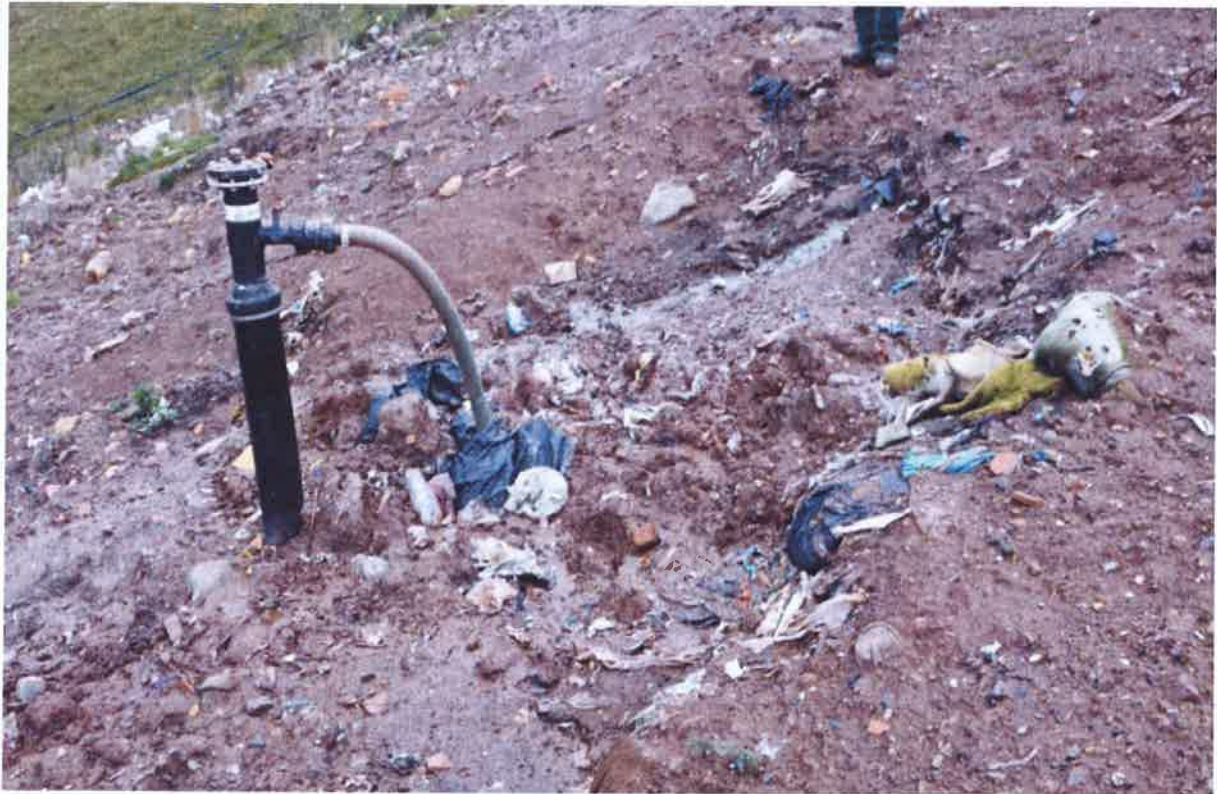
13	2000ppm	SJ3097645445	Emanating from an unmarked well on the flank, no flow and POSITIVE PRESSURE (Ref GA2000+ reading) and high H2S. Well must be marked as such. PHOTO 06.
14	120-86ppm	SJ3094945458	Emission close to well HFDGW005
15	3000ppm	SJ3095445451	Emission detected on upper third of flank close to well HFDGW005
16	100ppm		Emission from base of well HFGW030
17	81-100ppm		In air around well HFGW030. Significant ambient reading.
18	23%-36%	SJ3093945404	High emission at the base of a second Leachate well on the eastern side of the site close to the working face. PHOTO 07.
19	67ppm		Unsealed port on top of leachate storage tank on the eastern side of the site.
20	18.7%		High emission from sidewall riser (SWR1) on the Eastern side of the site. NOTE: Gaffer tape sealing end cap and no gas extraction on this riser. PHOTOS 08 & 09.
21	64%	SJ31056454397	Disconnected valve on riser (SWR1) showing very high concentrations of methane, suspect enrichment due to water. No extraction. PHOTOS 08 & 09.

Fugitive Gas Emissions from gas well on flank, Point 13, Photo 06:

4. Poorly marked gas collection infrastructure should be marked with a consistent and clear numbering sequence for on-site identification and subsequent review of monitoring data.

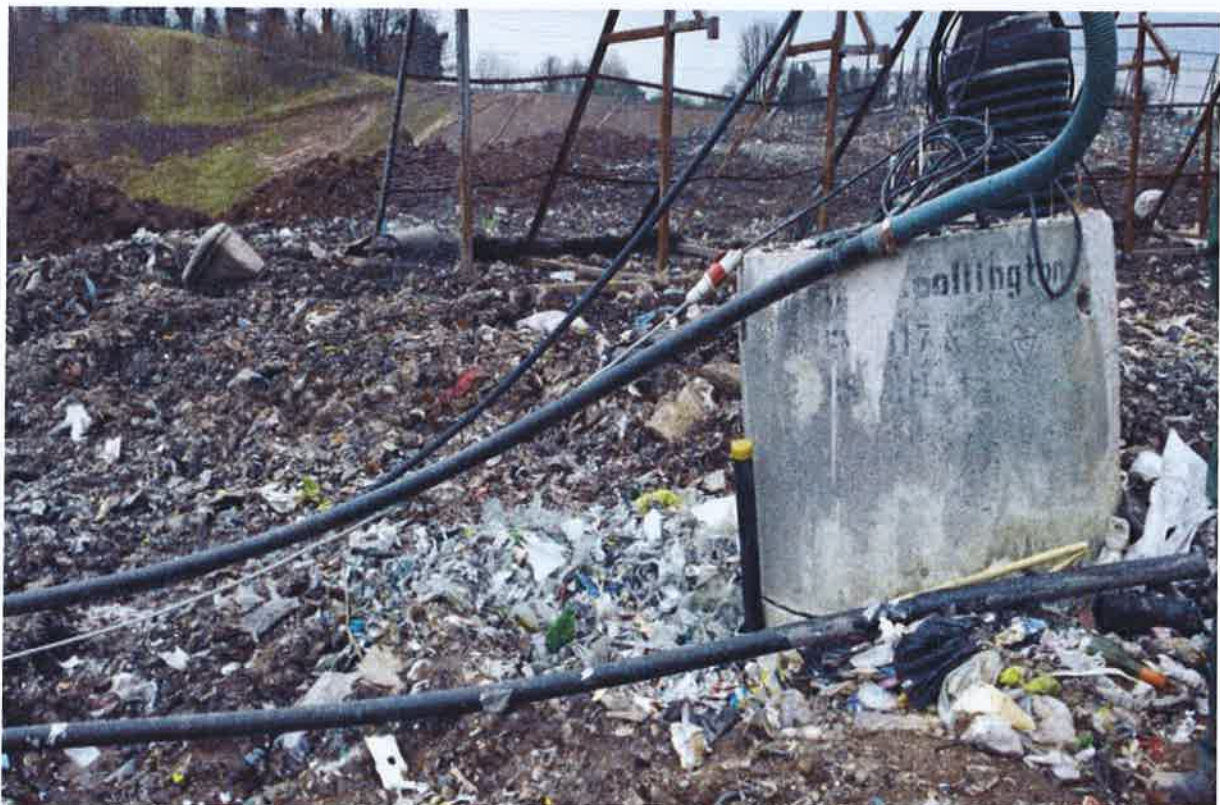
Emissions from leachate tower (LMP1?) on working area, Point 18, Photo 07:

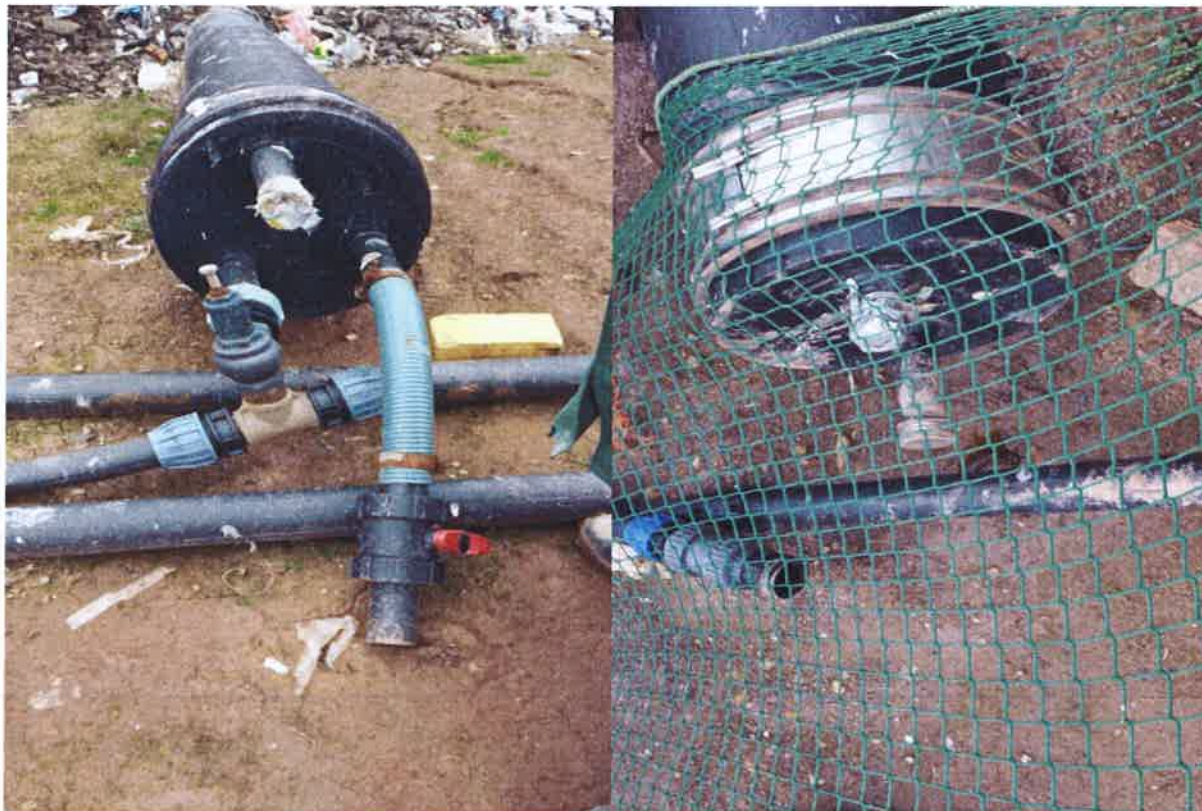
22	7.7%		Second sidewall riser (SWR2) on the Eastern flank. End cap again sealed with gaffer tape. PHOTOS 08 & 09.

Gas emissions from sidewall risers (SWR1 & SWR2), Points 20 – 22, Photos 08 & 09:

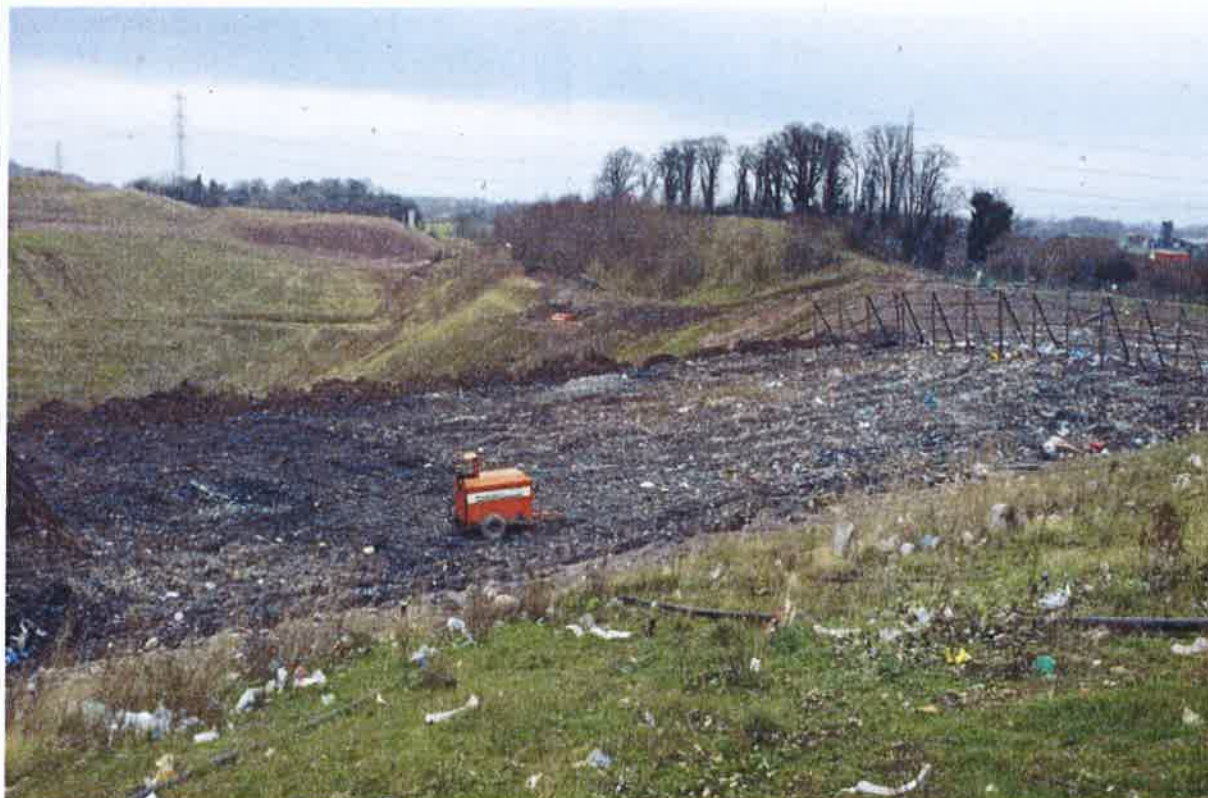
Concerns over lack of deep well coverage on part of the working area on Cell 3:

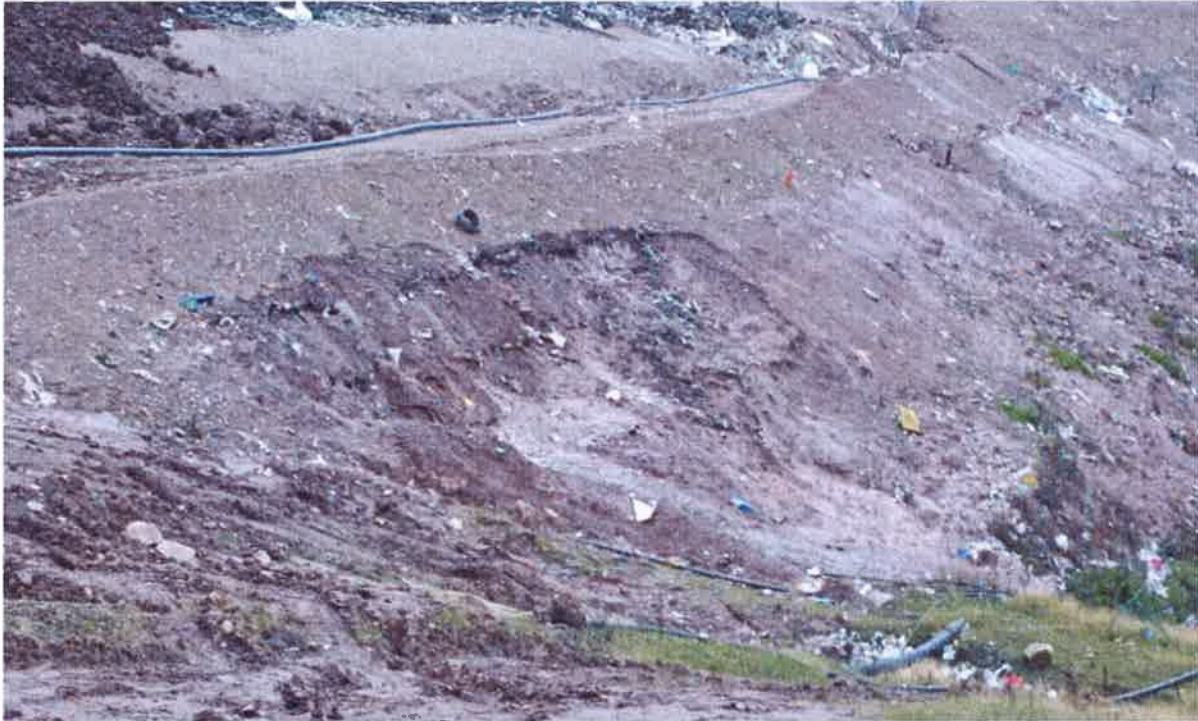
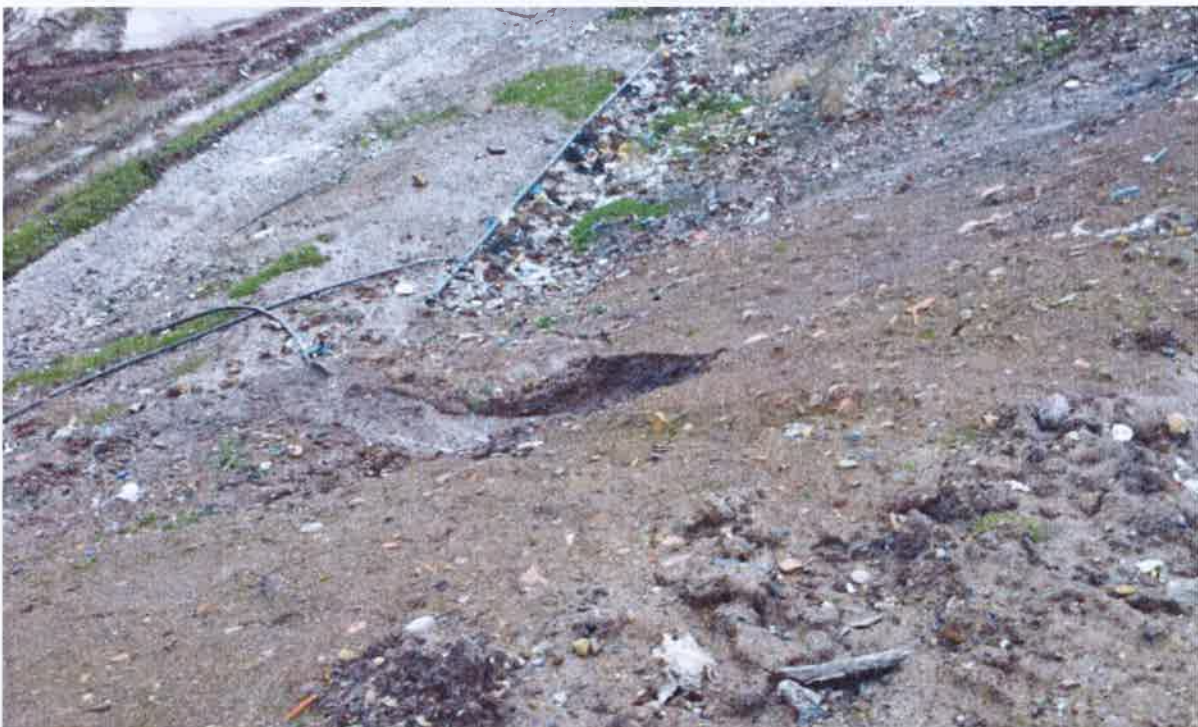
The steepness of the Northern flank of Cell 3 is currently a cause of concern to NRW. There is evidence of rotational failures on the slope already having taken place in a number of locations as detailed in the audit report attached. Signs of leachate discharging and seeping down the face of the flank appear to be contributing to this instability.

Due to the increased tipping heights in this cell the Northern Flank now appears to be too steep. Areas of this flank appeared to be demonstrating a gradient of up to 1:2; waste and temporary capping materials are also showing signs of tension cracking and there are areas that have slipped already indicating some degree of instability. Leachate outbreaks on the flank are most likely contributing to the instability issues. Photos of the flank are included below for reference:

Rotational failures on Northern Flank of Cell 3:

Consideration should be given to reducing the steepness on this flank, in particular the NW area pictured above. The addition of a bench at each waste lift may also reduce the instability that appears to be present. Specialist advice and guidance from suitably qualified engineering person(s) should be sought to assess if further works are required in this area.

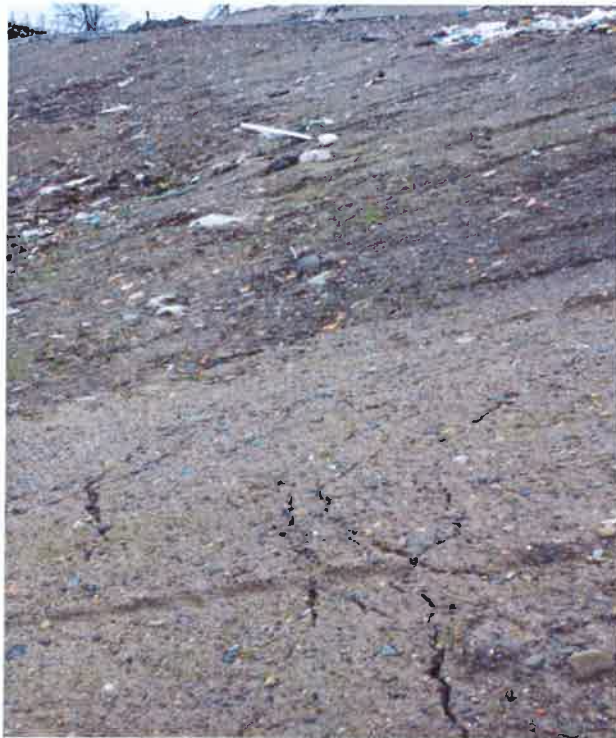
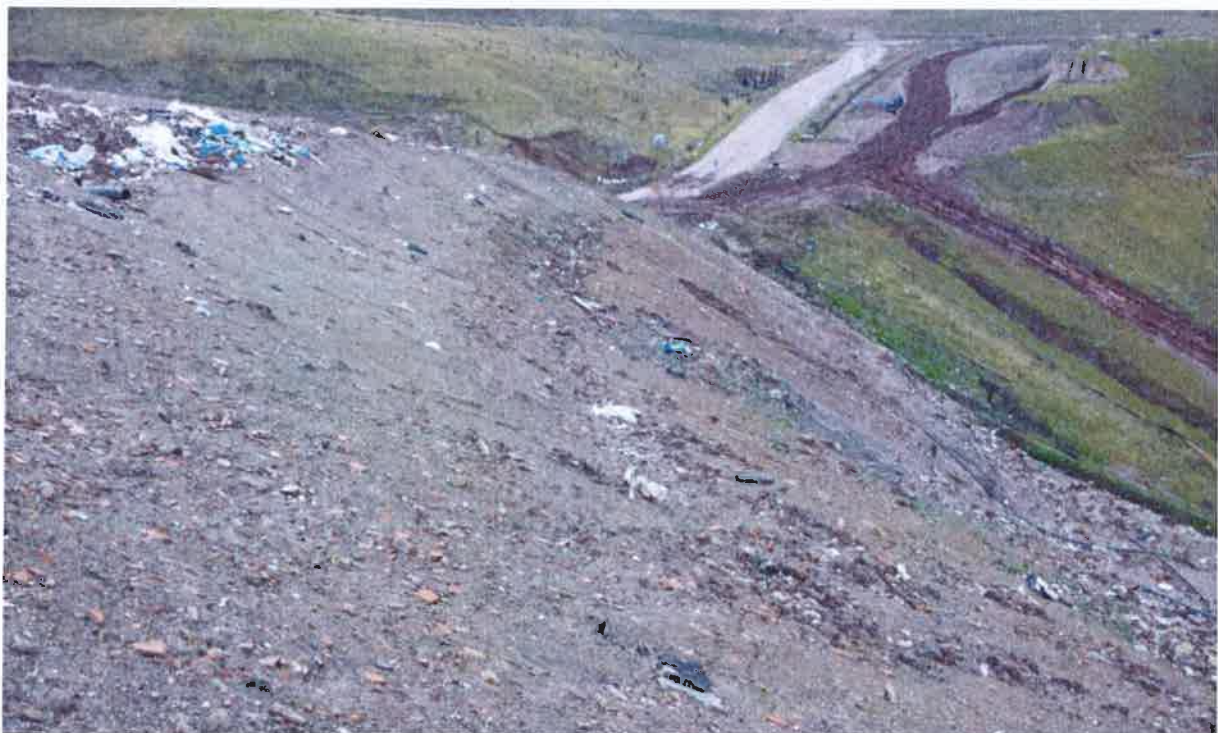
Tension cracking and slope steepness on North West area of Cell 3 Flank:
