## **Re. Pen y Bont Landfill – 2015 Capping Works CQA Validation Report**

*Stratus Environmental, February 2016, CQA Validation Report. 2015 Capping Works. Pen y-Bont Landfill. Report Ref: WR7251/5/7/001L*

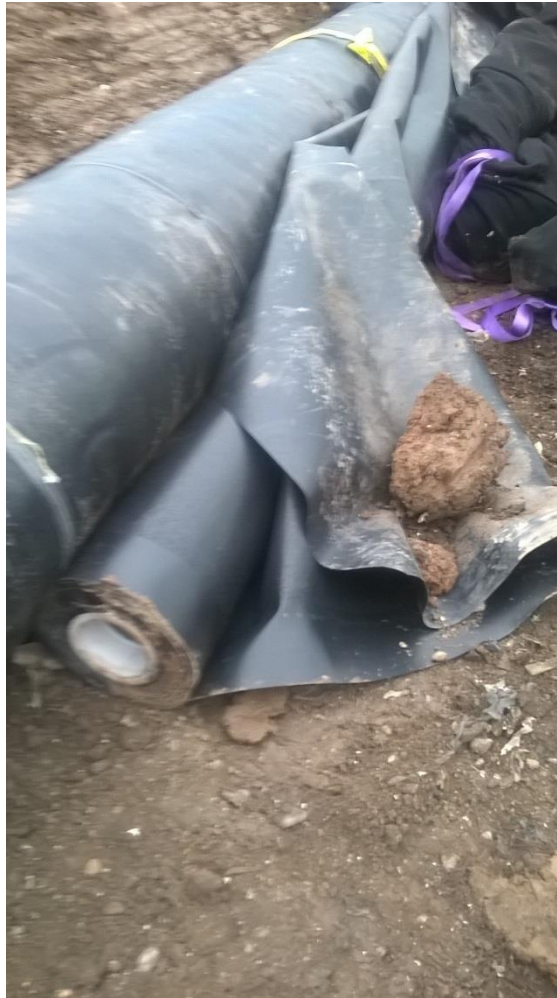
*Photograph reference 003, taken 27/10/2015*

**1.** The handling and storage of materials would benefit further discussion. The on site storage area was not clean, had rocks weighing down free edges and neither benefited a smooth or protected base on which to store rolls of geosynthetics. [see picture over page]
