Incident Investigation Report Dangerous Occurrence / Near Miss Event	
Site / Area: Kronospan Lorry Park	Reference:
Date of Incident: 06/06/2013	Time of incident: 10:05
Name of person(s) involved in the incident: Stephen Ellard (Synthite Driver)	
If a contractor name & address of employer: Synthite, Alyn Road, Denbigh Works, Mold, CH7 1BT	
Occupation(s): Tanker Driver	
Name of Witnesses: None	
Department / Area: Formalin / Despatch Lorry Park (a reception area prior to entering the site)	
Manager/supervisor: In Site Formalin Plant – Chris Taylor (Formalin Plant Manager)	
Date & time of preliminary investigation: 06/06/2013 (written report 07/06/2013)	
Place where incident occurred: Kronospan Lorry Park	
Date and time of formal investigation: 06/06/2013 (written report 07/06/2013)	
Whether reported to the HSE inspector: Yes, also reported to the NRW, WCBC and the Local parish Councillors

Medium / High Level Investigation Report

Site / Area: Kronospan / Lorry park (Lorry tanker reception area)

Nature of Occurrence: A Synthite tanker delivering methanol to the Kronospan Site was driving around the Lorry Park reception area when the rear axle on the left hand side of the vehicle buck

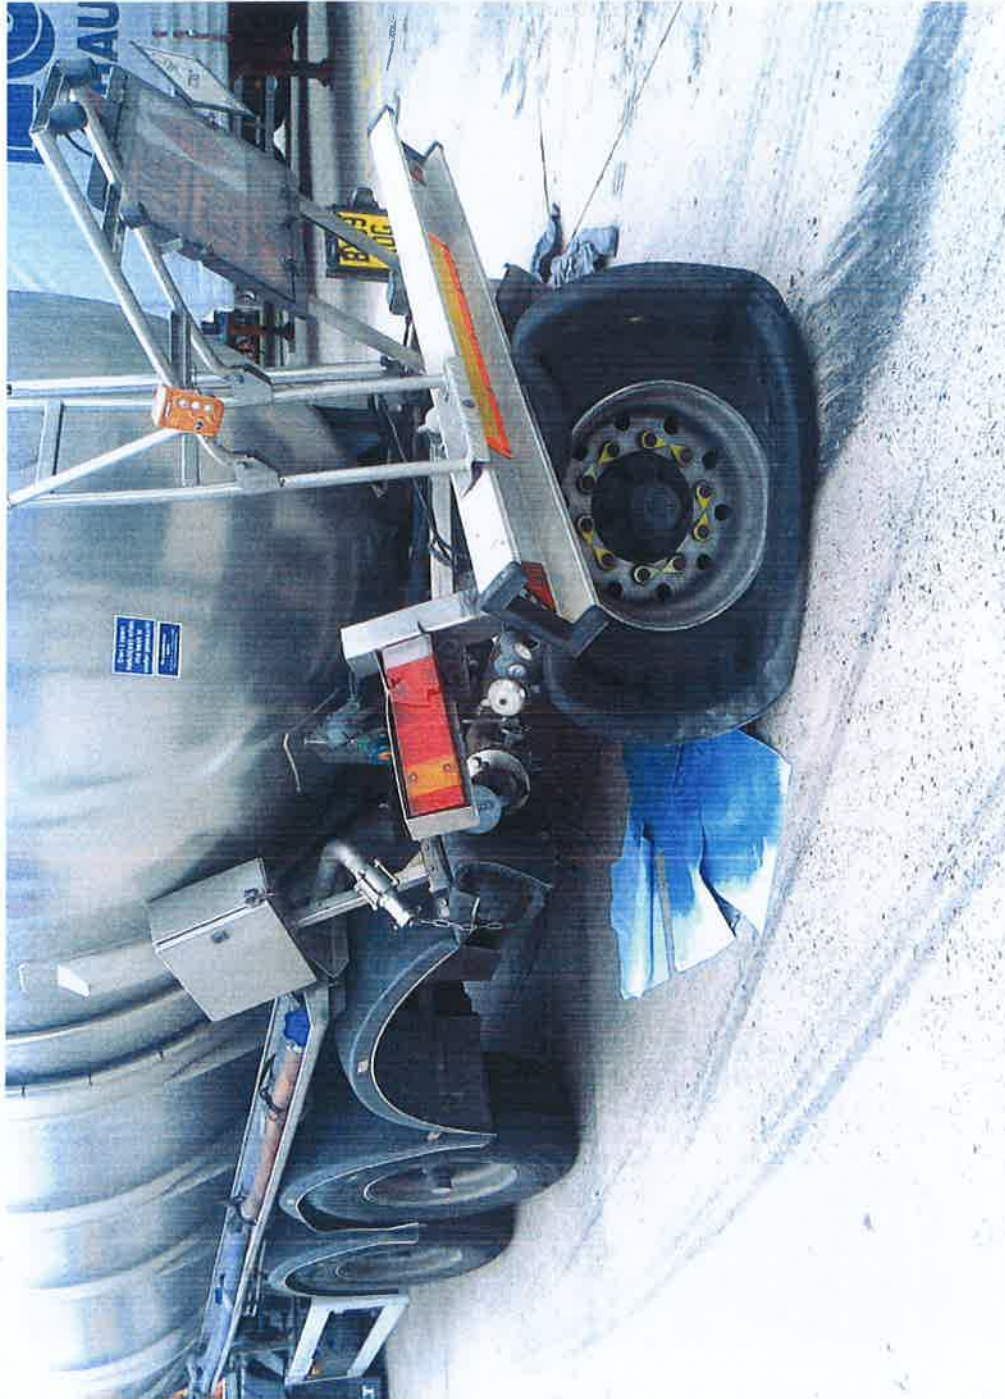
He stopped his vehicle and initially isolated the power via the tanker isolation switch, he then got out of his cab to find out what had happened. On examination he found that the rear axle on the left hand side of the vehicle had buckled and there was a tyre blow out on the same side. This had resulted in a weep of methanol from a flange on the delivery pipe that was going to floor.

Appendix 3 – Damage to rear axle and tyre

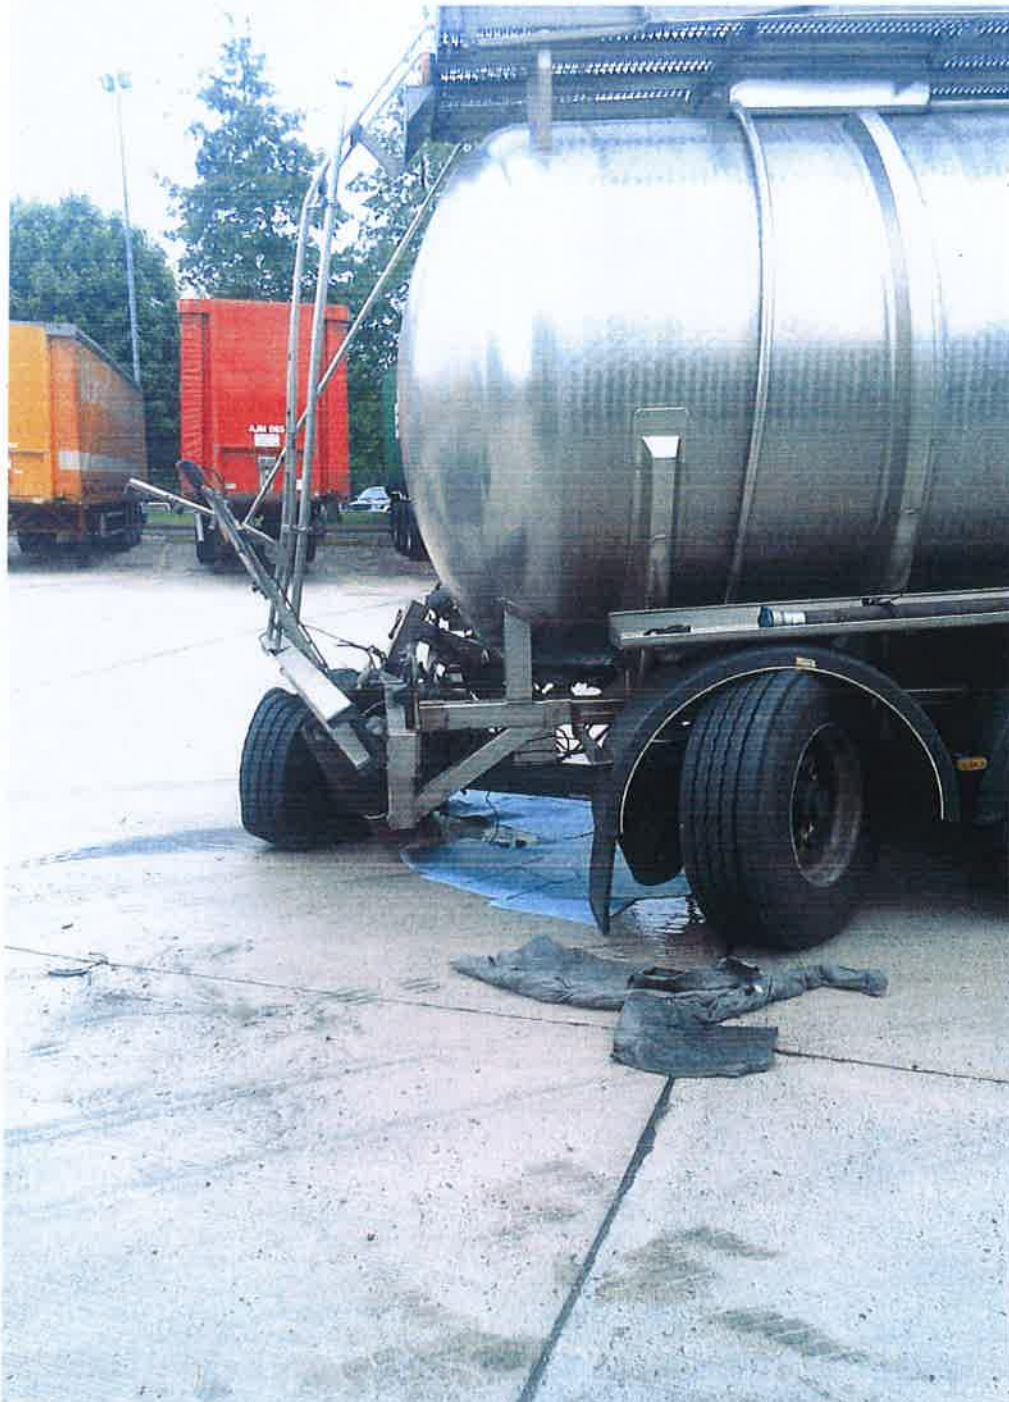
Appendix 3 – Damage to rear axle and tyre

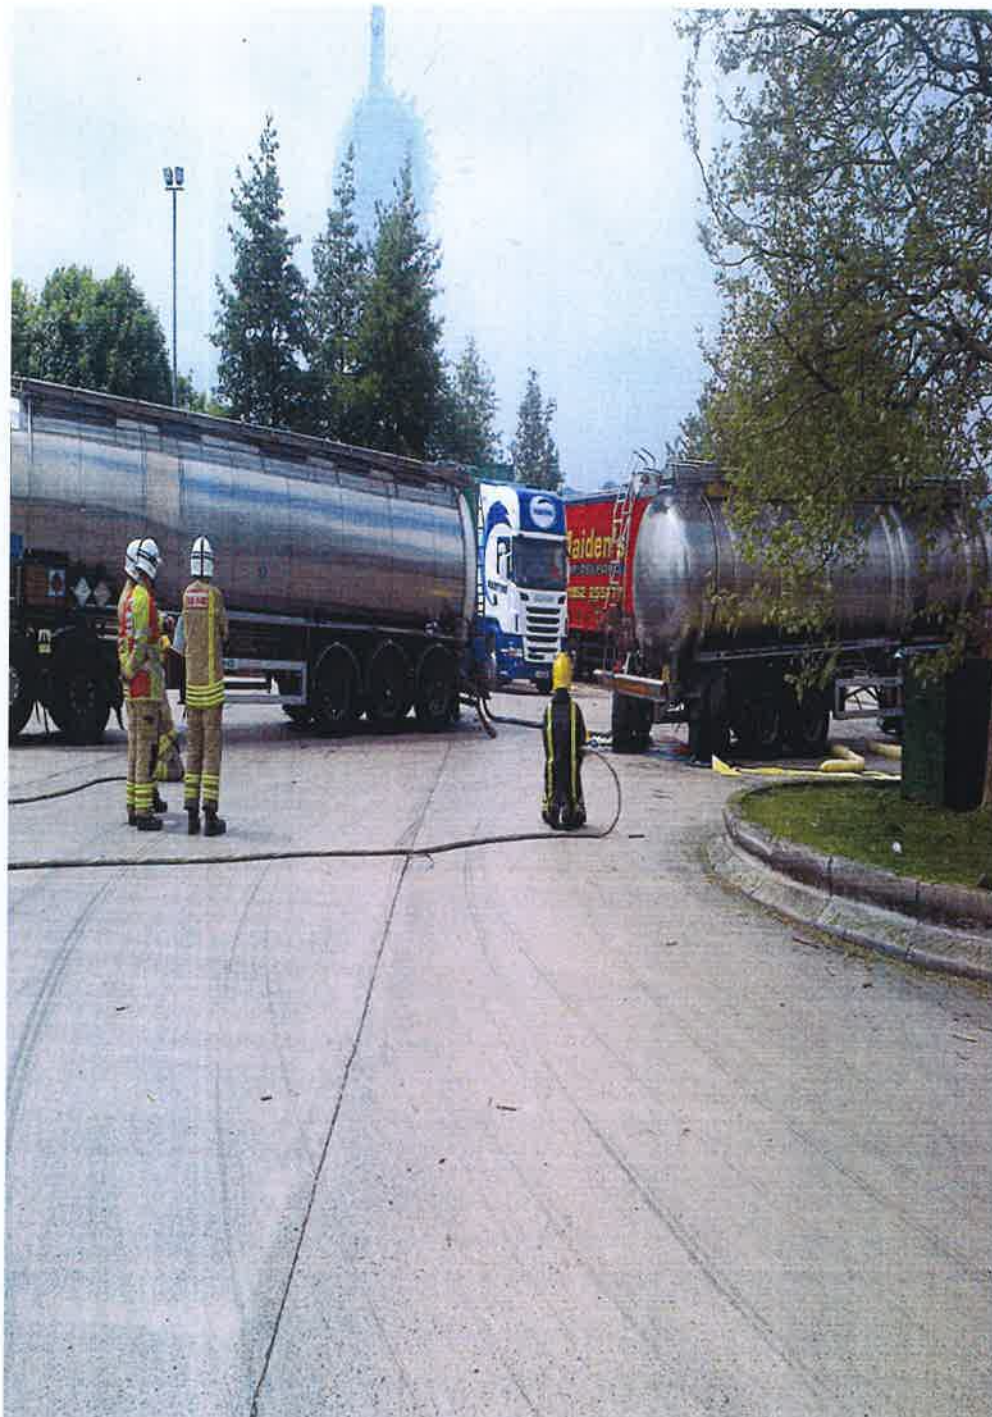
Tanker to tanker transfer could not be carried out in the usual way due to the damage to the crippled tanker so two manhole covers had to be removed from the top of the tank and a hose dropped in to effect tanker transfer.

Appendix 3 – Methanol Tanker to tanker transfer
