**WYNNSTAY GROUP PLC  
LLYSONNEN MILL, TRAVELLERS REST,  
CARMARTHEN**

**DISCHARGE OPTIONS APPRAISAL AND  
DRAINAGE IMPROVEMENT SPECIFICATIONS**

**FEBRUARY 2011**

| <b>REPORT No.:</b> | <b>129-01-02.R1</b> |

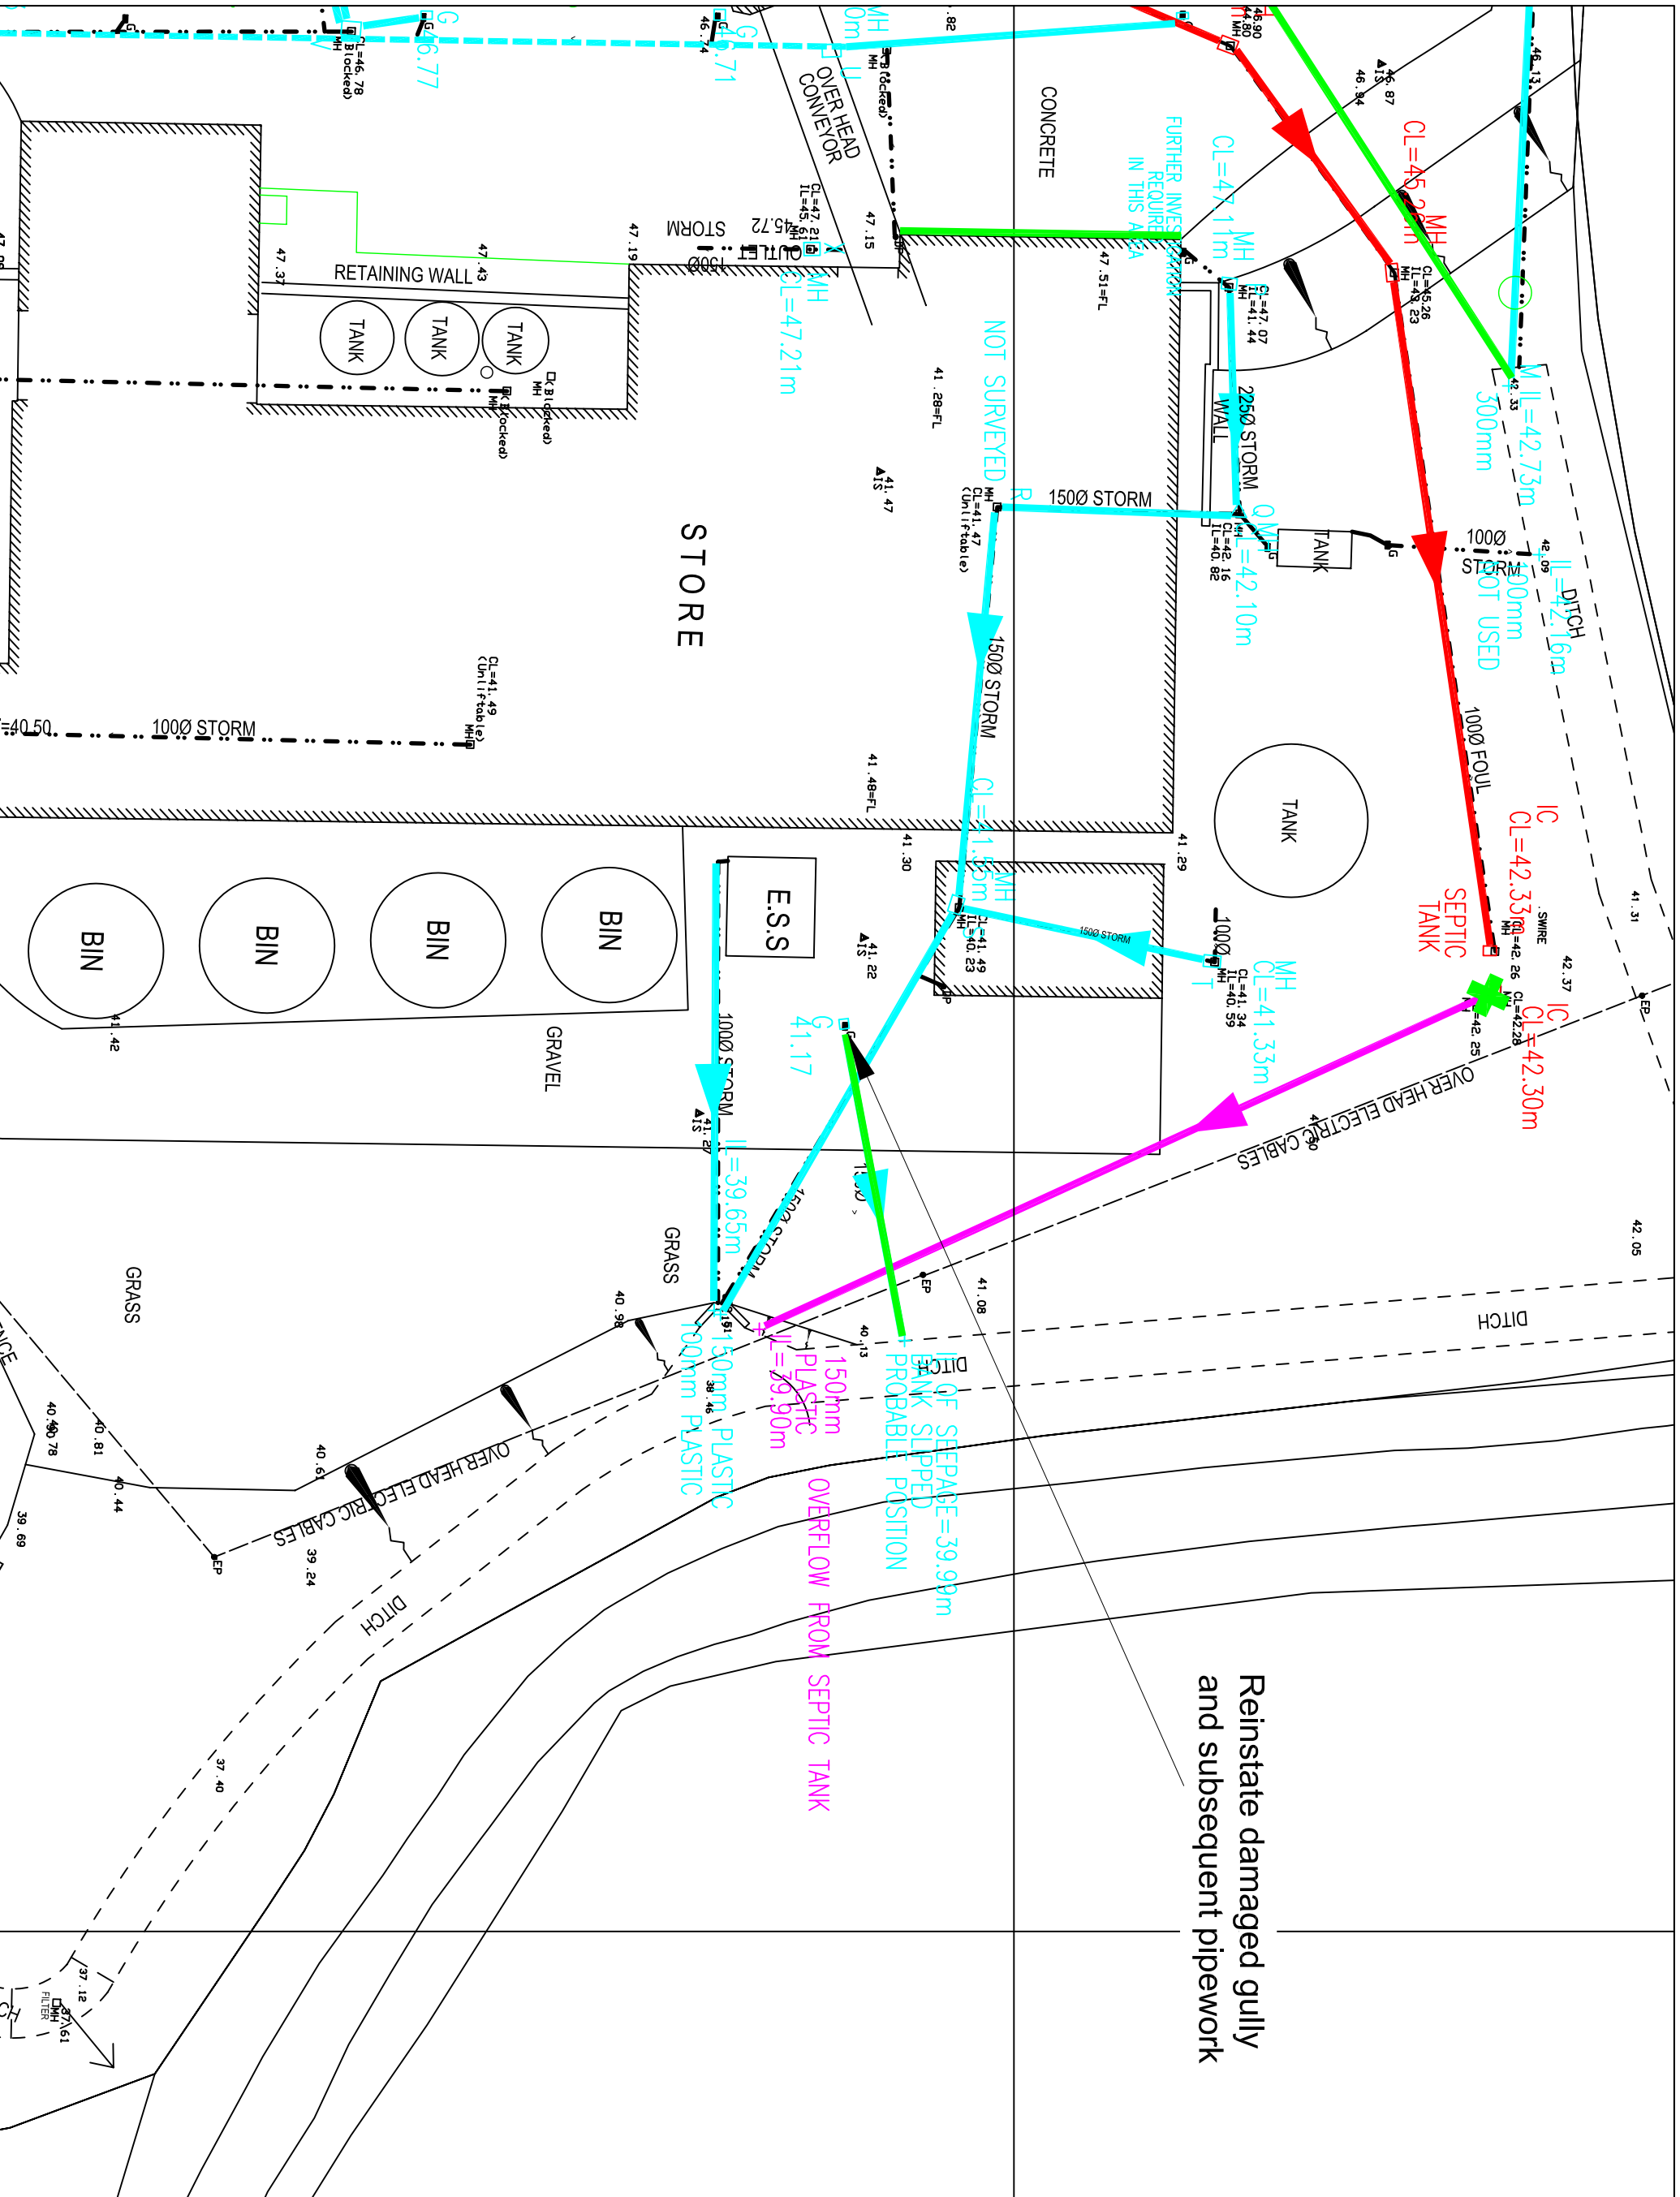
During our investigation of the discharges into the surface water drainage trench, ground water appeared to be seeping into the trench approximately 3m north of the store septic tank overflow. The drainage study has identified that the seepage is caused by damaged surface water drainage.

In order to remedy this issue, reinstatement of the damaged drainage will be required.

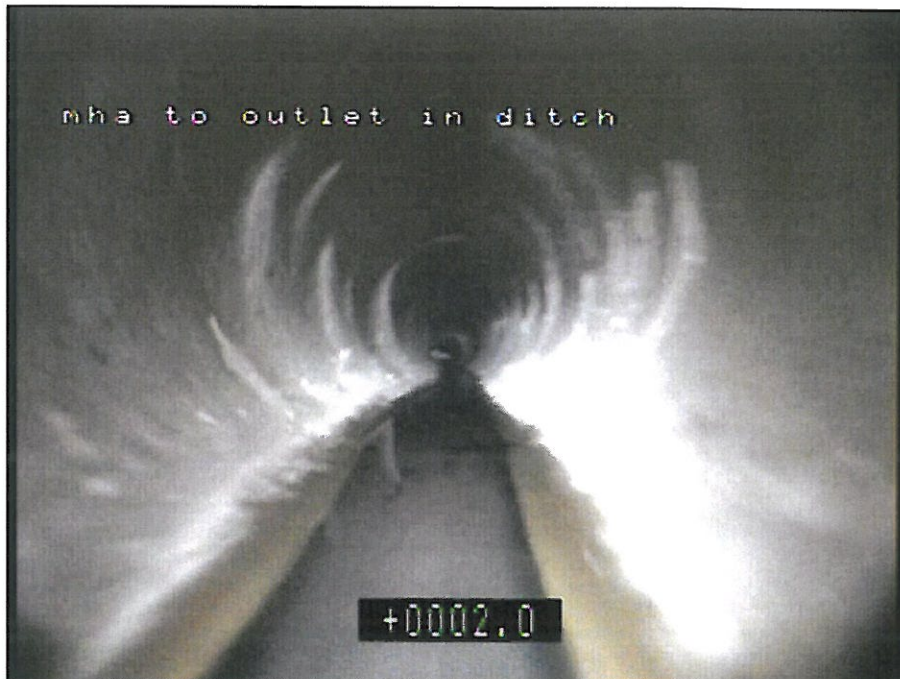
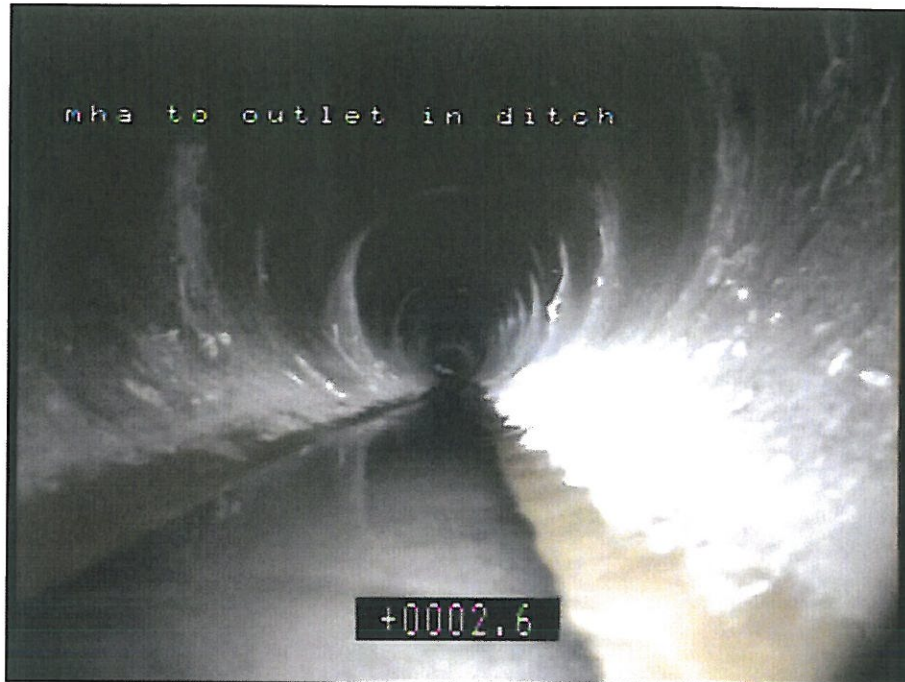
Photo: 1\_5a, Tape No.: 01, 00:00:31  
2m, Sewer Material changes at this point, Polyvinyl chloride

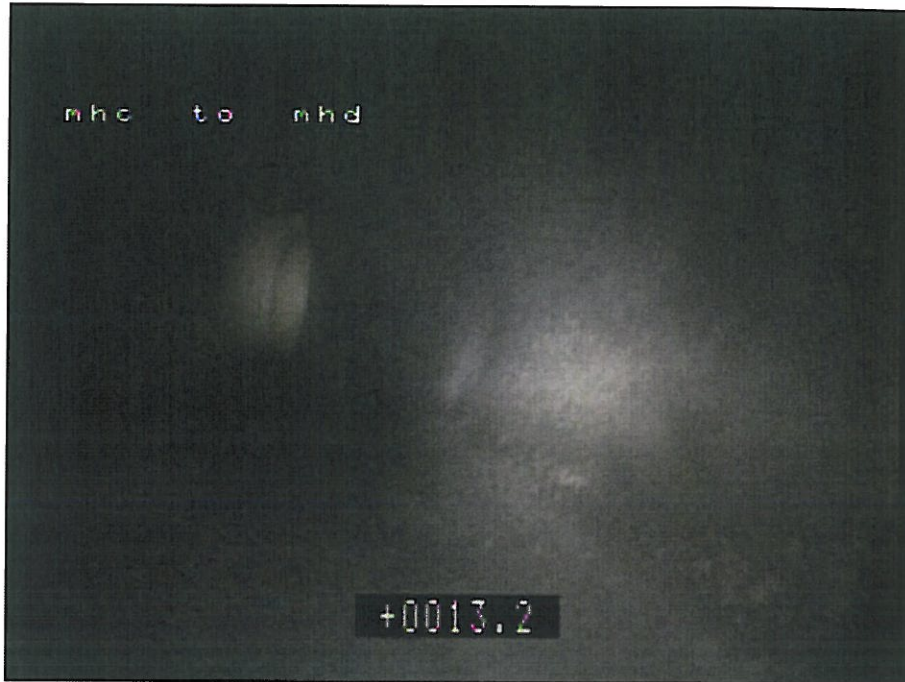
| 1:250 | position | code | observation | MPEG | photo | grade |
|---|---|---|---|---|---|---|
| | 13.90 | CXI | Connection defective, at 09 o'clock, dia 100 mm, intrusion 50 mm | 00:02:07 | 36_4a | (Constr) 4 |

Photo: 36\_4a, Tape No.: 01, 00:02:07  
13.9m, Connection defective, at 09 o'clock, dia 100 mm, intrusion 50 mm

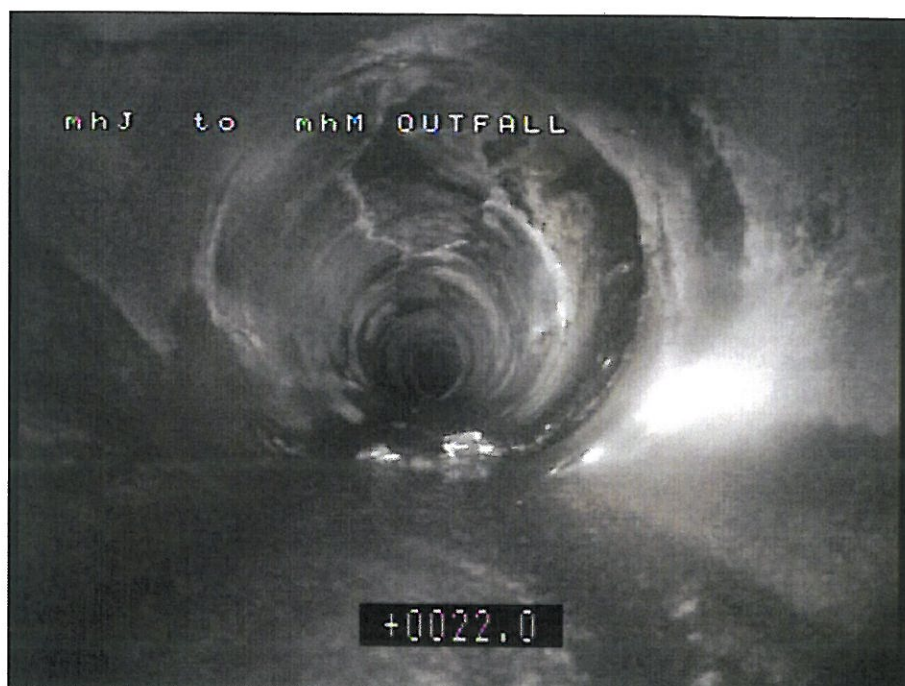
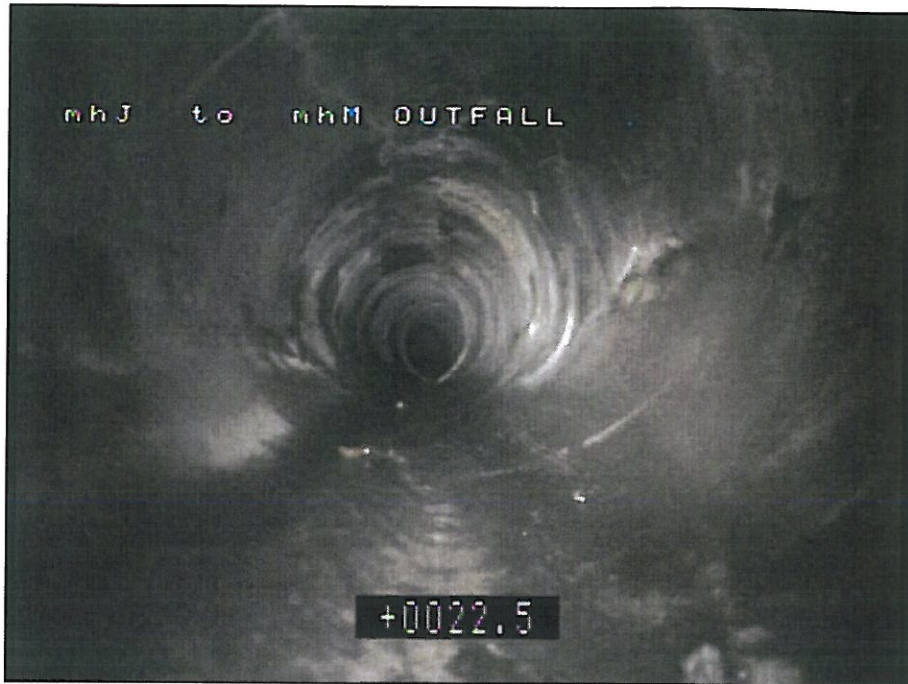
| 1:186 | position | code | observation | MPEG | photo | grade |
|---|---|---|---|---|---|---|
| | 22.40 | CX | Connection defective, at 02 o'clock, dia 100 mm | 00:03:12 | 9_11a, b | (Constr) 4 |

Photo: 9\_11a, Tape No.: 01, 00:03:12  
22.4m, Connection defective, at 02 o'clock, dia 100 mm

Photo: 9\_11b, Tape No.: 01, 00:03:12  
22.4m, Connection defective, at 02 o'clock, dia 100 mm

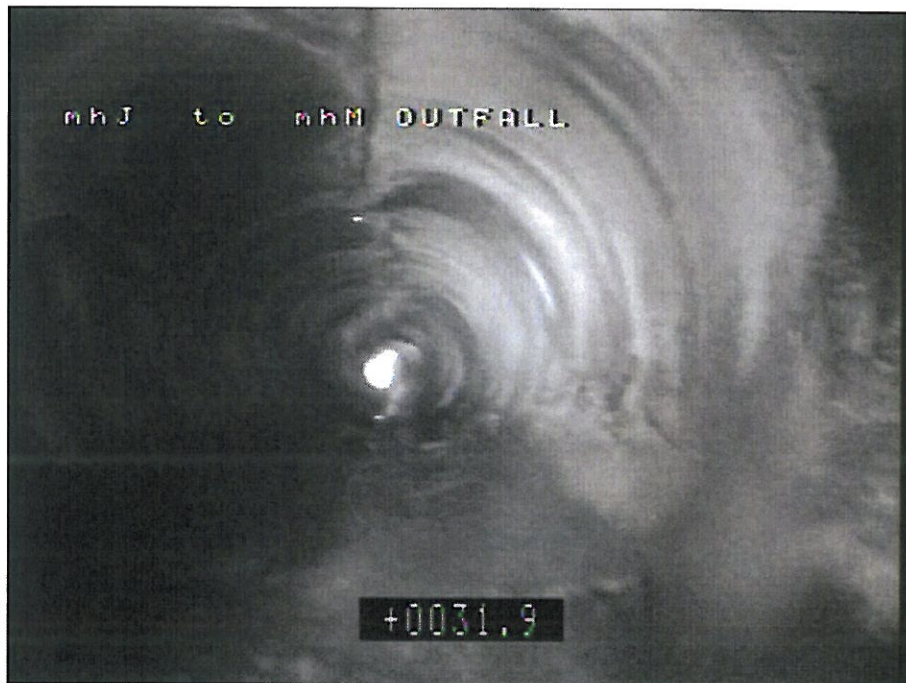
| 31.90 | B | Sewer Broken, from 09 to 12 o'clock | 00:04:22 | | (Struct) 4 |

Photo: 9\_20a, Tape No.: 01, 00:04:22  
31.9m, Sewer Deformed, 10 %

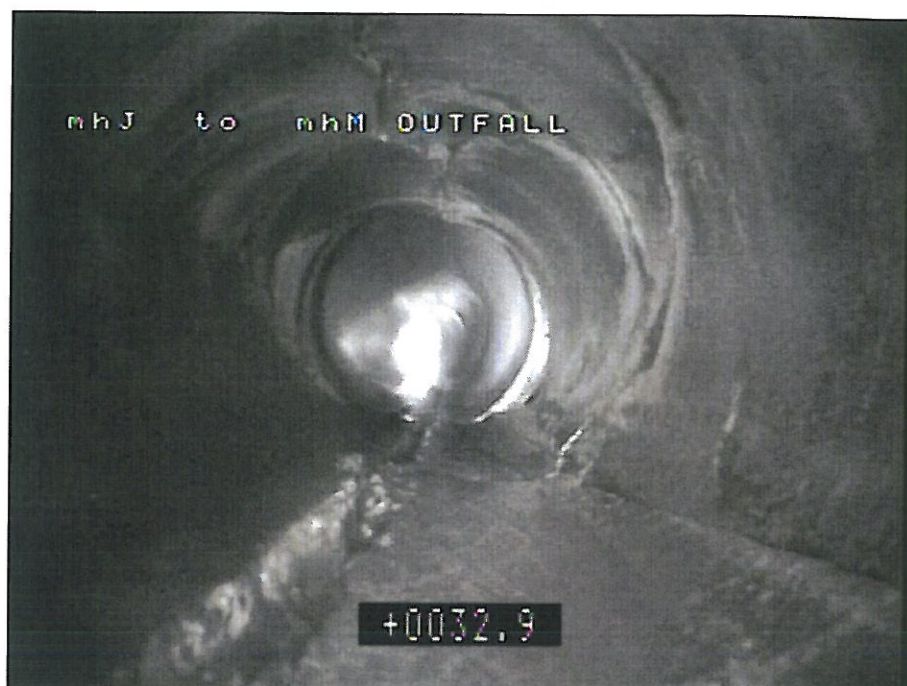
| 33.00 | FC | Circumferential Fracture, from 12 to 05 o'clock | 00:04:46 | 96_23a | (Struct) 3 |

Photo: 96\_23a, Tape No.: 01, 00:04:46  
33m, Circumferential Fracture, from 12 to 05 o'clock
