## / Main sections

| Project name :<br><b>Protherics UK Ltd, Wales, Drainage</b> | Project number :<br><b>J48577</b> | Contact : | Date :<br><b>26/09/2017</b> |

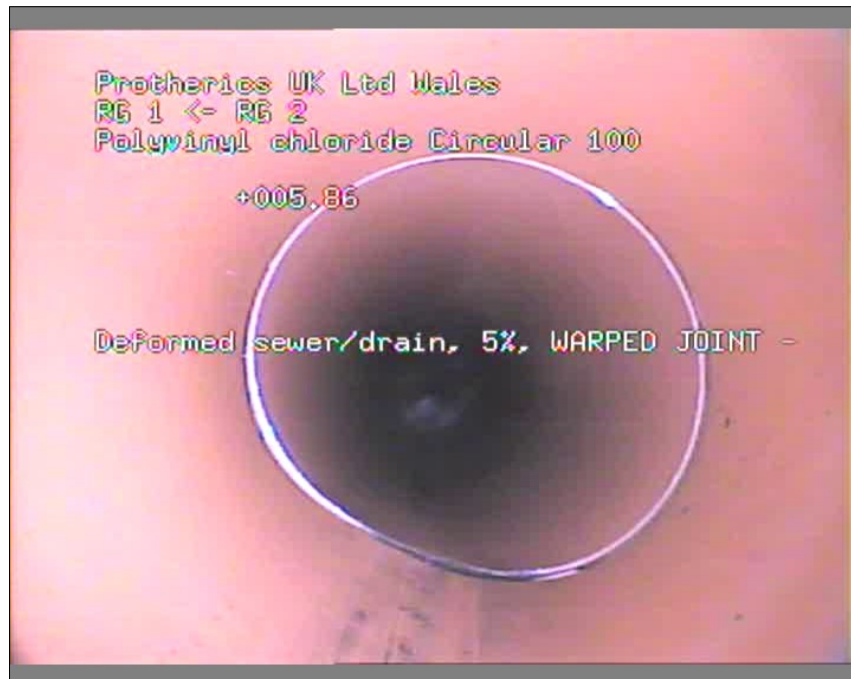
Photo: 1\_1\_4\_A.JPG

5.86m, Deformed sewer/drain, 5%

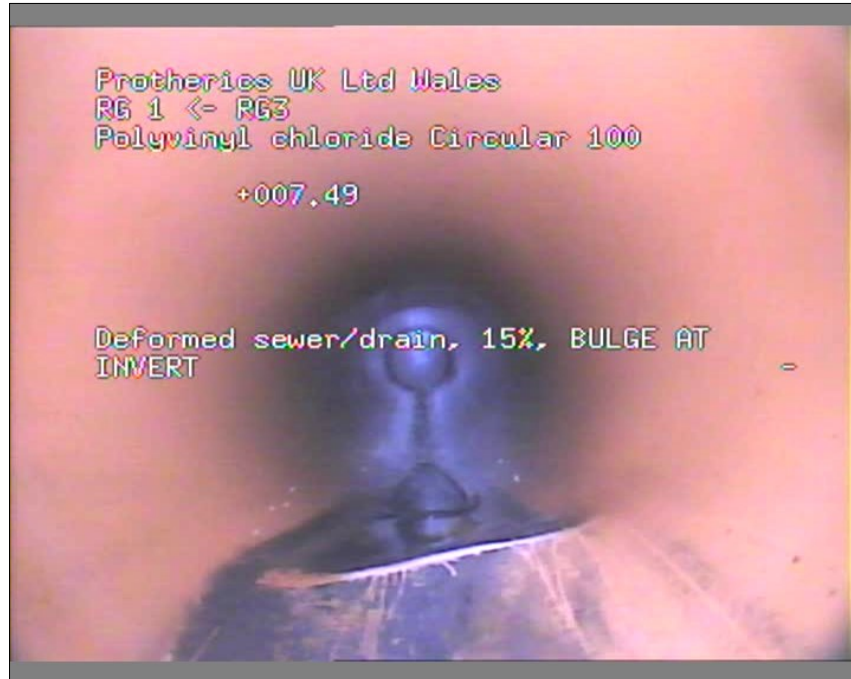
Photo: 4\_4\_10\_A.JPG  
 7.49m, Deformed sewer/drain, 15%

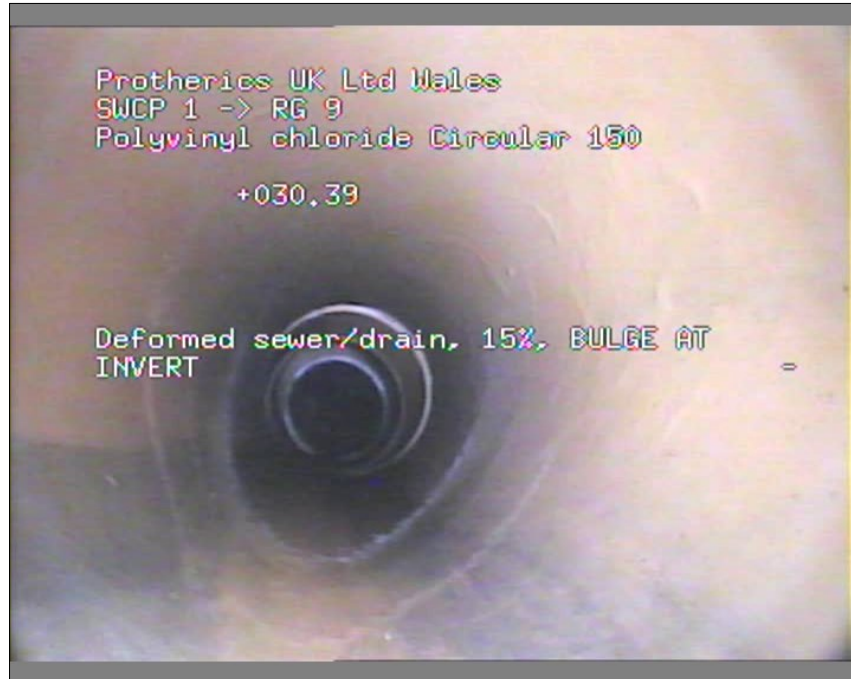
Photo: 12\_12\_60\_A.JPG  
 30.39m, Deformed sewer/drain, 15%

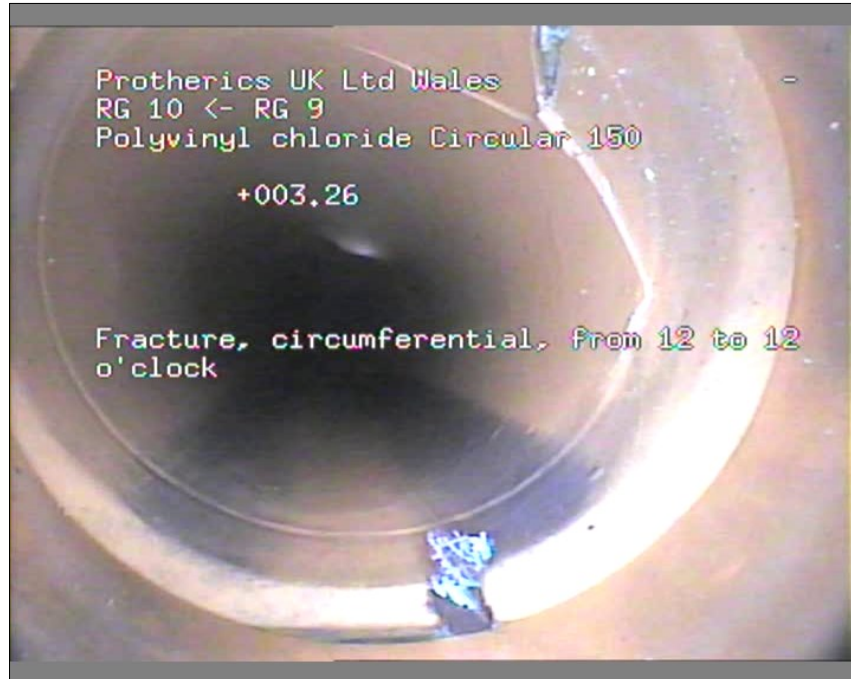
Photo: 14\_14\_81\_A.JPG  
 3.26m, Fracture, circumferential, from 12 to 12 o'clock

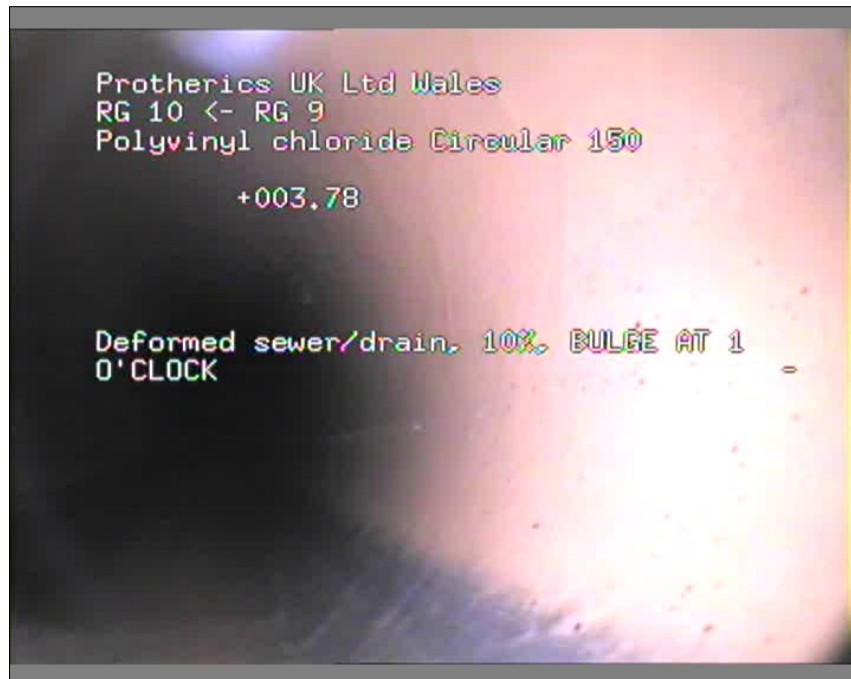
Photo: 14\_14\_82\_A.JPG  
 3.78m, Deformed sewer/drain, 10%

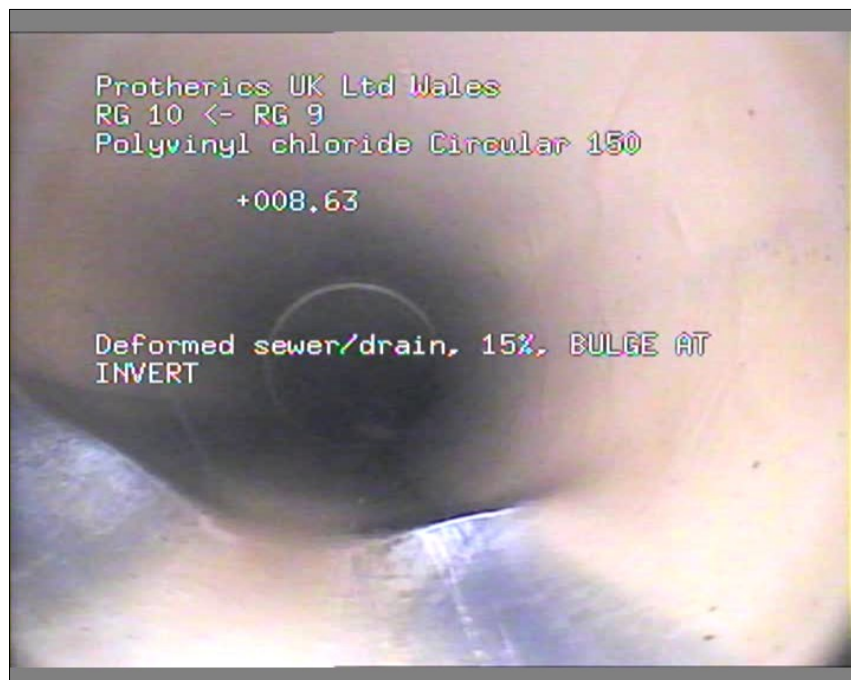
Photo: 14\_14\_83\_A.JPG  
 8.63m, Deformed sewer/drain, 15%

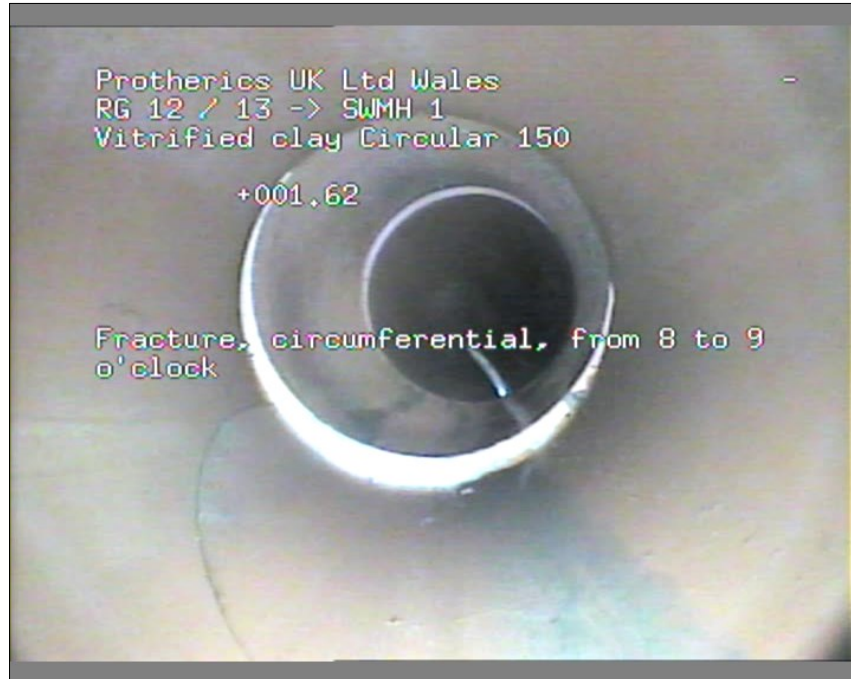
| 1:90<br>Depth: 0.89 | Position | Observation | Grade | |
|---|---|---|---|---|
| | 1.62 | Fracture, circumferential, from 8 to 9 o'clock | 3 | 1.62 m |

Photo: 18\_18\_94\_A.JPG  
 1.62m, Fracture, circumferential, from 8 to 9 o'clock

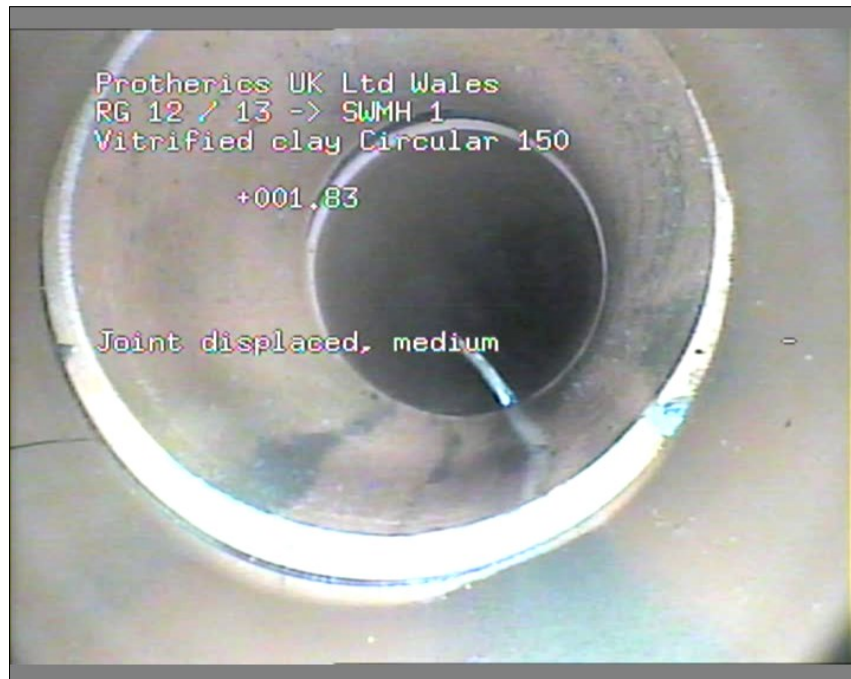
Photo: 18\_18\_95\_A.JPG  
 1.83m, Joint displaced, medium

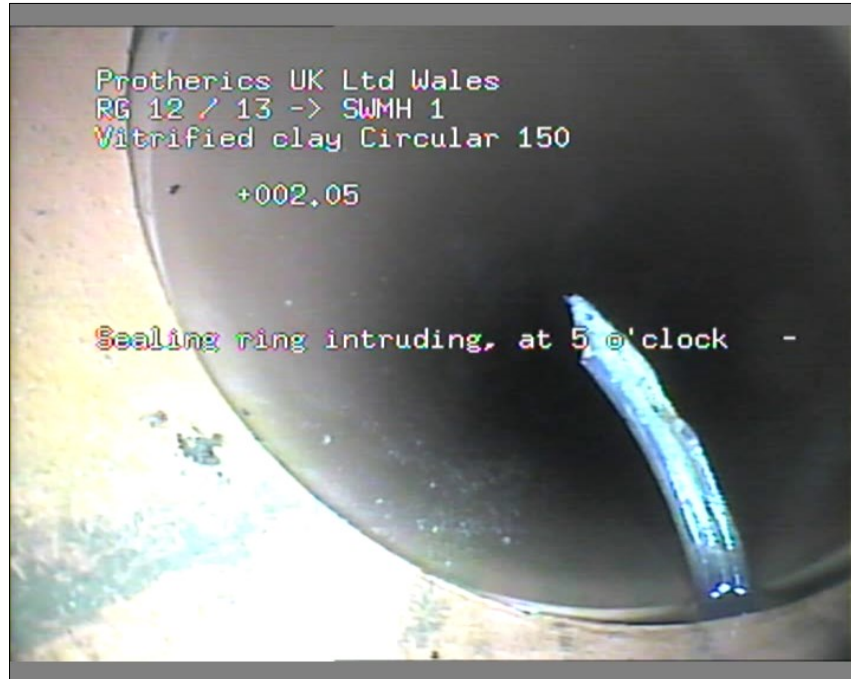
Photo: 18\_18\_97\_A.JPG  
 2.05m, Sealing ring intruding, at 5 o'clock

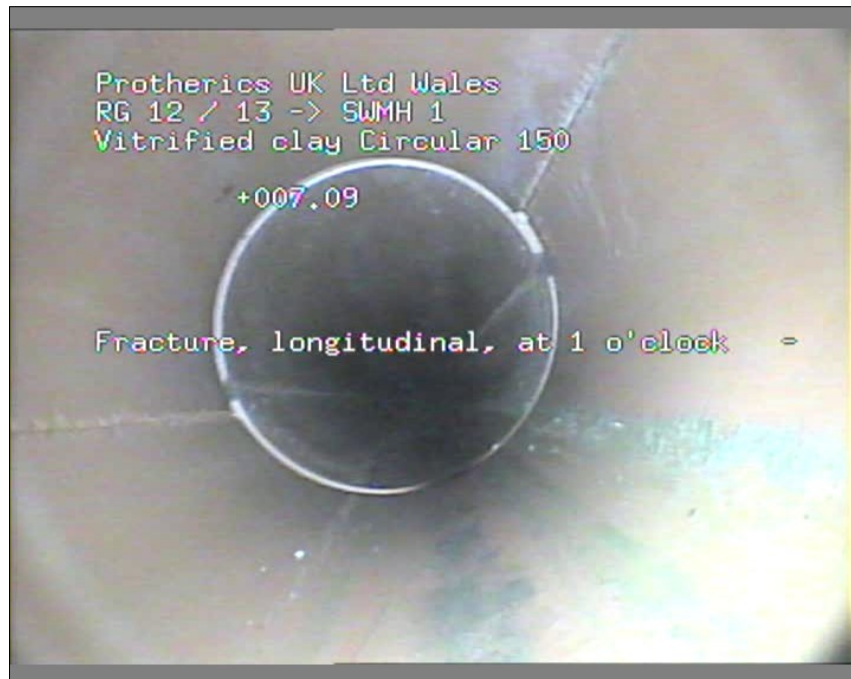
| 1:90<br>Depth: 0.89 | Position | Observation | Grade | |
|---|---|---|---|---|
| | 7.09 | Fracture, longitudinal, at 1 o'clock | 3 | |

Photo: 18\_18\_99\_A.JPG  
 7.09m, Fracture, longitudinal, at 1 o'clock

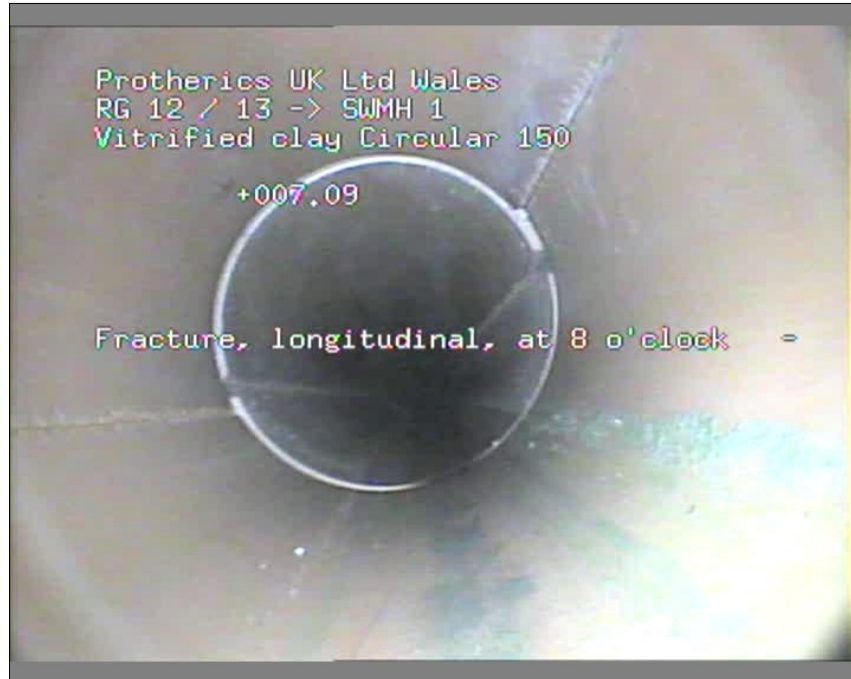
| 1:90<br>Depth: 0.89 | Position | Observation | Grade | |
|---|---|---|---|---|
| | 7.09 | Fracture, longitudinal, at 8 o'clock | 3 | 7.09 m |

Photo: 18\_18\_100\_A.JPG  
 7.09m, Fracture, longitudinal, at 8 o'clock

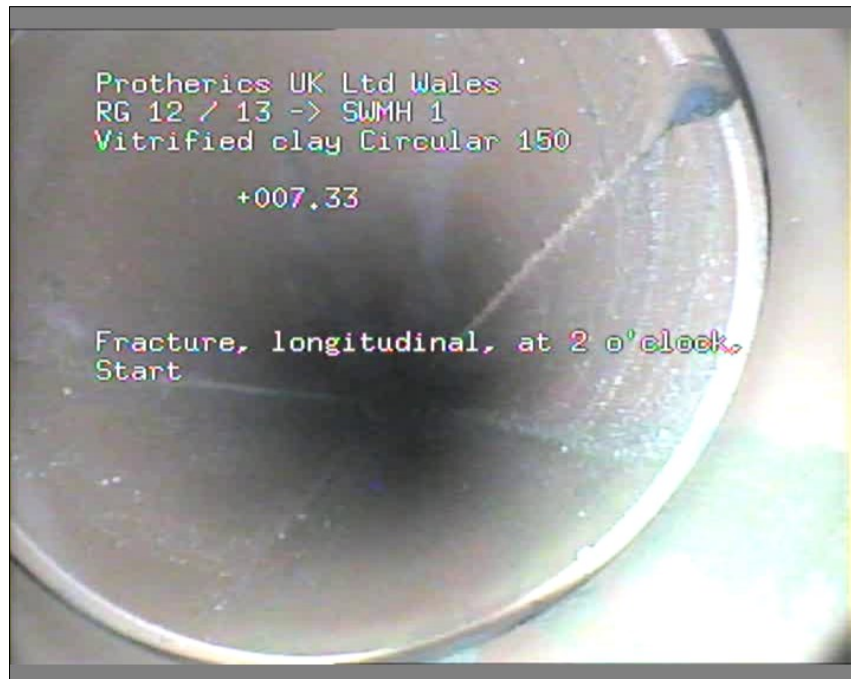
| 1:90<br>Depth: 0.89 | Position | Observation | Grade | |
|---|---|---|---|---|
| | 7.33 S01 | Fracture, longitudinal, at 2 o'clock, Start | 3 | |

Photo: 18\_18\_101\_A.JPG  
 7.33m, Fracture, longitudinal, at 2 o'clock, Start

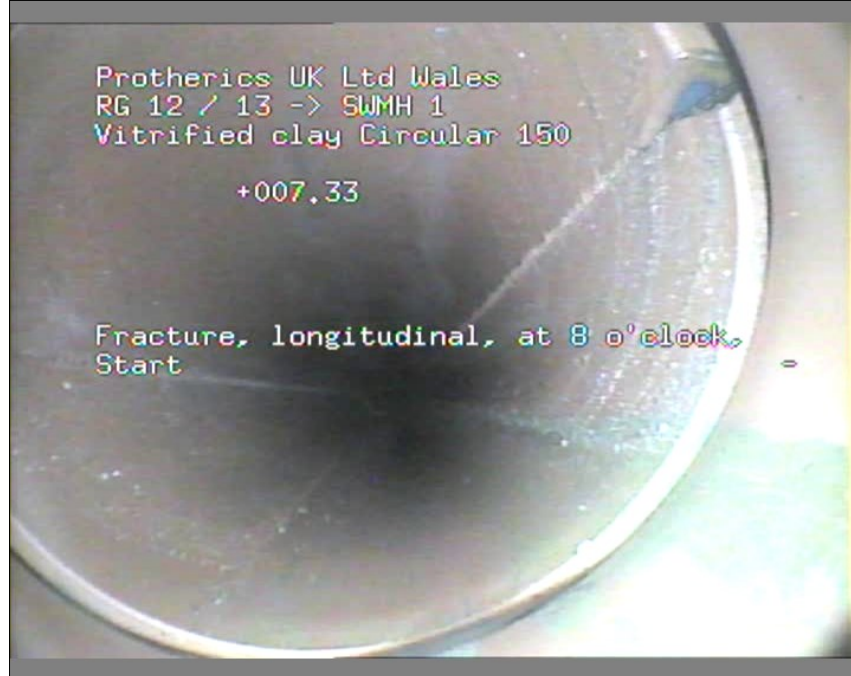
| 1:90<br>Depth: 0.89 | Position | Observation | Grade | |
|---|---|---|---|---|
| | 7.33 S02 | Fracture, longitudinal, at 8 o'clock, Start | 3 | |

Photo: 18\_18\_102\_A.JPG  
 7.33m, Fracture, longitudinal, at 8 o'clock, Start

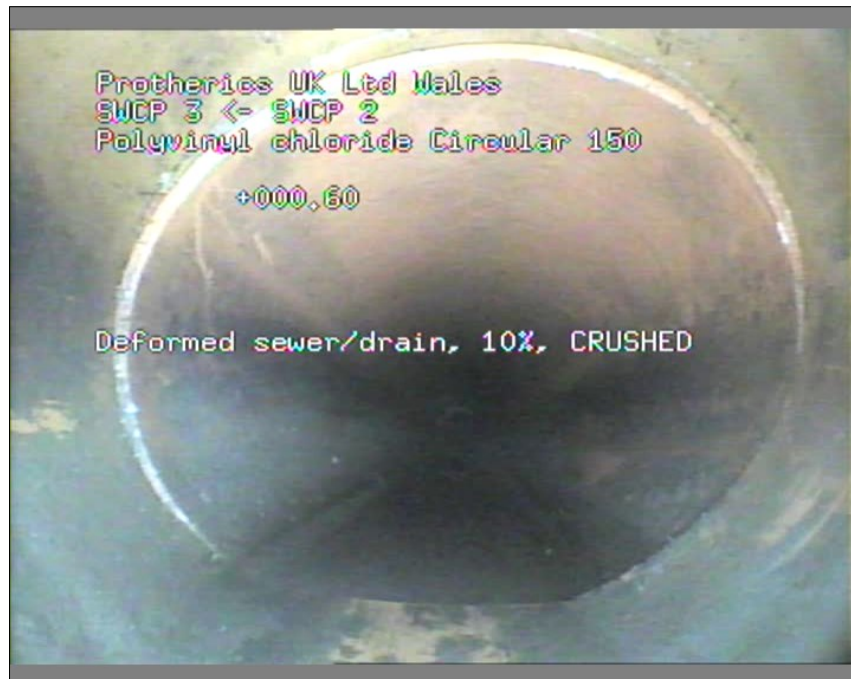
Photo: 27\_27\_160\_A.JPG  
 0.6m, Deformed sewer/drain, 10%

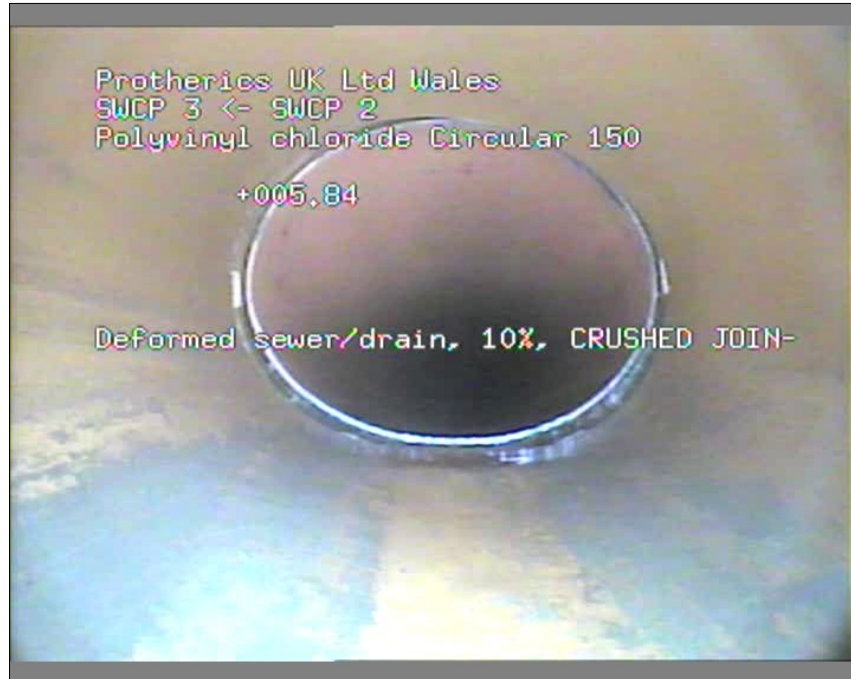
Photo: 27\_27\_161\_A.JPG  
 5.84m, Deformed sewer/drain, 10%

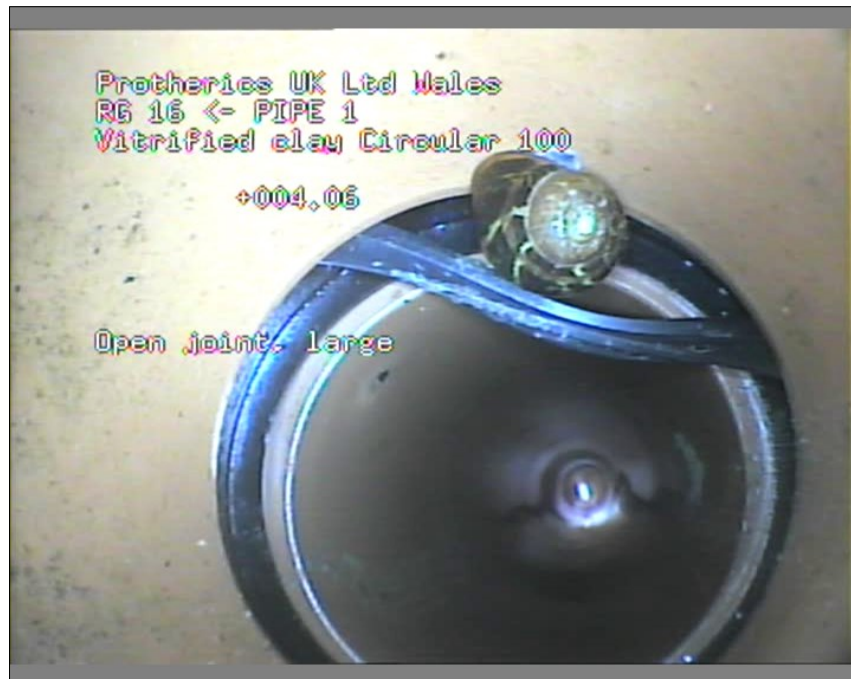
Photo: 32\_32\_192\_A.JPG  
 4.06m, Open joint, large

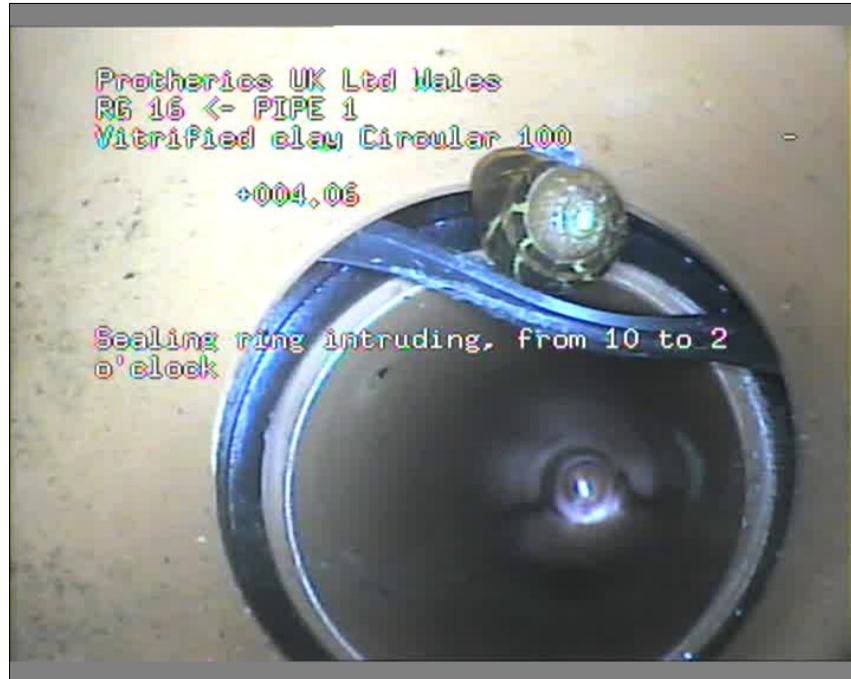
Photo: 32\_32\_193\_A.JPG  
 4.06m, Sealing ring intruding, from 10 to 2 o'clock

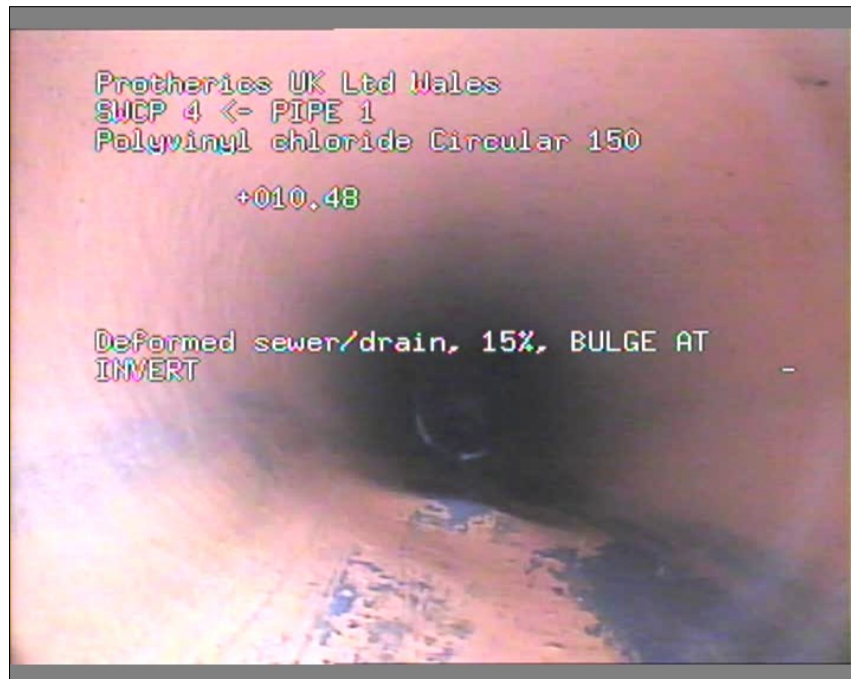
Photo: 33\_33\_200\_A.JPG  
 10.48m, Deformed sewer/drain, 15%

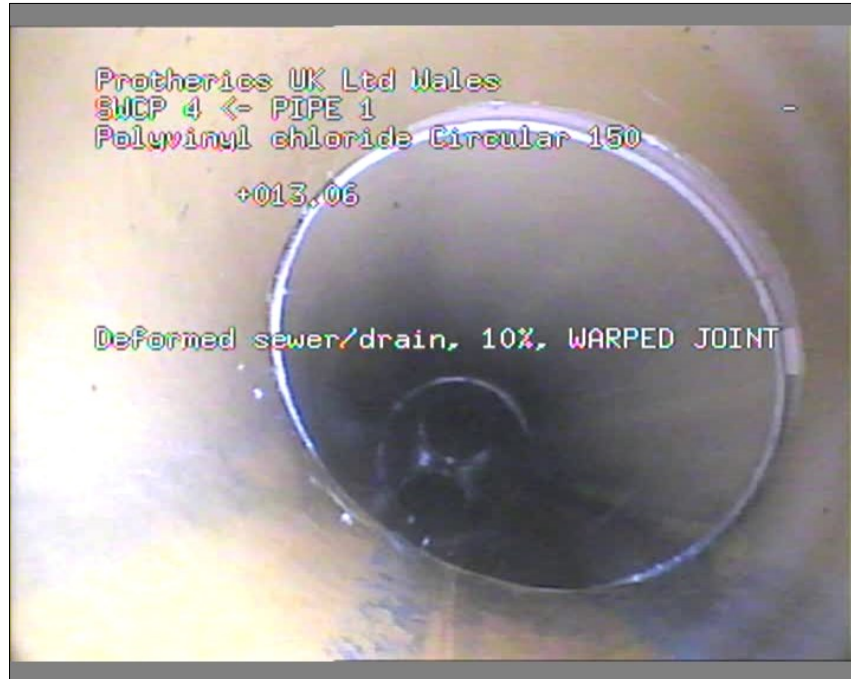
Photo: 33\_33\_201\_A.JPG  
 13.06m, Deformed sewer/drain, 10%

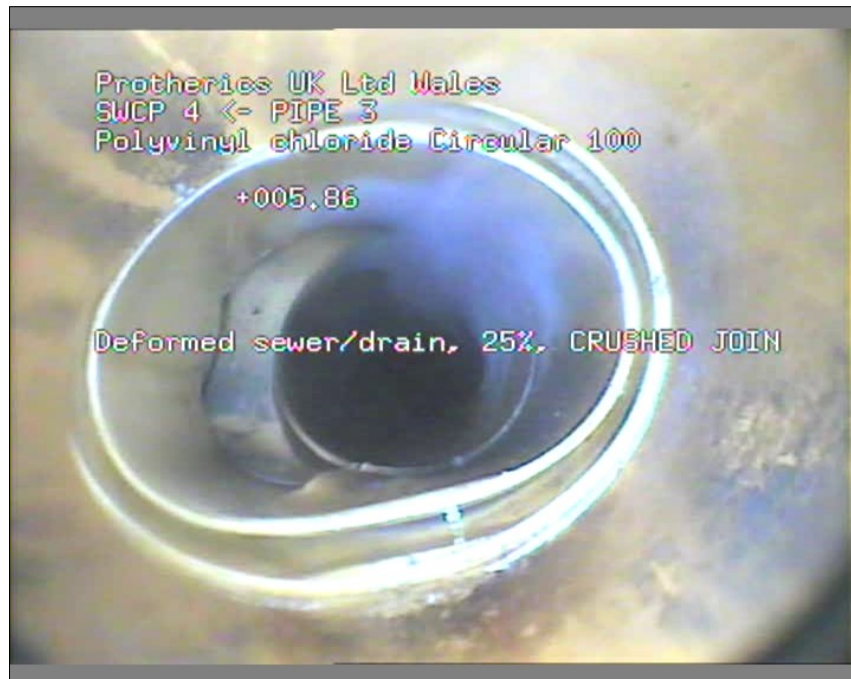
Photo: 35\_35\_216\_A.JPG  
 5.86m, Deformed sewer/drain, 25%

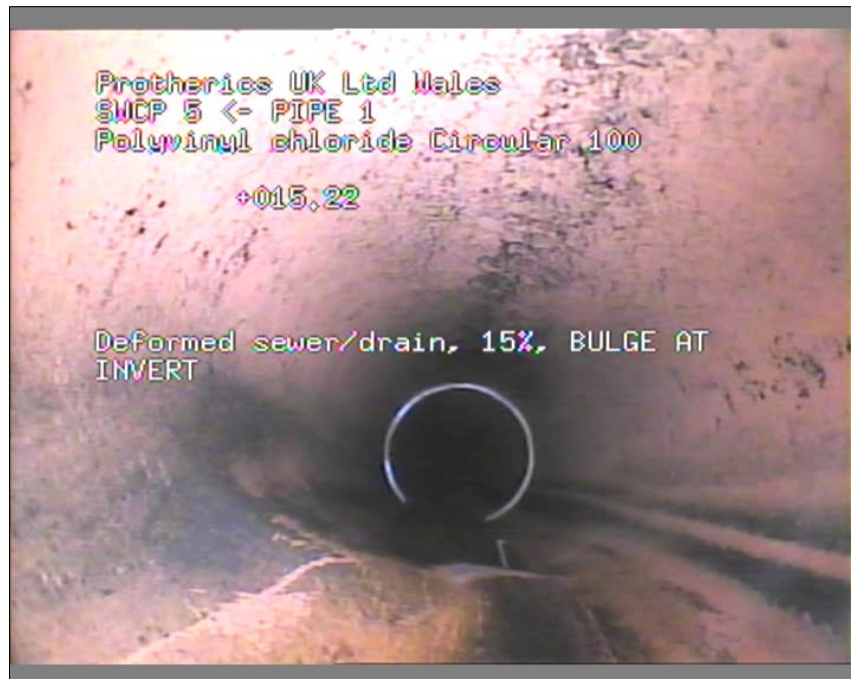
Photo: 39\_39\_246\_A.JPG  
 15.22m, Deformed sewer/drain, 15%

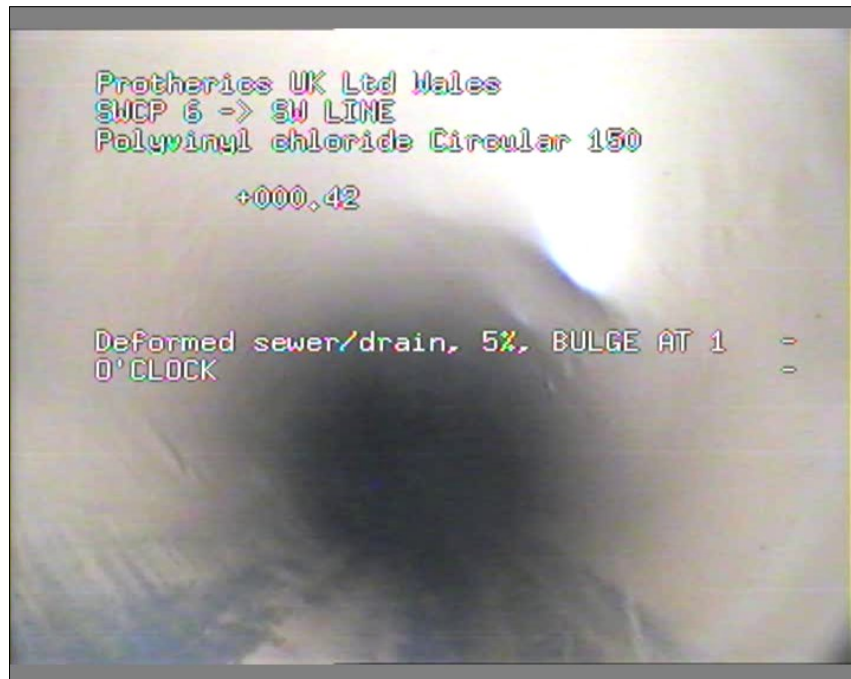
Photo: 42\_42\_263\_A.JPG  
 0.42m, Deformed sewer/drain, 5%

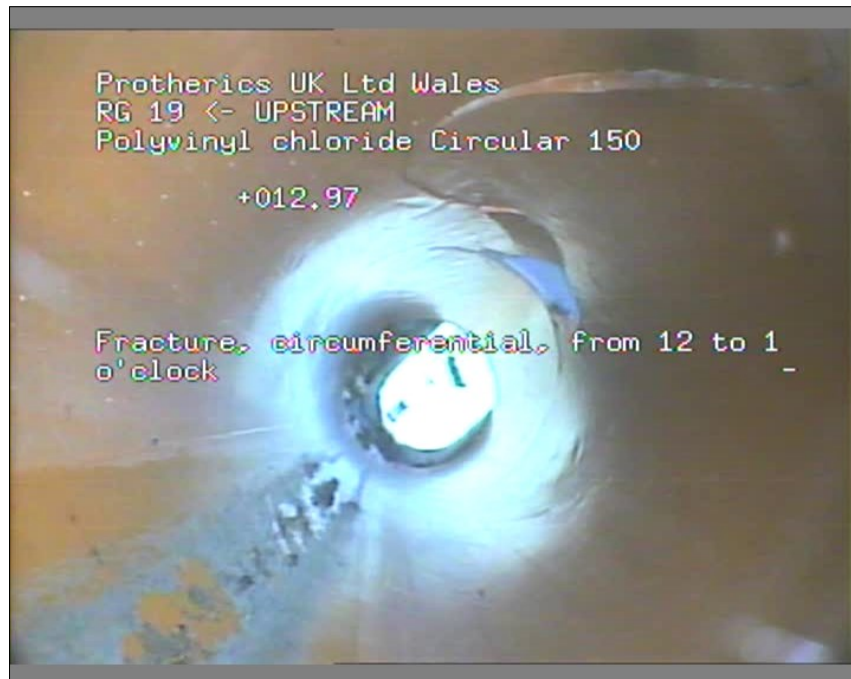
| 1:120 | Position | Observation | Grade | | | | | | |
|---|---|---|---|---|---|---|---|---|---|
| | 12.97 | Fracture, circumferential, from 12 to 1 o'clock | 3 | | | | | | |

Photo: 49\_49\_309\_A.JPG  
 12.97m, Fracture, circumferential, from 12 to 1 o'clock

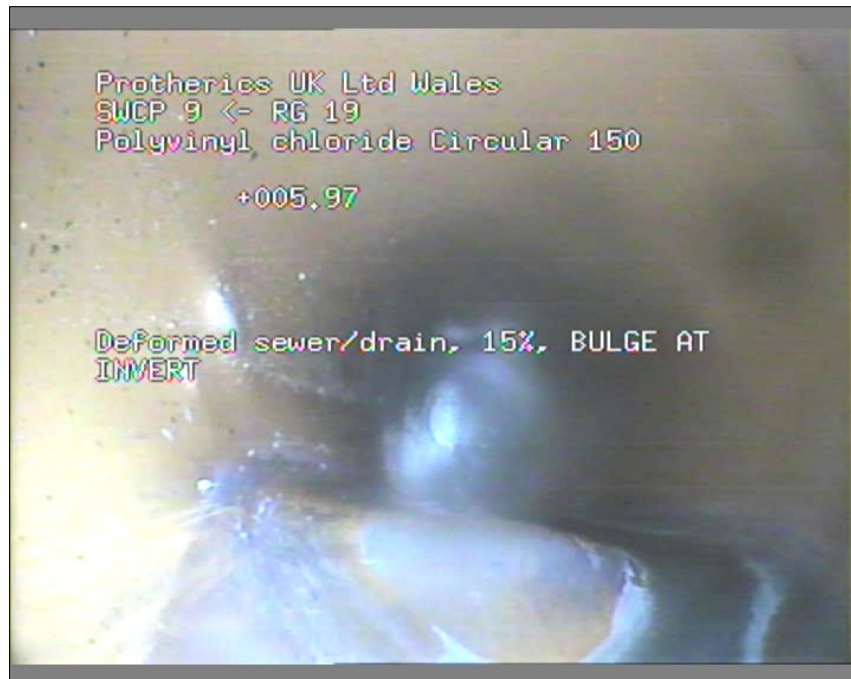
Photo: 50\_50\_314\_A.JPG  
 5.97m, Deformed sewer/drain, 15%

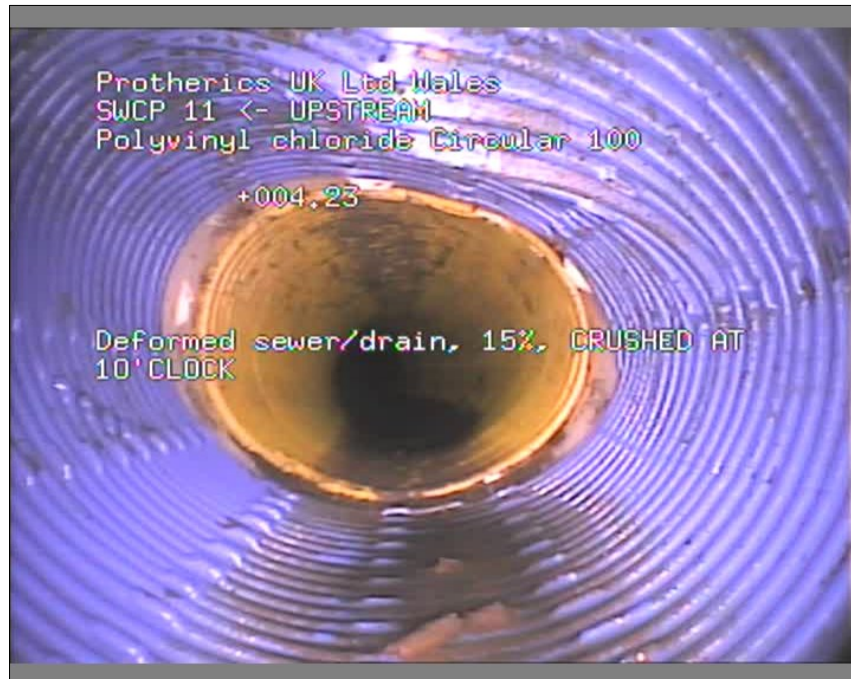
Photo: 53\_53\_338\_A.JPG  
 4.23m, Deformed sewer/drain, 15%

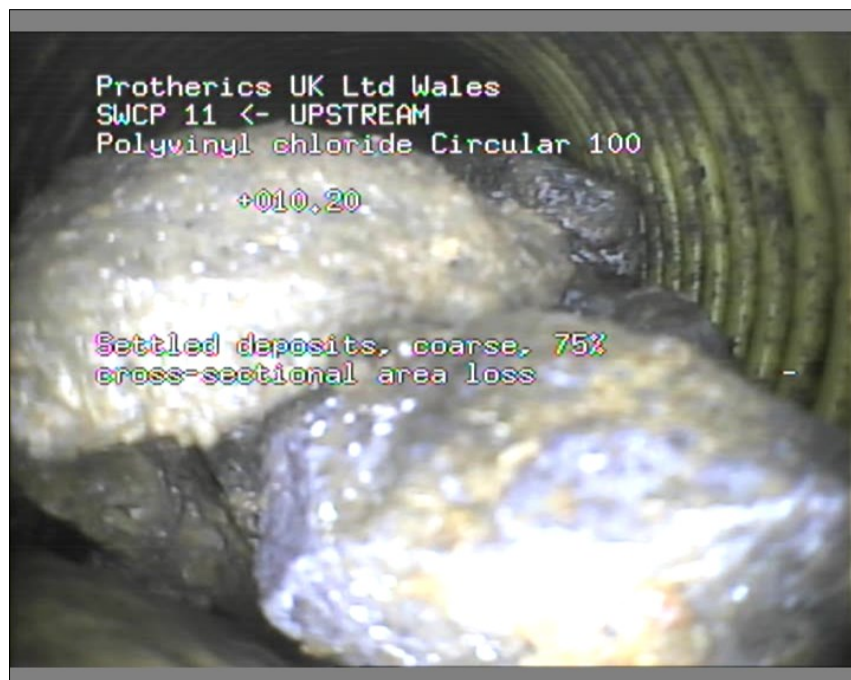
Photo: 53\_53\_340\_A.JPG  
 10.2m, Settled deposits, coarse, 75% cross-sectional area loss

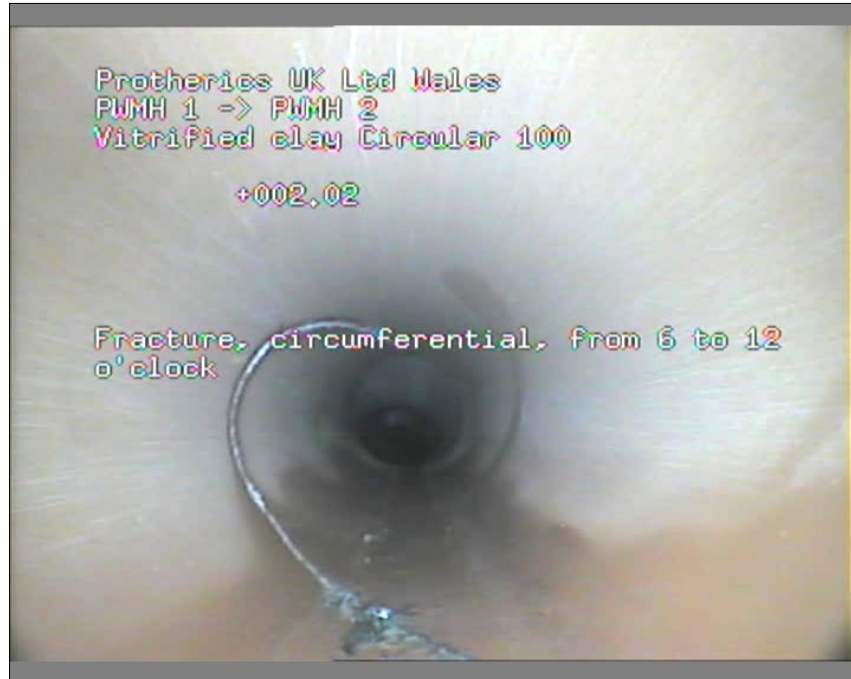
Photo: 79\_79\_518\_A.JPG

2.02m, Fracture, circumferential, from 6 to 12 o'clock

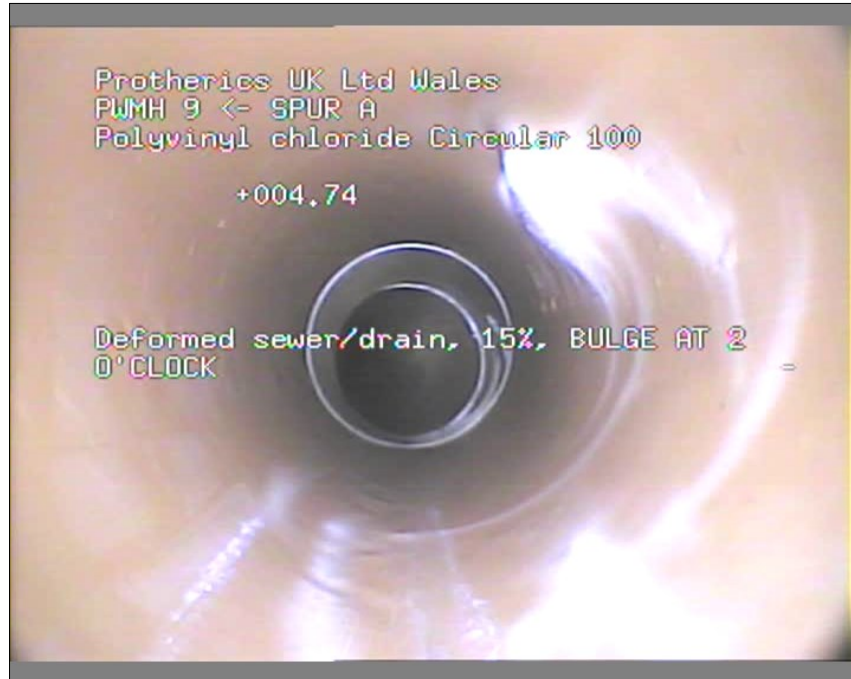
Photo: 93\_93\_601\_A.JPG  
 4.74m, Deformed sewer/drain, 15%

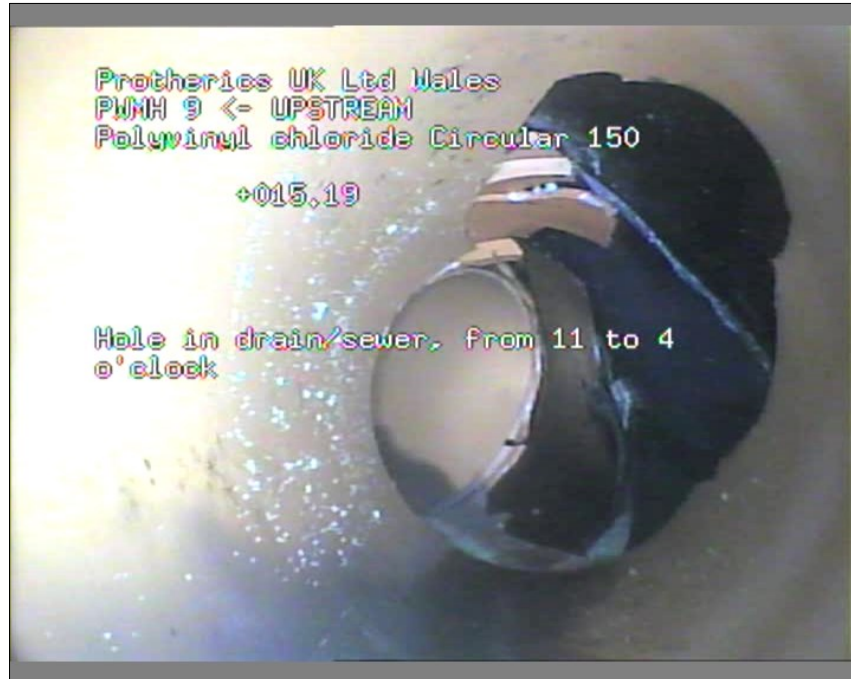
Photo: 94\_94\_615\_A.JPG  
 15.19m, Hole in drain/sewer, from 11 to 4 o'clock

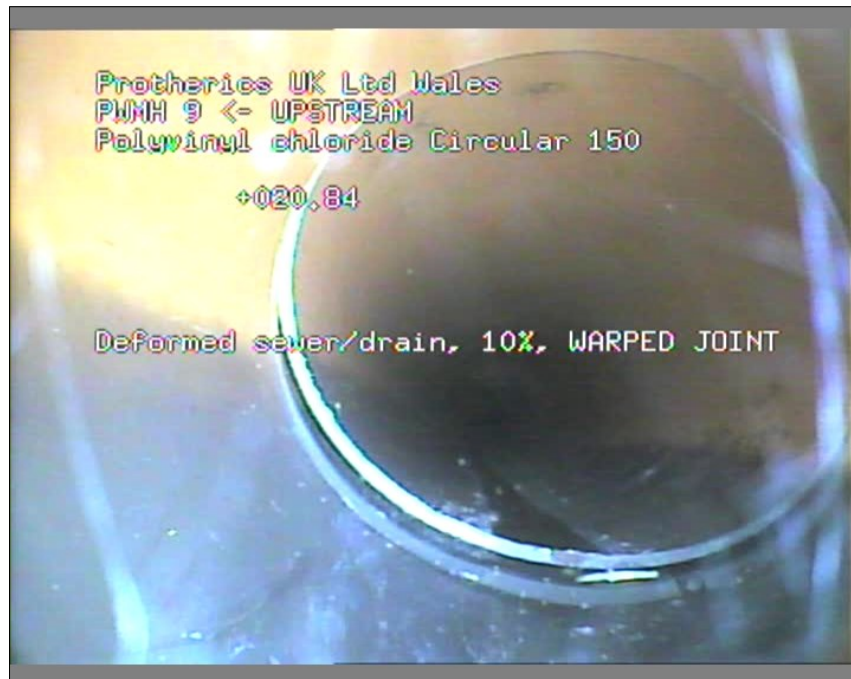
Photo: 94\_94\_617\_A.JPG  
 20.84m, Deformed sewer/drain, 10%

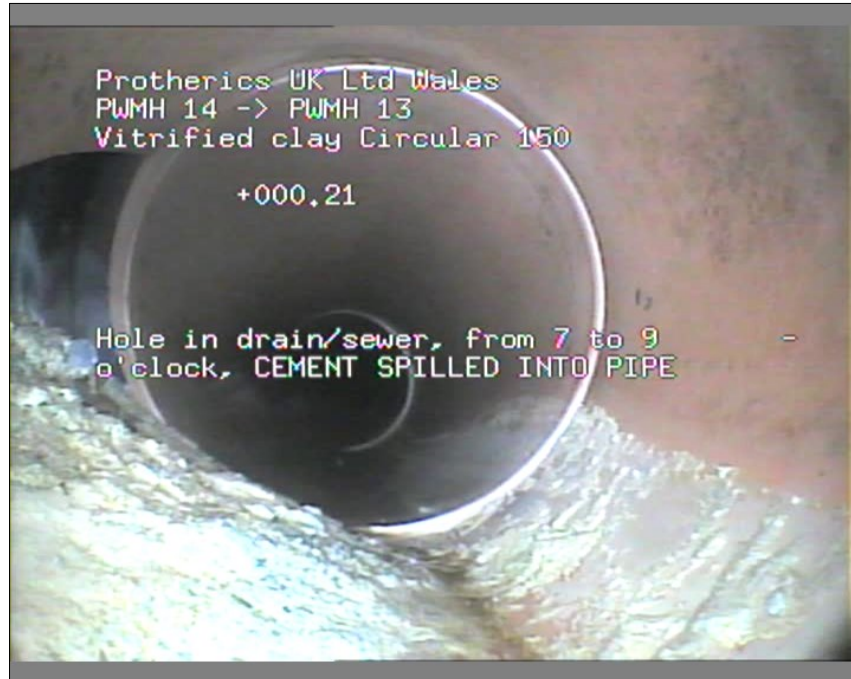
Photo: 100\_100\_647\_A.JPG  
0.21m, Hole in drain/sewer, from 7 to 9 o'clock

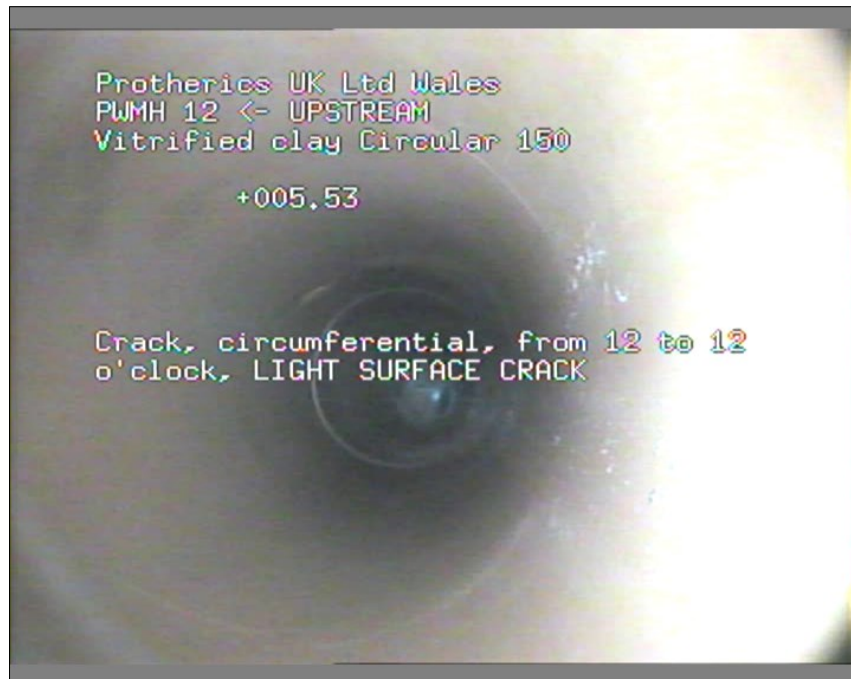
Photo: 101\_101\_653\_A.JPG  
 5.53m, Crack, circumferential, from 12 to 12 o'clock

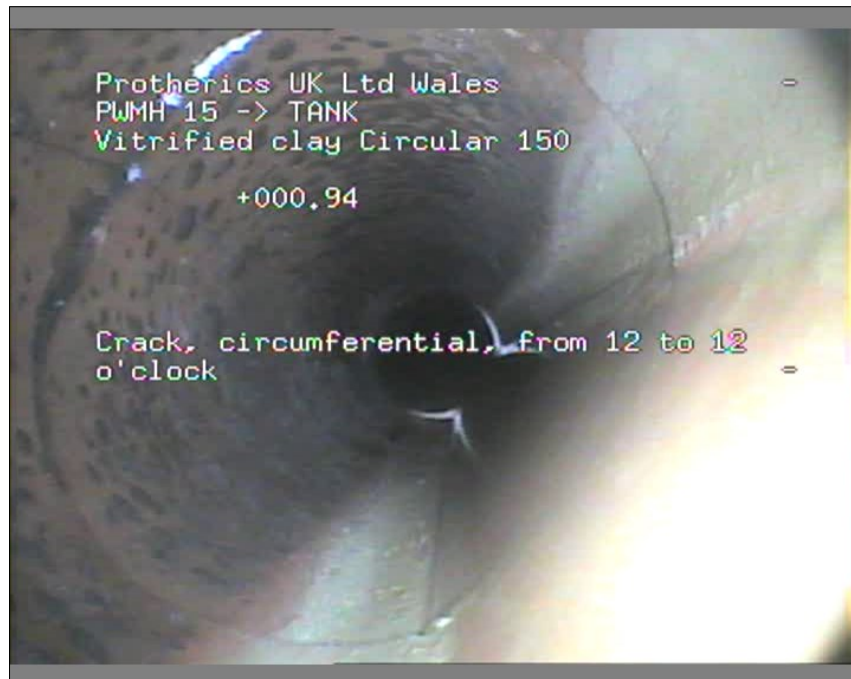
Photo: 106\_106\_683\_A.JPG  
 0.94m, Crack, circumferential, from 12 to 12 o'clock

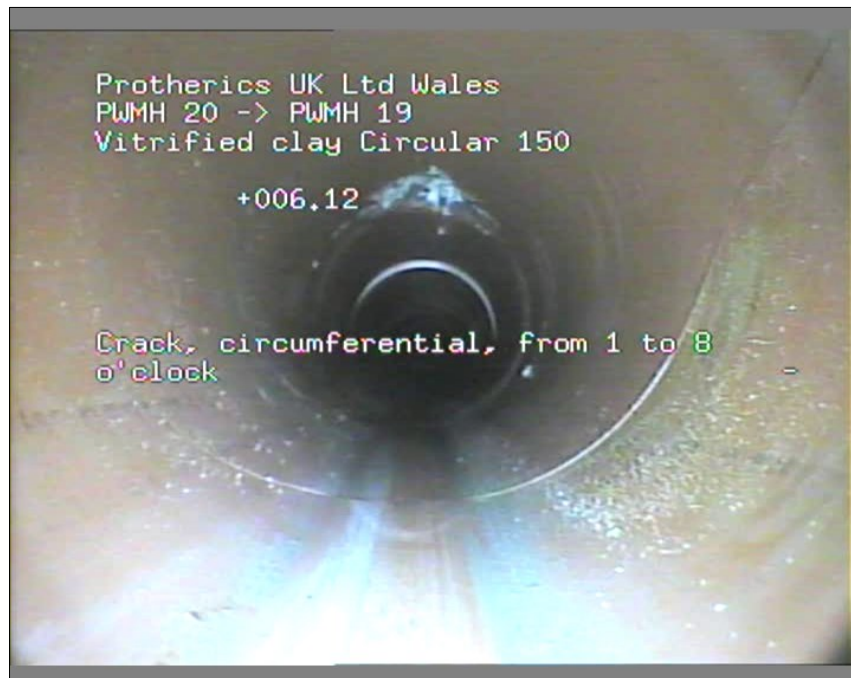
Photo: 114\_114\_740\_A.JPG  
 6.12m, Crack, circumferential, from 1 to 8 o'clock

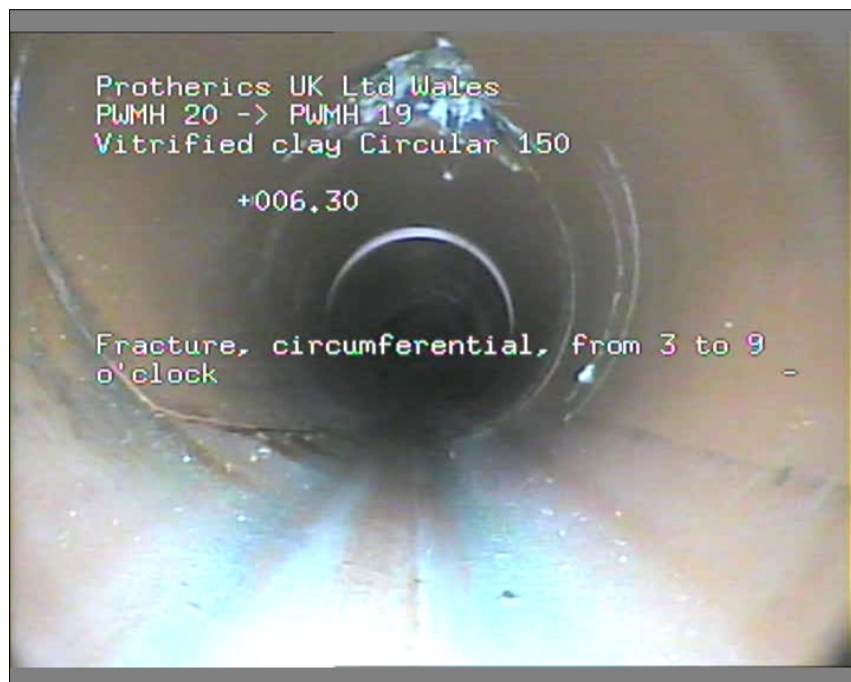
Photo: 114\_114\_741\_A.JPG  
 6.3m, Fracture, circumferential, from 3 to 9 o'clock

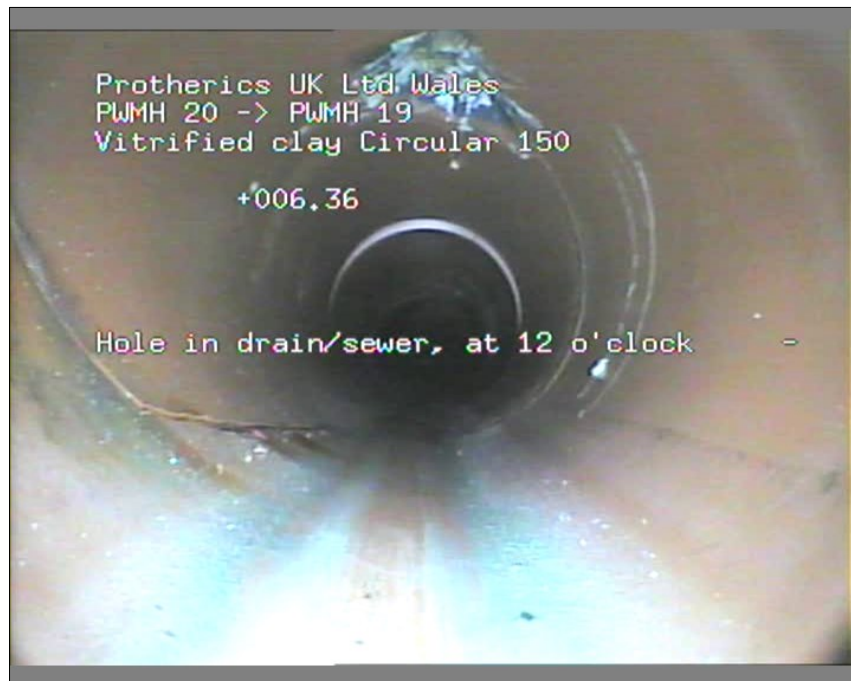
Photo: 114\_114\_742\_A.JPG  
 6.36m, Hole in drain/sewer, at 12 o'clock

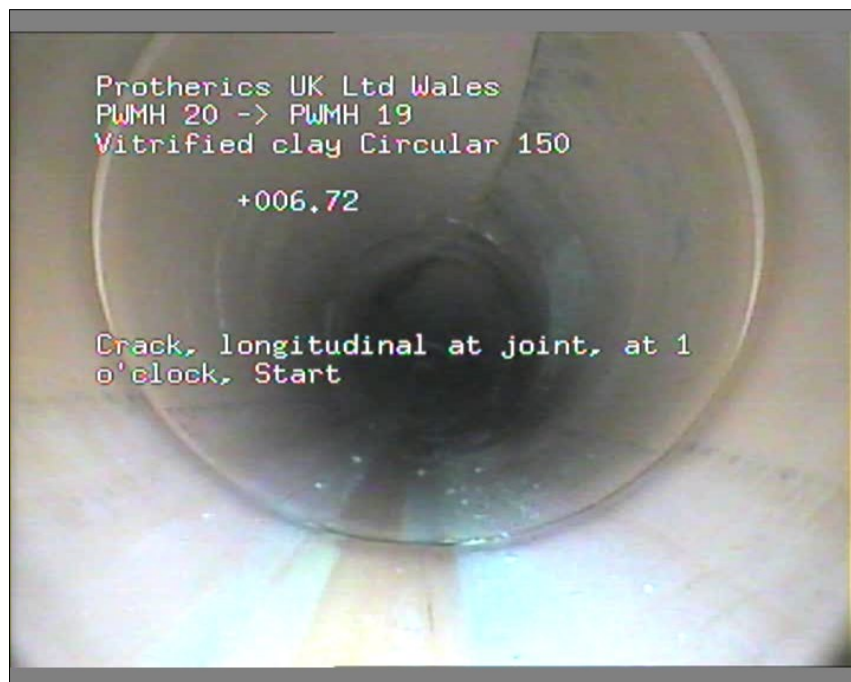
Photo: 114\_114\_743\_A.JPG  
 6.72m, Crack, longitudinal at joint, at 1 o'clock, Start

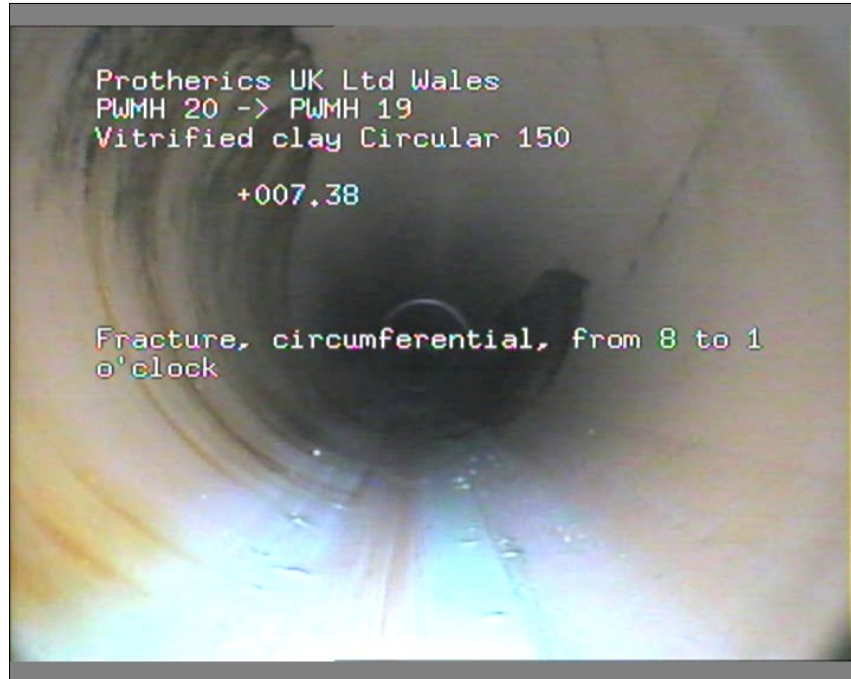
Photo: 114\_114\_744\_A.JPG  
 7.38m, Fracture, circumferential, from 8 to 1 o'clock
