## / Main sections

| Project name :<br><b>Protherics UK Ltd, Wales, Drainage</b> | Project number :<br><b>J48577</b> | Contact : | Date :<br><b>26/09/2017</b> |

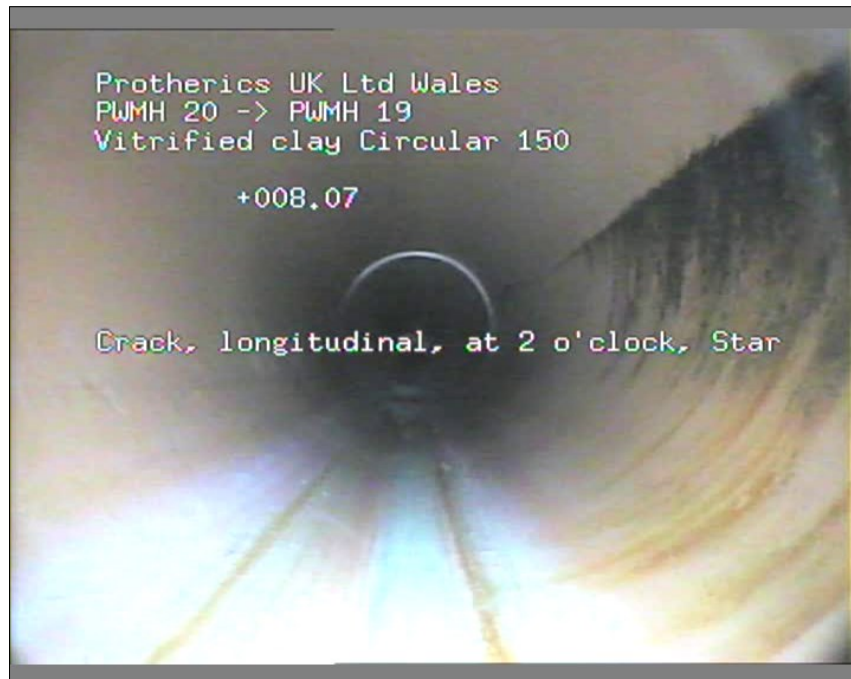
Photo: 114\_114\_746\_A.JPG  
 8.07m, Crack, longitudinal, at 2 o'clock, Star

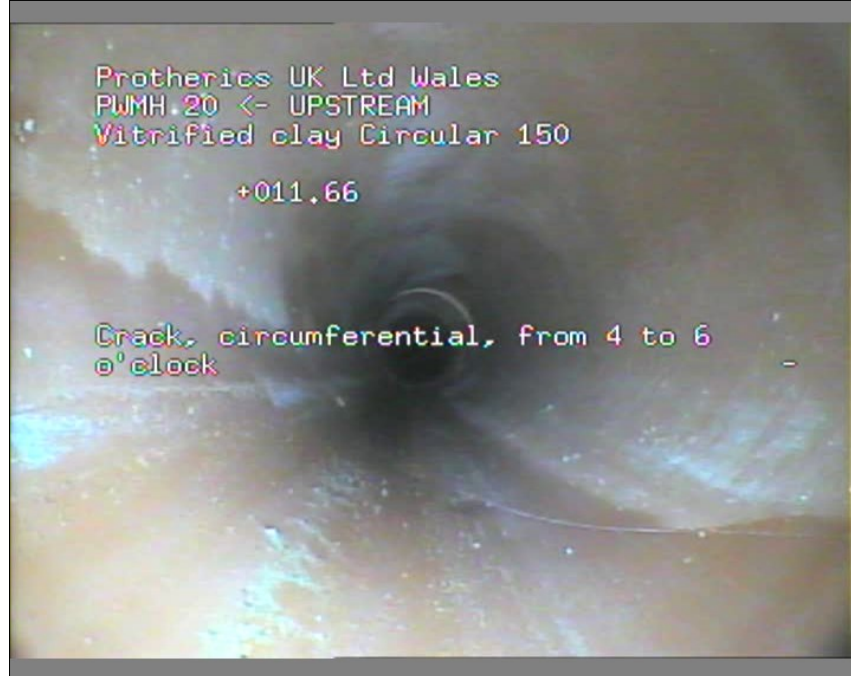
Photo: 115\_115\_753\_A.JPG  
 11.66m, Crack, circumferential, from 4 to 6 o'clock

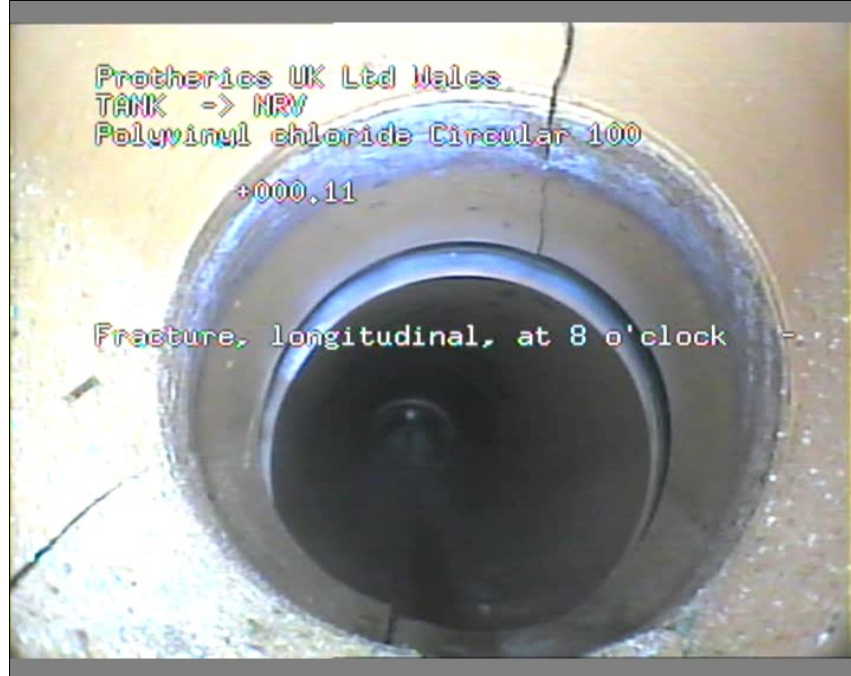
Photo: 127\_127\_842\_A.JPG  
 0.11m, Fracture, longitudinal, at 8 o'clock

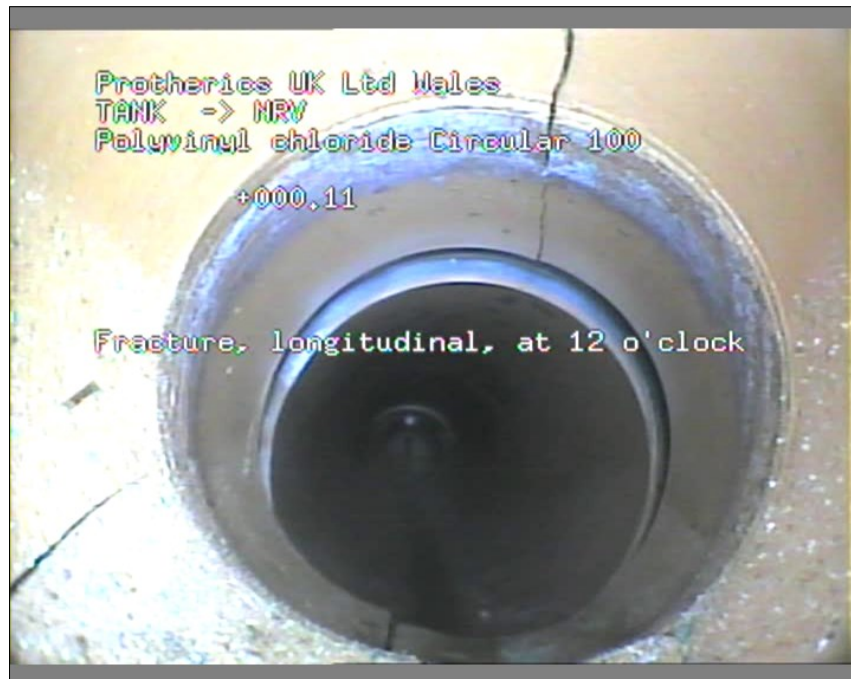
Photo: 127\_127\_843\_A.JPG  
 0.11m, Fracture, longitudinal, at 12 o'clock
