| Location Plan: | | Loughor Embankment | |
| | | Assessment Date: 28/07/2020 | |
| | | Structure Reference: | 221 49 |

# COASTAL ASSET CONDITION SURVEY REPORT

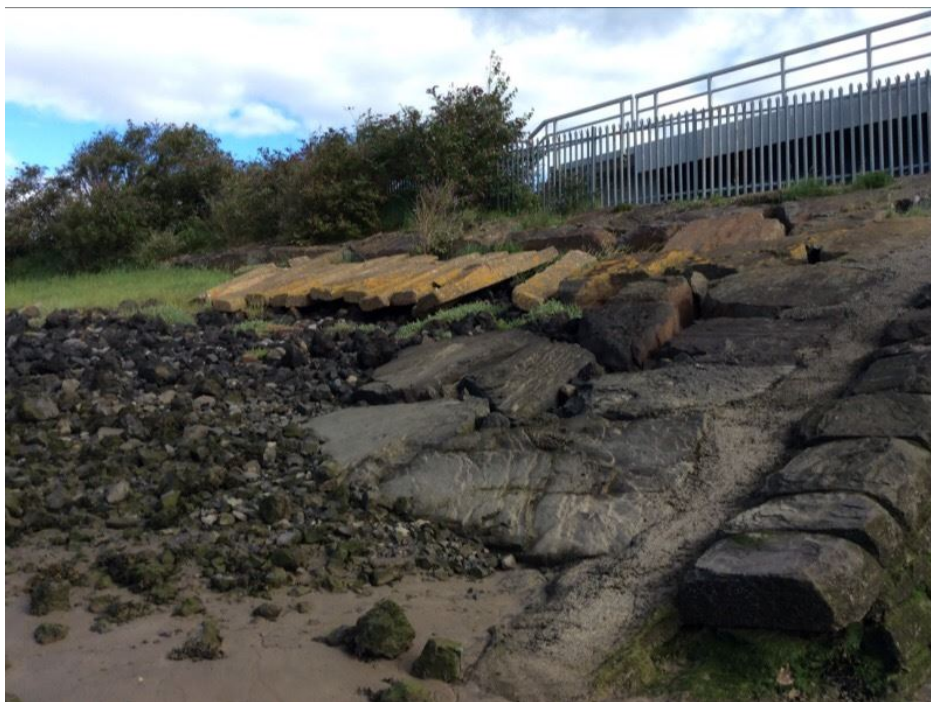
**Section A  
Embankment  
Armour  
Photo number: 21**

| Minor Elements | Photo No. | Attributes and General Notes | Condition Grade | Weighting (1-9) | Overall (CG x W) |
|---|---|---|---|---|---|
| Embankment Armour | 21 | Rock (Rock (ungraded, displaced units, minor erosion of supporting material).). | 3 | 7 | 21 |

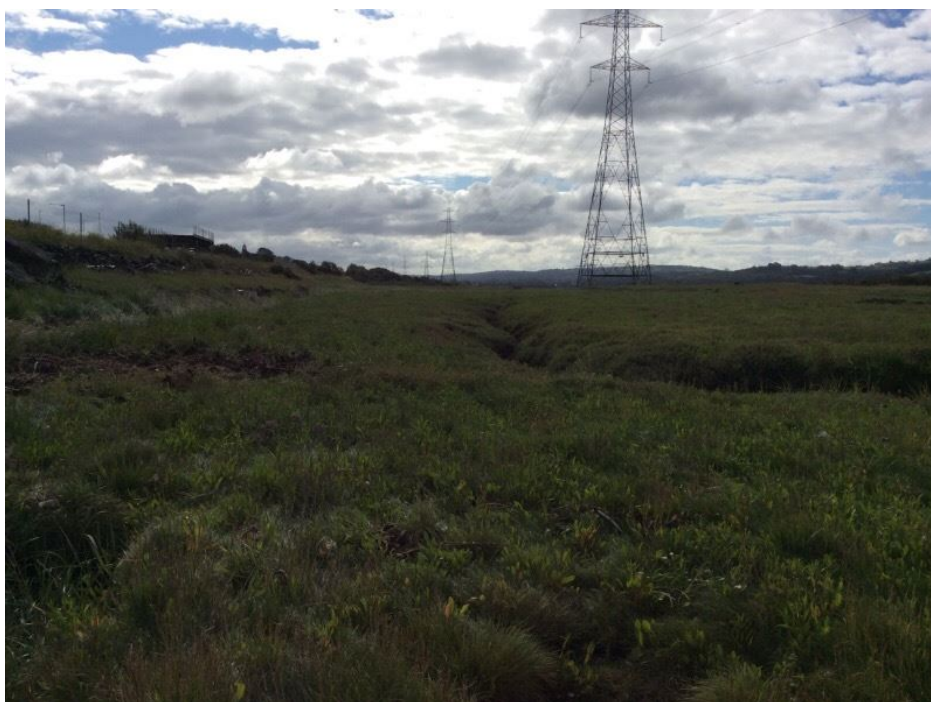
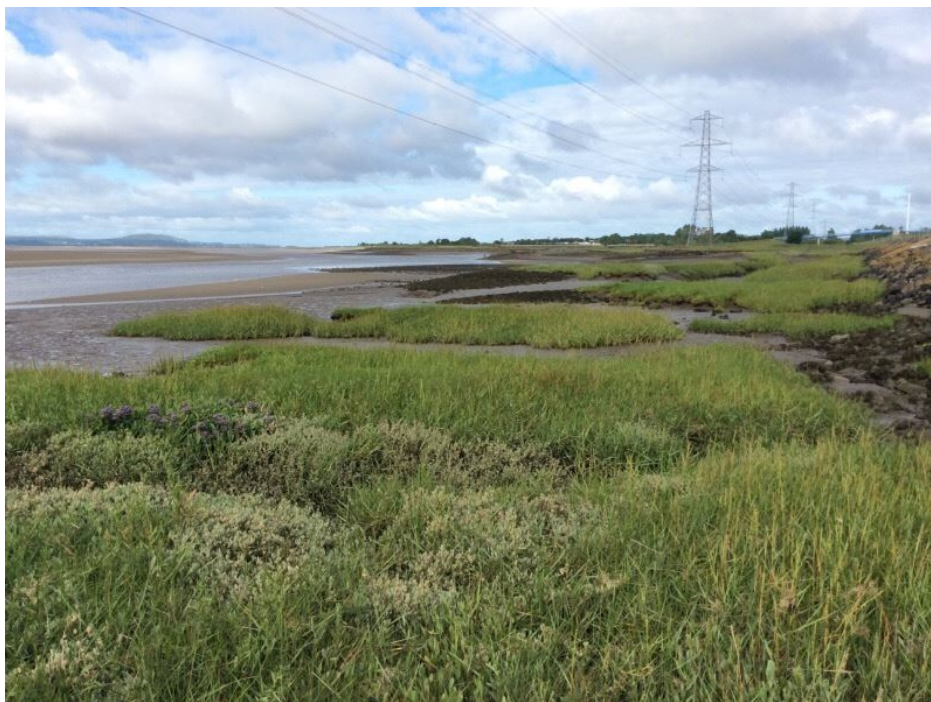
| Minor Elements | Photo No. | Attributes and General Notes | Condition Grade | Weighting (1-9) | Overall (CG x W) |
|---|---|---|---|---|---|
| Embankment Natural | 22, 23 | Vegetated (Vegetated (loss of vegetation, scour at toe, instability of slope, extensive erosion).). | 3 | 5 | 15 |

**Section A  
Embankment  
Natural  
Photo number: 22**

**Section A**  
**Embankment**  
**Natural**  
**Photo number: 23**

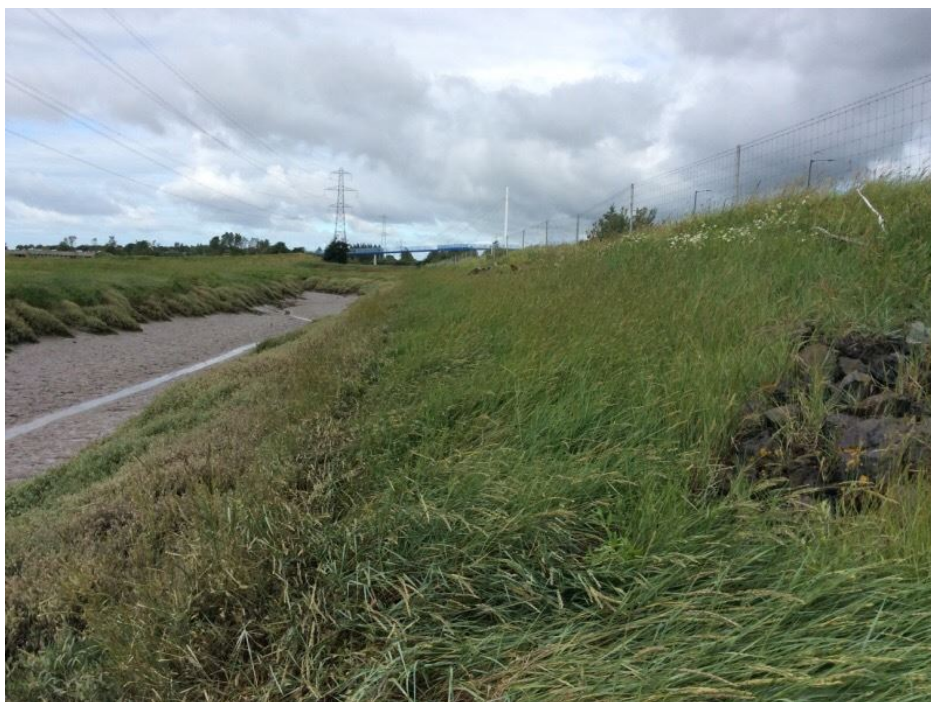
| Minor Elements | Photo No. | Attributes and General Notes | Condition Grade | Weighting (1-9) | Overall (CG x W) |
|---|---|---|---|---|---|
| Embankment Natural | 24 | Vegetated (Vegetated (loss of vegetation, scour at toe, instability of slope, extensive erosion).). | 3 | 5 | 15 |

**Section B**  
**Embankment**  
**Natural**  
**Photo number: 24**

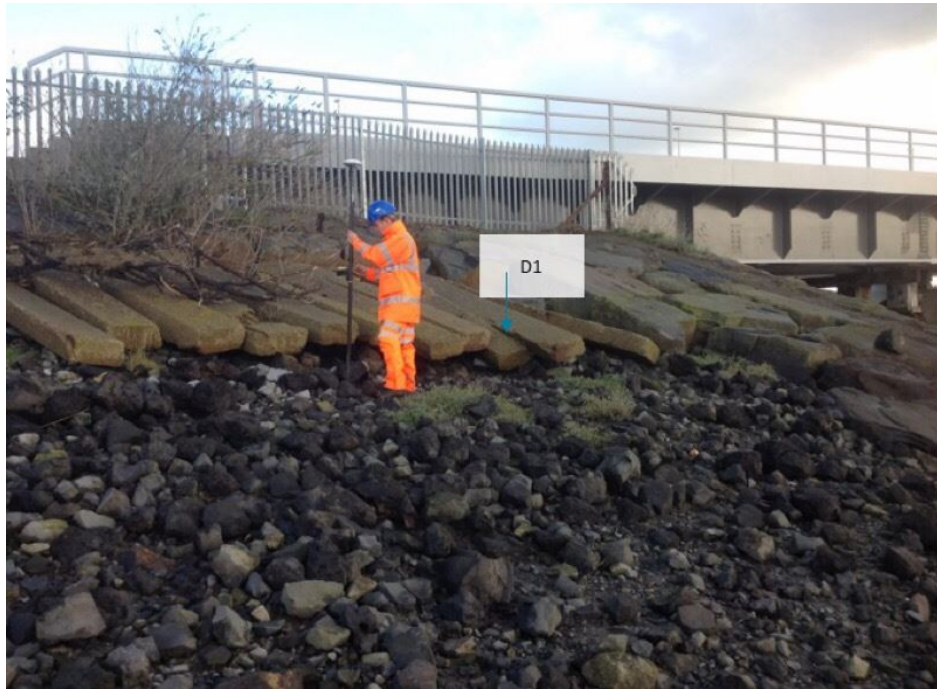
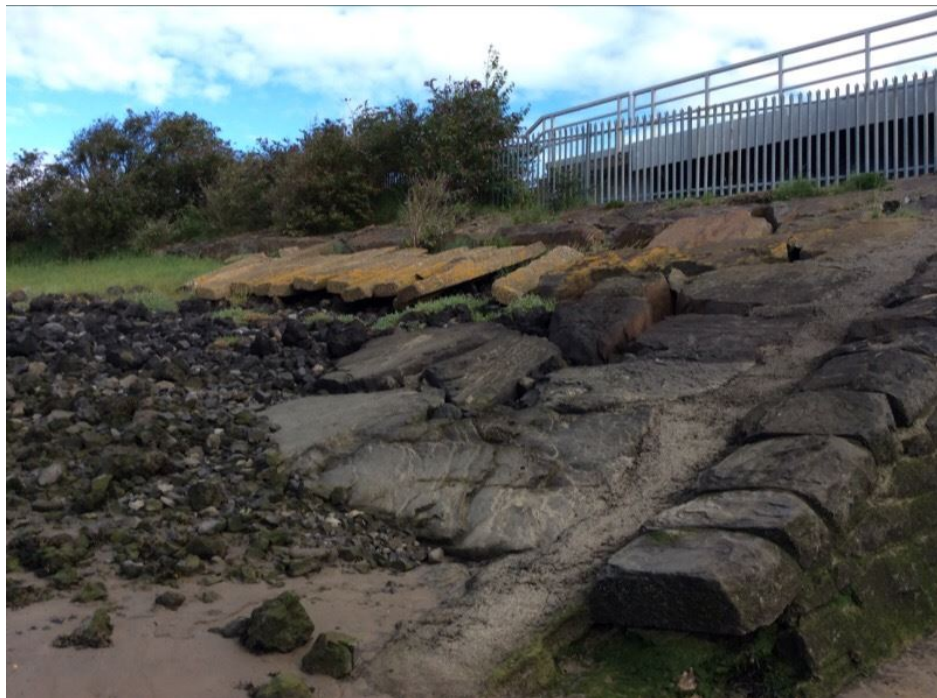
| Defect Ref No. | Defect Location (NGR) | Major Element | Minor Element | Photo Ref | Severity | Probability | Risk Score | Below MHWS | Defect Description | Recommendations | Defect Priority |
|---|---|---|---|---|---|---|---|---|---|---|---|
| D1 | 255929, 198040 | Embankment | Embankment Armour | 25, 34 | 1 | 2 | 2 | False | Undercutting of concrete armour sections. No change between 2014 and 2020 inspections. | Monitor and consider replacing with rock armour. | 5 |

**Section A  
Embankment  
Armour  
Defect Ref: D1  
Description:**  
Undercutting of  
concrete armour  
sections. No change  
between 2014 and  
2020 inspections.  
**Photo number: 25**

**Section A  
Embankment  
Armour  
Defect Ref: D1  
Description:**  
Undercutting of  
concrete armour  
sections. No change  
between 2014 and  
2020 inspections.  
**Photo number: 34**

| Defect Ref No. | Works Category | Recommendations | Recommended Closure Date | Latest Status |
|---|---|---|---|---|
| D1 | | Monitor and consider replacing with rock armour. | | Active Defect (Approved) |

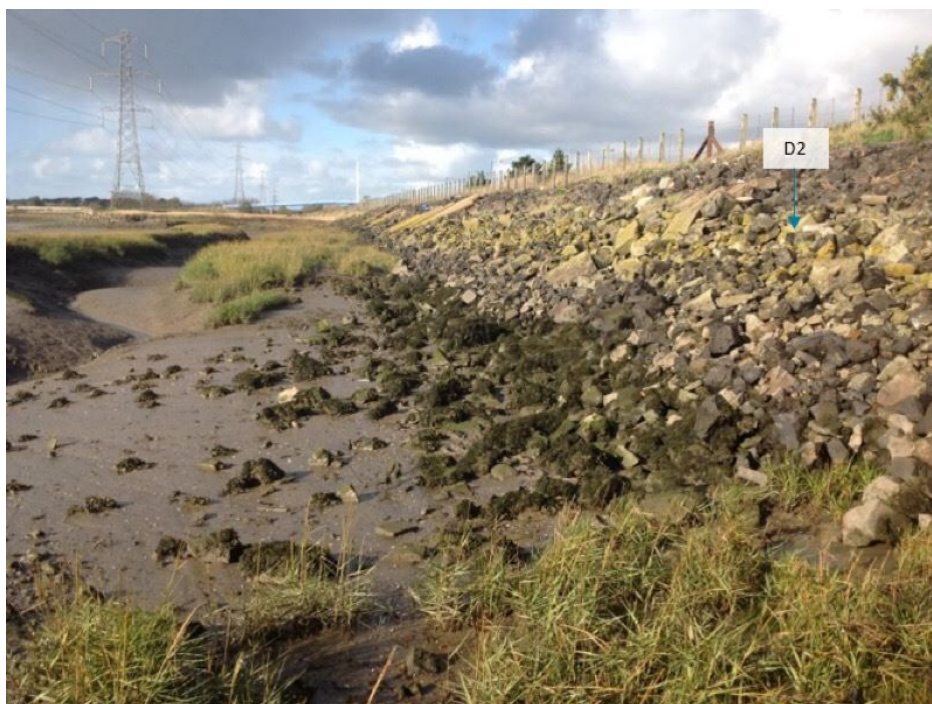
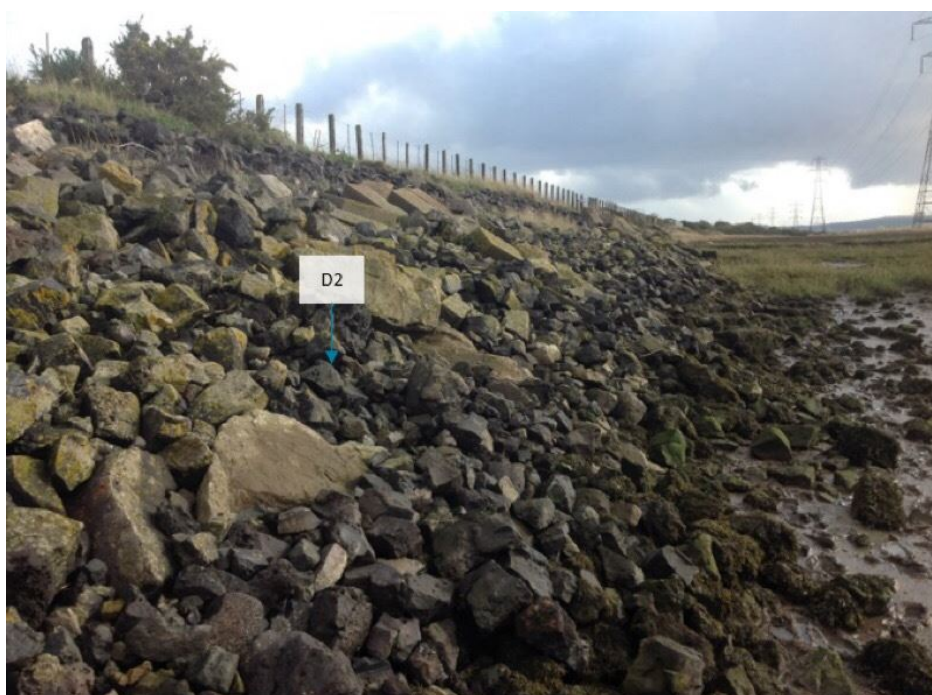
| Defect Ref No. | Defect Location (NGR) | Major Element | Minor Element | Photo Ref | Severity | Probability | Risk Score | Below MHWS | Defect Description | Recommendations | Defect Priority |
|---|---|---|---|---|---|---|---|---|---|---|---|
| D2 | 255793, 198084 | Embankment | Embankment Armour | 27, 26 | 3 | 2 | 6 | False | Undersized rock armour on embankment. In storm conditions these units may provide inadequate protection. No change between 2014 and 2020 inspections. | Monitor and consider redesigning rock armour embankment. | 3 |

**Section A**  
**Embankment**  
**Armour**  
**Defect Ref: D2**  
**Description:**  
Undersized rock armour on embankment. In storm conditions these units may provide inadequate protection. No change between 2014 and 2020 inspections.  
**Photo number: 27**

**Section A**  
**Embankment**  
**Armour**  
**Defect Ref: D2**  
**Description:**  
Undersized rock armour on embankment. In storm conditions these units may provide inadequate protection. No change between 2014 and 2020 inspections.  
**Photo number: 26**

| Defect Ref No. | Works Category | Recommendations | Recommended Closure Date | Latest Status |
|---|---|---|---|---|
| D2 | Other | Monitor and consider redesigning rock armour embankment. | | Active Defect (Approved) |

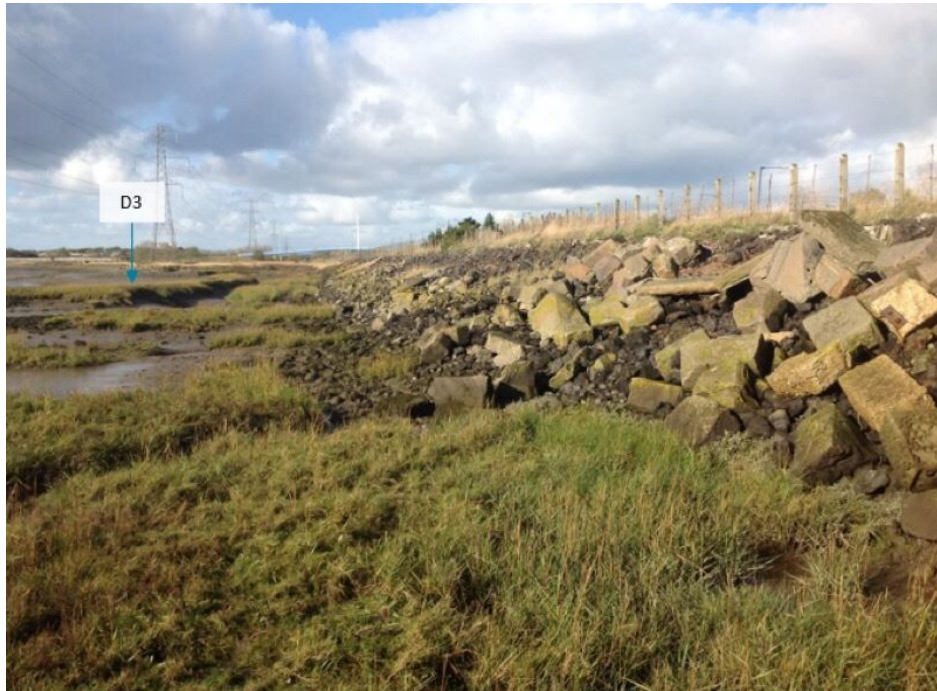
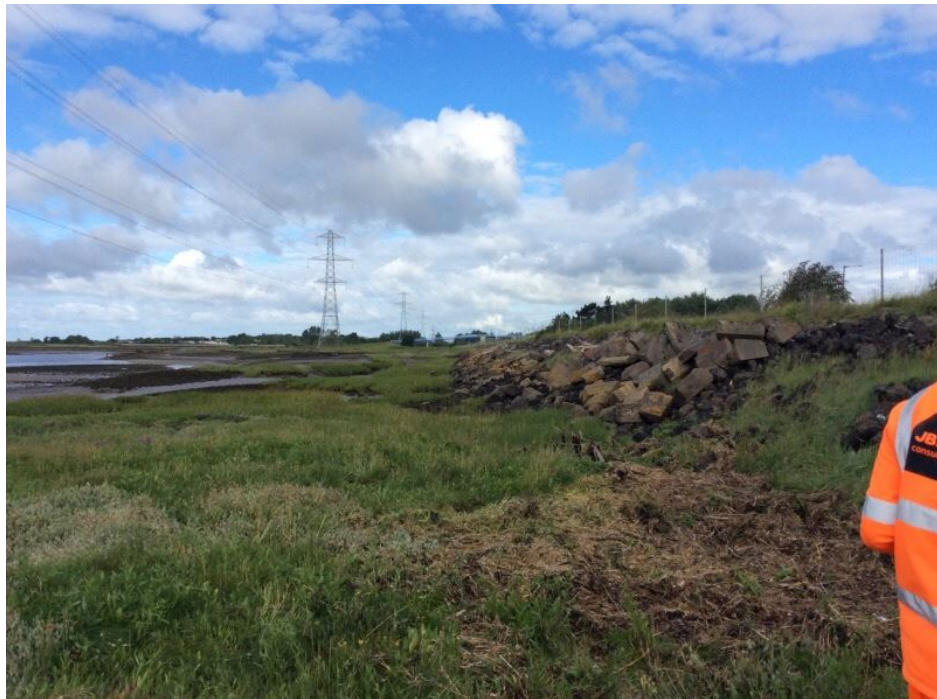
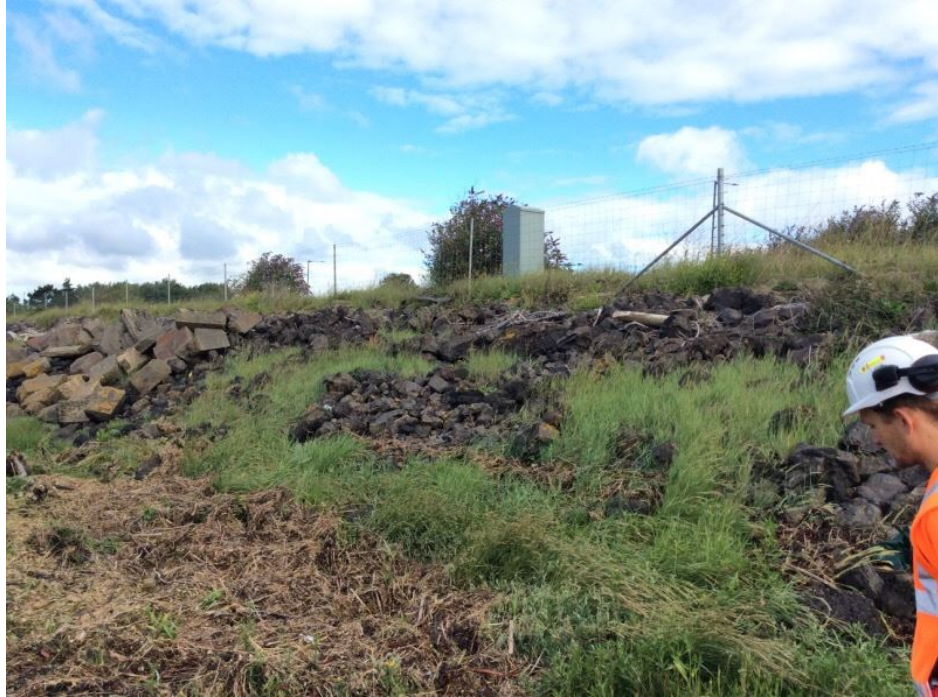
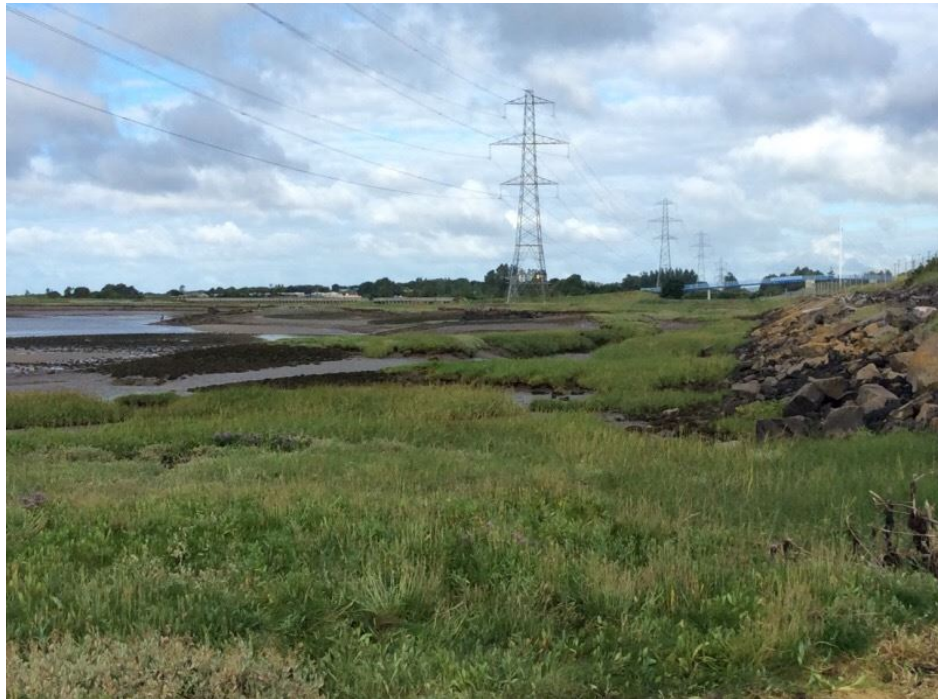
| Defect Ref No. | Defect Location (NGR) | Major Element | Minor Element | Photo Ref | Severity | Probability | Risk Score | Below MHWS | Defect Description | Recommendations | Defect Priority |
|---|---|---|---|---|---|---|---|---|---|---|---|
| D3 | 255721, 198103 | Embankment | Embankment Natural | 28, 35, 36, 37 | 2 | 3 | 6 | True | Reduced protective extent of saltmarsh. Continued erosion will increase the vulnerability of the embankment. Between 2014 and 2020 further minor deterioration of the protective extent of the saltmarsh was observed. | Monitor and consider building embankment toe protection. | 1 |

**Section A**  
**Embankment**  
**Natural**  
**Defect Ref: D3**  
**Description:**  
Reduced protective extent of saltmarsh. Continued erosion will increase the vulnerability of the embankment. Between 2014 and 2020 further minor deterioration of the protective extent of the saltmarsh was observed.  
**Photo number: 28**

**Section A**  
**Embankment**  
**Natural**  
**Defect Ref: D3**  
**Description:**  
Reduced protective extent of saltmarsh. Continued erosion will increase the vulnerability of the embankment. Between 2014 and 2020 further minor deterioration of the protective extent of the saltmarsh was observed.  
**Photo number: 35**

**Section A**  
**Embankment**  
**Natural**  
**Defect Ref: D3**  
**Description:**  
Reduced protective extent of saltmarsh. Continued erosion will increase the vulnerability of the embankment. Between 2014 and 2020 further minor deterioration of the protective extent of the saltmarsh was observed.  
**Photo number: 36**

**Section A**  
**Embankment**  
**Natural**  
**Defect Ref: D3**  
**Description:**  
Reduced protective extent of saltmarsh. Continued erosion will increase the vulnerability of the embankment. Between 2014 and 2020 further minor deterioration of the protective extent of the saltmarsh was observed.  
**Photo number: 37**

| Defect Ref No. | Works Category | Recommendations | Recommended Closure Date | Latest Status |
|---|---|---|---|---|
| D3 | Other | Monitor and consider building embankment toe protection. | | Active Defect (Approved) |

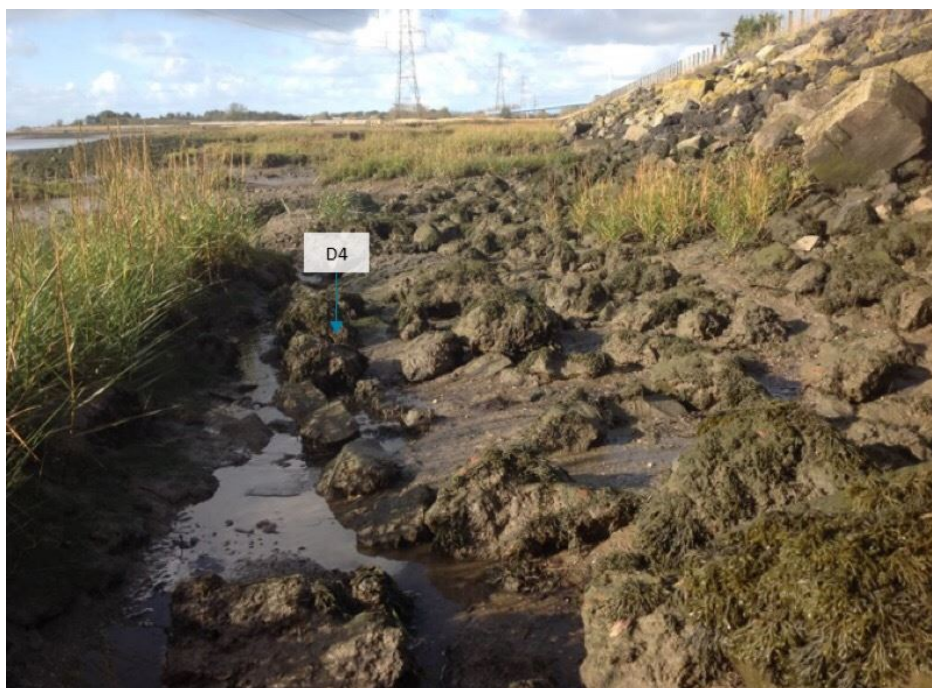
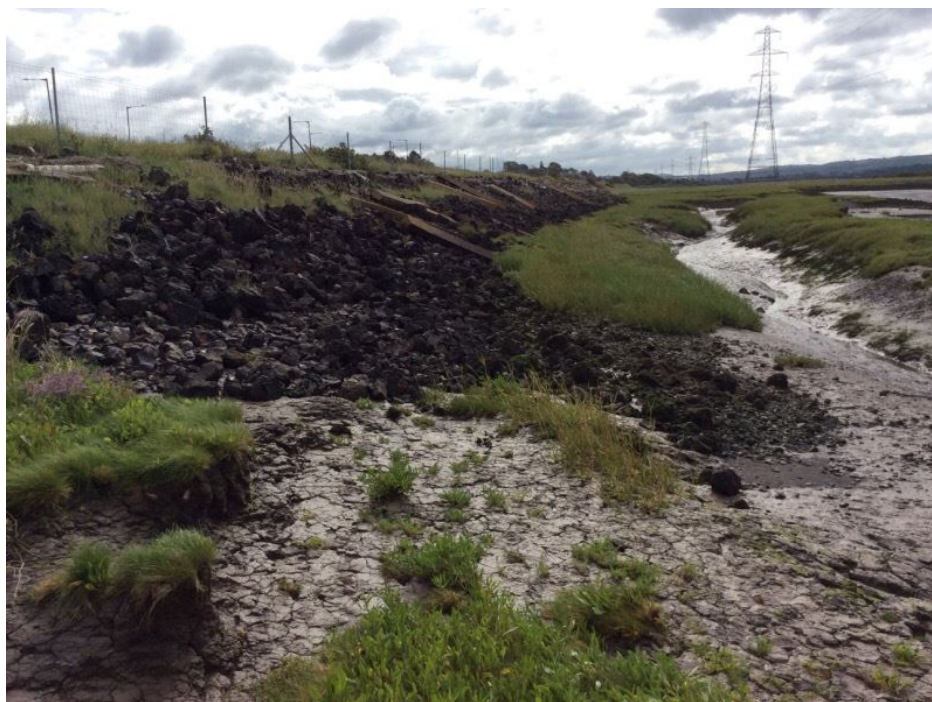
| Defect Ref No. | Defect Location (NGR) | Major Element | Minor Element | Photo Ref | Severity | Probability | Risk Score | Below MHWS | Defect Description | Recommendations | Defect Priority |
|---|---|---|---|---|---|---|---|---|---|---|---|
| D4 | 255707, 198107 | Embankment | Embankment Armour | 29, 38 | 2 | 2 | 4 | True | Expelled rock armour units. No change between 2014 and 2020 inspections. | Monitor and consider redesigning rock armour embankment. | 4 |

Expelled rock armour units. No change between 2014 and 2020 inspections.

| Defect Ref No. | Works Category | Recommendations | Recommended Closure Date | Latest Status |
|---|---|---|---|---|
| D4 | Brickwork/Stone Repairs | Monitor and consider redesigning rock armour embankment. | | Active Defect (Approved) |

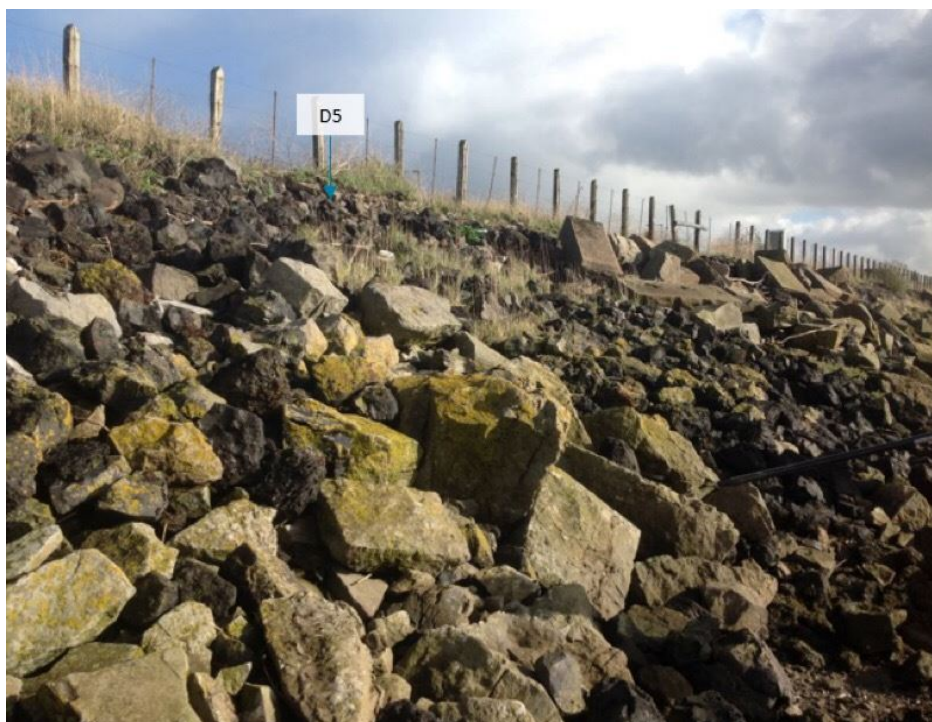
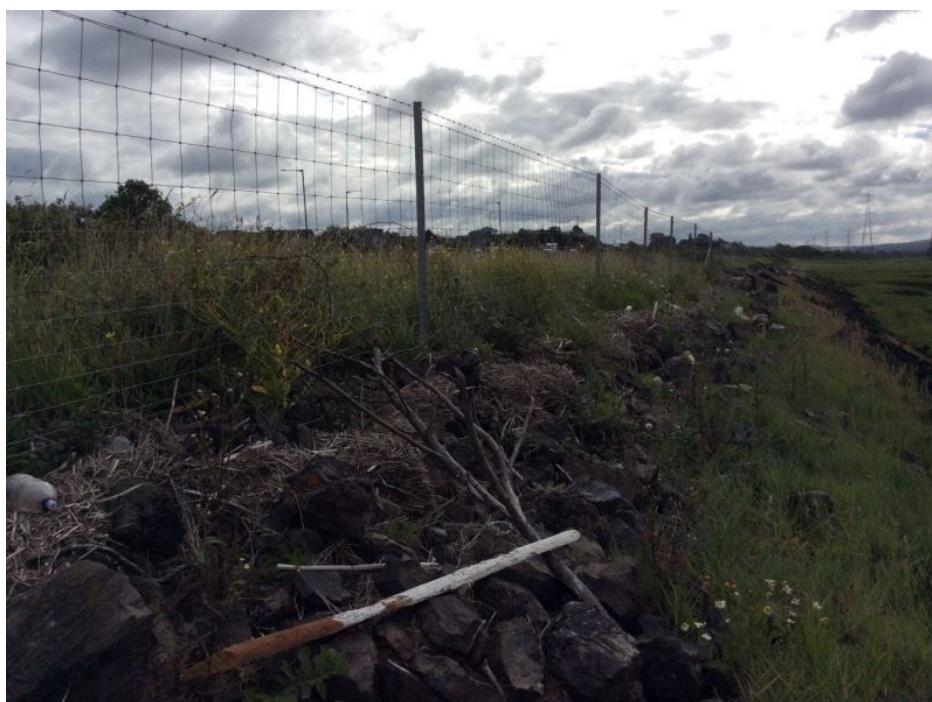
| Defect Ref No. | Defect Location (NGR) | Major Element | Minor Element | Photo Ref | Severity | Probability | Risk Score | Below MHWS | Defect Description | Recommendations | Defect Priority |
|---|---|---|---|---|---|---|---|---|---|---|---|
| D5 | 255697, 198113 | Embankment | Embankment Armour | 30, 39 | 3 | 2 | 6 | False | Narrow crest, reduced protection to the railway. No change between 2014 and 2020 inspections. | Monitor and consider redesigning rock armour embankment. | 2 |

**Section B**  
**Embankment**  
**Armour**  
**Defect Ref: D5**  
**Description:** Narrow crest, reduced protection to the railway. No change between 2014 and 2020 inspections.  
**Photo number: 30**

**Section B**  
**Embankment**  
**Armour**  
**Defect Ref: D5**  
**Description:** Narrow crest, reduced protection to the railway. No change between 2014 and 2020 inspections.  
**Photo number: 39**

| Defect Ref No. | Works Category | Recommendations | Recommended Closure Date | Latest Status |
|---|---|---|---|---|
| D5 | Other | Monitor and consider redesigning rock armour embankment. | | Active Defect (Approved) |

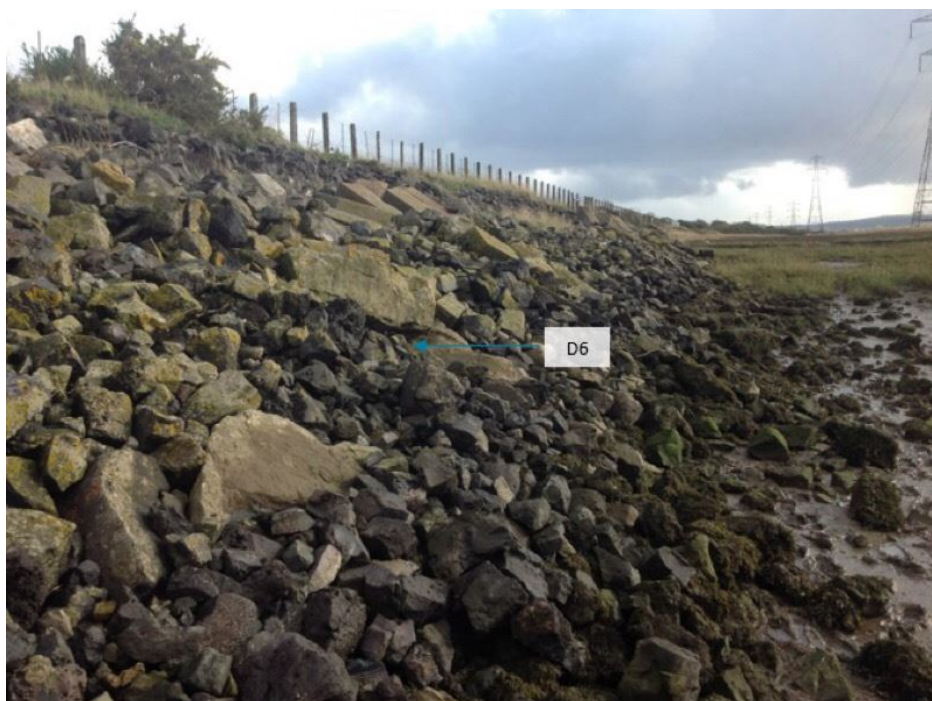
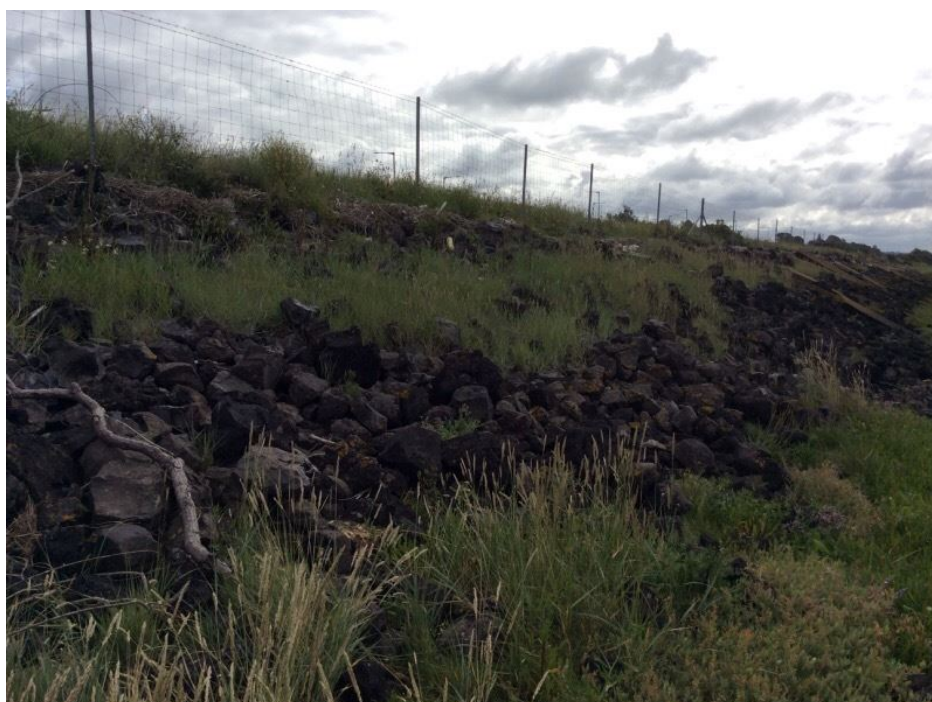
| Defect Ref No. | Defect Location (NGR) | Major Element | Minor Element | Photo Ref | Severity | Probability | Risk Score | Below MHWS | Defect Description | Recommendations | Defect Priority |
|---|---|---|---|---|---|---|---|---|---|---|---|
| D6 | 255652, 198126 | Embankment | Embankment Armour | 31, 40 | 3 | 2 | 6 | True | Bulge in embankment indicating, a minor slip failure. No change between 2014 and 2020 inspections. | Monitor and consider redesigning rock armour embankment. | 2 |

**Section B**  
**Embankment**  
**Armour**  
**Defect Ref: D6**  
**Description:** Bulge in embankment indicating, a minor slip failure. No change between 2014 and 2020 inspections.  
**Photo number: 31**

**Section B**  
**Embankment**  
**Armour**  
**Defect Ref: D6**  
**Description:** Bulge in embankment indicating, a minor slip failure. No change between 2014 and 2020 inspections.  
**Photo number: 40**

| Defect Ref No. | Works Category | Recommendations | Recommended Closure Date | Latest Status |
|---|---|---|---|---|
| D6 | Other | Monitor and consider redesigning rock armour embankment. | | Active Defect (Approved) |

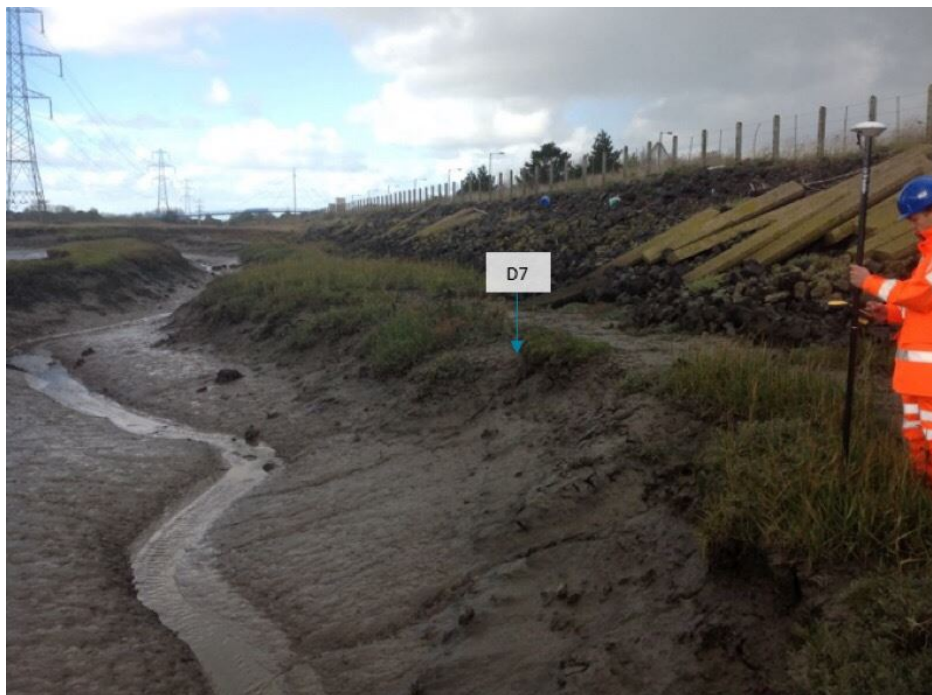
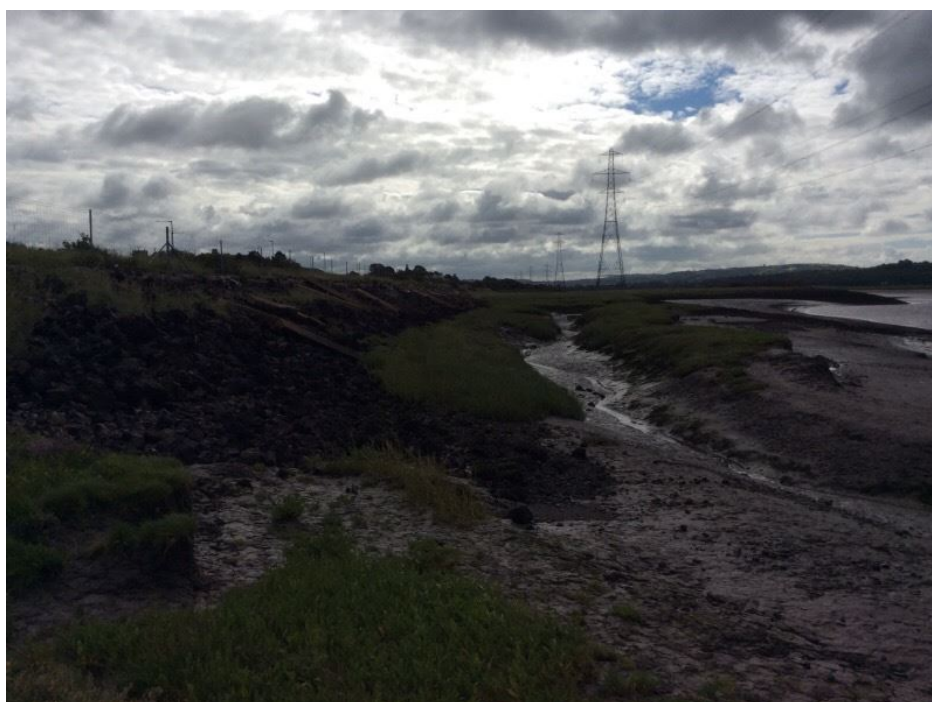
| Defect Ref No. | Defect Location (NGR) | Major Element | Minor Element | Photo Ref | Severity | Probability | Risk Score | Below MHWS | Defect Description | Recommendations | Defect Priority |
|---|---|---|---|---|---|---|---|---|---|---|---|
| D7 | 255638, 198128 | Embankment | Embankment Armour | 32, 41 | 2 | 3 | 6 | True | Intertidal drainage eroding saltmarsh protection for embankment. Risk of undercutting toe. No change between 2014 and 2020 inspections. | Monitor and consider building embankment toe protection. | 1 |

Intertidal drainage eroding saltmarsh protection for embankment. Risk of undercutting toe. No change between 2014 and 2020 inspections.

| Defect Ref No. | Works Category | Recommendations | Recommended Closure Date | Latest Status |
|---|---|---|---|---|
| D7 | Other | Monitor and consider building embankment toe protection. | | Active Defect (Approved) |

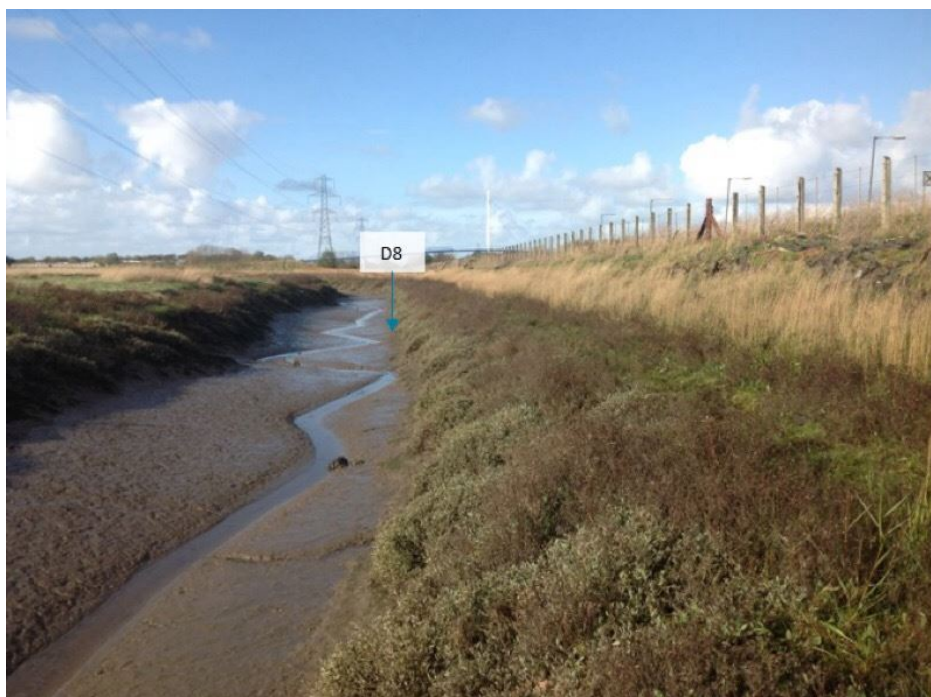
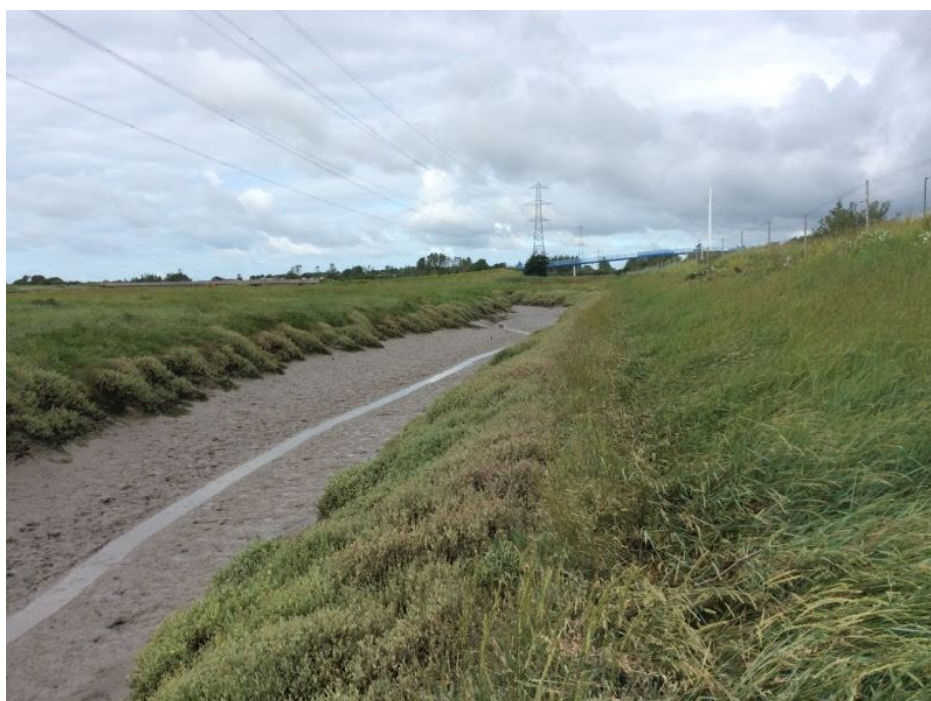
| Defect Ref No. | Defect Location (NGR) | Major Element | Minor Element | Photo Ref | Severity | Probability | Risk Score | Below MHWS | Defect Description | Recommendations | Defect Priority |
|---|---|---|---|---|---|---|---|---|---|---|---|
| D8 | 255532, 198165 | Embankment | Embankment Armour | 33, 42 | 2 | 3 | 6 | True | Intertidal drainage eroding saltmarsh protection for embankment. Risk of undercutting toe. No change between 2014 and 2020 inspections. | Monitor and consider building embankment toe protection. | 1 |

**Section B**  
**Embankment**  
**Armour**  
**Defect Ref: D8**  
**Description:**  
Intertidal drainage  
eroding saltmarsh  
protection for  
embankment. Risk of  
undercutting toe. No  
change between  
2014 and 2020  
inspections.  
**Photo number: 33**

**Section B**  
**Embankment**  
**Armour**  
**Defect Ref: D8**  
**Description:**  
Intertidal drainage  
eroding saltmarsh  
protection for  
embankment. Risk of  
undercutting toe. No  
change between  
2014 and 2020  
inspections.  
**Photo number: 42**

| Defect Ref No. | Works Category | Recommendations | Recommended Closure Date | Latest Status |
|---|---|---|---|---|
| D8 | Other | Monitor and consider building embankment toe protection. | | Active Defect (Approved) |
