Annual Performance and Monitoring review EPR Permit BR9685IX Dow Silicones UK Ltd - 2021

+This report is to fulfil ERP permit BR9685IX condition 4.2.2

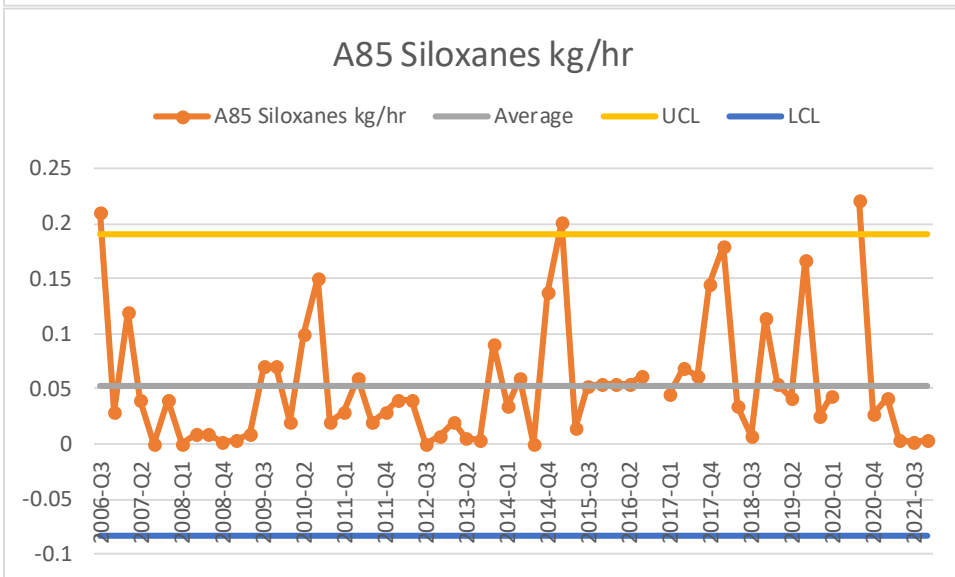
2021 results lower than previous years. This will continue to be monitored.

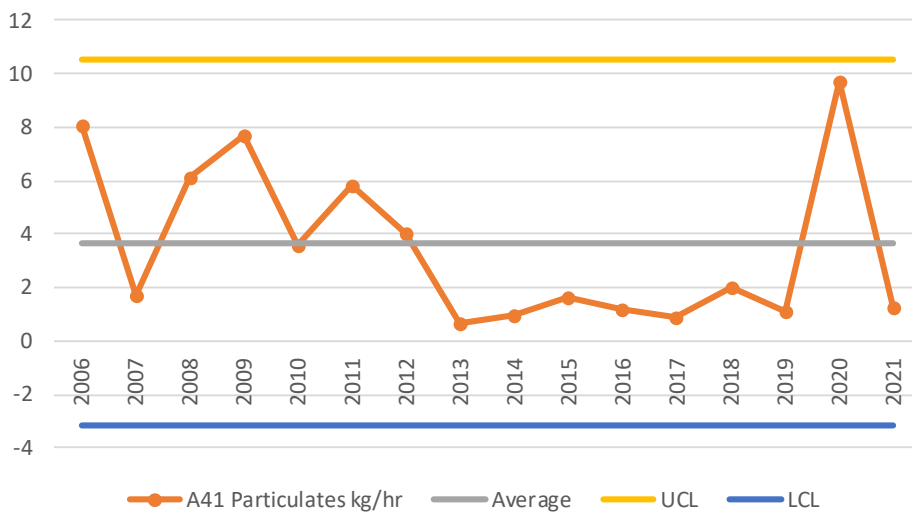
A41 Particulates kg/hr

Results for 2021 back at normal levels and within permit limit (10 mg/m³).

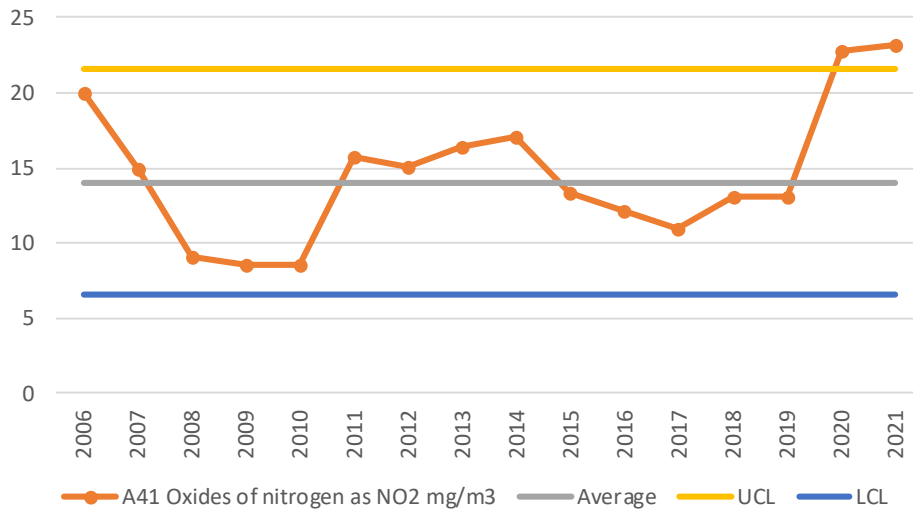
A41 Oxides of nitrogen as NO2 mg/m3

Results out of control high, but still well within permit limit (100mg/m3). This will continue to be monitored on a monthly basis.

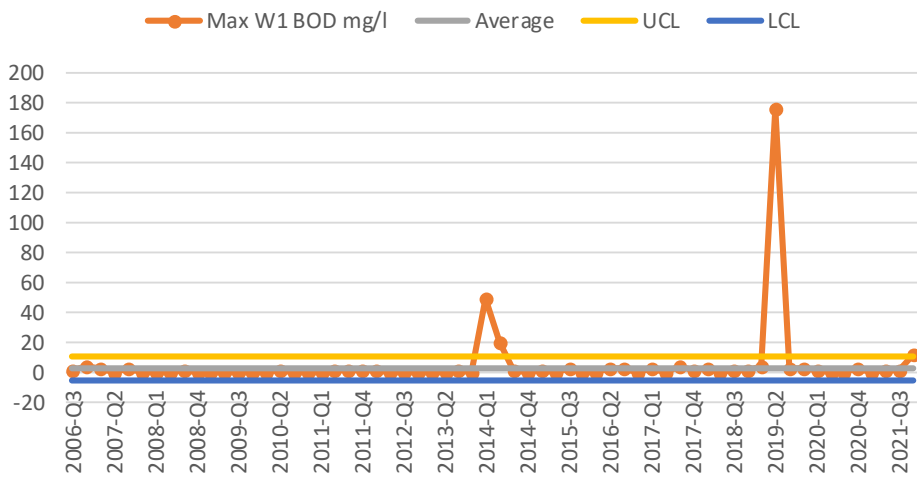
Max W1 BOD mg/l

1 Result out of control during 202, but still within permit limit (20 mg/l)

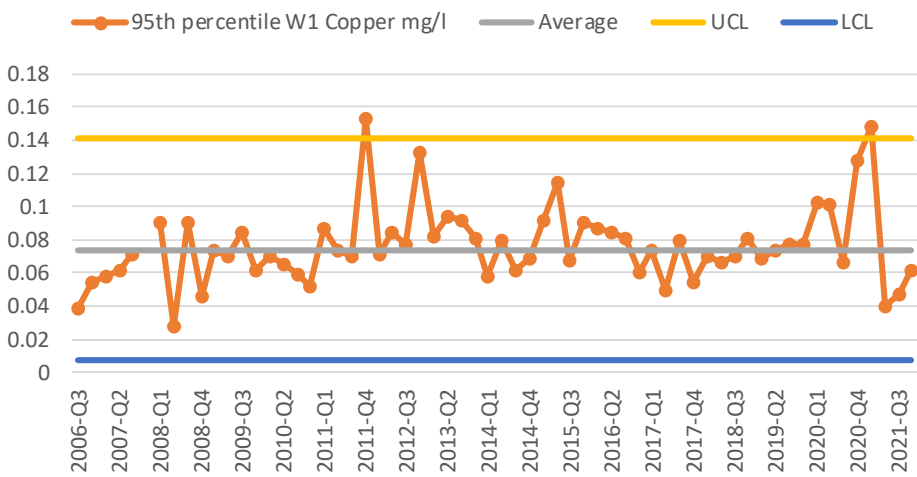
95th percentile W1 Copper mg/l

During Q1 ten final effluent composite samples were over 0.1 mg/l of Copper.

The average for the quarter was 0.0534mg/l.

Two sequential results were attributed to the cleanliness of the composite sampler.

Two other sequential results were attributed to high solids in the final effluent due to a bioreactor mixer failure.

A further 6 results were sequential and resulted from a lower than usual pH in the bioreactor, due to issues with the Magnesium Hydroxide dosing system. Manual dosing of sodium hydroxide was carried out to fix the issue and allow the dosing system to be repaired.

Q1 2021 95th % result was above the permit limit, but work on the PWWT and SWWT processes throughout 2021 have had a good result with the Q2, Q3 and Q4 95th % results being lower than they have been for more than 10 years.

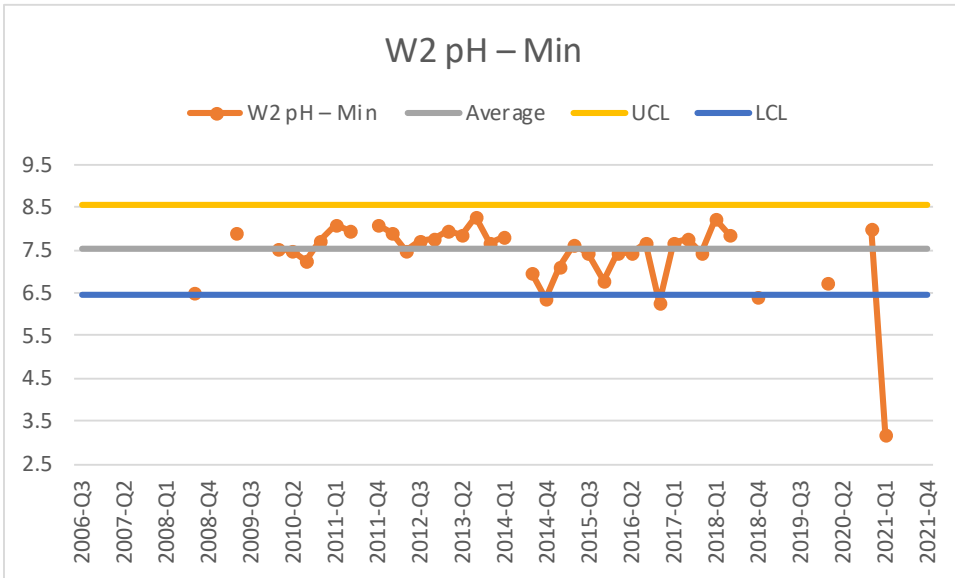
Whilst waste-water treatment was shut-down, storm water from W413 was being discharged to river via W2 authorised discharge point.

Water was discharged for approximately 2 hours with low pH (3.16 - 3.33) and slightly elevated zinc. The flow was stopped as soon as this was realised.

The low pH water entered the storm sump via two sequential passing valves. The storm sump pH and TOD analysis was operating normally, but due to the analyser supply pump requiring maintenance, sampling was being carried out manually to ensure compliance with permit discharge parameters. This procedure is normal practice if the analysers are not fully operational.

Storm water released to river in Q1 2021 only.

This resulted in a permit breach and a schedule 5 was submitted.

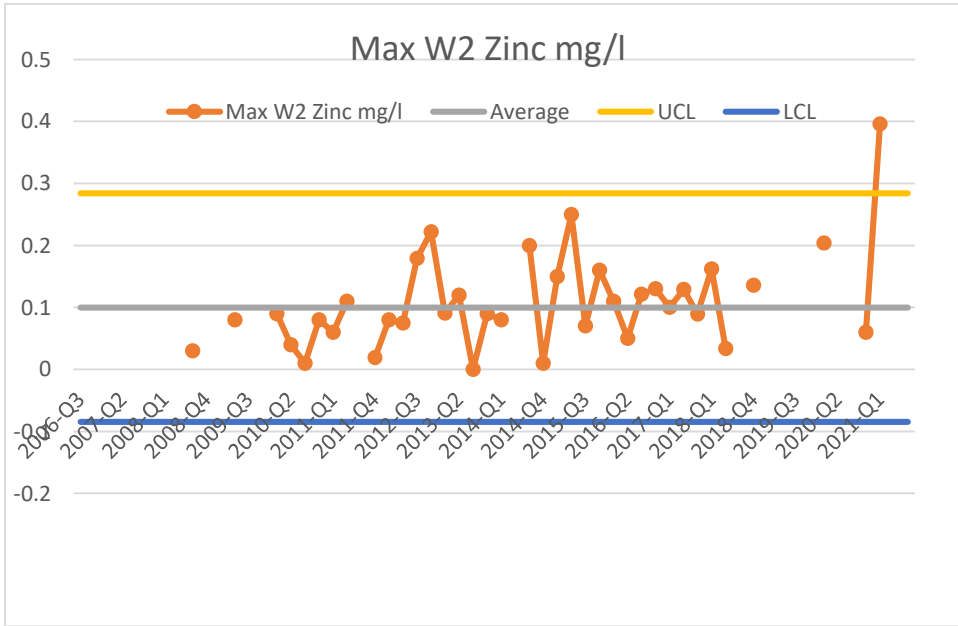
Storm water released to river in Q1 2021 only.

This resulted in a permit breach and a schedule 5 was submitted.
