REPORT ON

**TREHIR LANDFILL SITE
ASSESSMENT OF LANDFILL SLOPE STABILITY**

January 2003

02523476.500/B.0

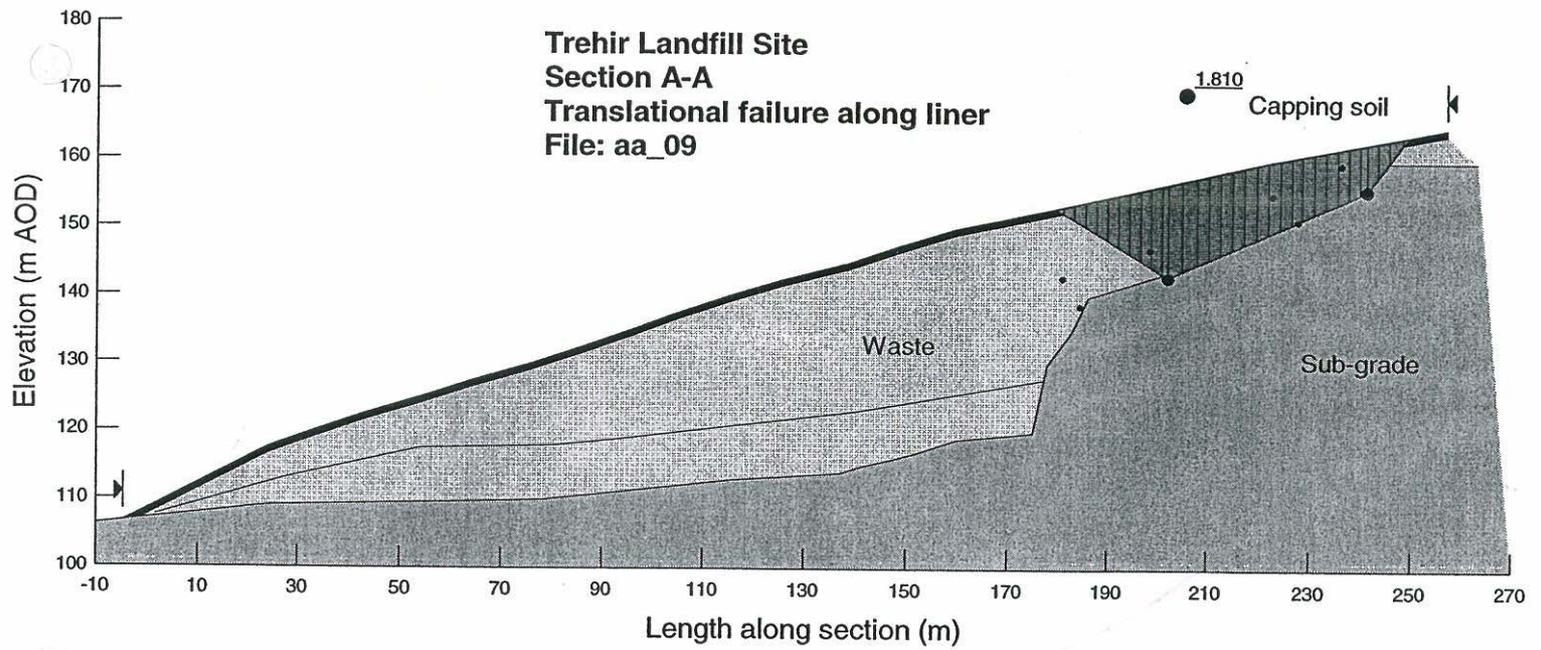
**Trehir Landfill Site
Section A-A
Translational failure along liner
File: aa_09**

Translational failure of the waste along the liner in the upper section of landfill is considered unlikely with a calculated factor of safety of 1.36 using pessimistic values for geosynthetic interface friction and pore water pressure at the interface.

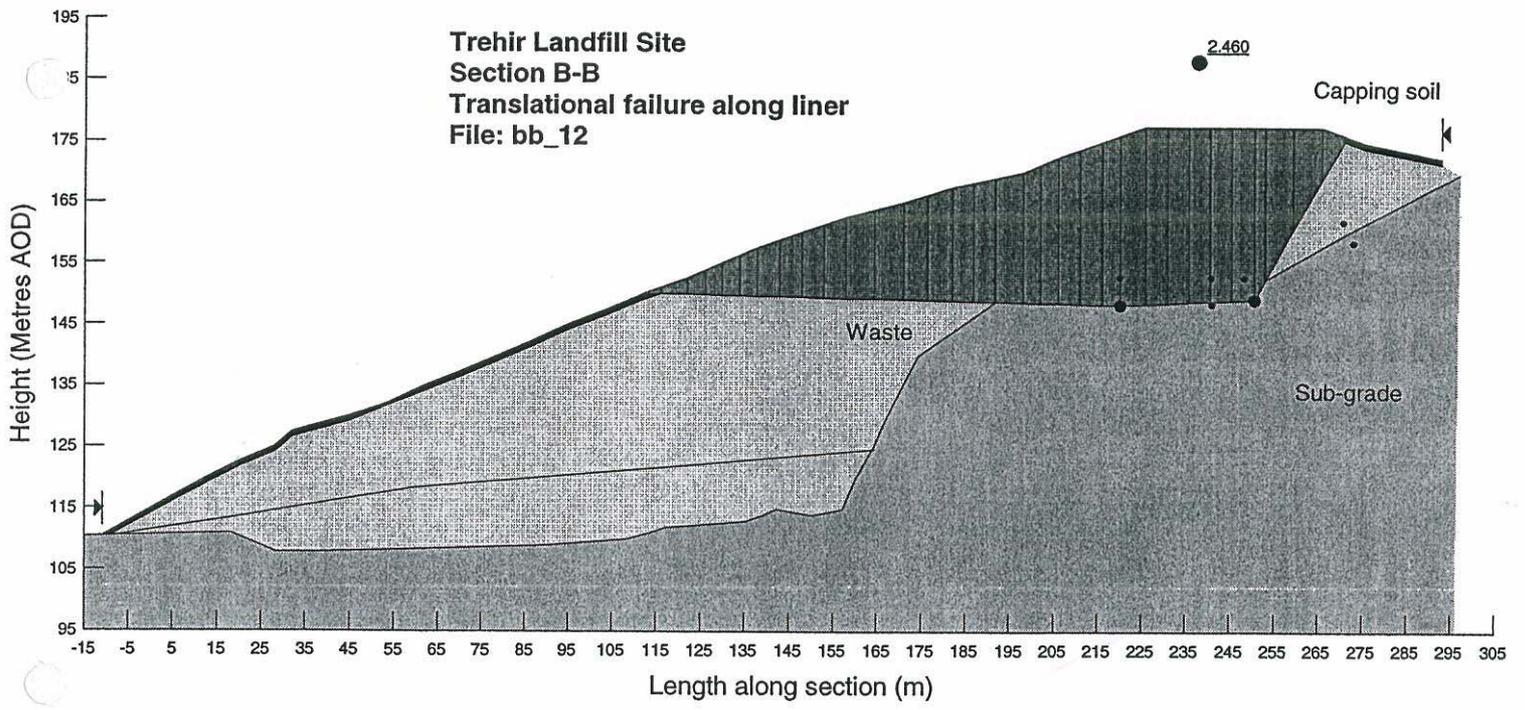
Trehir Landfill Site
Section B-B
Translational failure along liner
File: bb_12

Translational failure of the waste along the liner in the upper section of landfill is considered unlikely with a calculated factor of safety of 2.01 using pessimistic values for geosynthetic interface friction and pore water pressure at the interface.

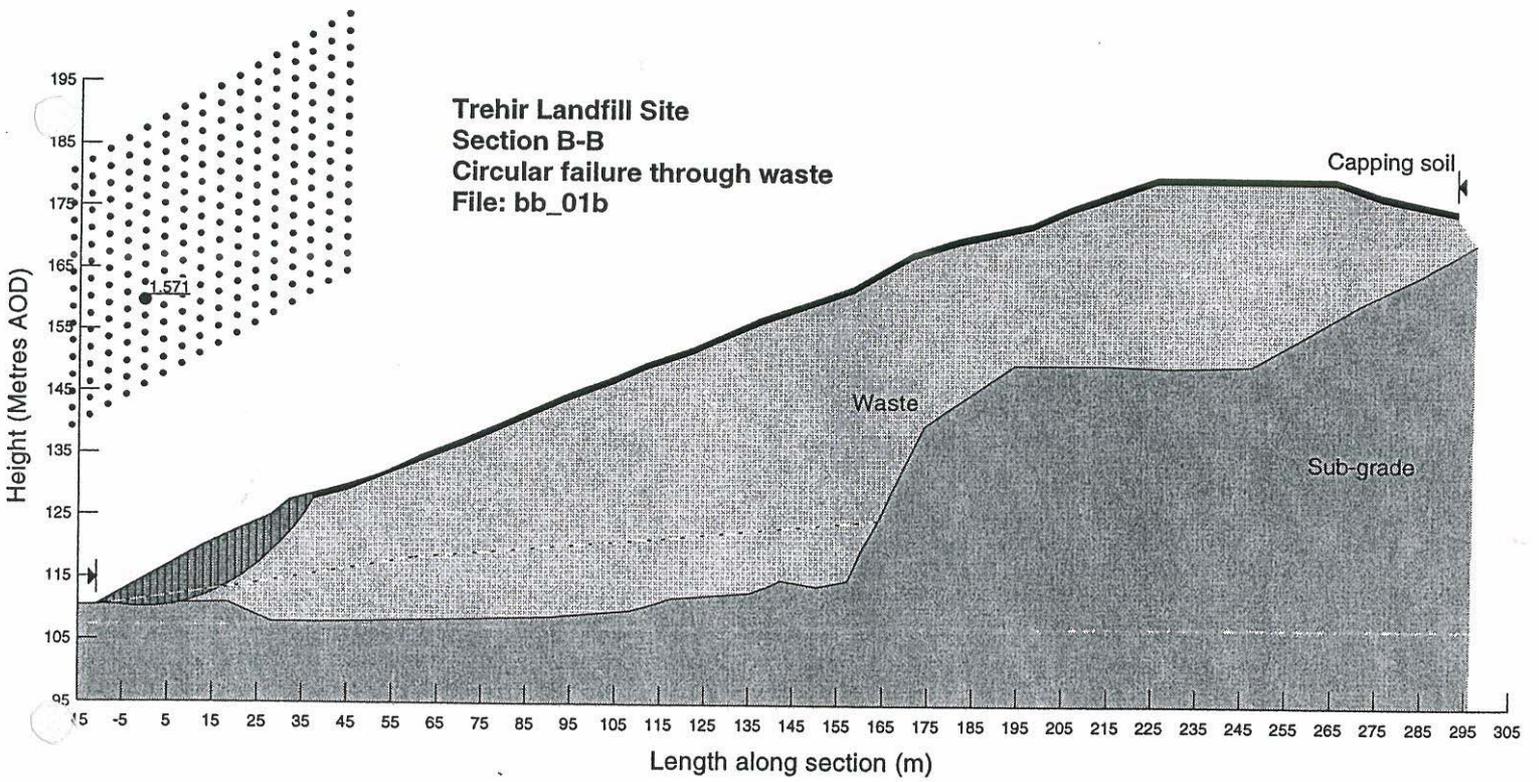
Treher Landfill Site
Section B-B
Circular failure through waste
File: bb_01b

As requested by TDC we have assessed the effect of increasing the approved pre-settlement profile vertically by 3 m in Phase 2 on the overall stability of the site. The analyses shows that there is no discernable effect on the most critical failure surface which is near the toe of the waste slope. However, increasing the pre-settlement profile may effect the local stability of the upper slope, but the factor of safety against such a failure will be higher than the critical failure mechanism.

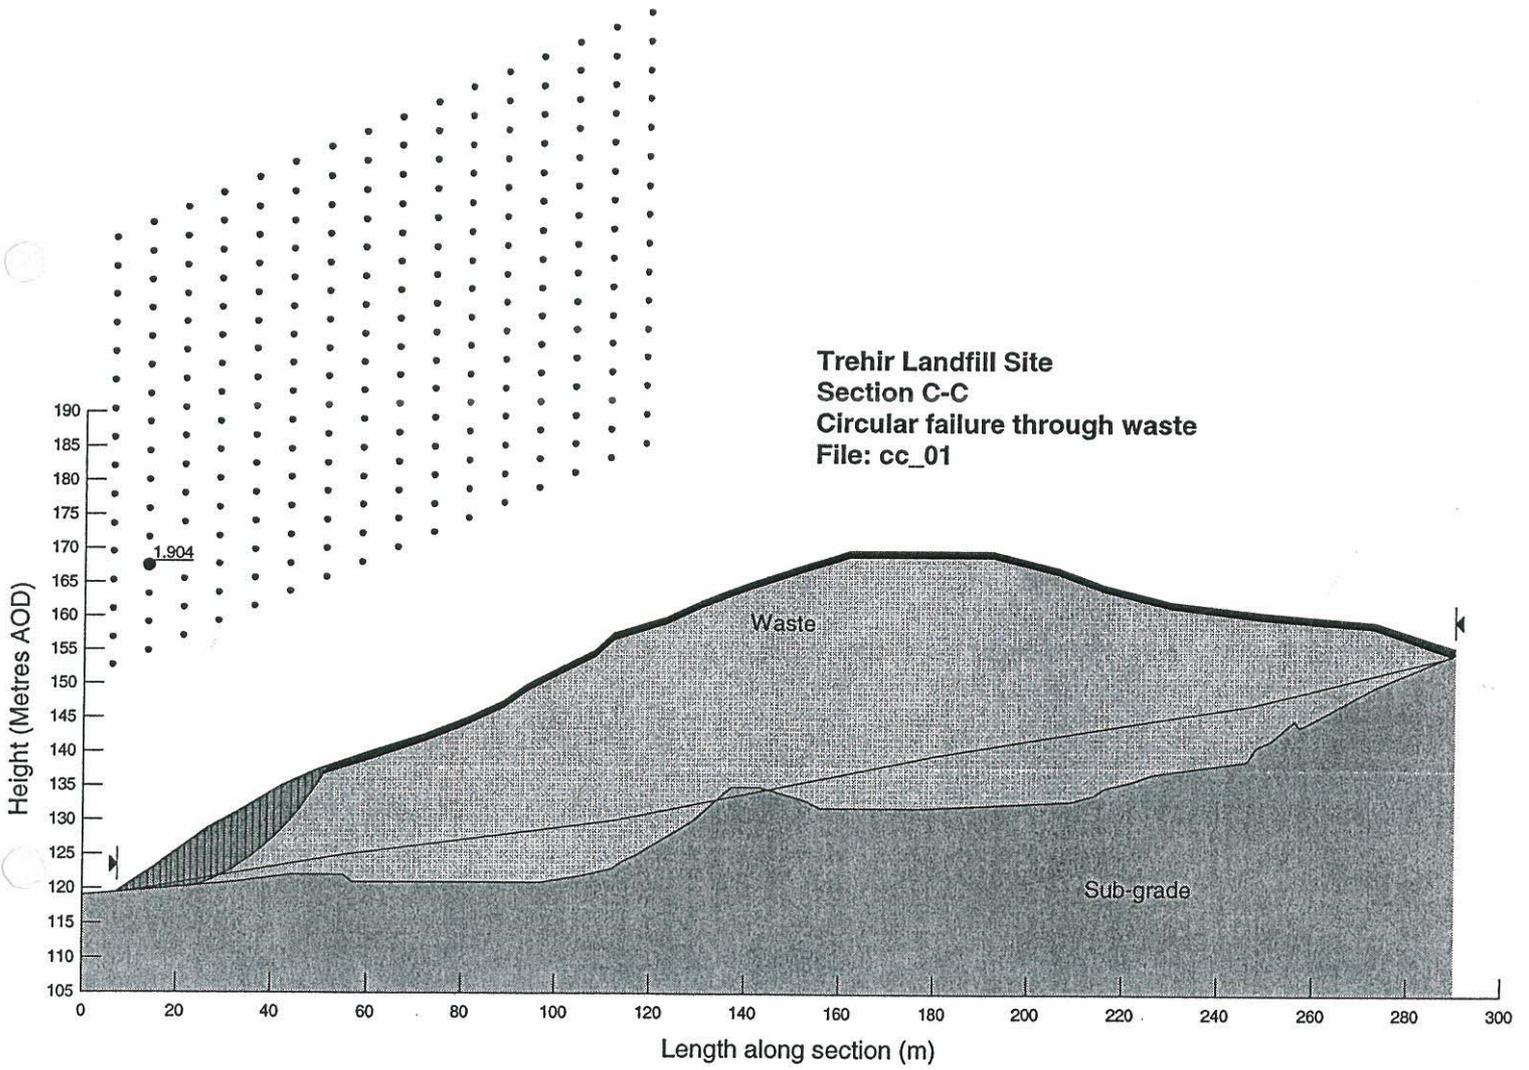
Trehir Landfill Site
Section C-C
Circular failure through waste
File: cc_01

The measured leachate levels in the vicinity of Section C-C are relatively low compared to the other two cross-sections and this is seen in the higher calculated factors of safety. The factor of safety against a circular failure within the waste body for the initial condition is 1.90 and this decreases with increasing leachate levels to 1.34 for 14 m and 18 m of leachate at M2/1 and M2/4 respectively.
