**Structural Assessment of
Bunds At Mekatek Ltd, Amex
Park, Llanstephan Road,
Johnstown, Carmarthen,
SA31 3NF**

TDA-01276-REPT-01

Structural Engineer's Report

Assessment of existing bund walls and bases on storage areas at Mekatek.

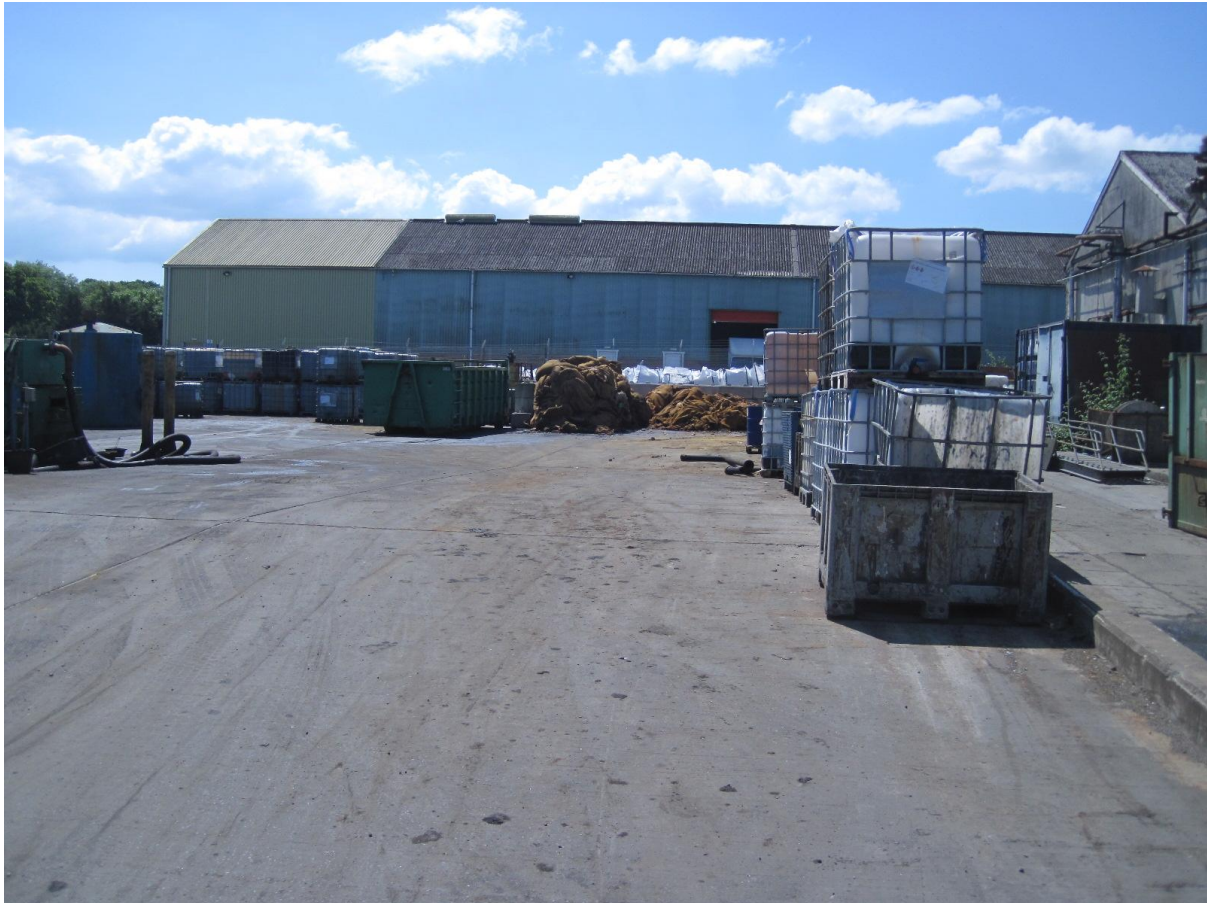
Photograph 1.1, General View of the Oil Storage Area

Overall the base of the bund, and surrounding area is in a good condition as shown in photograph 1.1, 1.2 and 1.3. The sealant at the surface of the joints of the concrete base have been removed presumably pressure washed away as shown in photograph 1.4.

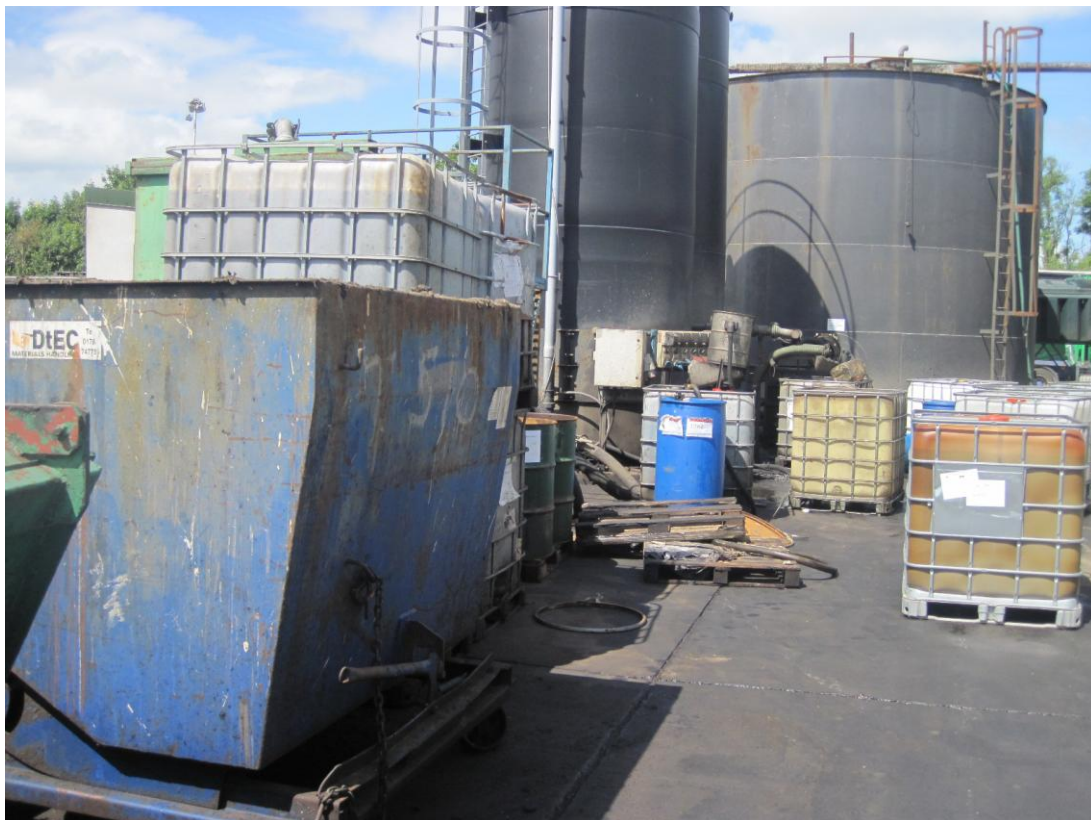
Photograph 1.2. View Looking North

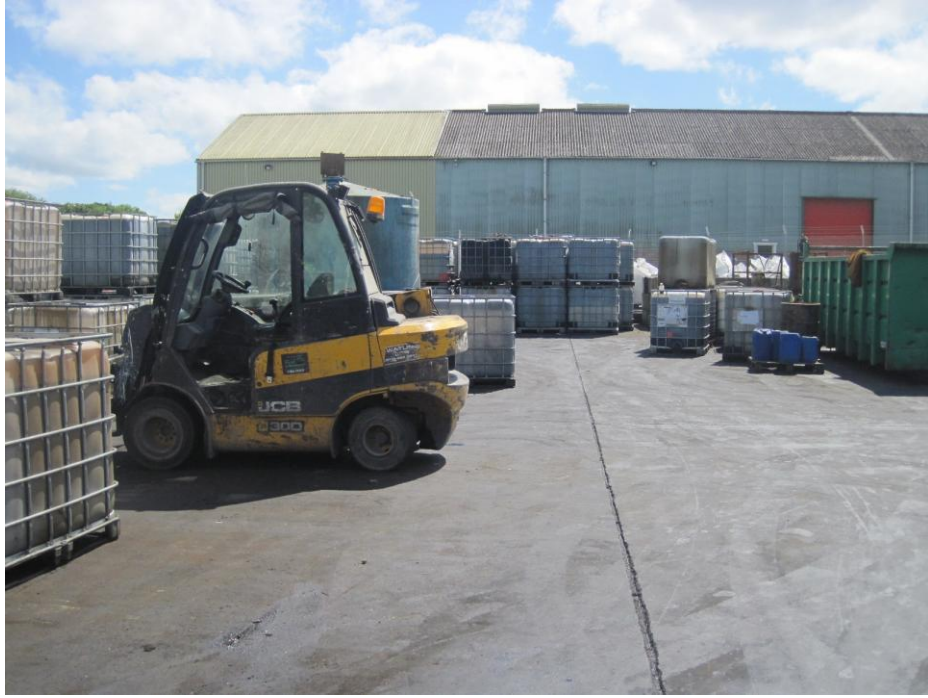
Photograph 1.3. View Looking South

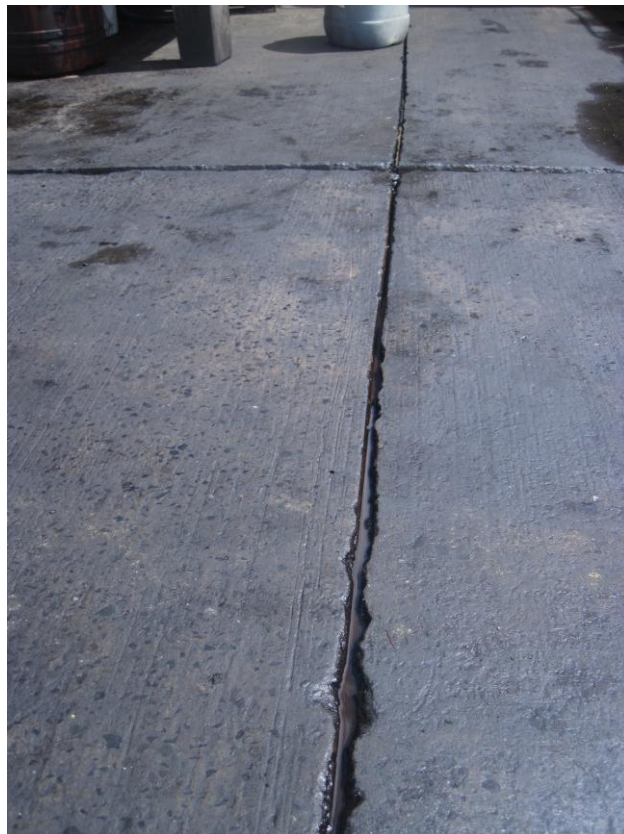
Photograph 1.4 Typical construction joint (showing missing sealant at surface)

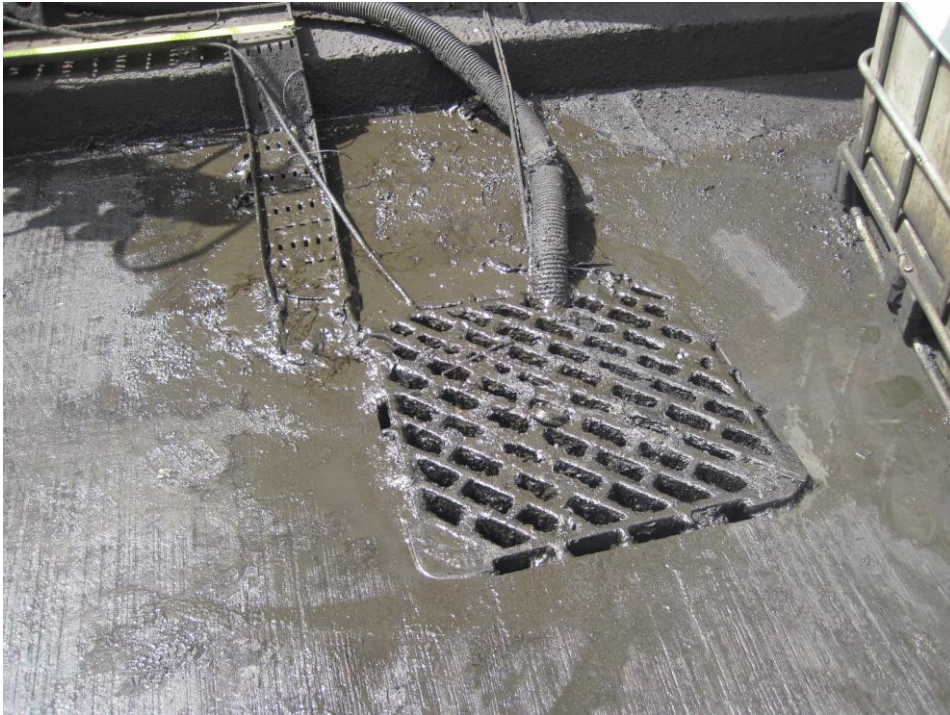
All contamination falls to a single gulley shown in photograph 1.5.

Photograph 1.5. View Of Gully At Dead Low Point Of Base

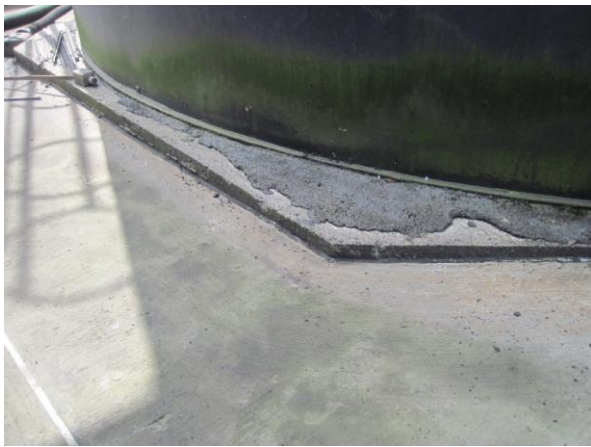
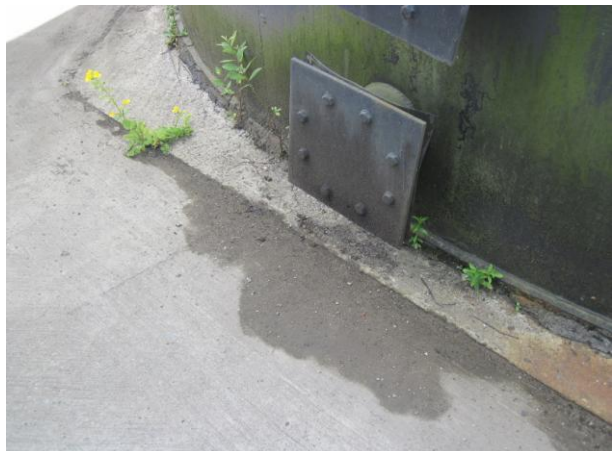
Photograph 1.6. View Of Joints At The North End Of The Oil Storage Bund

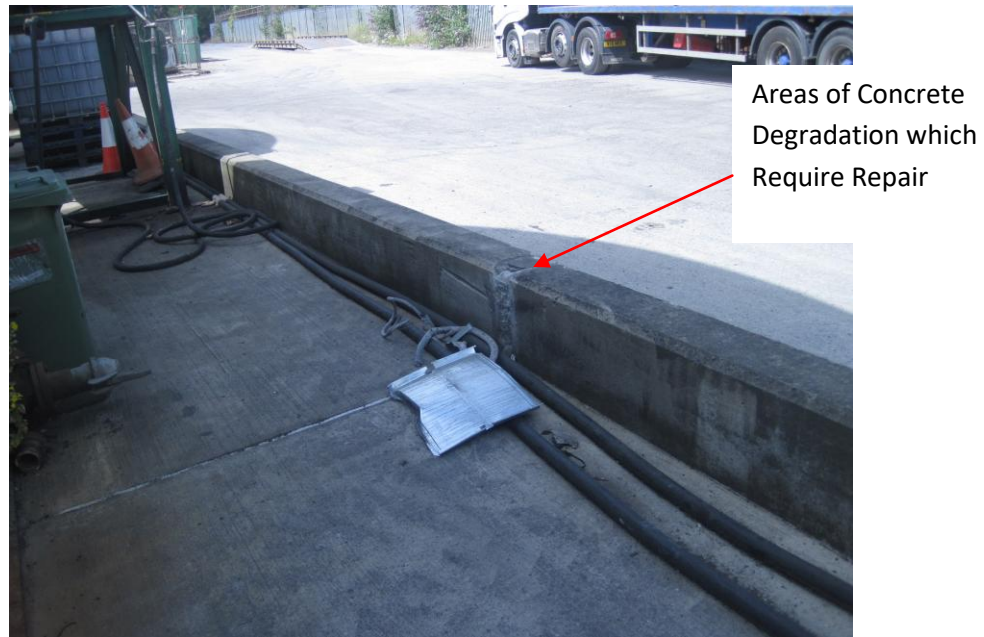
Overall the condition of the north bund wall is good. However, the construction joint approximately 7m from the east wall has a crack 5mm wide which requires repair, see photograph 1.7 and 1.8. The internal wall height at the area of the joint is 370mm and area of spalling is 110mm wide.

Photograph 1.7, Internal Face of North Bund Wall

1. Remove all loose material / break away the loose concrete to the walls of the bund.
2. Scabble wall to expose aggregate at the location of the joint. This can be carried out with a pressure washer or scabble gun.
3. Make good using renderoc HB 45 by Fosroc, concrete repair (or similar approved) leaving a 20mm x 15mm groove for new sealant.
4. After 24hrs the sealant can be applied.

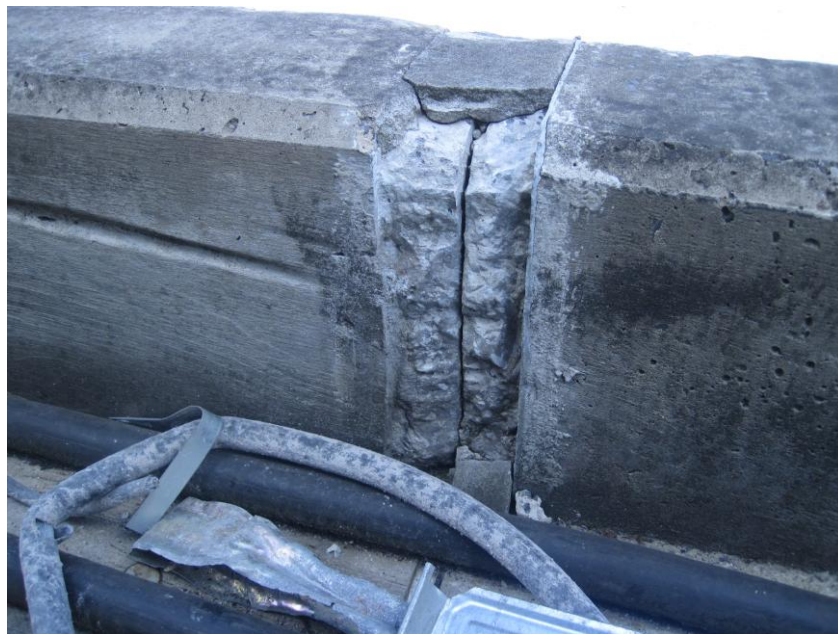
Photograph 1.8, Close Up Of Construction Joint

Item No.	Description of Works	Priority
1.1	Repair concrete walls where spalling to the joints at the bund walls has occurred as shown in photographs 1.8, 1.11 and 1.13. Slot to be primed with sika primer - 215 and filled to the surface with Sikaflex-Tank N. (Mekatek to confirm suitability of product with contents stored) A paint may be applied to protect the concrete further (see appendix A).	0
1.2	Replace the sealant to the top of the joints at the surface of the concrete base as shown in photograph 1.4. The slot to be primed with sika primer - 215 and filled to the surface with Sikaflex-Tank N. with . A paint may be applied to protect the concrete further as per 1.1	0

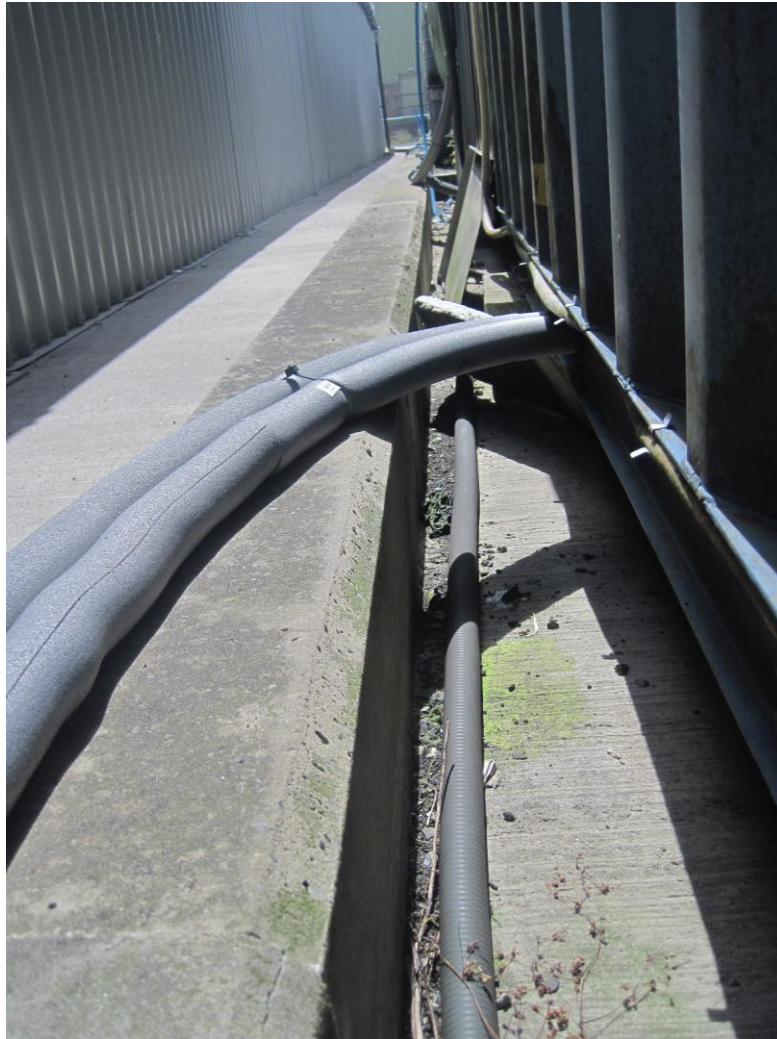
The internal height of the east bund wall is 380mm and the bund wall is 250mm wide with a 35mm chamfer. The east bund wall is very good condition.

Photograph 1.9 View of East Bund Wall

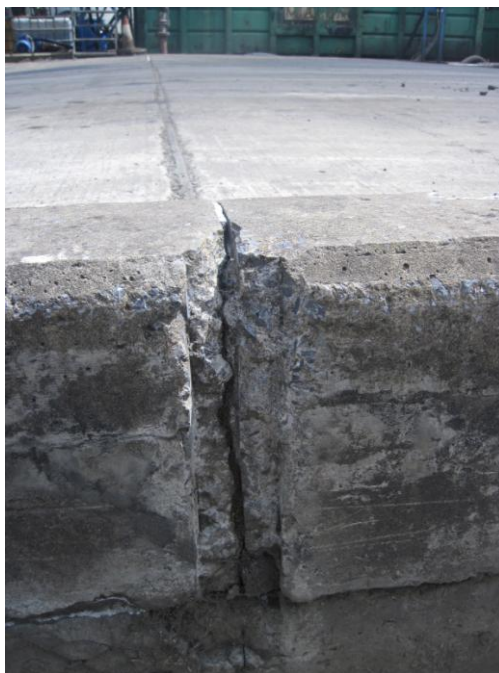
Overall the west bund wall is in good condition. However, there is concrete spalling to the construction joint as shown in photograph. There is a crack over 5mm width which requires repair, see photograph 1.11.

Photograph 1.11, Close Up Of External Face Of West Wall

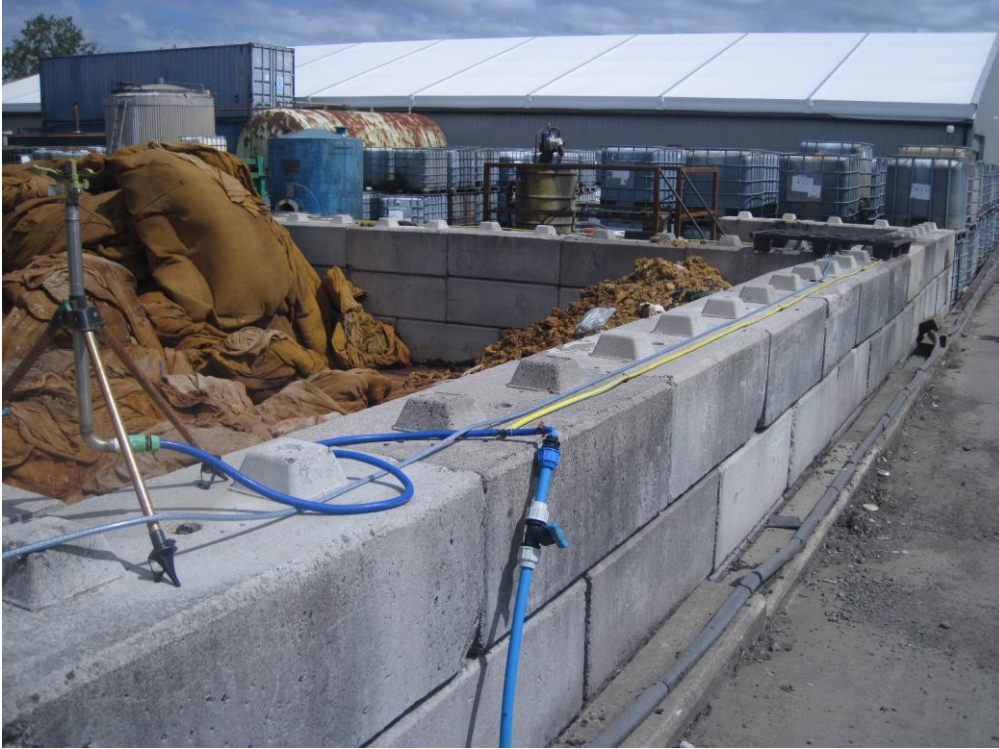
At the south west corner inside the bund walls concrete block have been stacked three blocks high as shown in photograph 1,12.

Photograph 1.12, View Of Concrete Block Wall At The South West Corner

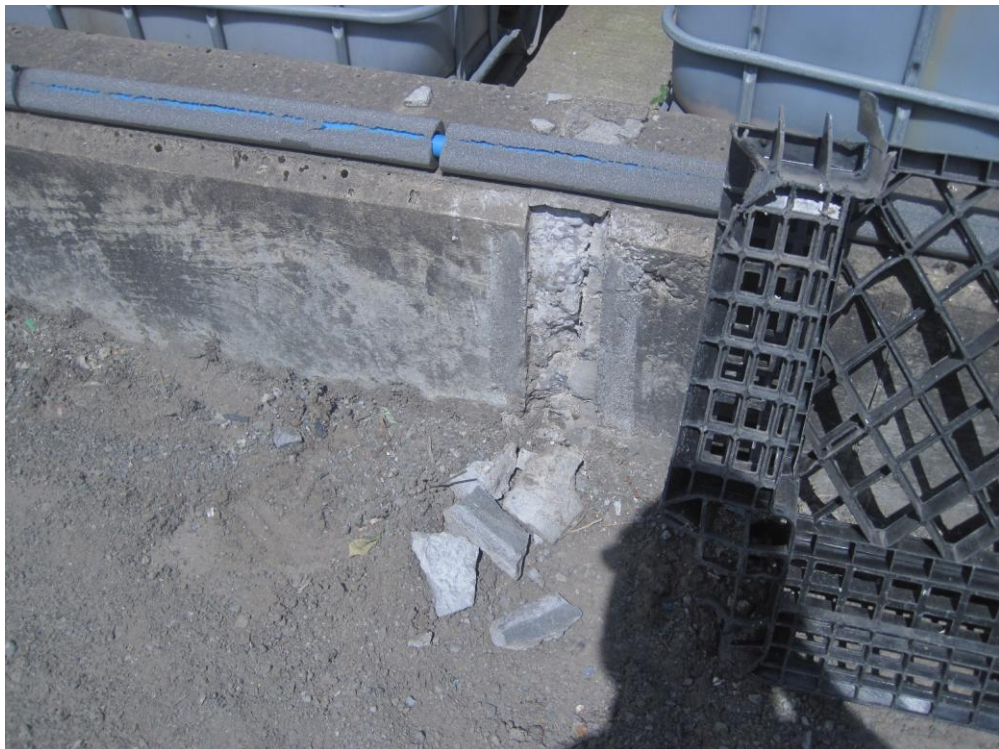
Photograph 1.13 View Of Spalling Of Concrete At Joint Location

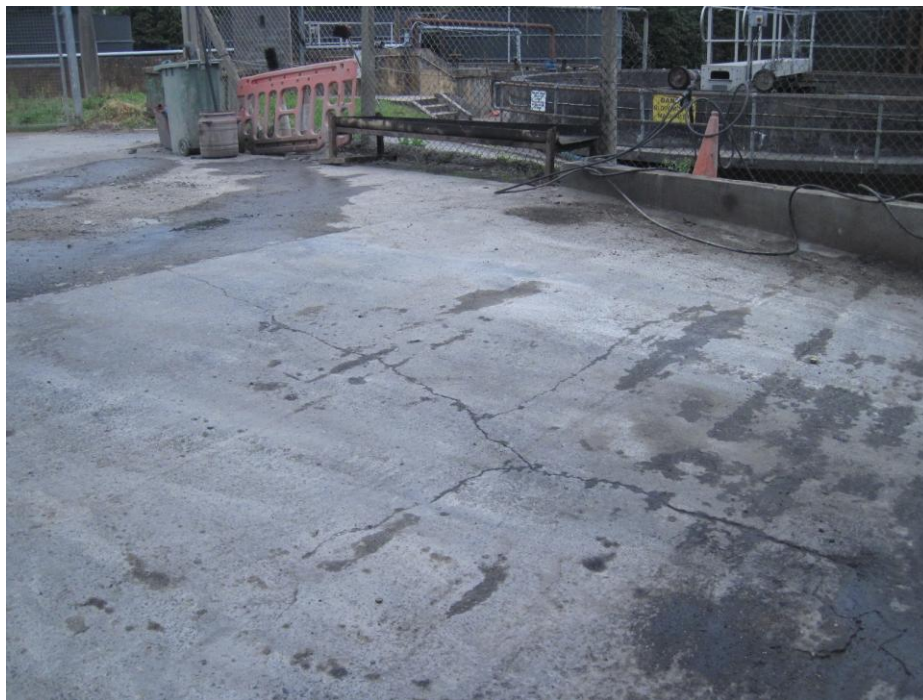
There is surface cracking visible to the concrete base slab as shown in photograph 3.2. The cracks are less than 2mm width and not detrimental to the slabs structural strength / integrity or will lessen the ability for the base to resist the ingress of contamination.

Photograph 3.2, View Of Cracking To The Surface Of The Concrete Base

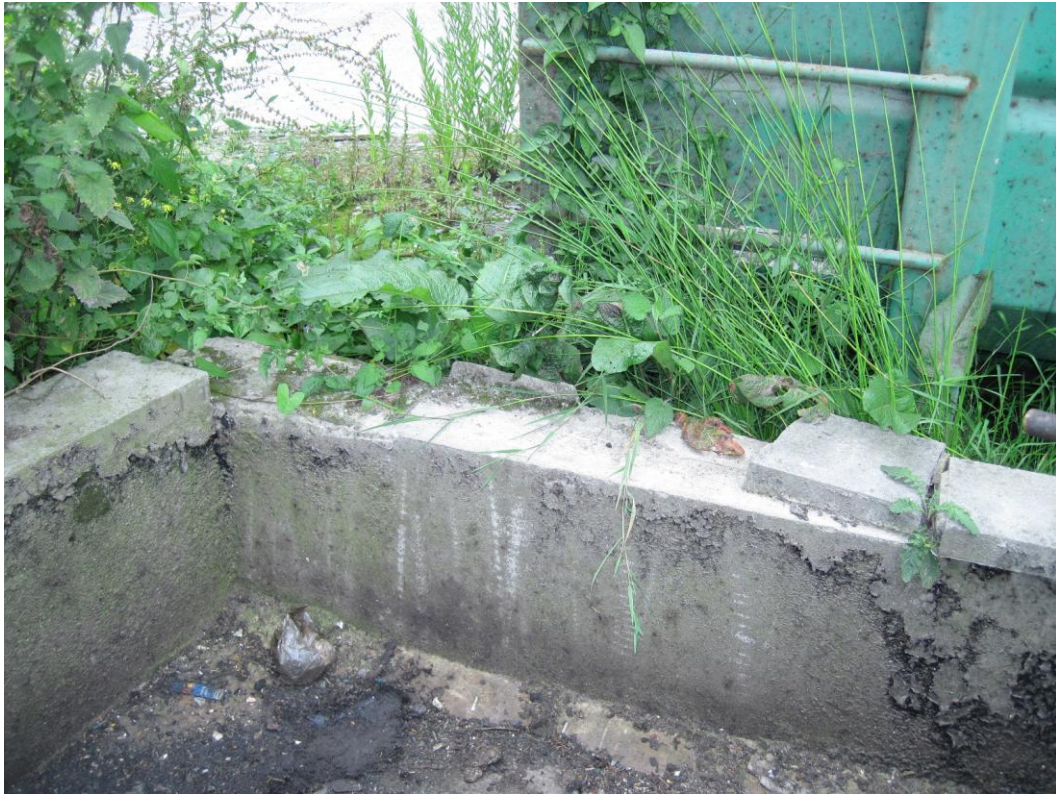
There is a 50mm concrete coping surmounted to the majority of the wall but is missing in at the southwest corner as shown on photograph 3.3. Each existing concrete coping is 910mm length 250mm wide and 50mm height. The purpose of the coping is to protect the top of the masonry wall from the elements, i.e. rainwater, snow or ice causing the masonry to degrade.

Phptograph 3.3, View Of Missing Coping To The Top Of The Wall

Item No.	Description of Works	Priority
3.1	Ensure drains are area kept clear and free from debris (ongoing good site procedures)	0
3.2	Replace coping stones which are missing to protect the masonry wall.	1
3.3	Clear vegetation from behind the south and east bund walls.	1

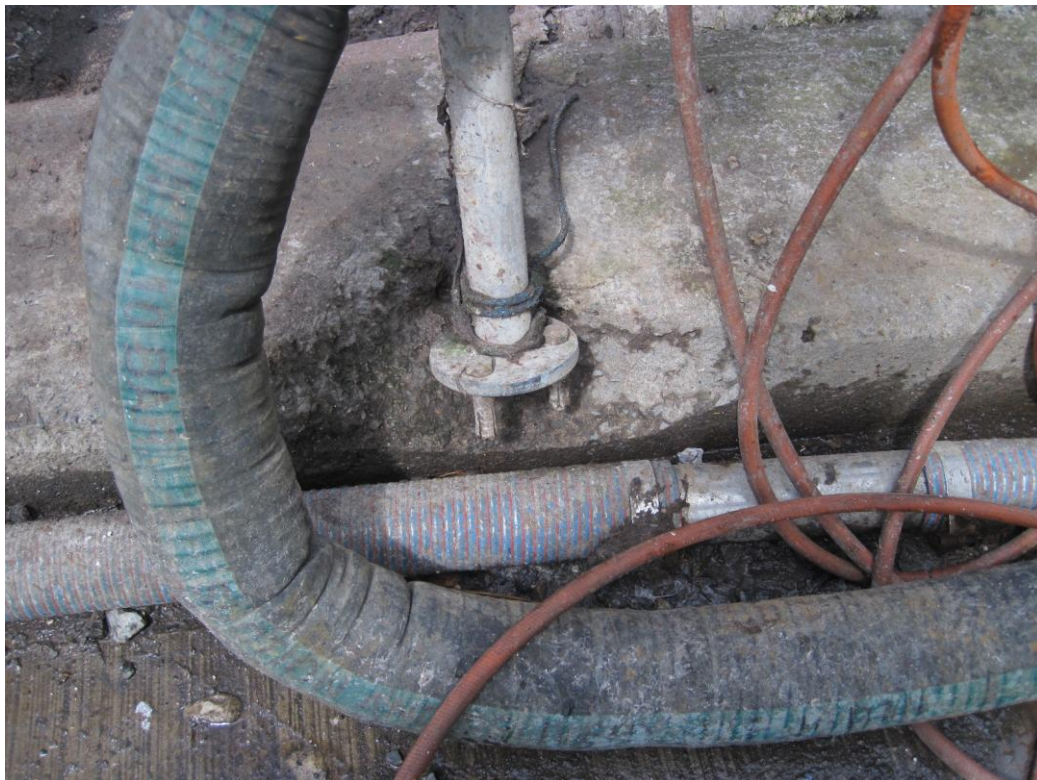
The north bund wall is 450mm wide. We noted that the handrails which were fixed to this wall have been impacted and there is localised damage to the concrete wall at the base of the standard as shown in photograph 4.2.

Photograph 4.2, Damage To Base Of Handrail Standard (North Bund Wall)

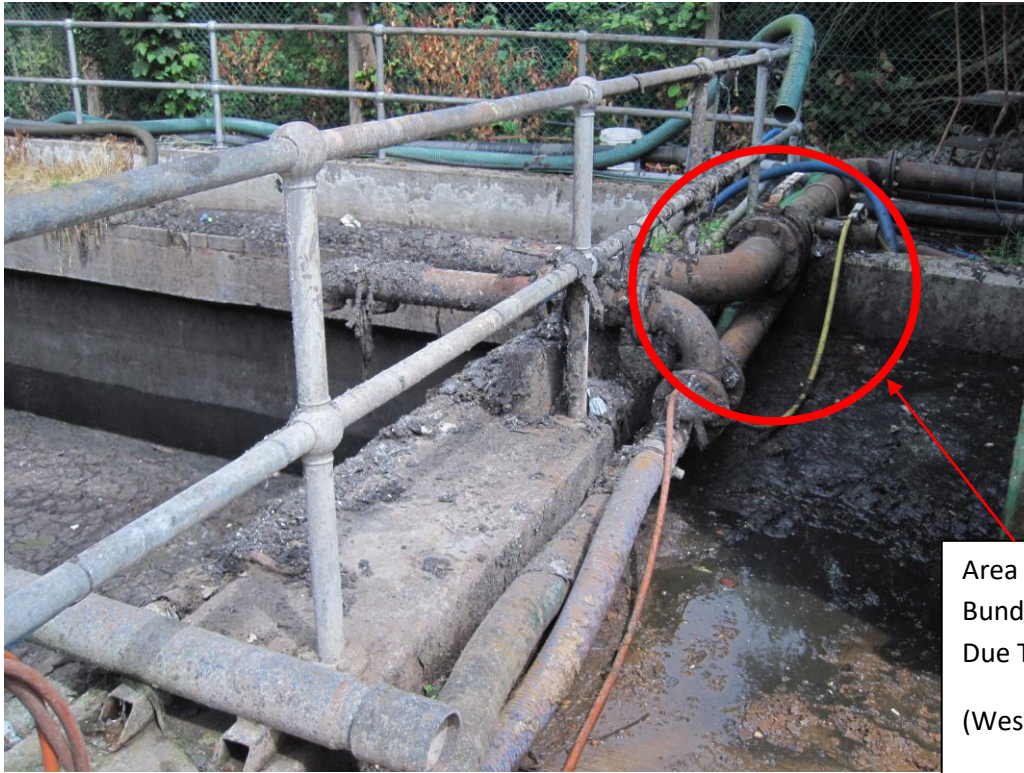
Photograph 4.3, View Of North East Corner

Area Of Reduced
Bund Wall Height
Due To Pipework
(West Elevation)

Overall the condition of the concrete base and walls are in good condition. There is slight damage to the wall at the base of a handrail stanchion as shown in photograph 4.3. and the height of the wall at the north east corner is to be increased by 170mm as shown in figure 4.1.

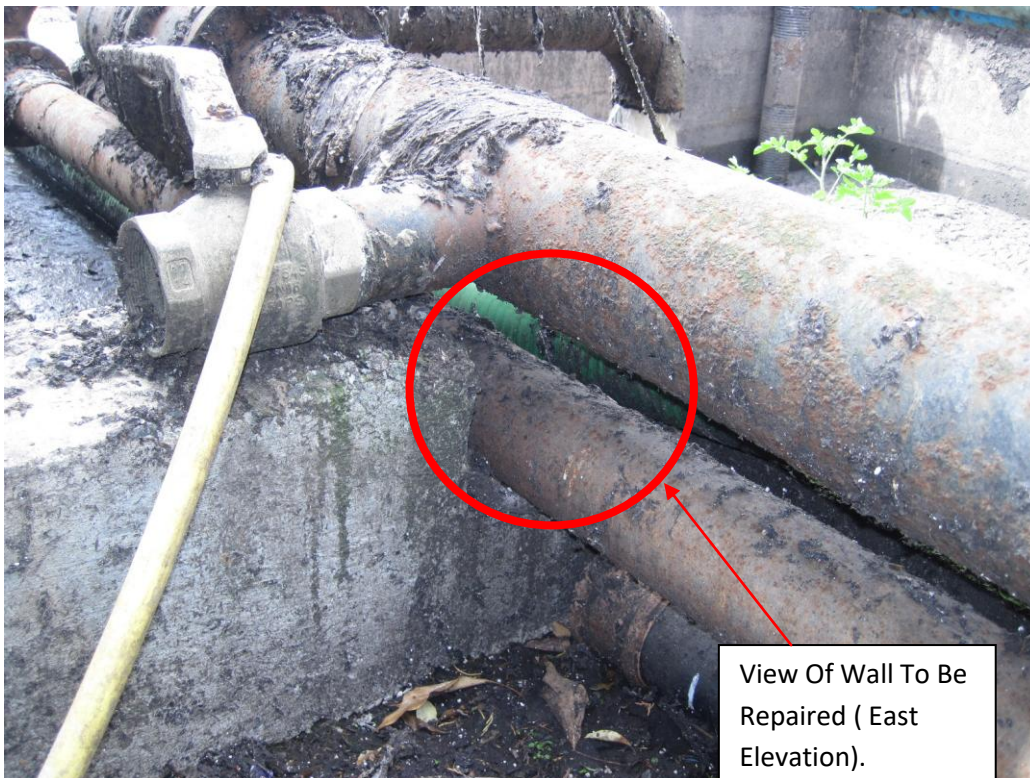
Photograph 4.4, Close Up Of North East Corner

View Of Wall To Be
Repaired (East
Elevation).
