| Location Plan: | | Sudbrook Wall | |
| | | Structure Reference: | <b>13 50</b> |

# COASTAL ASSET CONDITION SURVEY REPORT

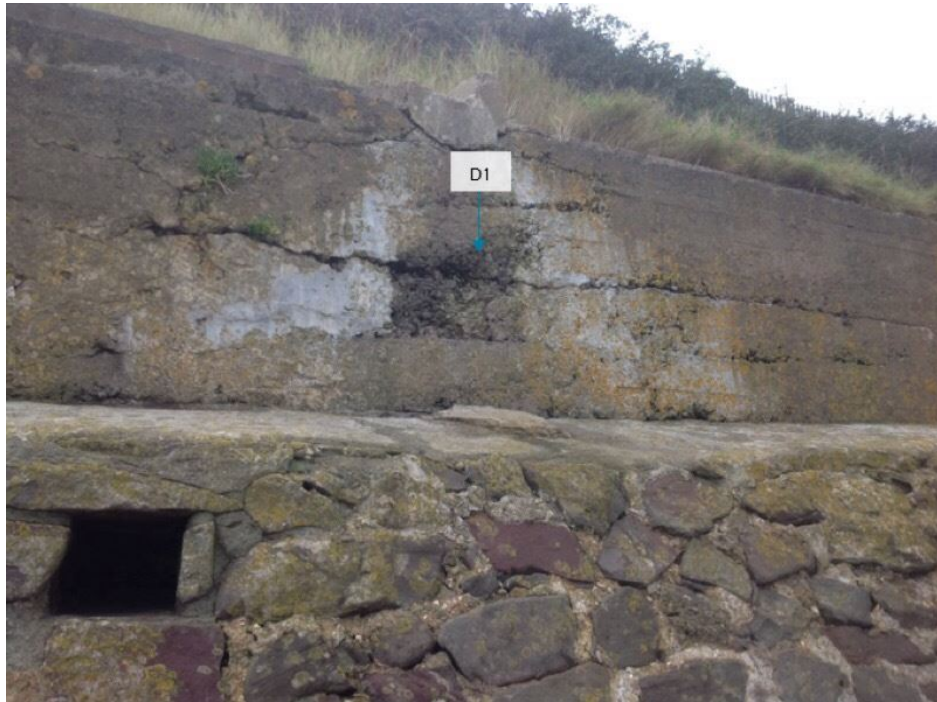
| Defect Ref No. | Defect Location (NGR) | Major Element | Minor Element | Photo Ref | Severity | Probability | Risk Score | Below MHWS | Defect Group | Defect Description | Recommendations | Defect Priority |
|---|---|---|---|---|---|---|---|---|---|---|---|---|
| D1 | 350700, 187300 BSW 13.1022 | Wall | Wall section | 17, 56, 64, 108 | 2 | 5 | 10 | N/A | Concrete damage | Spalling concrete. There has been minor changes between the 2020 and 2021 inspections with evidence that this is occurring throughout most of the structure. | Break out spalled areas and replace concrete. | 19 |

**Section A**  
**Wall section**  
**Defect Ref: D1**  
**Description:** Spalling concrete. There has been minor changes between the 2020 and 2021 inspections with evidence that this is occurring throughout most of the structure.  
**Photo number: 17**

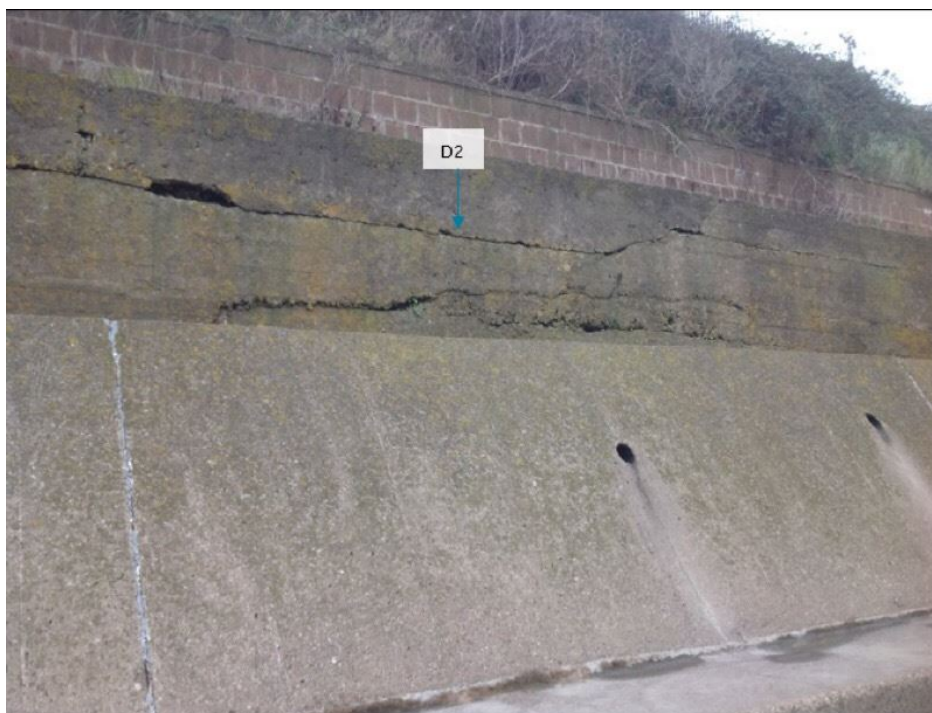
| Defect Ref No. | Defect Location (NGR) | Major Element | Minor Element | Photo Ref | Severity | Probability | Risk Score | Below MHWS | Defect Group | Defect Description | Recommendations | Defect Priority |
|---|---|---|---|---|---|---|---|---|---|---|---|---|
| D2 | 350700, 187300 BSW 13.1022 | Wall | Wall section | 18, 44, 65, 106 | 2 | 4 | 8 | N/A | Concrete damage | Cracks in concrete. No change between 2020 and 2021 inspections. | Fill void and fractures. | 20 |

**Section A**  
**Wall section**  
**Defect Ref: D2**  
**Description:** Cracks  
in concrete. No  
change between  
2020 and 2021  
inspections.  
**Photo number: 18**

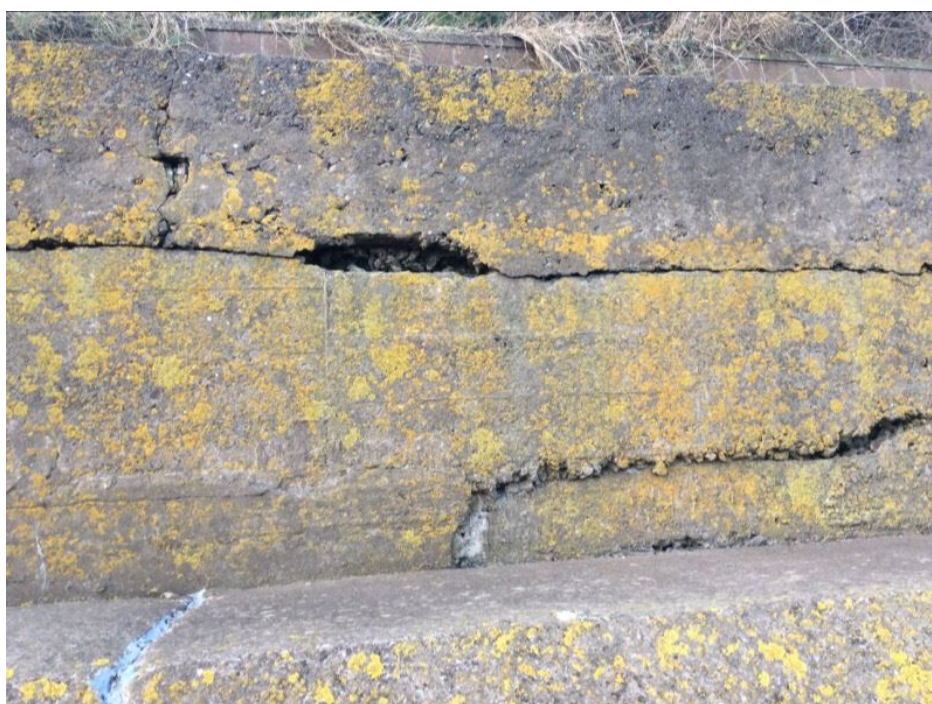
**Section A**  
**Wall section**  
**Defect Ref: D2**  
**Description:** Cracks  
in concrete. No  
change between  
2020 and 2021  
inspections.  
**Photo number: 44**

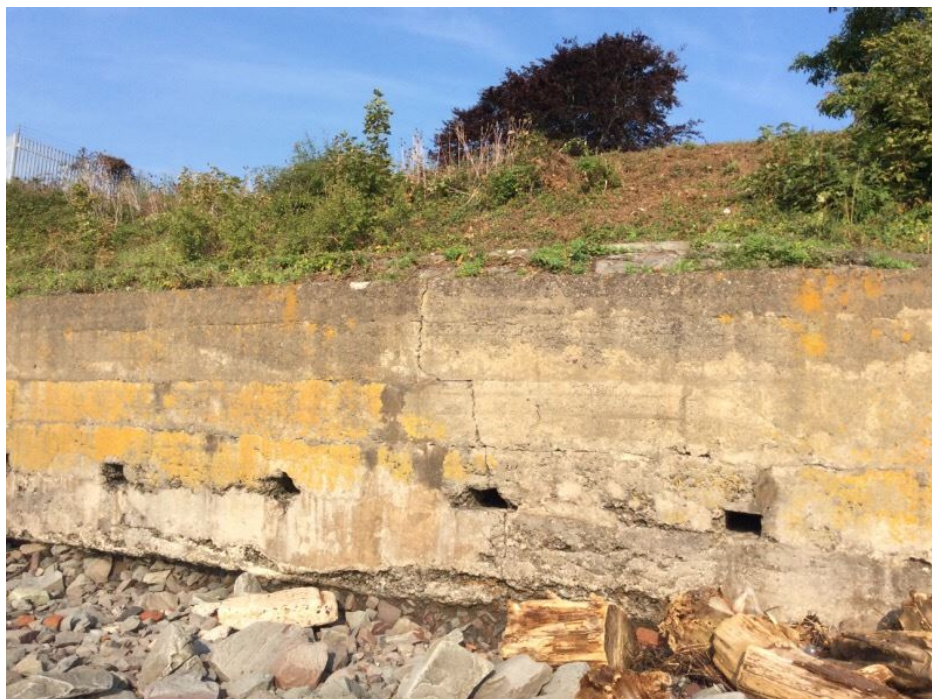
**Section A**  
**Wall section**  
**Defect Ref: D2**  
**Description:** Cracks in concrete. No change between 2020 and 2021 inspections.  
**Photo number: 65**

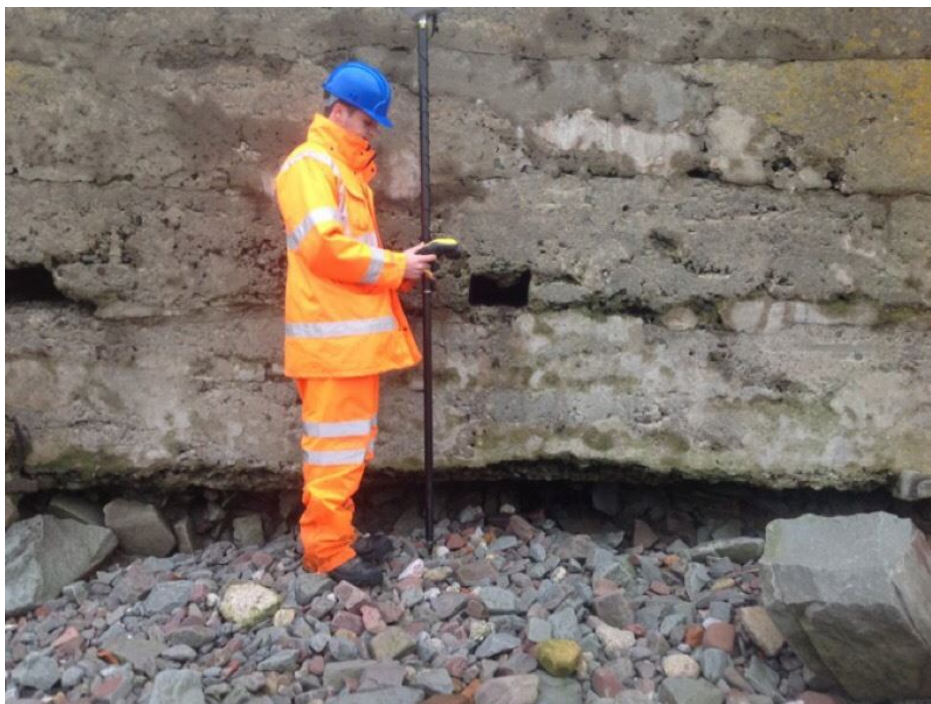
| Defect Ref No. | Defect Location (NGR) | Major Element | Minor Element | Photo Ref | Severity | Probability | Risk Score | Below MHWS | Defect Group | Defect Description | Recommendations | Defect Priority |
|---|---|---|---|---|---|---|---|---|---|---|---|---|
| D3 | 350833, 187423 BSW 13.0951 | Wall | Wall section | 19, 20, 33, 34, 35, 67, 101 | 4 | 3 | 12 | N/A | N/A | 2021 toe repairs and beach level higher. Undermining of wall toe. No change between 2019 and 2020 inspections | Detailed structural survey to be undertaken to help inform suitability of remedial works. Wall toe needs underpinning and protecting. | 7 |

**Section A**  
**Wall section**  
**Defect Ref: D3**  
**Description:** 2021  
toe repairs and beach  
level higher.  
Undermining of wall  
toe. No change  
between 2019 and  
2020 inspections  
**Photo number: 19**

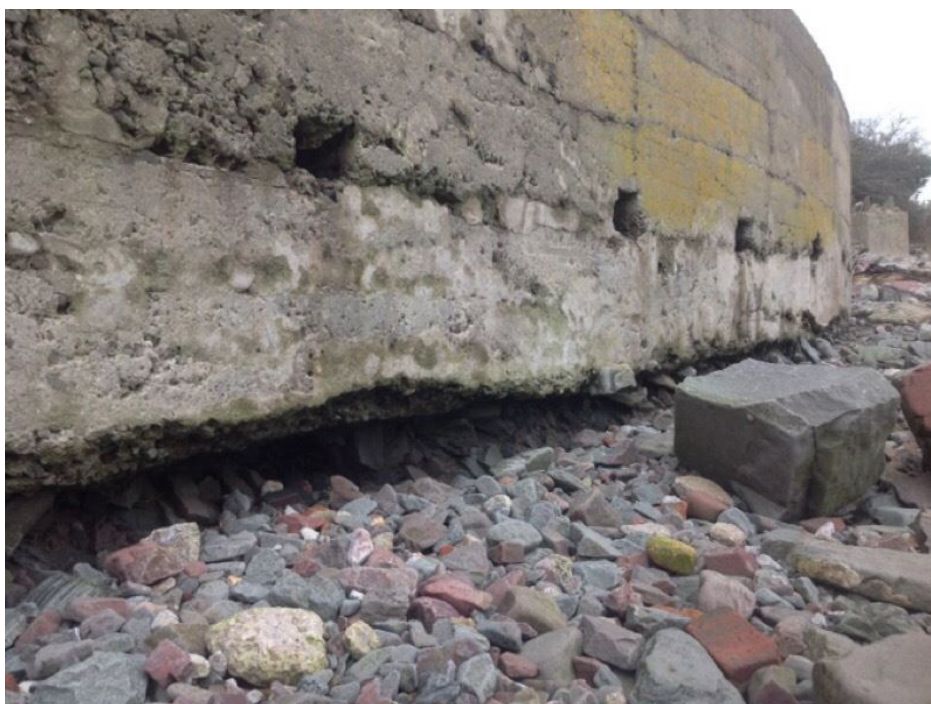
**Section A**  
**Wall section**  
**Defect Ref: D3**  
**Description:** 2021  
toe repairs and beach  
level higher.  
Undermining of wall  
toe. No change  
between 2019 and  
2020 inspections  
**Photo number: 20**

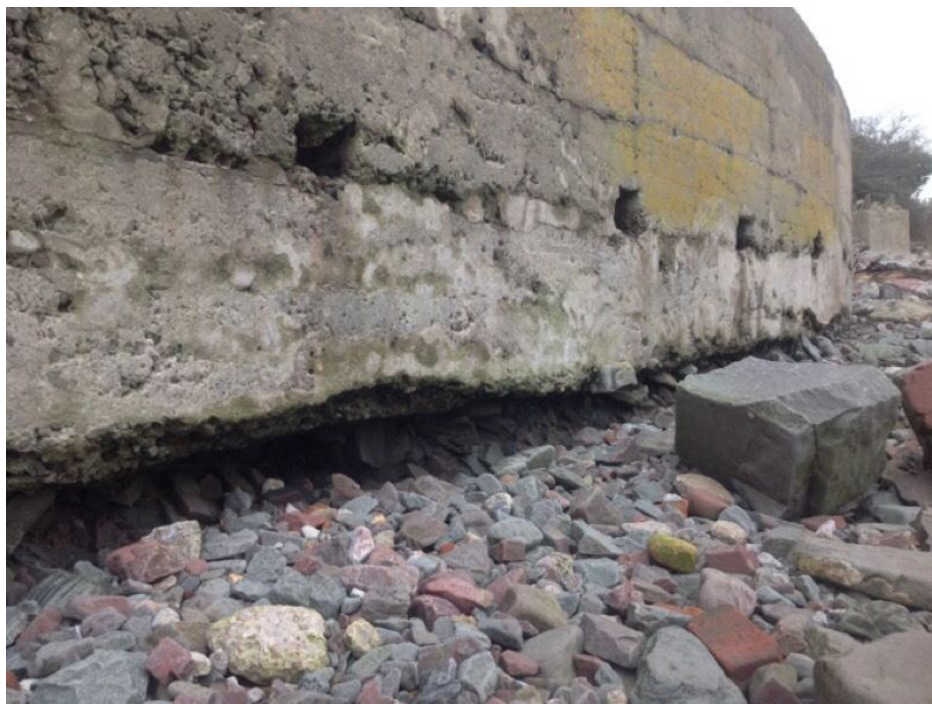
| Defect Ref No. | Defect Location (NGR) | Major Element | Minor Element | Photo Ref | Severity | Probability | Risk Score | Below MHWS | Defect Group | Defect Description | Recommendations | Defect Priority |
|---|---|---|---|---|---|---|---|---|---|---|---|---|
| | 350833, 187423 BSW 13.0951 | Wall | Wall section | 21, 36, 66, 102 | 2 | 4 | 8 | N/A | Scour/undermining | Undermining of wall toe. Between the 2020 and 2021 inspections, the concrete defect has roughly been repaired and cobbles placed under the toe. | Monitor the effectiveness of the repair. | 28 |

**Section A**  
**Wall section**  
**Defect Ref: D3**  
**Description:**  
Undermining of wall toe. Between the 2020 and 2021 inspections, the concrete defect has roughly been repaired and cobbles placed under the toe.

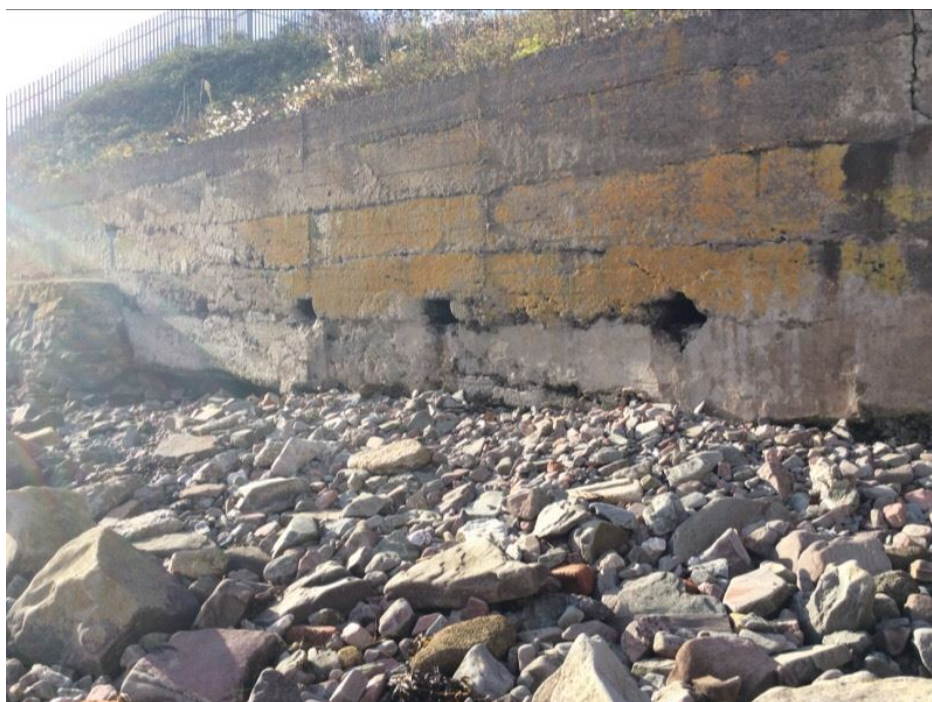
**Section A**  
**Wall section**  
**Defect Ref: D3**  
**Description:** 2021 toe repairs and beach level higher. Undermining of wall toe. No change between 2019 and 2020 inspections  
**Photo number: 33**

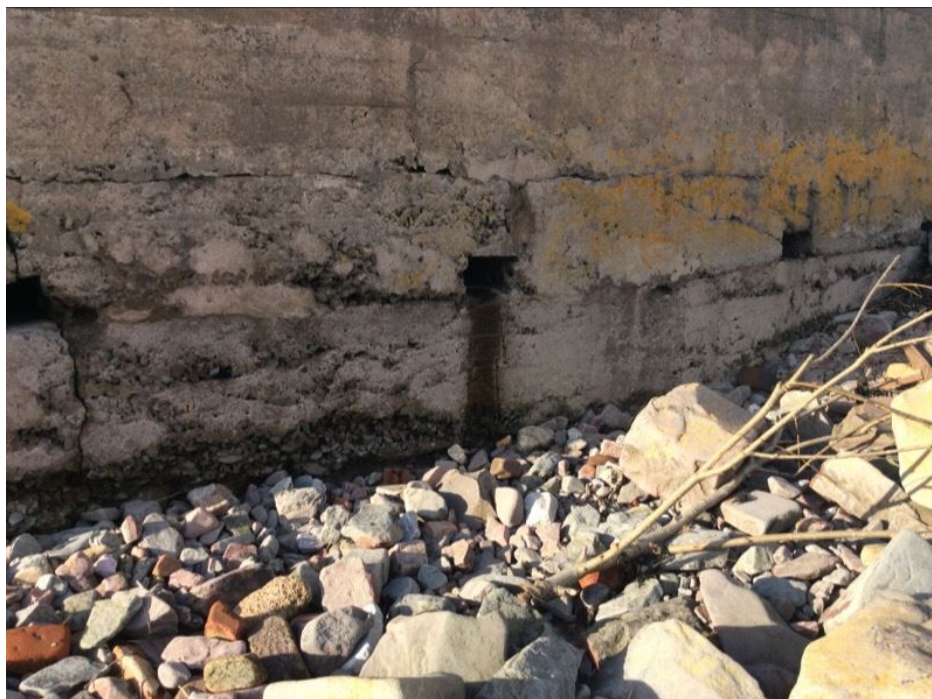
**Section A**  
**Wall section**  
**Defect Ref: D3**  
**Description:** 2021  
toe repairs and beach  
level higher.  
Undermining of wall  
toe. No change  
between 2019 and  
2020 inspections  
**Photo number: 34**

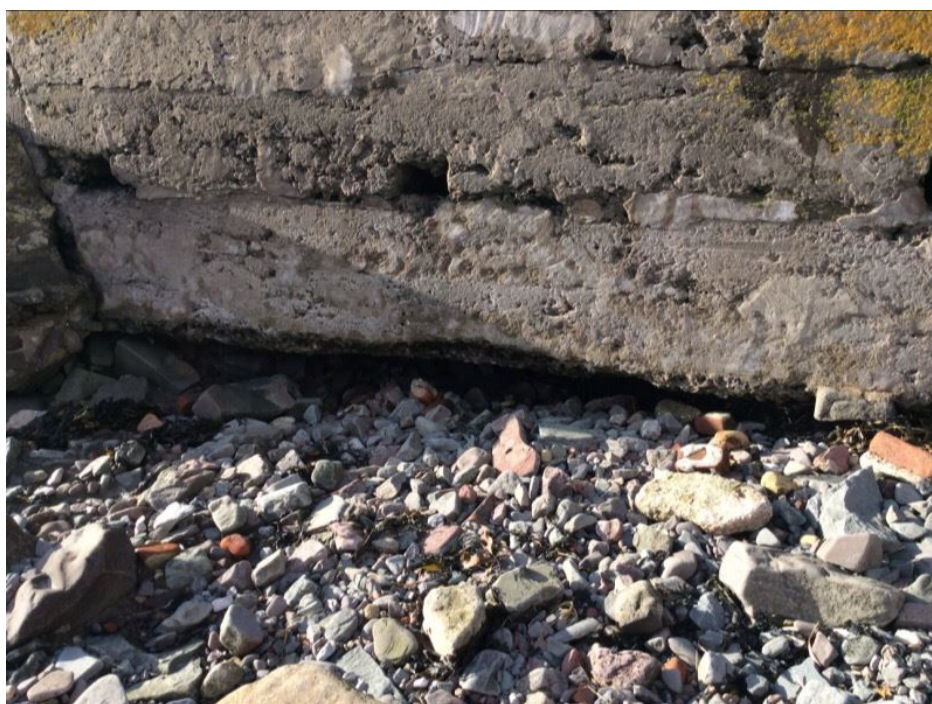
**Section A**  
**Wall section**  
**Defect Ref: D3**  
**Description:** 2021  
toe repairs and beach  
level higher.  
Undermining of wall  
toe. No change  
between 2019 and  
2020 inspections  
**Photo number: 35**

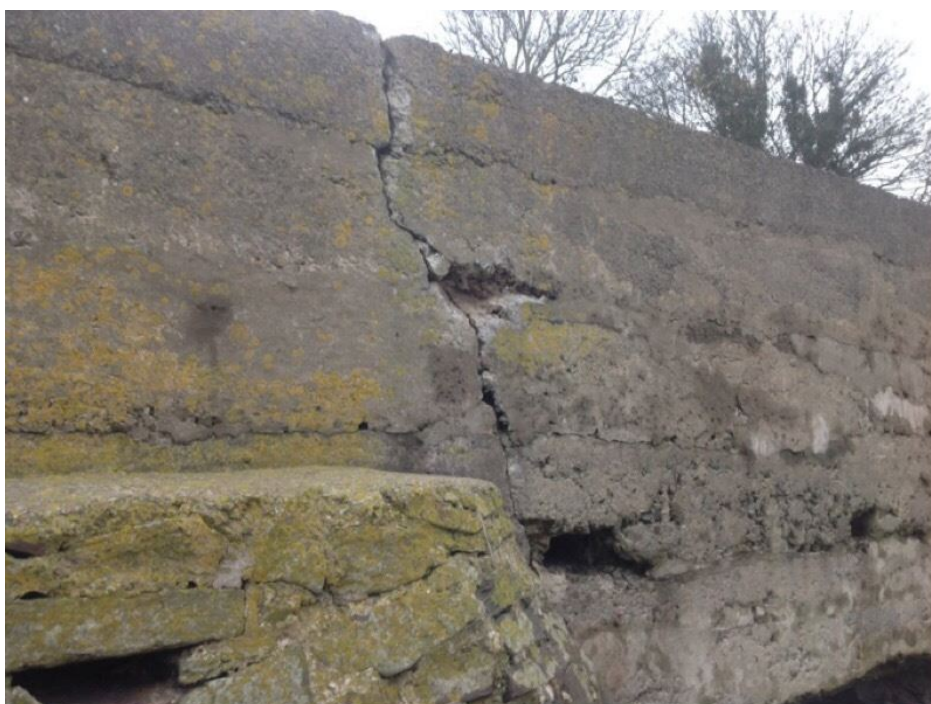
| Defect Ref No. | Defect Location (NGR) | Major Element | Minor Element | Photo Ref | Severity | Probability | Risk Score | Below MHWS | Defect Group | Defect Description | Recommendations | Defect Priority |
|---|---|---|---|---|---|---|---|---|---|---|---|---|
| D5 | 350828, 187415 BSW 13.0953 | Wall | Wall section | 22, 37, 68, 103 | 4 | 2 | 8 | N/A | Concrete damage | Vertical fracture in wall indicates possible subsidence. No change between 2020 and 2021 inspections. | Fill voids in wall and monitor for signs of subsidence. | 17 |

**Section A**  
**Wall section**  
**Defect Ref: D5**  
**Description:** Vertical fracture in wall indicates possible subsidence. No change between 2020 and 2021 inspections.  
**Photo number: 37**

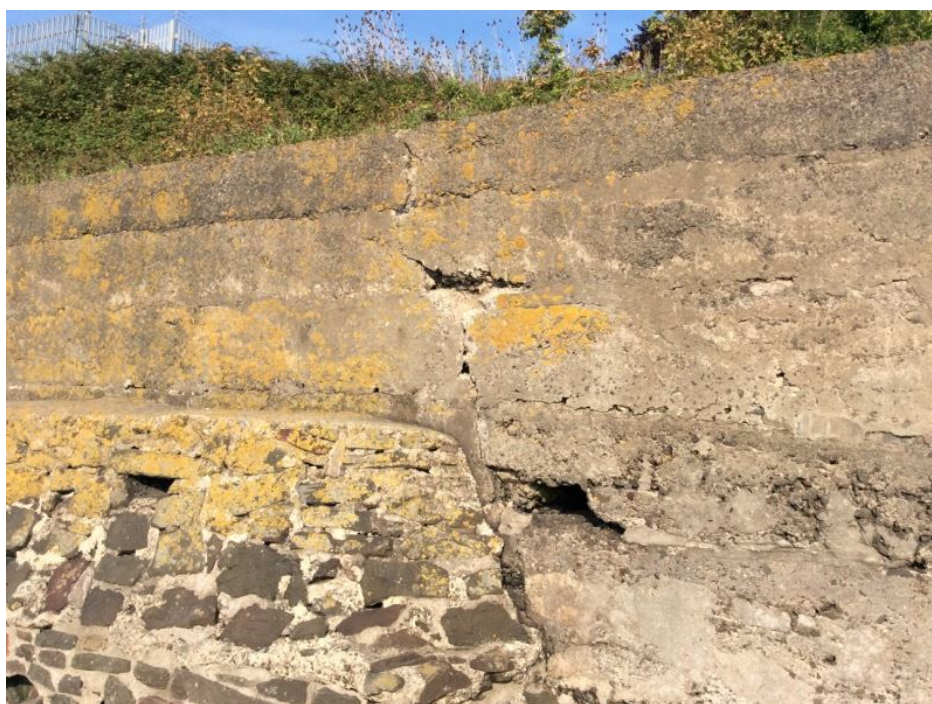
**Section A**  
**Wall section**  
**Defect Ref: D5**  
**Description:** Vertical fracture in wall indicates possible subsidence. No change between 2020 and 2021 inspections.  
**Photo number: 103**

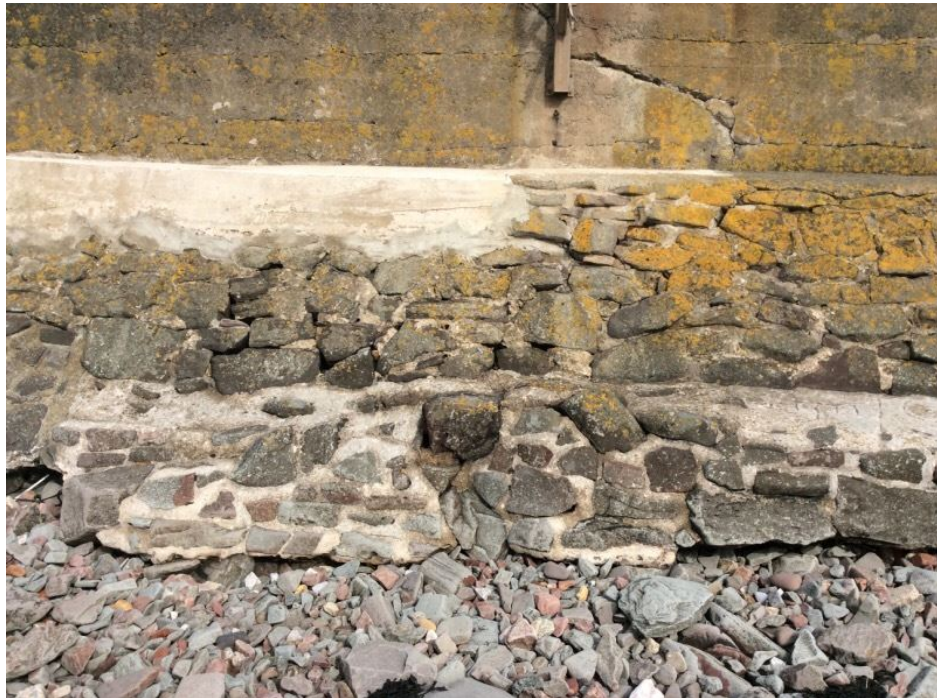
| Defect Ref No. | Defect Location (NGR) | Major Element | Minor Element | Photo Ref | Severity | Probability | Risk Score | Below MHWS | Defect Group | Defect Description | Recommendations | Defect Priority |
|---|---|---|---|---|---|---|---|---|---|---|---|---|
| D7 | 350819, 187396 BSW 13.0952 | Wall | Wall section | 24, 41, 69, 105 | 2 | 4 | 8 | N/A | Missing blockwork | Large top area open. Collapse of lower section of wall. Between the 2020 and 2021 inspections, larger voids have been repaired, but small voids are still present. | Small voids to be filled and monitor the effectiveness of the concrete repair. | 14 |

**Section A**  
**Wall section**  
**Defect Ref: D7**  
**Description:** Large top area open. Collapse of lower section of wall. Between the 2020 and 2021 inspections, larger voids have been repaired, but small voids are still present.  
**Photo number: 24**

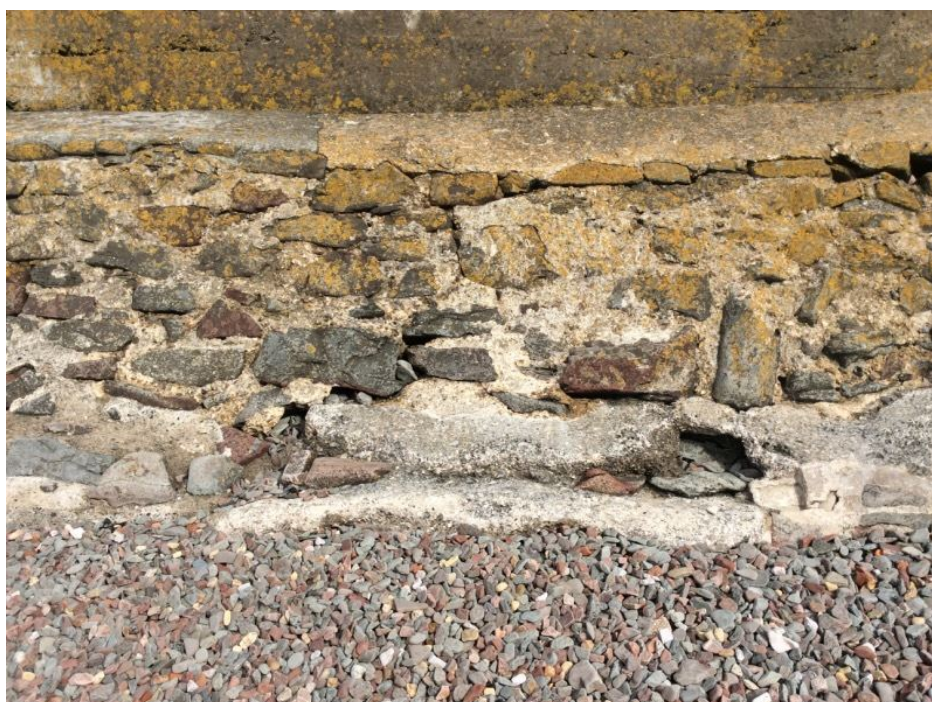
| Defect Ref No. | Defect Location (NGR) | Major Element | Minor Element | Photo Ref | Severity | Probability | Risk Score | Below MHWS | Defect Group | Defect Description | Recommendations | Defect Priority |
|---|---|---|---|---|---|---|---|---|---|---|---|---|
| D12 | 350753, 187333 BSW 13.0986 | Wall | Wall section | 29, 57, 77, 112 | 3 | 4 | 12 | N/A | Missing blockwork | Collapse of the lower section of the wall. Less evident during the 2021 inspection as cobbles have been placed/moved under the toe. | Detailed structural survey to be undertaken to help inform suitability of remedial works. Wall toe needs underpinning and protecting. | 1 |

**Section A**  
**Wall section**  
**Defect Ref: D12**  
**Description:**  
Collapse of the lower  
section of the wall.  
Less evident during  
the 2021 inspection  
as cobbles have been  
placed/moved under  
the toe.  
**Photo number: 29**

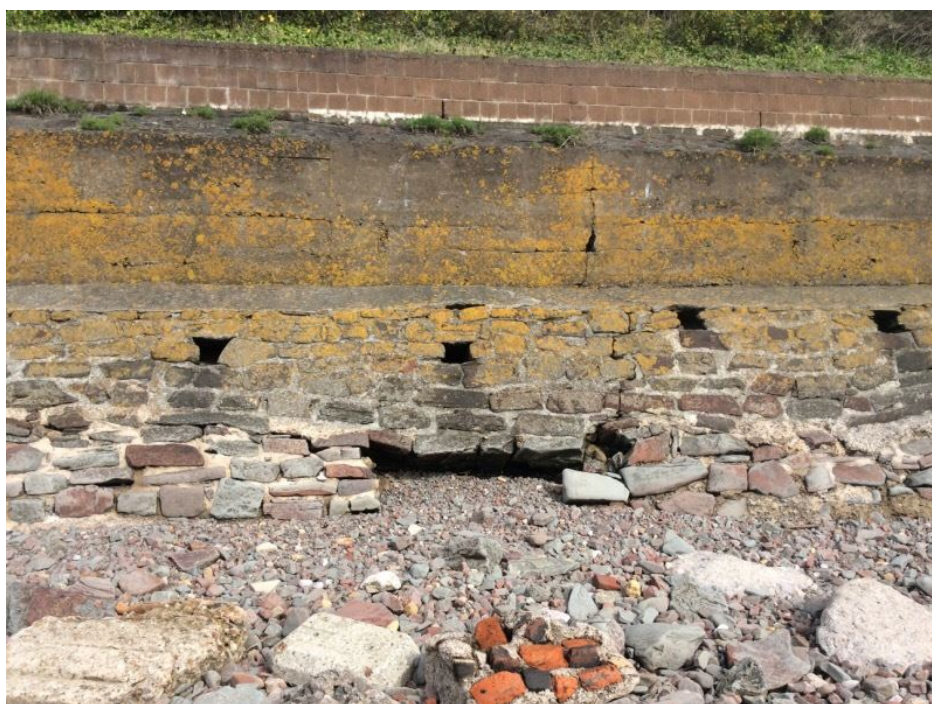
| Defect Ref No. | Defect Location (NGR) | Major Element | Minor Element | Photo Ref | Severity | Probability | Risk Score | Below MHWS | Defect Group | Defect Description | Recommendations | Defect Priority |
|---|---|---|---|---|---|---|---|---|---|---|---|---|
| D13 | 350719, 187312 BSW 13.1009 | Wall | Wall section | 30, 62, 81, 124 | 2 | 2 | 4 | N/A | Missing blockwork | Expelled rocks from block retaining structure protecting the tie in. No change between 2020 and 2021 inspections. | Place rock armour toe protection around the base of tie in. | 26 |

**Section A**  
**Wall section**  
**Defect Ref: D13**  
**Description:**  
Expelled rocks from  
block retaining  
structure protecting  
the tie in. No change  
between 2020 and  
2021 inspections.  
**Photo number: 30**

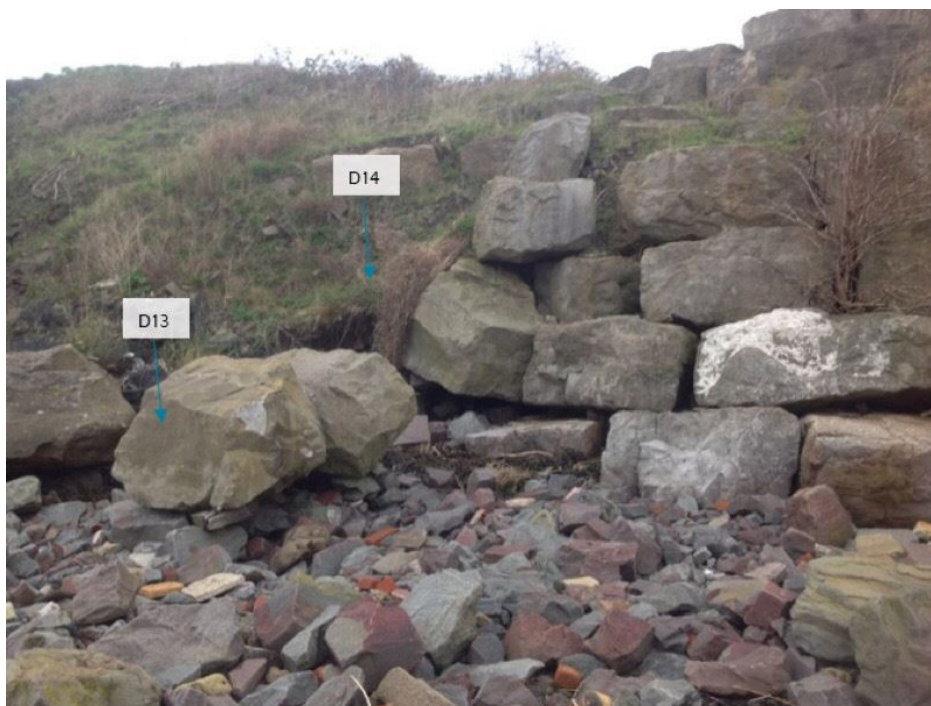
**Section A**  
**Wall section**  
**Defect Ref: D13**  
**Description:**  
Expelled rocks from  
block retaining  
structure protecting  
the tie in. No change  
between 2020 and  
2021 inspections.  
**Photo number: 62**

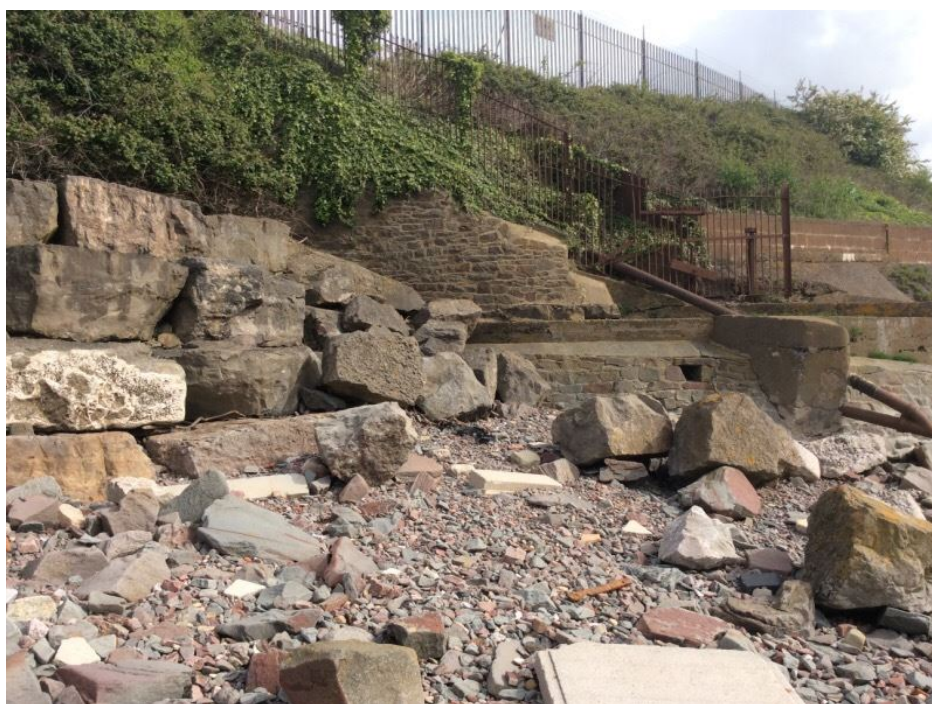
| Defect Ref No. | Defect Location (NGR) | Major Element | Minor Element | Photo Ref | Severity | Probability | Risk Score | Below MHWS | Defect Group | Defect Description | Recommendations | Defect Priority |
|---|---|---|---|---|---|---|---|---|---|---|---|---|
| D14 | 350701, 187307 BSW 13.1024 | Wall | Wall section | 31, 63, 82, 125 | 3 | 3 | 9 | N/A | Loss/damage of rock-armour | Outflanking erosion initiating failure of the tie in. Slightly increased in severity as further erosion was noted in 2021. | Place rock armour toe protection around the base of tie in. | 27 |

**Section A**  
**Wall section**  
**Defect Ref: D14**  
**Description:**  
Outflanking erosion  
initiating failure of the  
tie in. Slightly  
increased in severity  
as further erosion  
was noted in 2021.  
**Photo number: 31**

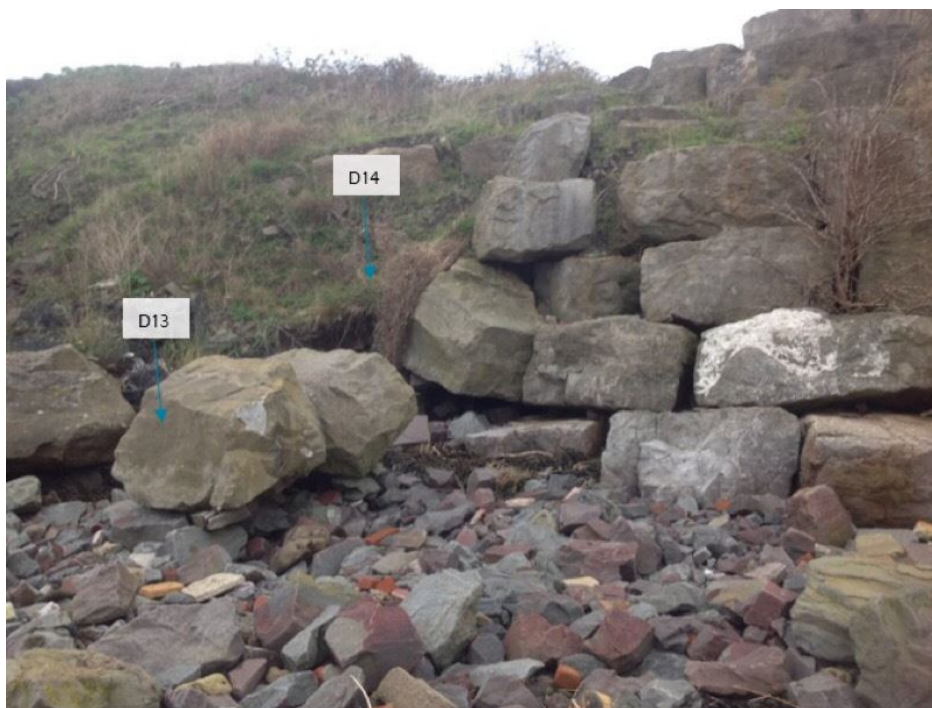
**Section A**  
**Wall section**  
**Defect Ref: D14**  
**Description:**  
Outflanking erosion  
initiating failure of the  
tie in. Slightly  
increased in severity  
as further erosion  
was noted in 2021.  
**Photo number: 63**

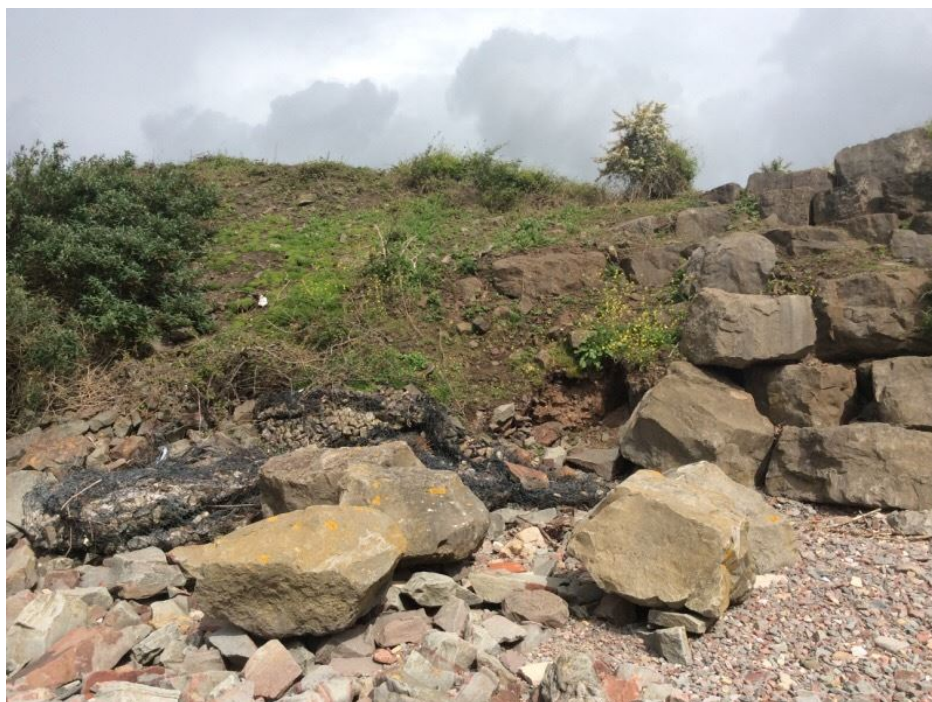
| Defect Ref No. | Defect Location (NGR) | Major Element | Minor Element | Photo Ref | Severity | Probability | Risk Score | Below MHWS | Defect Group | Defect Description | Recommendations | Defect Priority |
|---|---|---|---|---|---|---|---|---|---|---|---|---|
| D15 | 350698, 187299 BSW 13.1023 | Wall | Wall section | 32, 61, 83, 126 | 2 | 3 | 6 | N/A | Missing blockwork | Failed gabions no longer providing any defence function. No change between 2020 and 2021 inspections. | Remove failed gabion baskets. | 24 |

**Section A**  
**Wall section**  
**Defect Ref: D15**  
**Description:** Failed gabions no longer providing any defence function. No change between 2020 and 2021 inspections.  
**Photo number: 32**

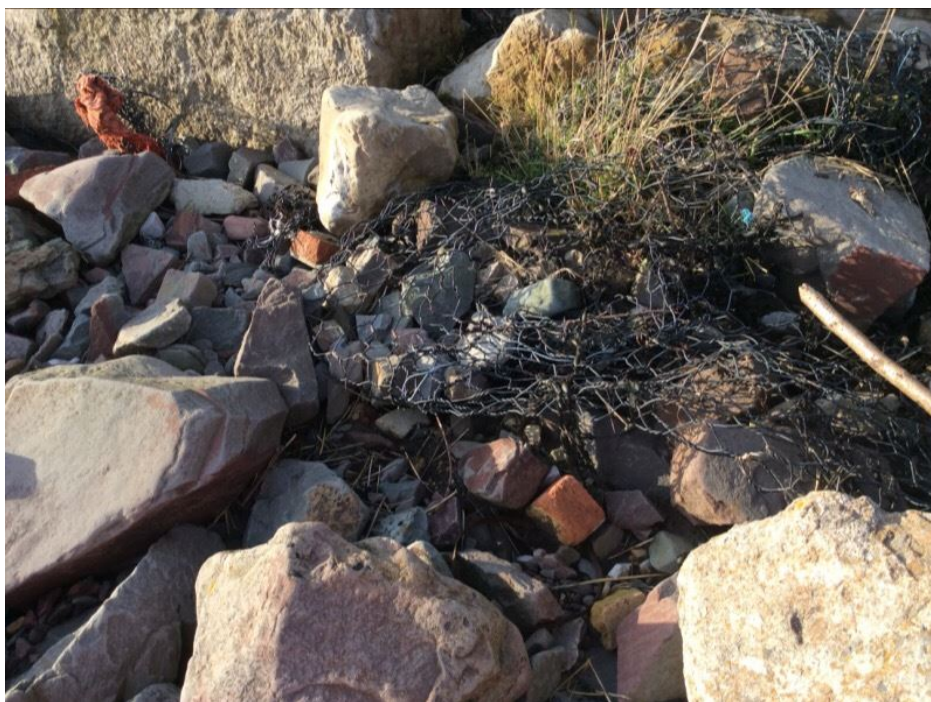
**Section A**  
**Wall section**  
**Defect Ref: D15**  
**Description:** Failed gabions no longer providing any defence function. No change between 2020 and 2021 inspections.  
**Photo number: 83**

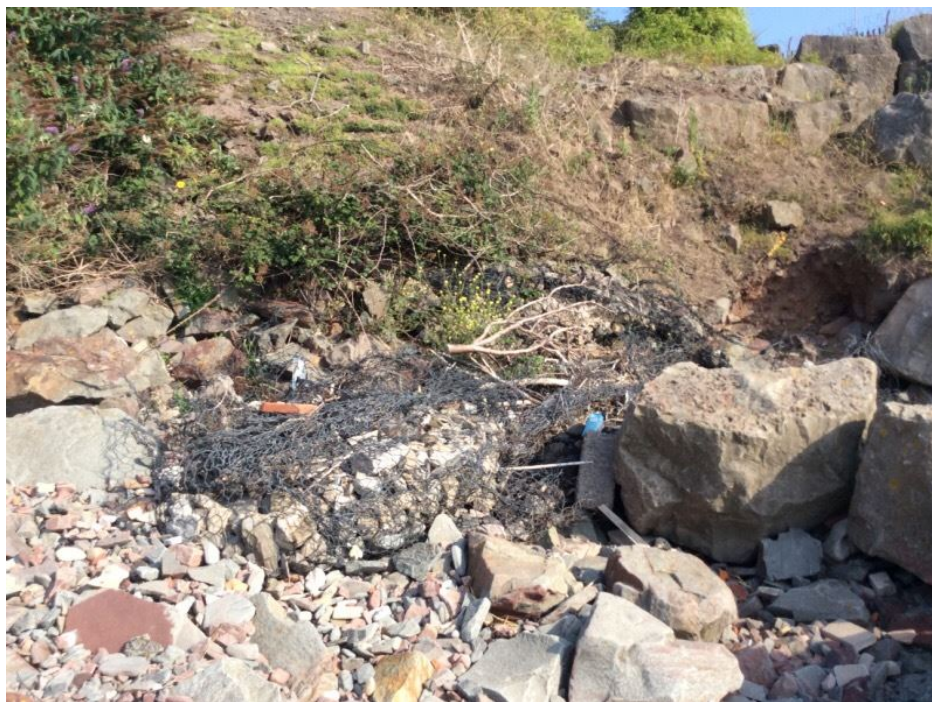
**Section A**  
**Wall section**  
**Defect Ref: D15**  
**Description:** Failed gabions no longer providing any defence function. No change between 2020 and 2021 inspections.  
**Photo number: 126**

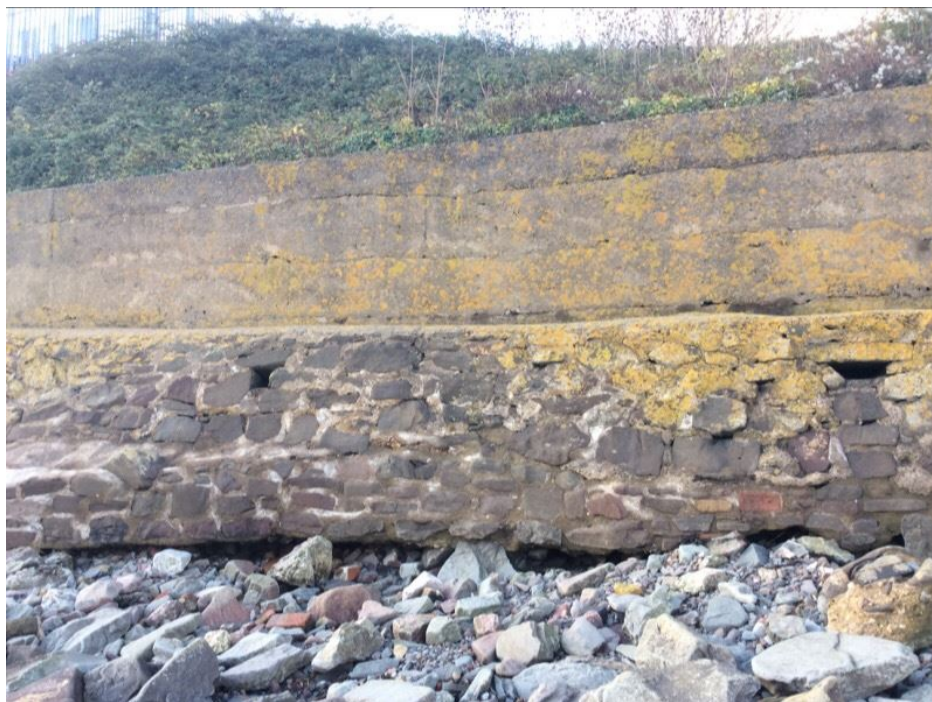
**Section A**  
**Wall section**  
**Defect Ref: D16**  
**Description:**  
Undermining of wall  
toe. No change  
between 2020 and  
2021 inspections.  
**Photo number: 84**

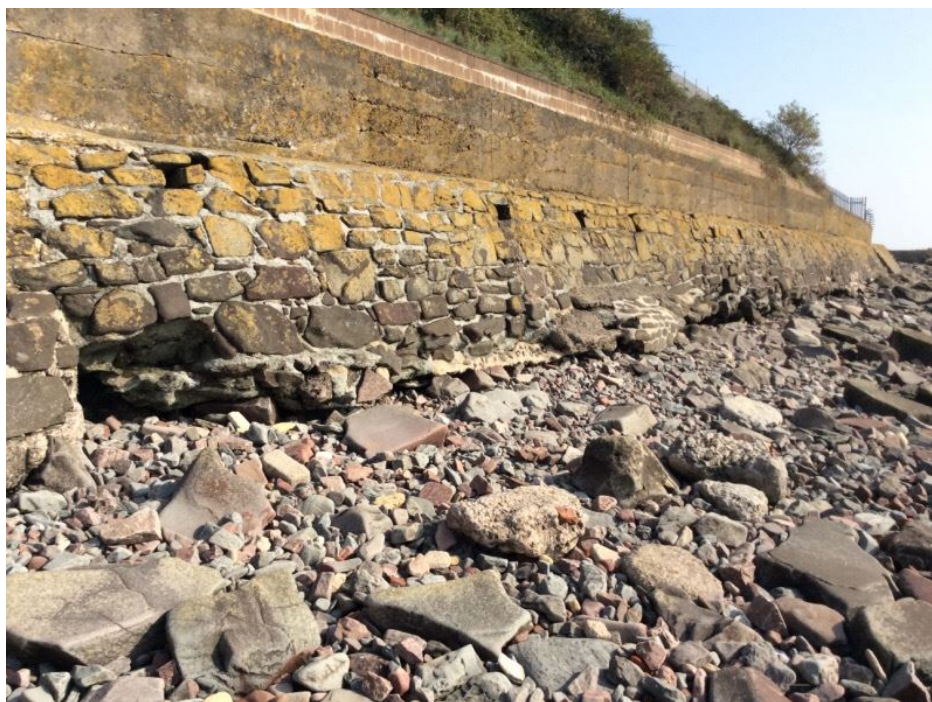
**Section A**  
**Wall section**  
**Defect Ref: D16**  
**Description:**  
Undermining of wall  
toe. No change  
between 2020 and  
2021 inspections.  
**Photo number: 109**

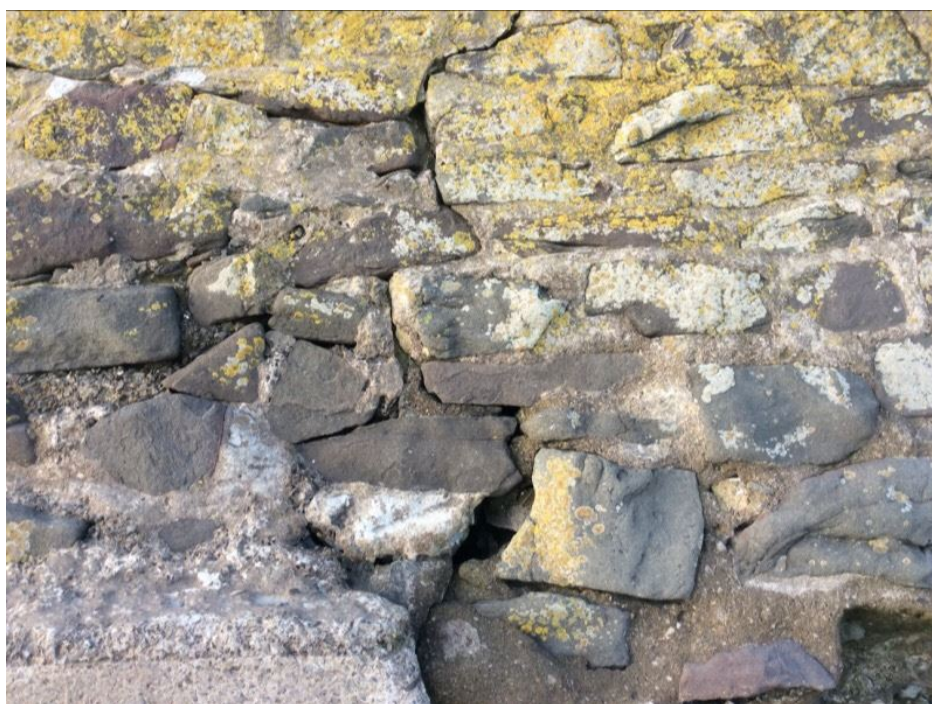
| Defect Ref No. | Defect Location (NGR) | Major Element | Minor Element | Photo Ref | Severity | Probability | Risk Score | Below MHWS | Defect Group | Defect Description | Recommendations | Defect Priority |
|---|---|---|---|---|---|---|---|---|---|---|---|---|
| D20 | N/A | Wall | Wall section | 46, 87, 116 | 4 | 2 | 8 | N/A | Repointing | Vertical crack and loss of fill. Loss of fill through open joints. No change between 2020 and 2021 inspections. | Injection grout void in structure and repoint open joints. | 14 |

**Section A**  
**Wall section**  
**Defect Ref: D20**  
**Description:** Vertical crack and loss of fill. Loss of fill through open joints. No change between 2020 and 2021 inspections.  
**Photo number: 87**

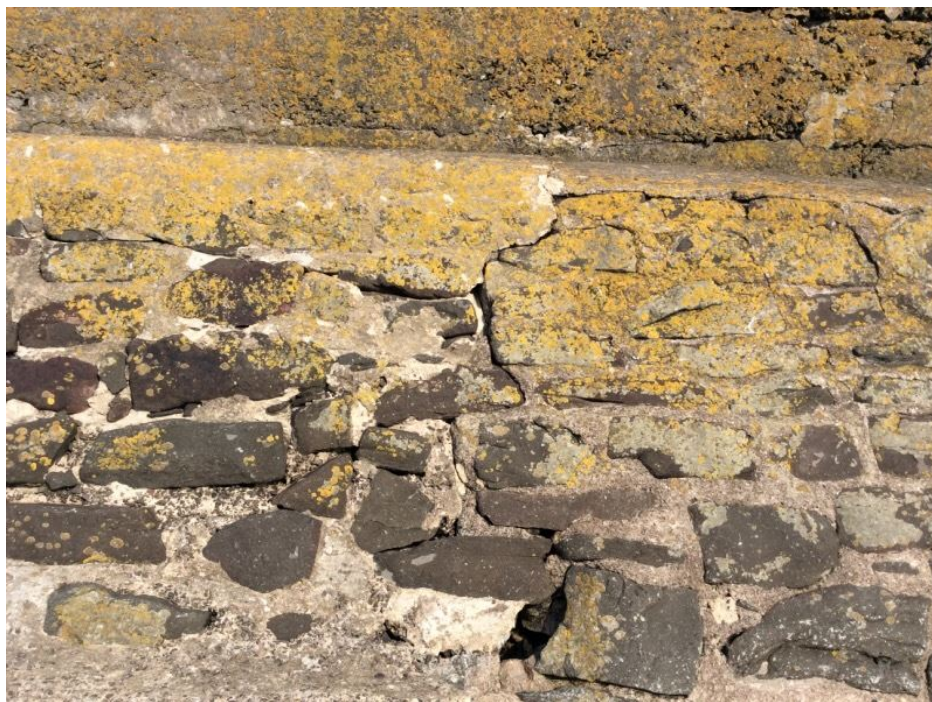
**Section A**  
**Wall section**  
**Defect Ref: D20**  
**Description:** Vertical crack and loss of fill. Loss of fill through open joints. No change between 2020 and 2021 inspections.  
**Photo number: 116**

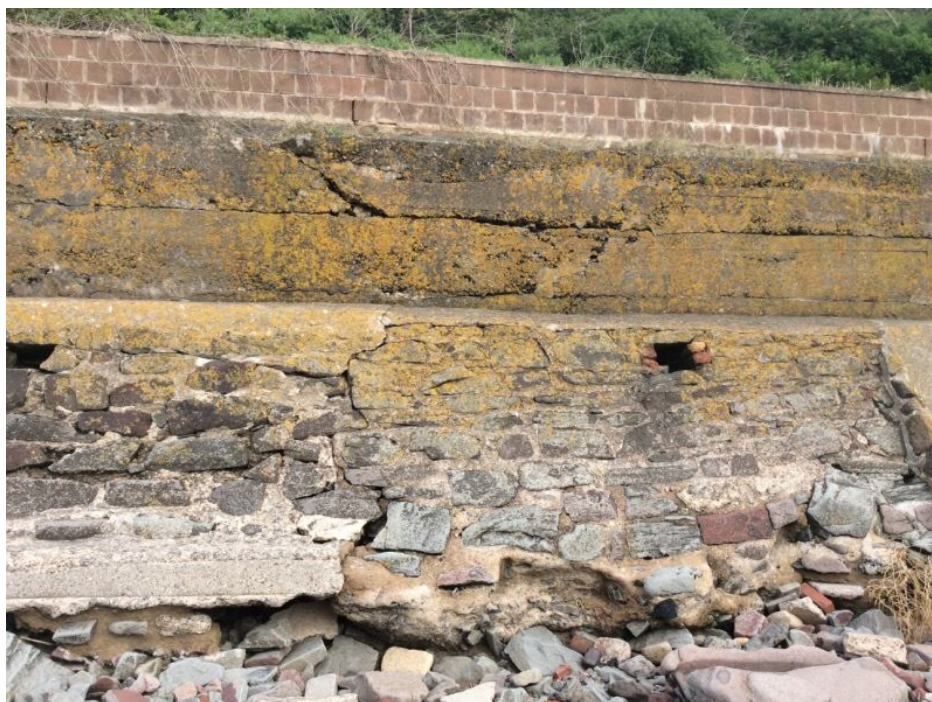
**Section A**  
**Wall section**  
**Defect Ref: D21**  
**Description:** Spalling concrete and localised section loss with possible reinforcement steel exposed. No change between 2020 and 2021 inspections.  
**Photo number: 47**

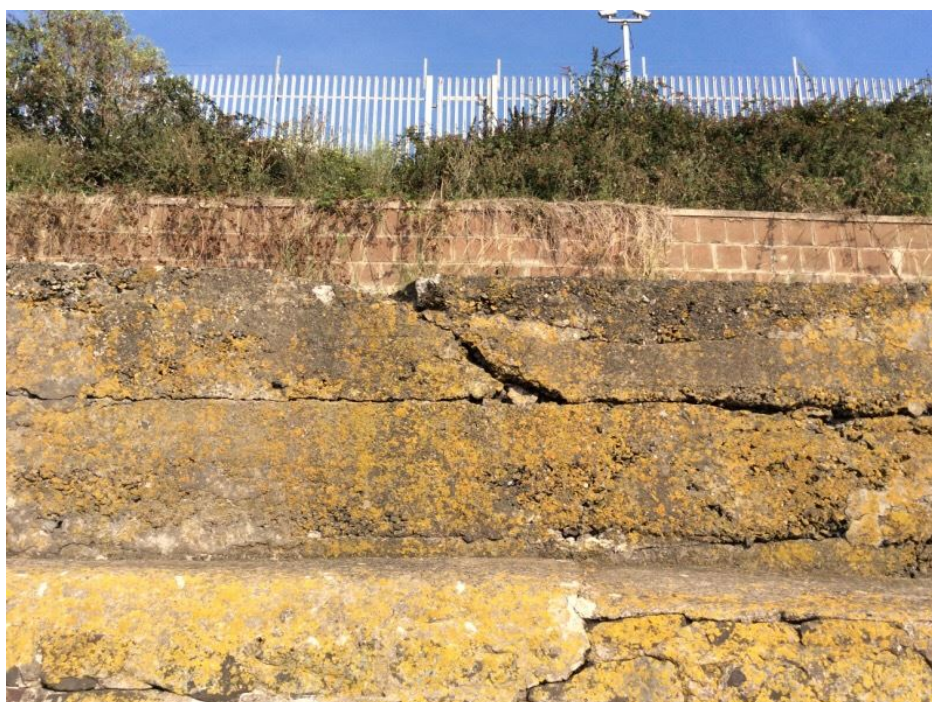
**Section A**  
**Wall section**  
**Defect Ref: D21**  
**Description:** Spalling concrete and localised section loss with possible reinforcement steel exposed. No change between 2020 and 2021 inspections.  
**Photo number: 117**

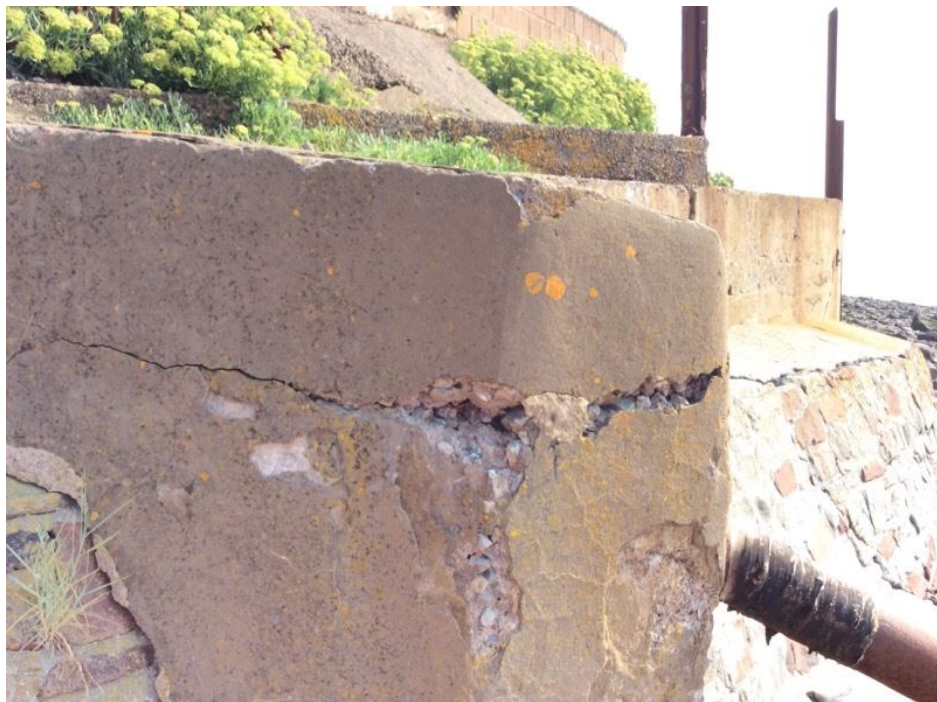
**Section B**  
**Downstream**  
**Headwall**  
**Defect Ref: D34**  
**Description:** Loss of mortar. No change between 2020 and 2021 inspections.  
**Photo number: 97**

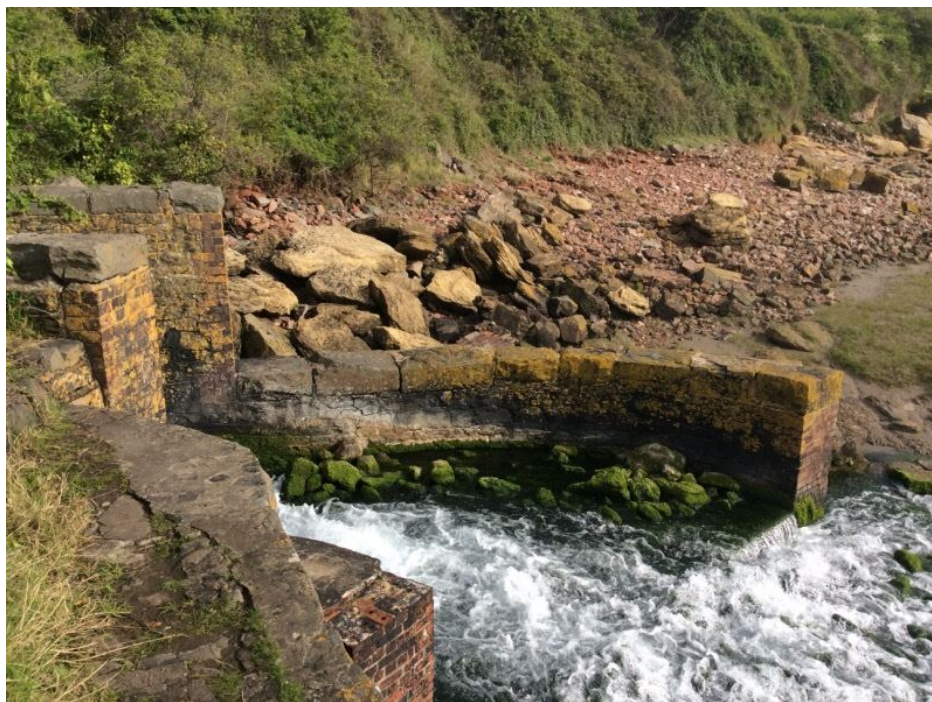
**Section B**  
**Downstream**  
**Headwall**  
**Defect Ref: D35**  
**Description:** Horizontal fracture of masonry wall (high wall). No change between 2020 and 2021 inspections.  
**Photo number: 98**
