Schedule 5 - Notification
NOTIFICATIONS OF UNAUTHORISED RELEASES in accordance with condition 4.3

Authorisation Reference **EPR/BK1341IN**

Operator **Valero Pembrokeshire Oil Terminal Limited** Reference Number **02/ 22**

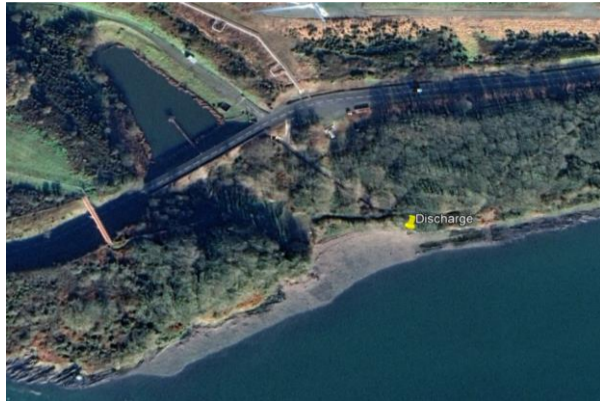
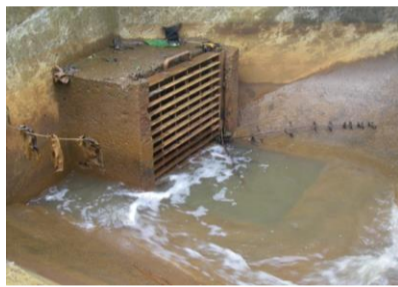
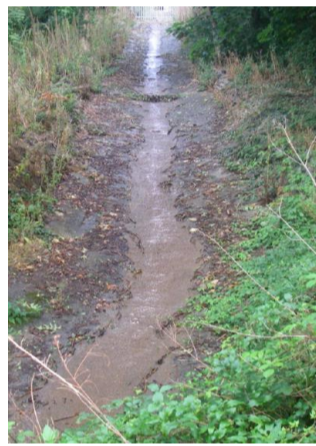
A member of the public reported 'oil gushing off site into Haven (spotted from coast path), 'dog covered in oil from swimming in slick (fuel oil)'. Reported via Site Security and NRW.
 The discharge was onto a public beach, 51°42'00.76"N 4°58'56.83"W.
 NRW Officers attended scene, Form LPR08 Number 10430, 8/9/22, 21:15.

Measures taken, or intended to be taken, to prevent a recurrence of the incident.
 Shift operators attended area. Samples collected. Investigation identified the East Catch Basin bypass channel grating was blocked with debris. This resulted in effluent discharging via the emergency overflow spill way onto a public beach.
 The bypass channel was cleared of debris which resulted in the level of the overflow chamber reducing and the effluent stream then took the conventional route offsite through the outfall pipeline, flow meter and auto sampler.
 VPOT shift operators will inspect the grating daily and remove debris as necessary.

Measures taken, or intended to be taken, to rectify, limit or prevent any pollution of the environment which has been or may be caused by the emission.
 No immediate measures identified. VPOT Management inspected scene 09:00 hrs Friday 9 September and no evidence of pollution observed.
 The bypass channel is in operation because of a leak in the clay liner of the East Catch Basin (Part A notification July 22, ref 22/01).
 The clay liner will be repaired so that the by pass channel is not the primary effluent discharge route in normal operation.
