Schedule 5 - Notification

NOTIFICATIONS OF UNAUTHORISED RELEASES in accordance with condition 4.3

Operator Valero Pembrokeshire Oil Terminal Limited

Reference Number 03/22

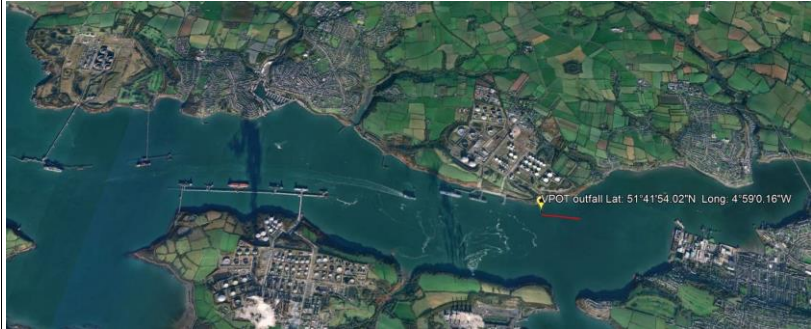
Oil sheen observed extending approximately 500 m from VPOT outfall diffuser towards Pembroke Dock (red line on images below is to scale, direction is for illustrative purposes only).

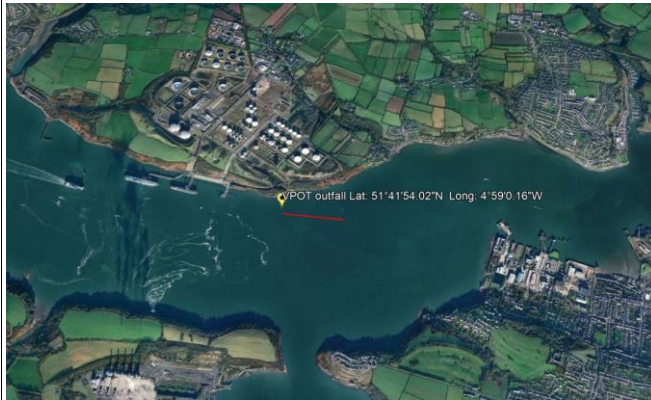
Description of where any release into the environment took place
