Photos from inspection on 03.10.19

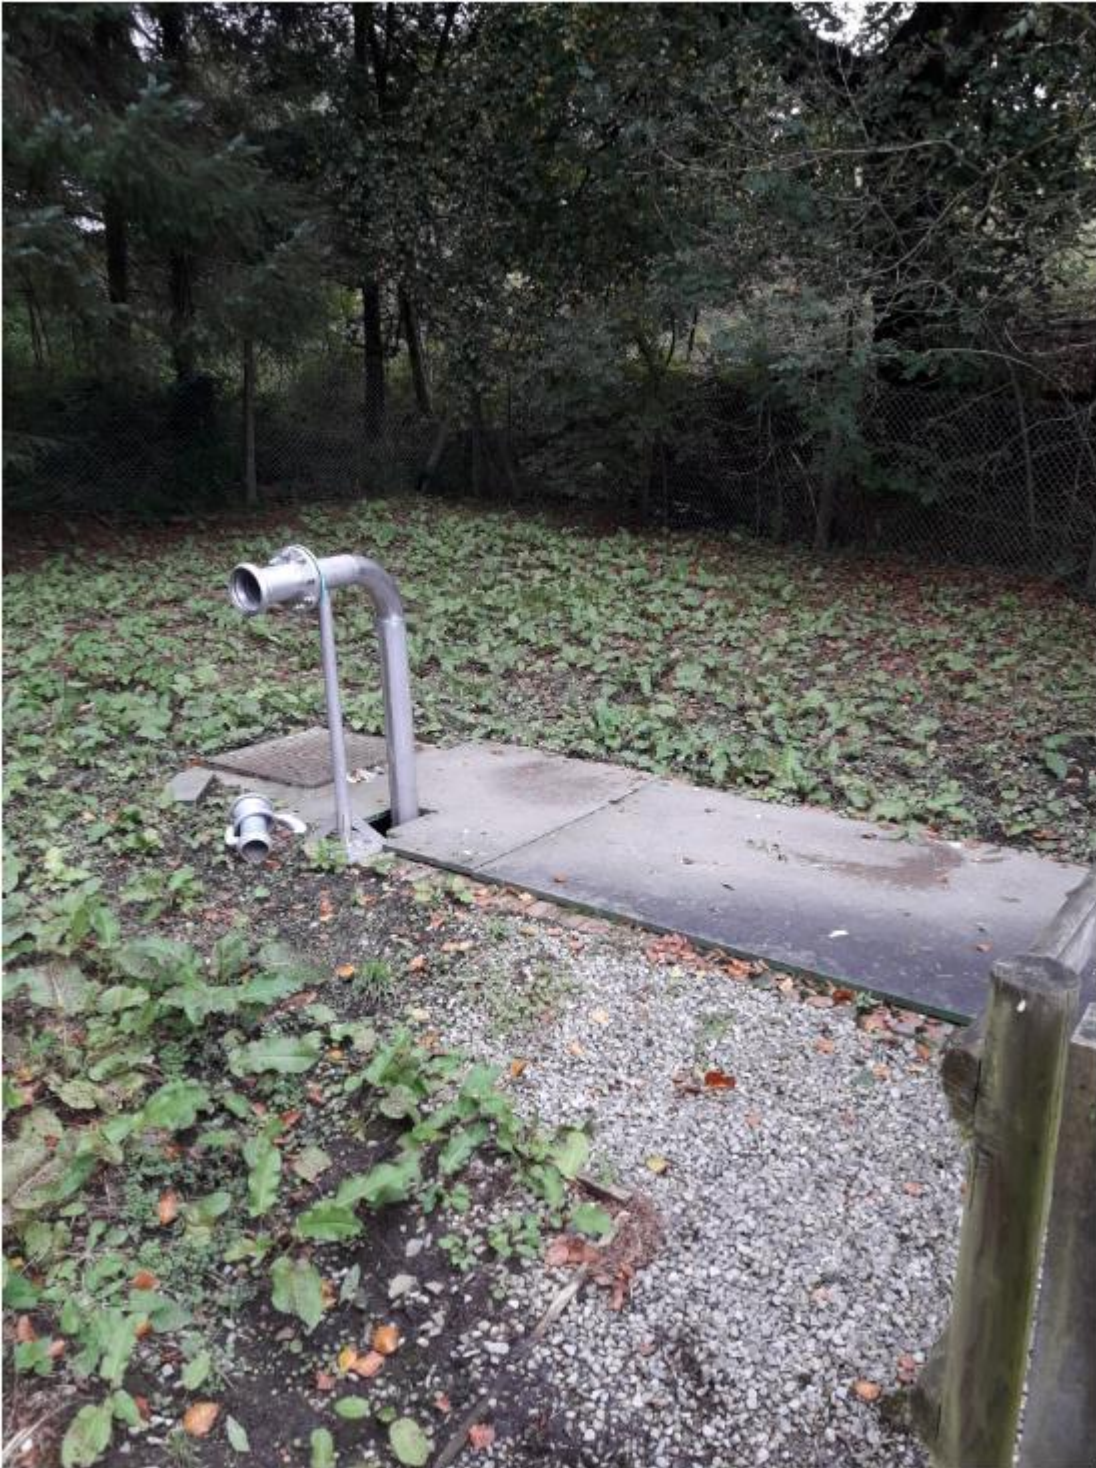
Inlet, primary tank and sludge tankering point.

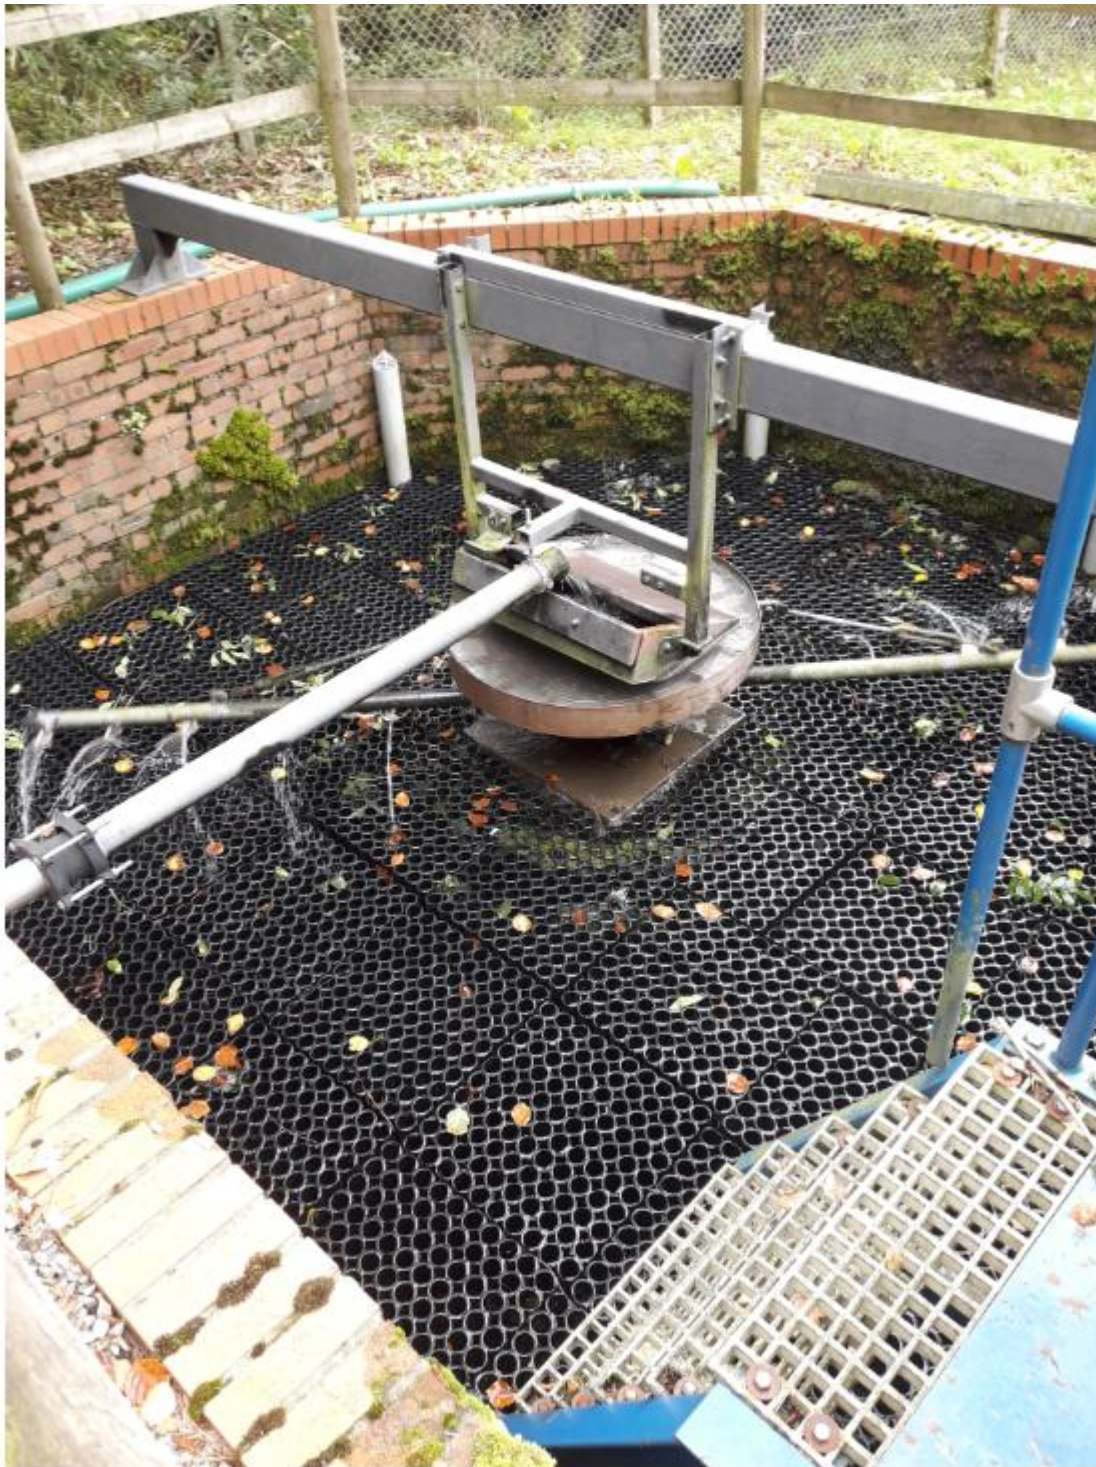
Trickling filter bed.

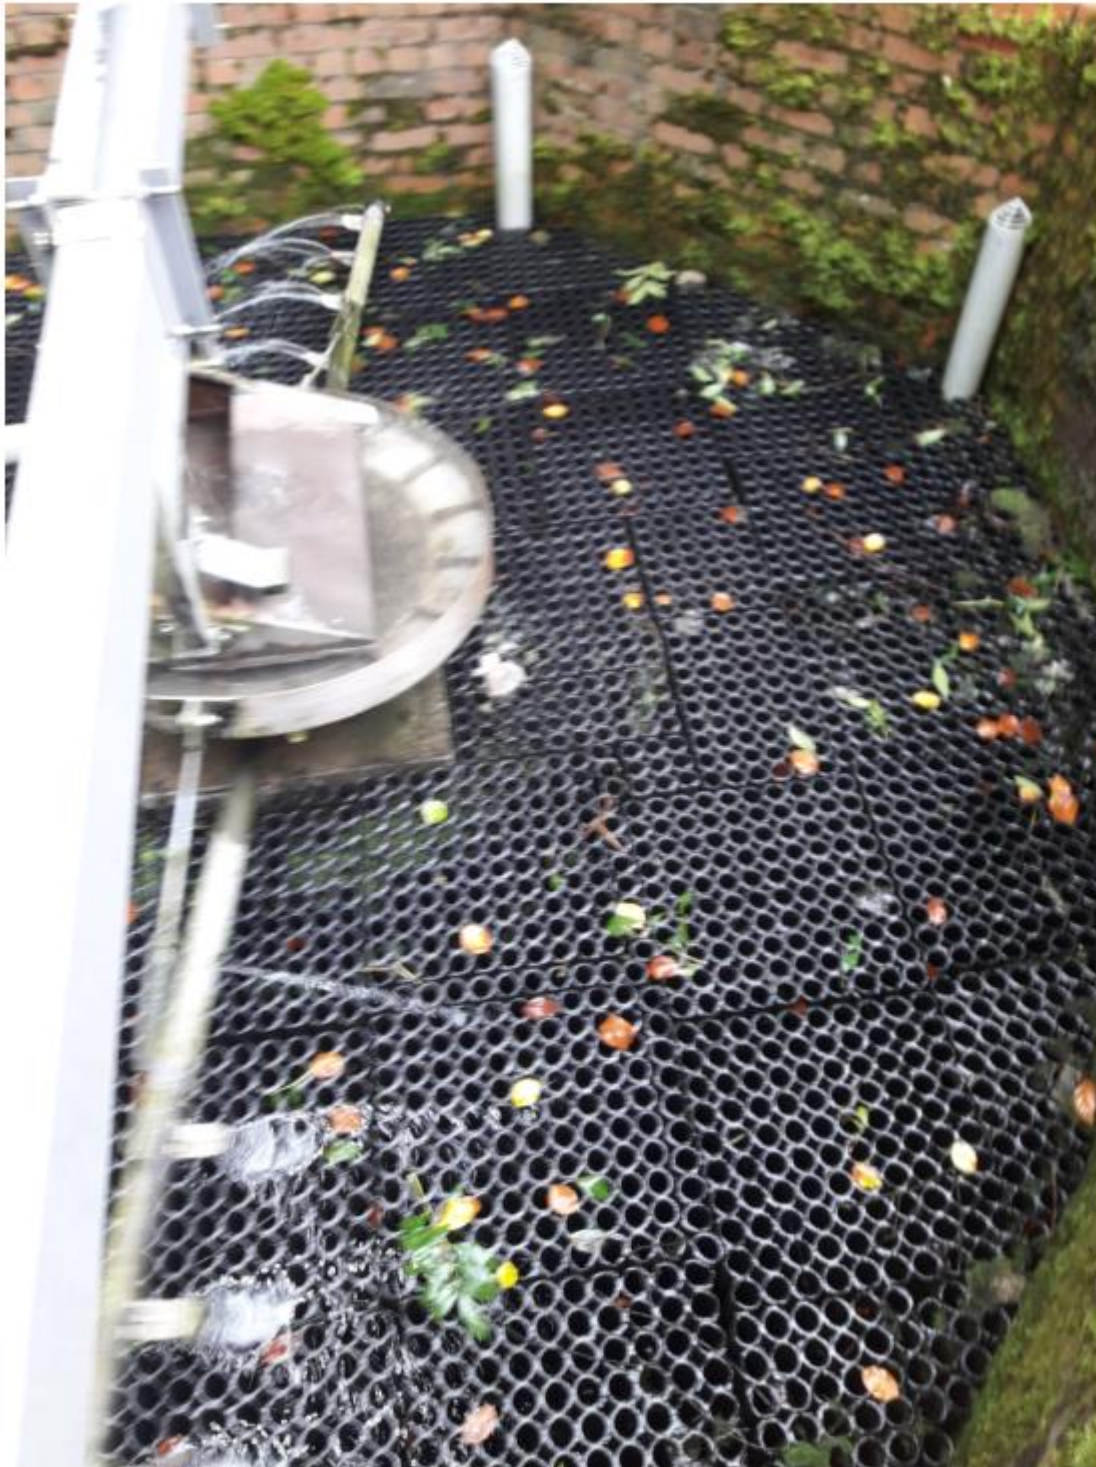
Sanitary waste on filter media.

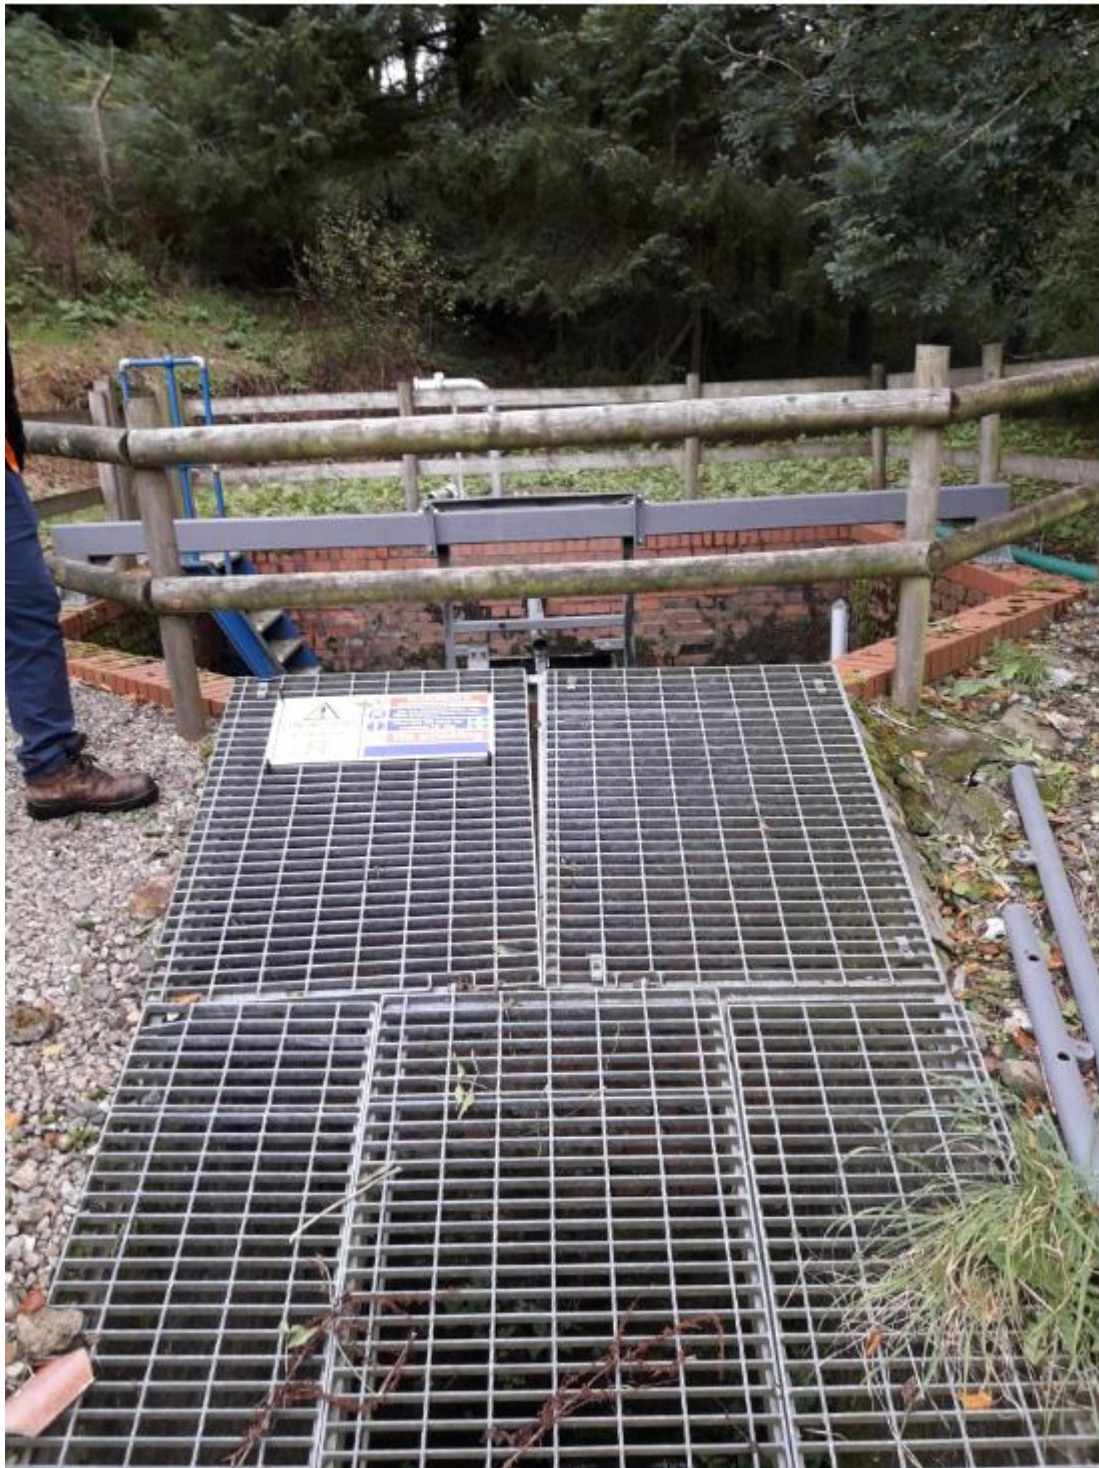
Outlet pipe from trickling filter bed flows into an open chamber where it can be observed.

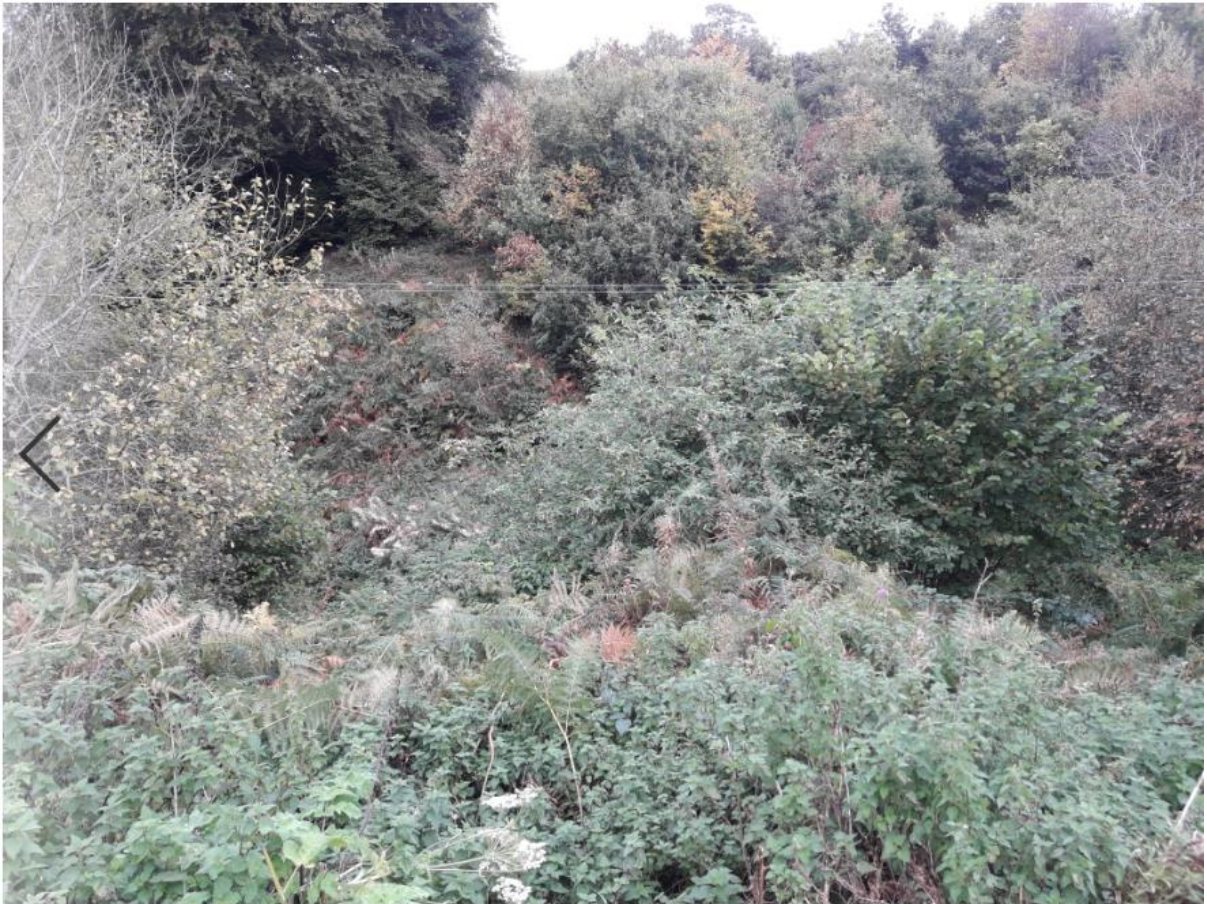
Suspected location of soakaway pit and herringbone soakaway
