Nine Mile Point Waste Processing Facility

Validation Report for Pre-Operational

Condition No. 9

| TITLE | Nine Mile Point Waste Processing Facility- Validation Report for Permit Pre-Operational Condition No. 9 |

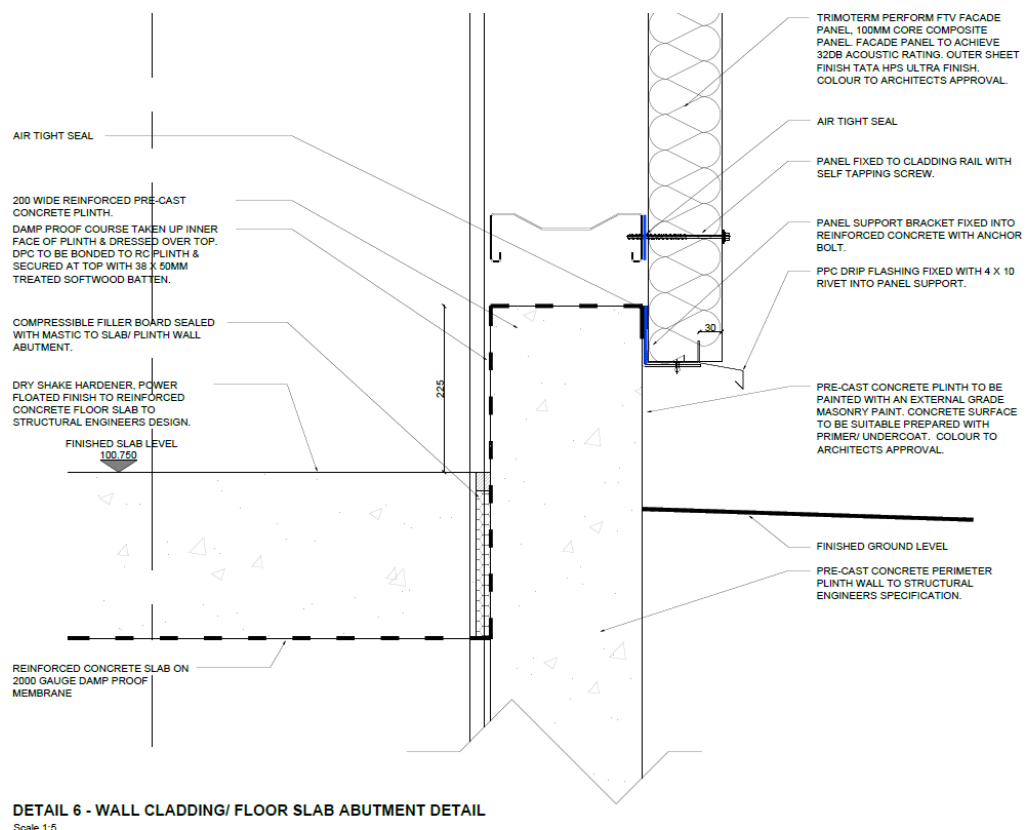
Figure 3.1 – Internal Reinforced Concrete Slab

- 3.2 Figure 3.1 above shows that the joint between the slab and building perimeter included compressible filler board sealed with mastic to provide an impermeable joint.
- 3.3 The 2000g membrane acts to prevent ground gas rising, but also acts to stop a liquids entering the underlying soil, therefore creating an impermeable surface.
- 3.4 The combination of a cast in situ reinforced slab and impermeable joints provide an impermeable surface for the waste reception, handling, processing and storage areas as

- 3.5 During site inspections, it was witnessed that all works were undertaken to high standard with no workmanship or quality issues identified that would impact the impermeability of the slab.
- 3.6 Frequent inspections of the internal slab and joints will need to be undertaken to ensure the integrity has not been compromised. Any necessary repairs should be undertaken immediately.

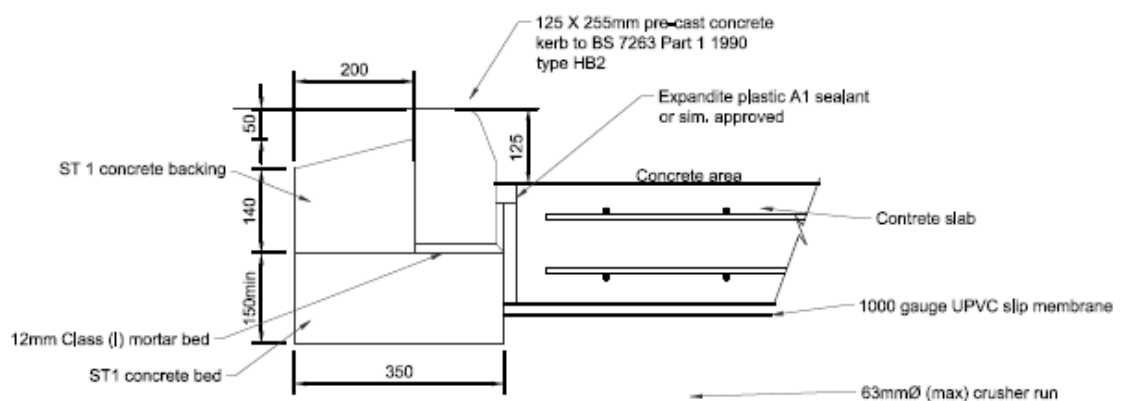
Figure 4.1 – External Reinforced Concrete Slab – Perimeter Joint

- 4.4 The combination of a cast in situ reinforced slab and impermeable joints provide an impermeable surface for the waste reception, handling, processing and storage areas as per the BAT Conclusion 19 of the Waste Treatment BAT Conclusion (EU 2018).
- 4.5 During site inspections, it was witnessed that all works were undertaken to high standard with no workmanship or quality issues identified that would impact the impermeability of the slab.
- 4.6 Frequent inspections of the external slab and joints will need to be undertaken to ensure the integrity has not been compromised. Any necessary repairs should be undertaken immediately.

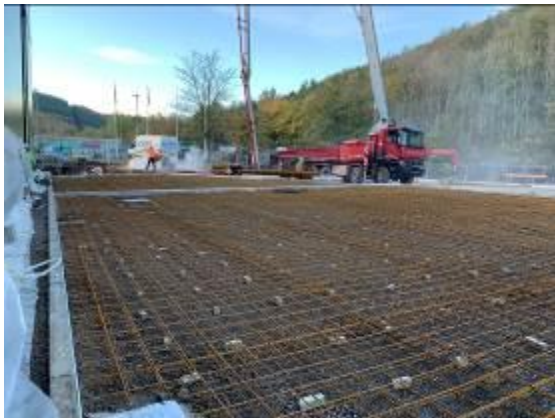
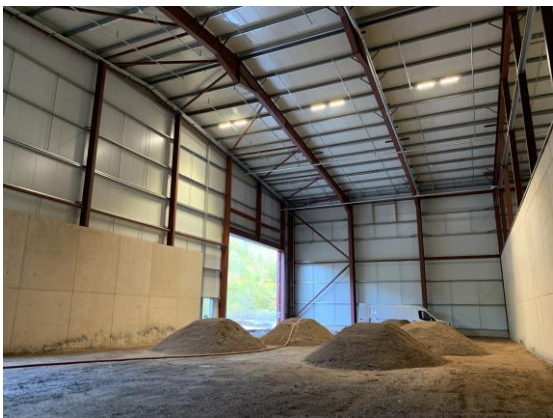
| CONTRACTOR'S ACTIVITIES & APPROX. LOCATION <ul style="list-style-type: none"> External concrete slab works being undertaken in rear yard – rebar installed and concrete being placed via concrete pump – no issues with works being undertaken. Internal reinforced concrete floor slab preparation works being undertaken, including placement of stone to form levels / subbase – no sharp objects or defects identified. Cladding works near completion – final cladding panels being installed on south east corner of main building – query raised with contractor over torque settings of cladding panels – Contractor to review with cladding sub-contractor and confirm via email. Surface water drainage works ongoing on eastern boundary of site. | |

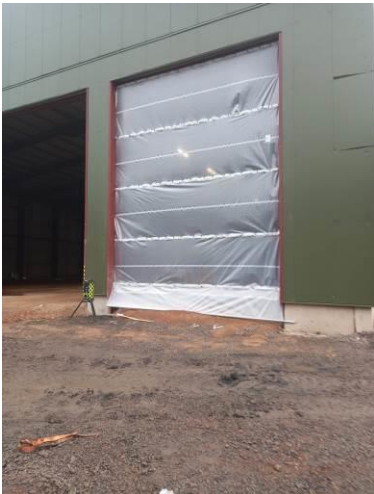
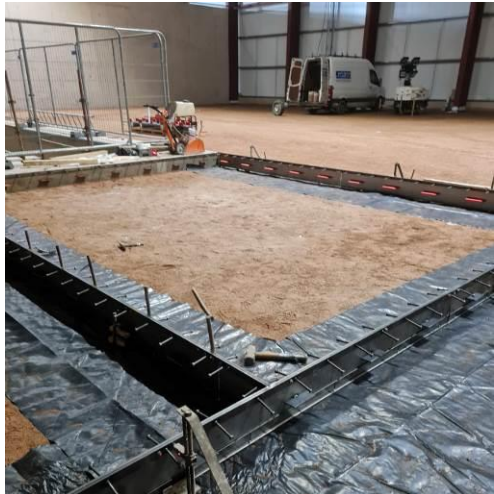
| <ul style="list-style-type: none"> External concrete slab works being undertaken in on eastern boundary – 2 layers (top & bottom) rebar being installed Internal reinforced concrete floor slab preparation – 2000g DPM being installed below slab and concrete shuttering progressing. Joints in membrane being sealed with tape. No sharp objects or issues identified with membrane. Western Power cable works ongoing Heol Tir Ton Road Additional delivery of cladding required to finish cladding works. Interim solution on south east corner. Temporary roller shutter door protection covers installed to protect reinforced concrete slab pour from precipitation and wind. Cable duct works progressing on western elevation – no issues identified | | | |
