| Location Plan: | | Pwll Sea Wall | |
| | | Structure Reference: | 226 21.5 |

# COASTAL ASSET CONDITION SURVEY REPORT

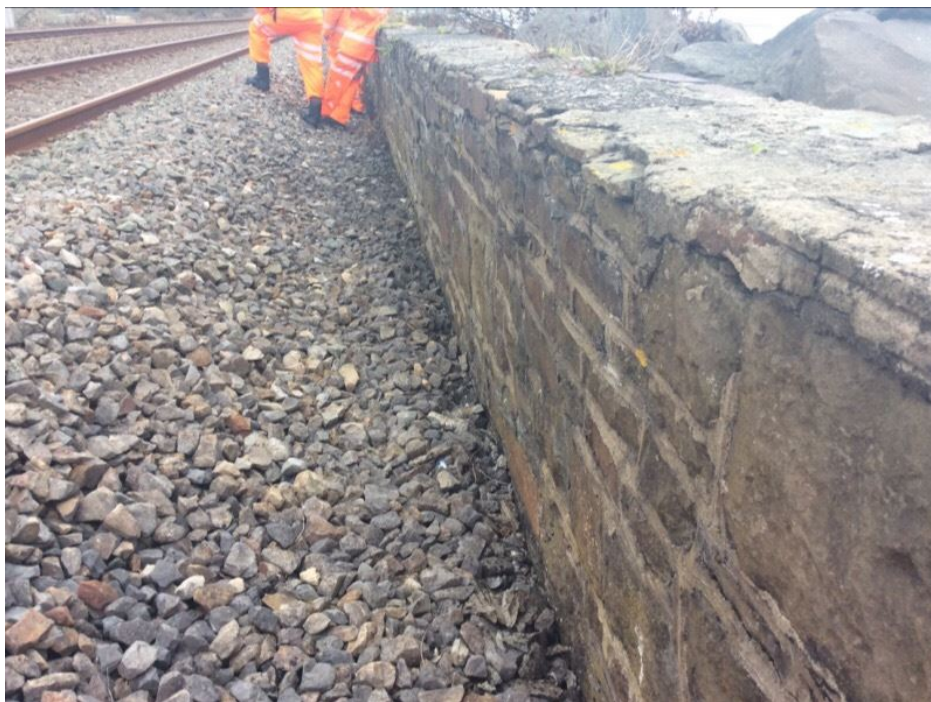
**Section A**  
**Capping Wall**  
**Defect Ref: D4**  
**Description:** Parapet wall is leaning towards the track. No change between the 2019 and 2020 inspections.  
**Photo number: 181**

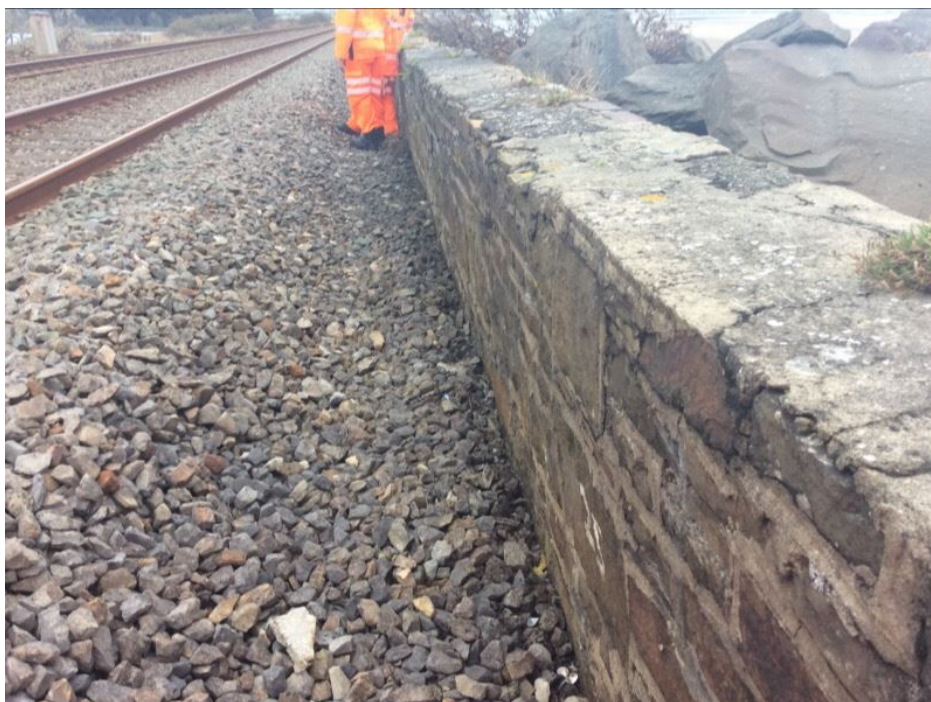
**Section A**  
**Capping Wall**  
**Defect Ref: D4**  
**Description:** Parapet wall is leaning towards the track. No change between the 2019 and 2020 inspections.  
**Photo number: 182**

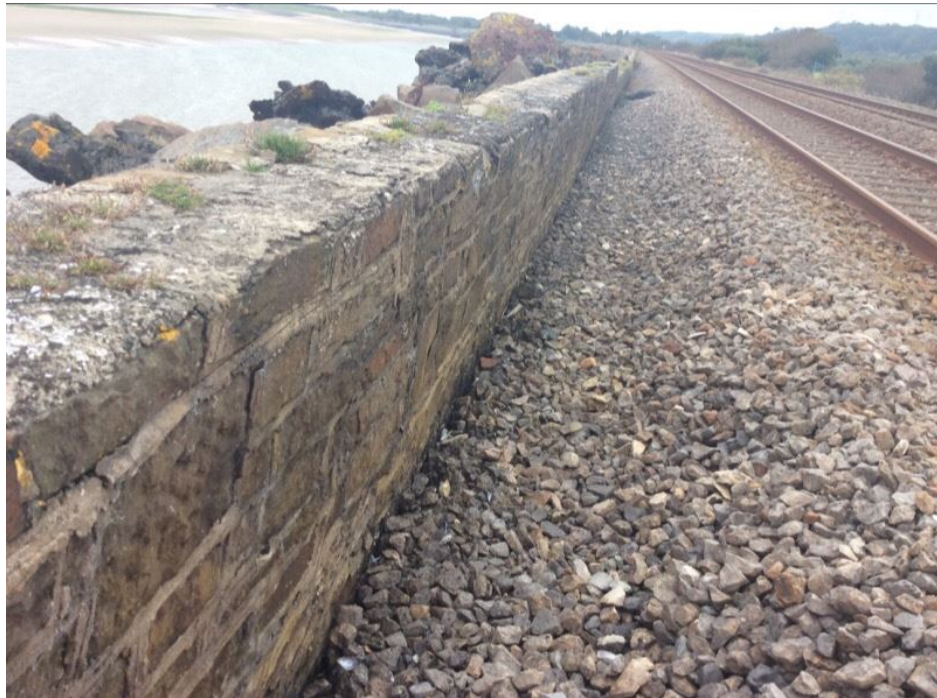
| Defect Ref No. | Defect Location (NGR) | Major Element | Minor Element | Photo Ref | Severity | Probability | Risk Score | Below MHS | Defect Description | Recommendations | Defect Priority |
|---|---|---|---|---|---|---|---|---|---|---|---|
| D5 | 249300, 200200 | Embankment | Capping Wall | 52, 53, 98, 105, 106, 164, 167 | 2 | 3 | 6 | False | Vegetation growth could weaken embankment armour and cause localised structural damage. Increased in severity between the 2019 and 2020 inspections as more vegetation and cracking in mortar was noted. | Remove vegetation, and repair any damage caused. | 6 |

**Section A**  
**Capping Wall**  
**Defect Ref: D5**  
**Description:** Vegetation growth could weaken embankment armour and cause localised structural damage. Increased in severity between the 2019 and 2020 inspections as more vegetation and cracking in mortar was noted.  
**Photo number: 52**

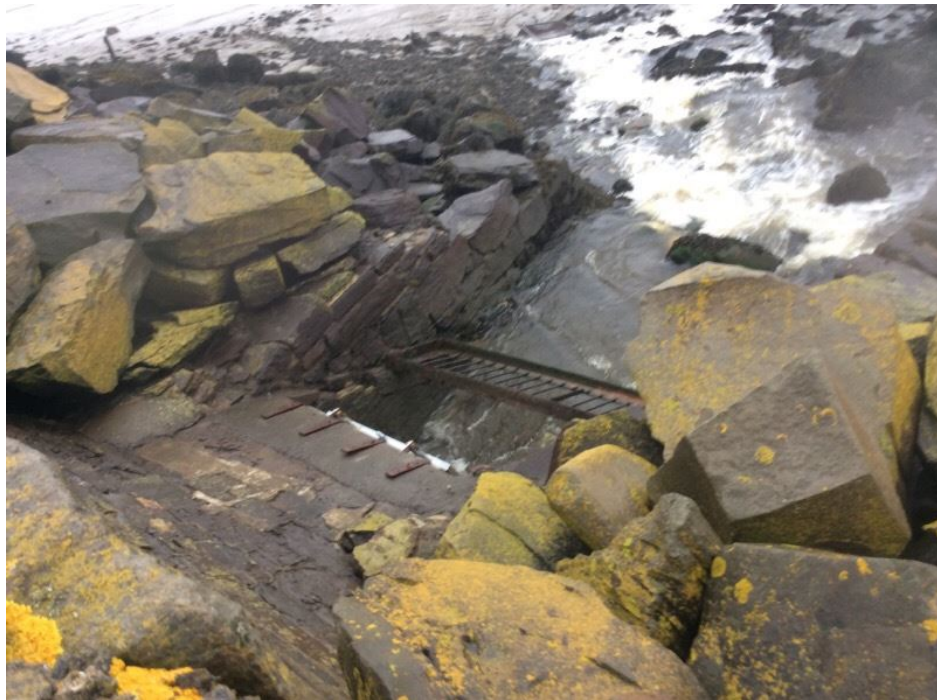
| Defect Ref No. | Defect Location (NGR) | Major Element | Minor Element | Photo Ref | Severity | Probability | Risk Score | Below MHS | Defect Description | Recommendations | Defect Priority |
|---|---|---|---|---|---|---|---|---|---|---|---|
| D6 | 248245, 200621 | Embankment | Capping Wall | 54, 112, 113, 192, 193 | 5 | 2 | 10 | True | Damaged and corroded trash screen. Both the lower and upper screens were found to be detached during the 2020 inspection. | Replace the trash screen and remove the existing ones. | 1 |

**Section A**  
**Capping Wall**  
**Defect Ref: D6**  
**Description:**  
Damaged and corroded trash screen. Both the lower and upper screens were found to be detached during the 2020 inspection.  
**Photo number: 113**

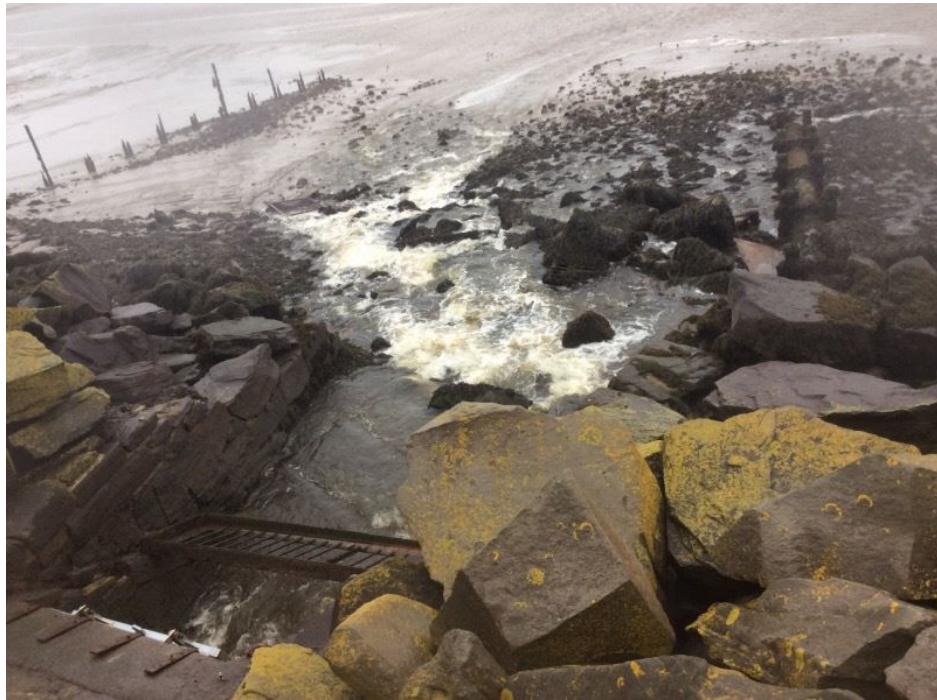
**Section A**  
**Capping Wall**  
**Defect Ref: D6**  
**Description:**  
Damaged and corroded trash screen. Both the lower and upper screens were found to be detached during the 2020 inspection.  
**Photo number: 192**

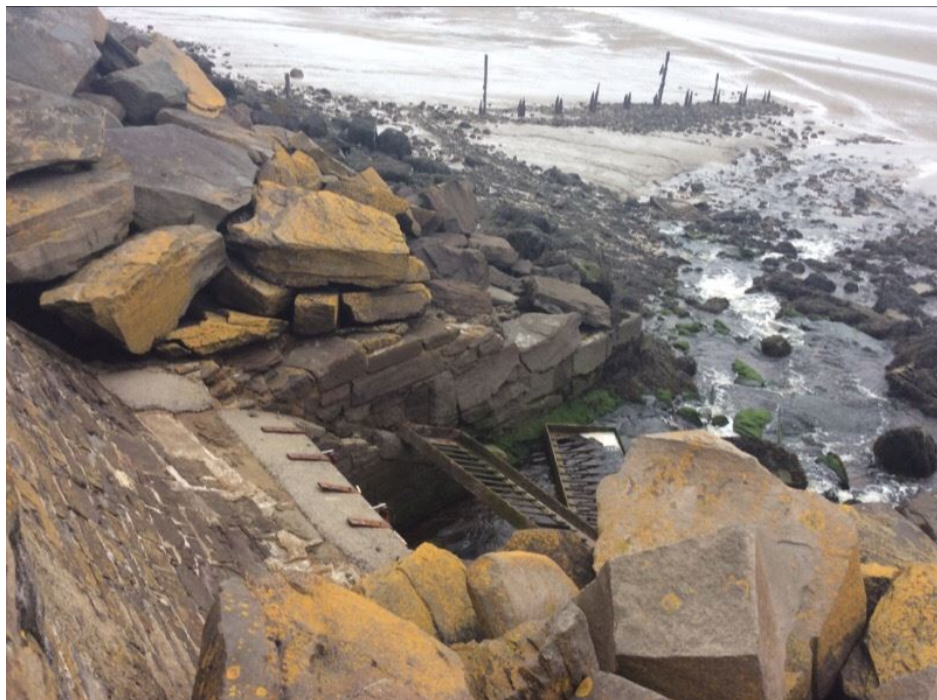
**Section A**  
**Capping Wall**  
**Defect Ref: D6**  
**Description:**  
Damaged and corroded trash screen. Both the lower and upper screens were found to be detached during the 2020 inspection.  
**Photo number: 193**

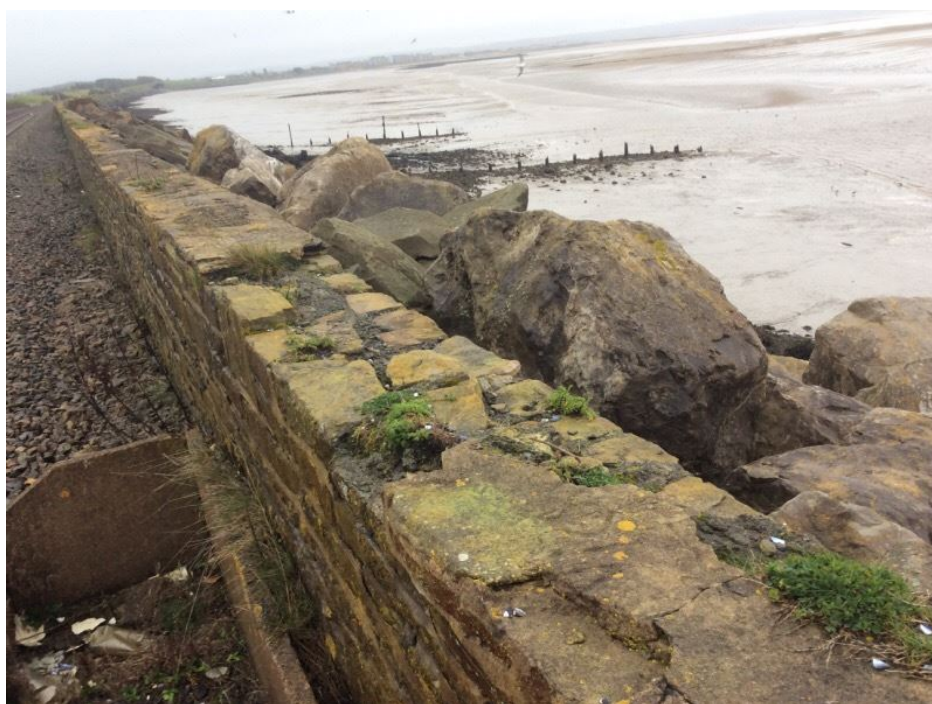
| Defect Ref No. | Defect Location (NGR) | Major Element | Minor Element | Photo Ref | Severity | Probability | Risk Score | Below MHS | Defect Description | Recommendations | Defect Priority |
|---|---|---|---|---|---|---|---|---|---|---|---|
| D7 | 249300, 200200 | Embankment | Capping Wall | 55, 56, 108, 109, 110, 194, 195, 196, 197, 198 | 2 | 3 | 6 | False | Damaged parapet and capping. A section of the capping wall has been replaced between the 2019 and 2020 inspections. However, there are still missing blocks noted in the existing wall. | Repair damaged sections. | 4 |

**Section A**  
**Capping Wall**  
**Defect Ref: D7**  
**Description:**  
Damaged parapet and capping. A section of the capping wall has been replaced between the 2019 and 2020 inspections. However, there are still missing blocks noted in the existing wall.  
**Photo number: 194**

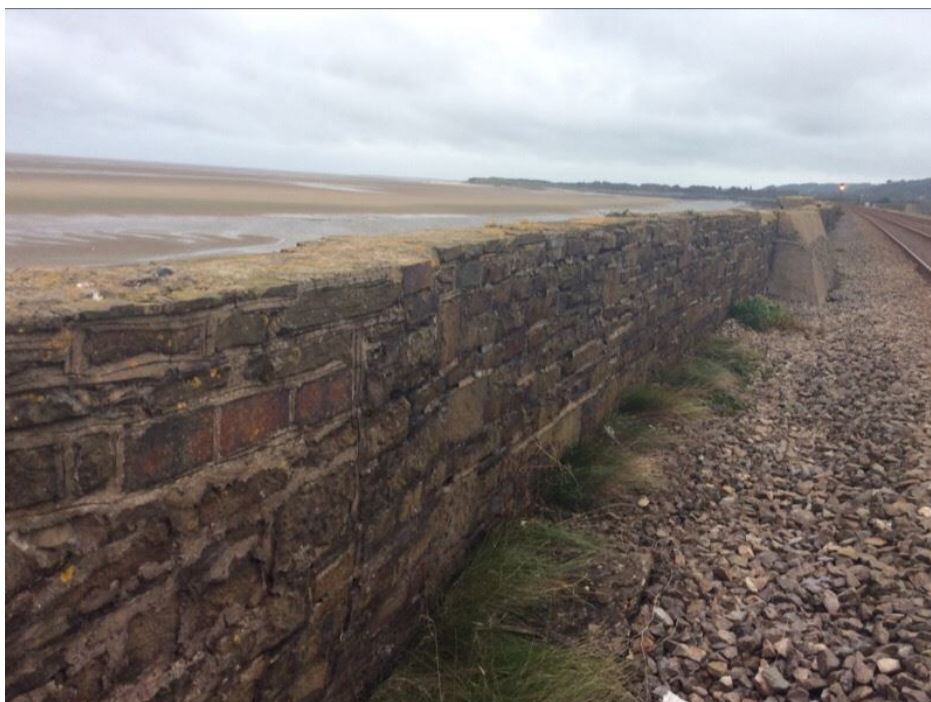
**Section A**  
**Capping Wall**  
**Defect Ref: D7**  
**Description:**  
Damaged parapet and capping. A section of the capping wall has been replaced between the 2019 and 2020 inspections. However, there are still missing blocks noted in the existing wall.  
**Photo number: 196**

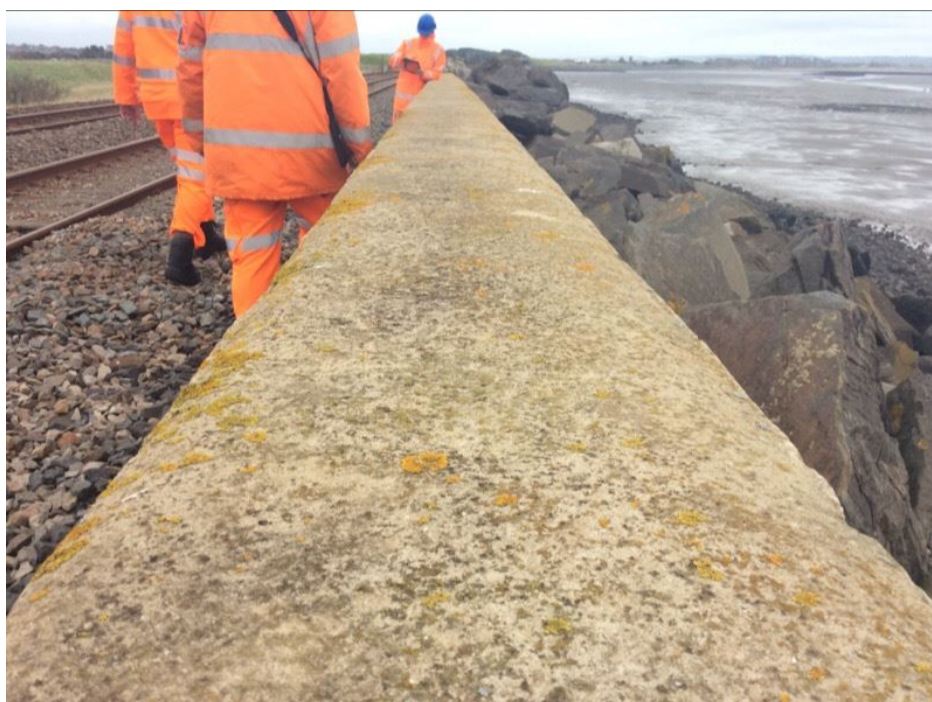
**Section A**  
**Capping Wall**  
**Defect Ref: D7**  
**Description:** Damaged parapet and capping. A section of the capping wall has been replaced between the 2019 and 2020 inspections. However, there are still missing blocks noted in the existing wall.  
**Photo number: 198**

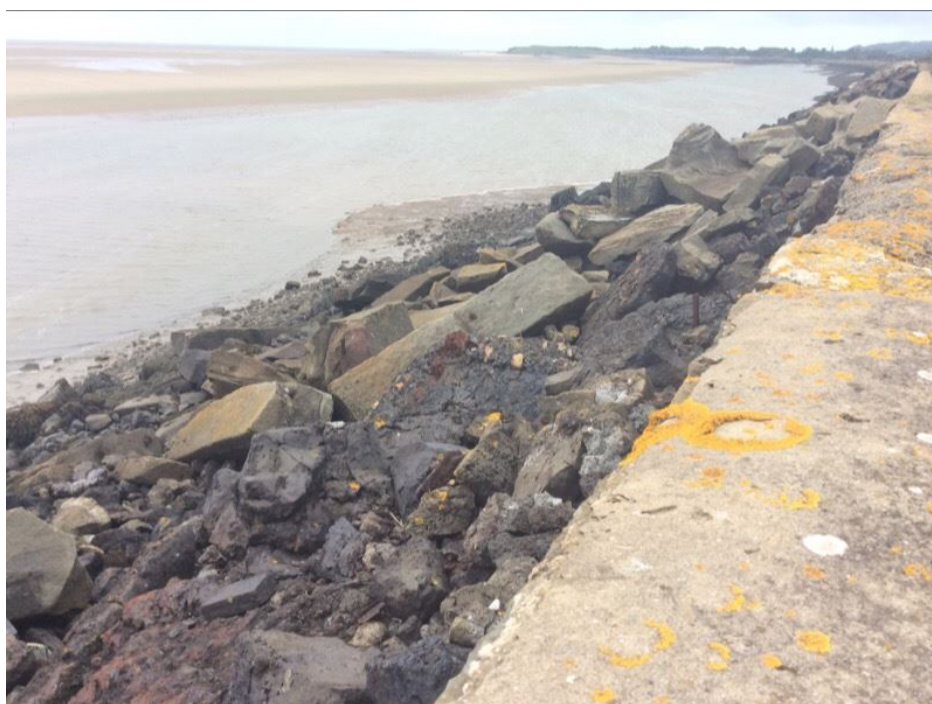
**Section A**  
**Embankment**  
**Armour**  
**Defect Ref: D9**  
**Description:** Lack of crest width on rock embankment, leading to instabilities in the defence. No change between 2019 and 2020 inspections.  
**Photo number: 58**

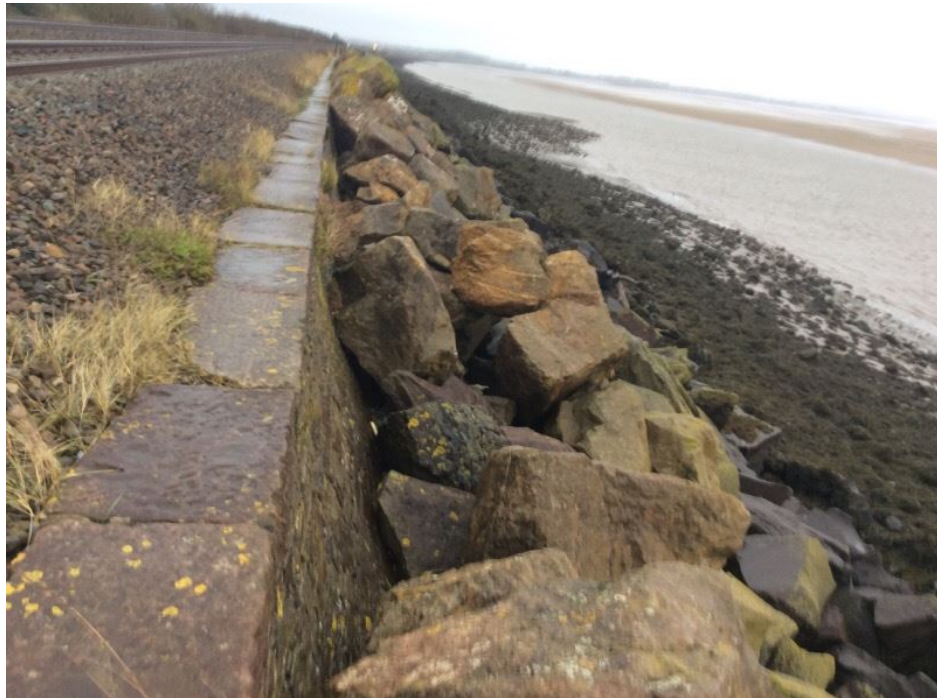
| Defect Ref No. | Defect Location (NGR) | Major Element | Minor Element | Photo Ref | Severity | Probability | Risk Score | Below MHS | Defect Description | Recommendations | Defect Priority |
|---|---|---|---|---|---|---|---|---|---|---|---|
| D12 | 249300, 200200 | Embankment | Embankment Armour | 61, 62, 63, 89, 90, 96, 121, 156, 157, 161, 163, 168 | 4 | 2 | 8 | False | Isolated lack of rock armour. Masonry wall exposed to increased wave loading. No change between 2019 and 2020 inspections. | Replace rock armour. | 8 |

**Section A**  
**Embankment**  
**Armour**  
**Defect Ref: D12**  
**Description:** Isolated lack of rock armour. Masonry wall exposed to increased wave loading. No change between 2019 and 2020 inspections.  
**Photo number: 96**

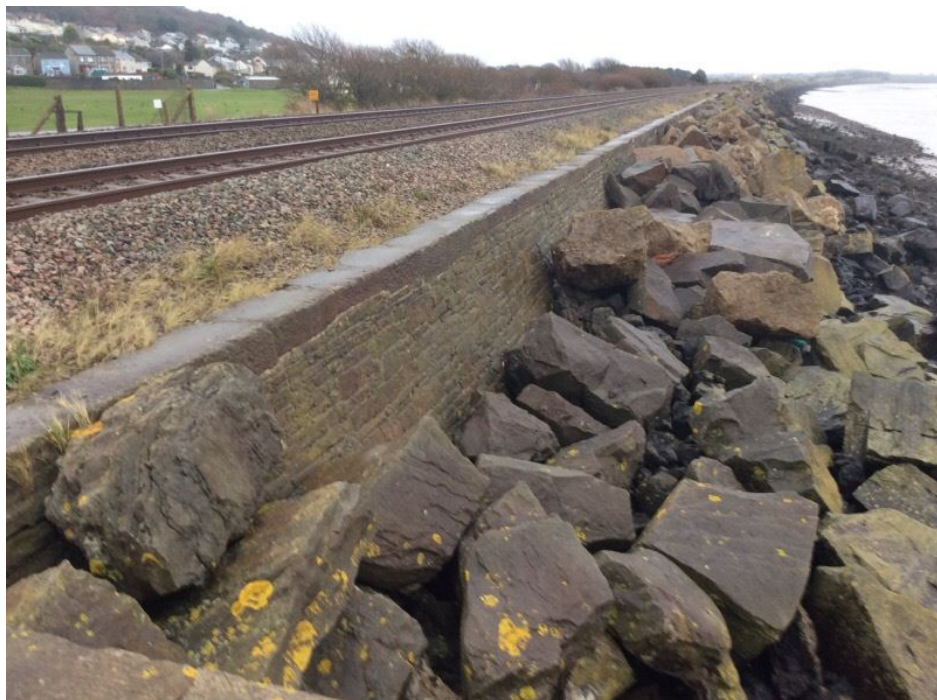
**Section A**  
**Embankment**  
**Armour**  
**Defect Ref: D12**  
**Description:** Isolated lack of rock armour. Masonry wall exposed to increased wave loading. No change between 2019 and 2020 inspections.  
**Photo number: 121**

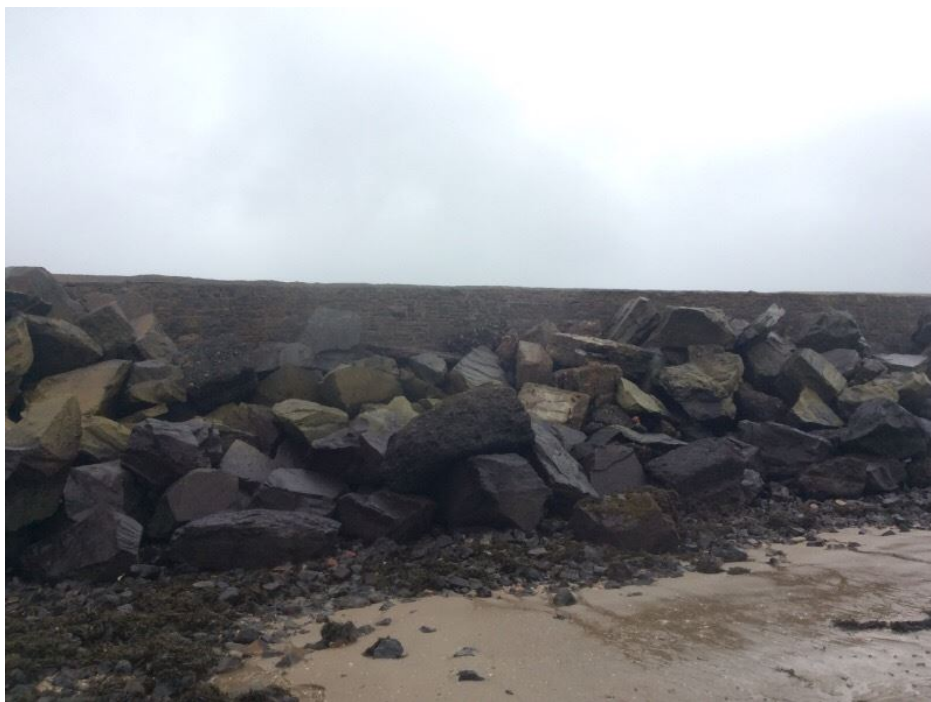
**Section A**  
**Embankment**  
**Armour**  
**Defect Ref: D12**  
**Description:** Isolated lack of rock armour. Masonry wall exposed to increased wave loading. No change between 2019 and 2020 inspections.  
**Photo number: 156**

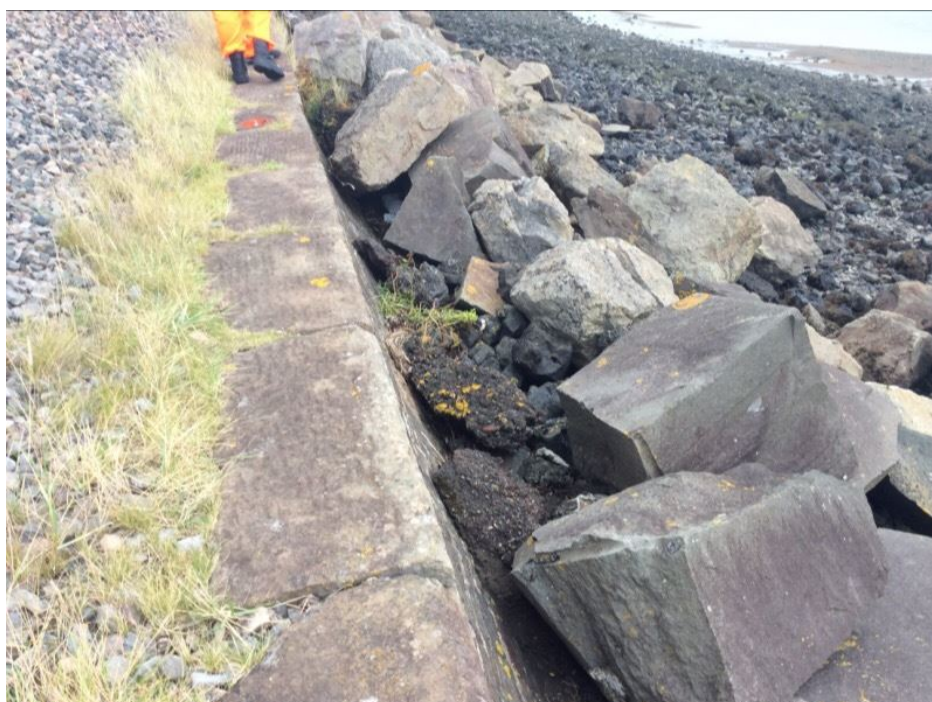
| Defect Ref No. | Defect Location (NGR) | Major Element | Minor Element | Photo Ref | Severity | Probability | Risk Score | Below MHS | Defect Description | Recommendations | Defect Priority |
|---|---|---|---|---|---|---|---|---|---|---|---|
| D13 | 247310, 200796 | Embankment | Embankment Armour | 64, 95, 171 | 1 | 1 | 1 | True | Algae covered access ramp providing slipping hazard. This defect has been addressed between 2019 and 2020 inspections. | Close out defect. | 9 |

**Section A**  
**Embankment**  
**Armour**  
**Defect Ref: D13**  
**Description:** Algae covered access ramp providing slipping hazard. This defect has been addressed between 2019 and 2020 inspections.  
**Photo number: 64**

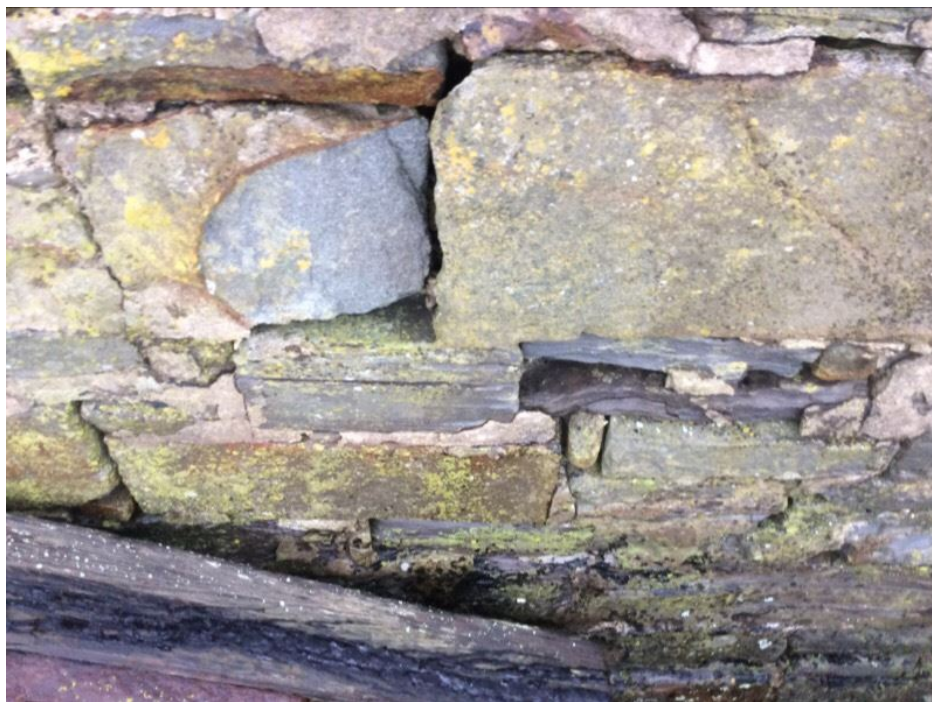
| Defect Ref No. | Defect Location (NGR) | Major Element | Minor Element | Photo Ref | Severity | Probability | Risk Score | Below MHS | Defect Description | Recommendations | Defect Priority |
|---|---|---|---|---|---|---|---|---|---|---|---|
| D14 | 247310, 200798 | Embankment | Capping Wall | 65, 101, 170 | 2 | 3 | 6 | True | Open joints, if left unrepaired further deterioration of the wall is expected. No change between 2019 and 2020 inspections. | Repoint missing and worn mortar between masonry units. | 5 |

**Section A**  
**Capping Wall**  
**Defect Ref: D14**  
**Description:** Open joints, if left unrepaired further deterioration of the wall is expected. No change between 2019 and 2020 inspections.  
**Photo number: 170**

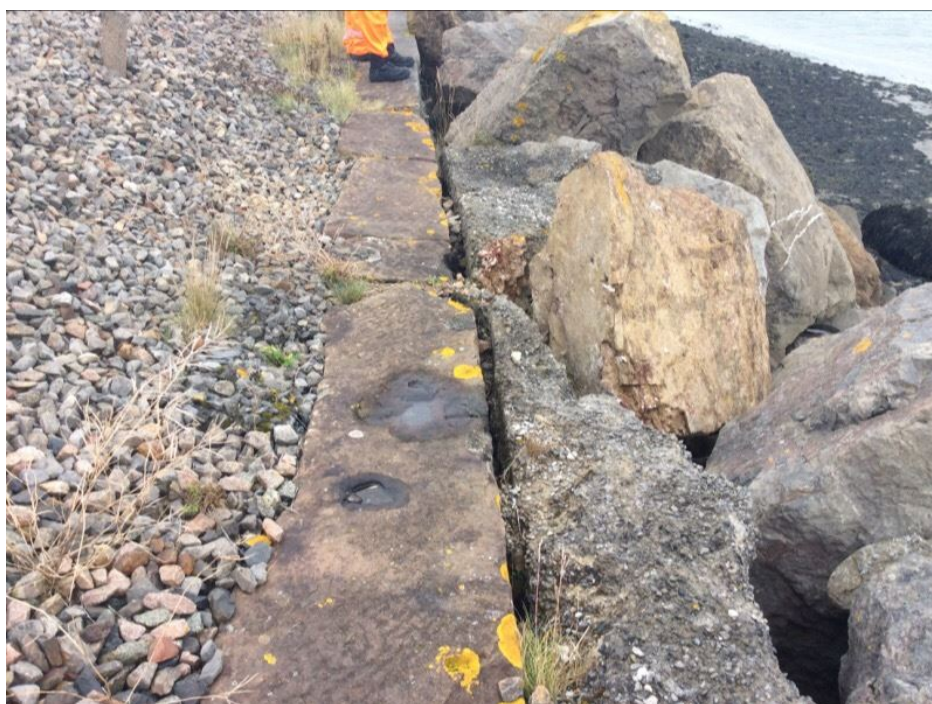
**Section A**  
**Embankment**  
**Armour**  
**Defect Ref: D17**  
**Description:**  
Embankment slope  
too steep by design  
standards. No change  
between 2019 and  
2020 inspections.  
**Photo number: 68**

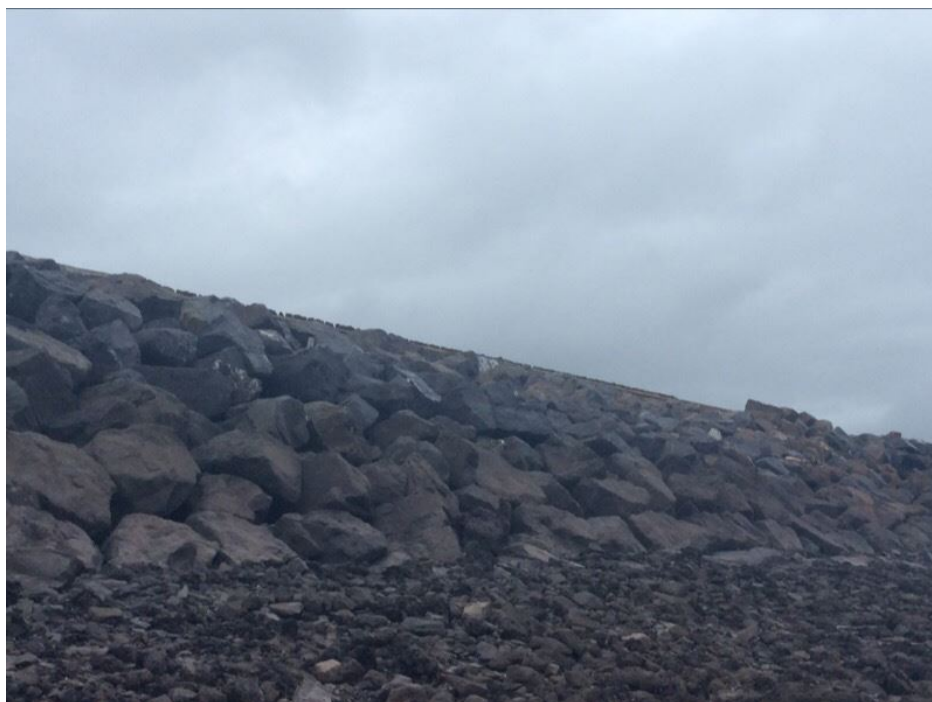
| Defect Ref No. | Defect Location (NGR) | Major Element | Minor Element | Photo Ref | Severity | Probability | Risk Score | Below MHWS | Defect Description | Recommendations | Defect Priority |
|---|---|---|---|---|---|---|---|---|---|---|---|
| D19 | 248806, 200444 | Embankment | Embankment Armour | 131, 132, 133, 201, 202 | 1 | 1 | 1 | False | Failed parapet wall sections. This defect has been repaired between 2014 and 2019. | Close out defect. | 15 |

**Section A**  
**Embankment**  
**Armour**  
**Defect Ref: D19**  
**Description:** Failed  
parapet wall sections.  
This defect has been  
repaired between  
2014 and 2019.  
**Photo number: 202**

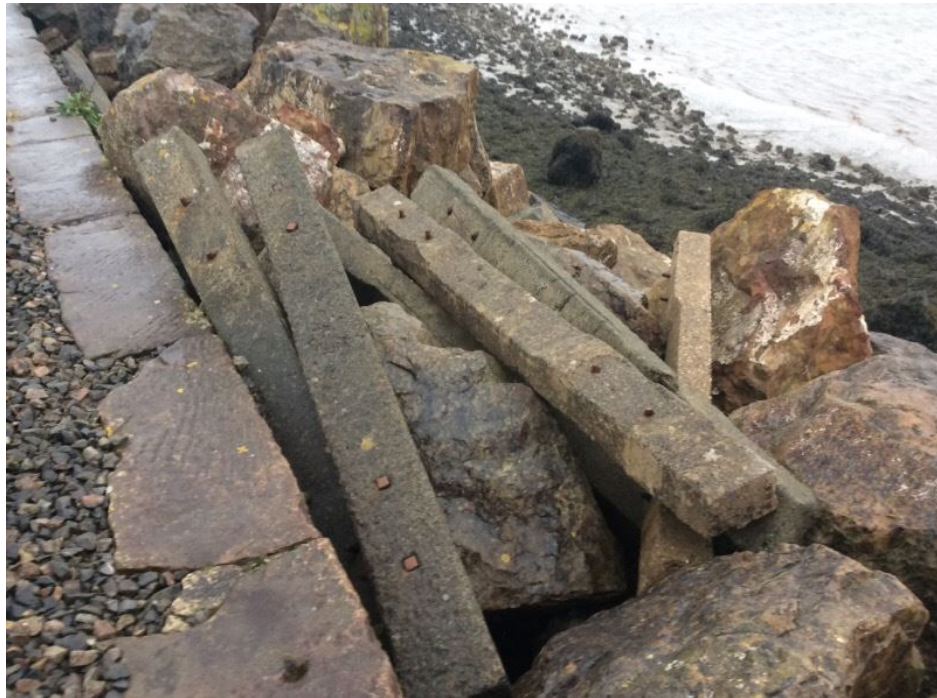
| Defect Ref No. | Defect Location (NGR) | Major Element | Minor Element | Photo Ref | Severity | Probability | Risk Score | Below MHWS | Defect Description | Recommendations | Defect Priority |
|---|---|---|---|---|---|---|---|---|---|---|---|
| D20 | 248629, 200487 | Embankment | Embankment Armour | 70, 88, 116, 159, 160, 203 | 4 | 2 | 8 | True | Non-standard and ineffective armour units. No change between 2019 and 2020 inspections. | Remove and replace ineffective protection with rock armour. | 14 |

**Section A**  
**Embankment**  
**Armour**  
**Defect Ref: D20**  
**Description:** Non-standard and ineffective armour units. No change between 2019 and 2020 inspections.  
**Photo number: 116**

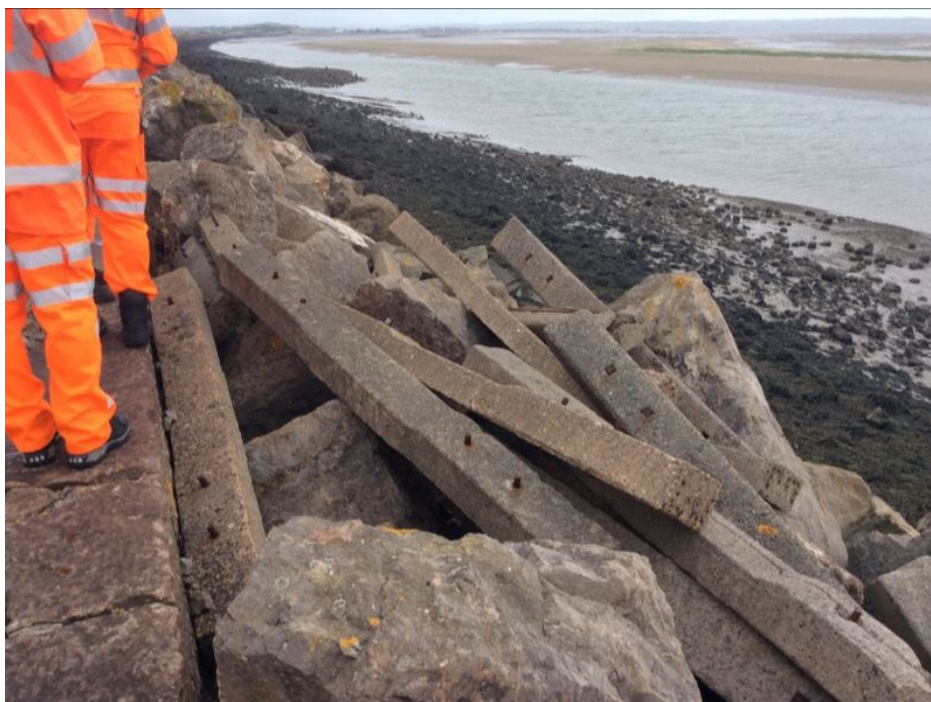
**Section A  
Embankment  
Armour  
Defect Ref: D20  
Description:** Non-  
standard and  
ineffective armour  
units. No change  
between 2019 and  
2020 inspections.  
**Photo number: 203**

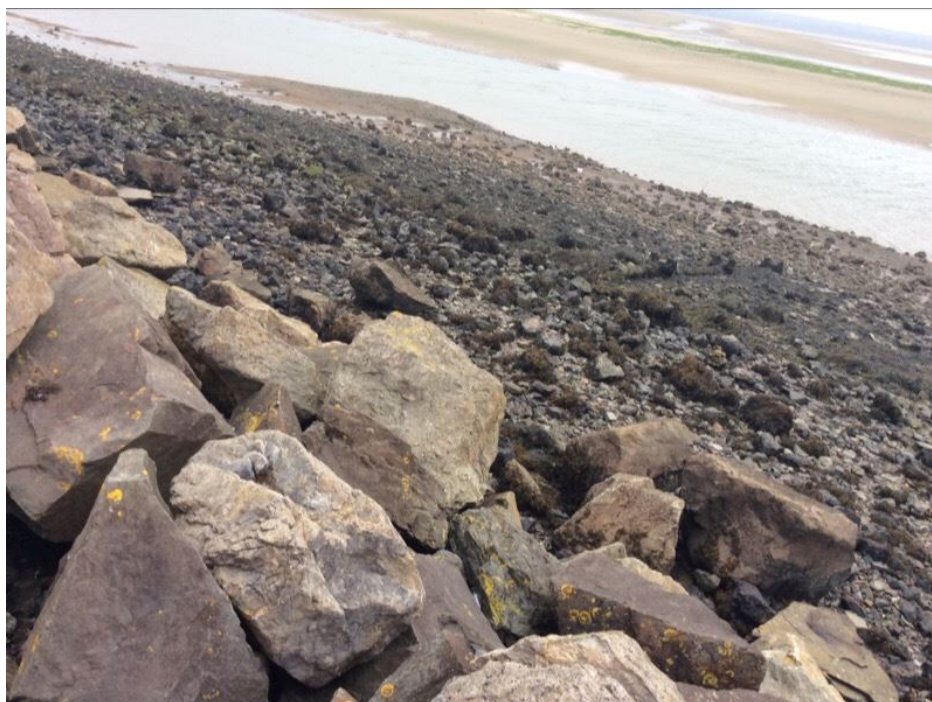
**Section A**  
**Embankment**  
**Armour**  
**Defect Ref: D22**  
**Description:**  
Exposed wall section.  
No change between  
2019 and 2020  
inspections.  
**Photo number: 72**

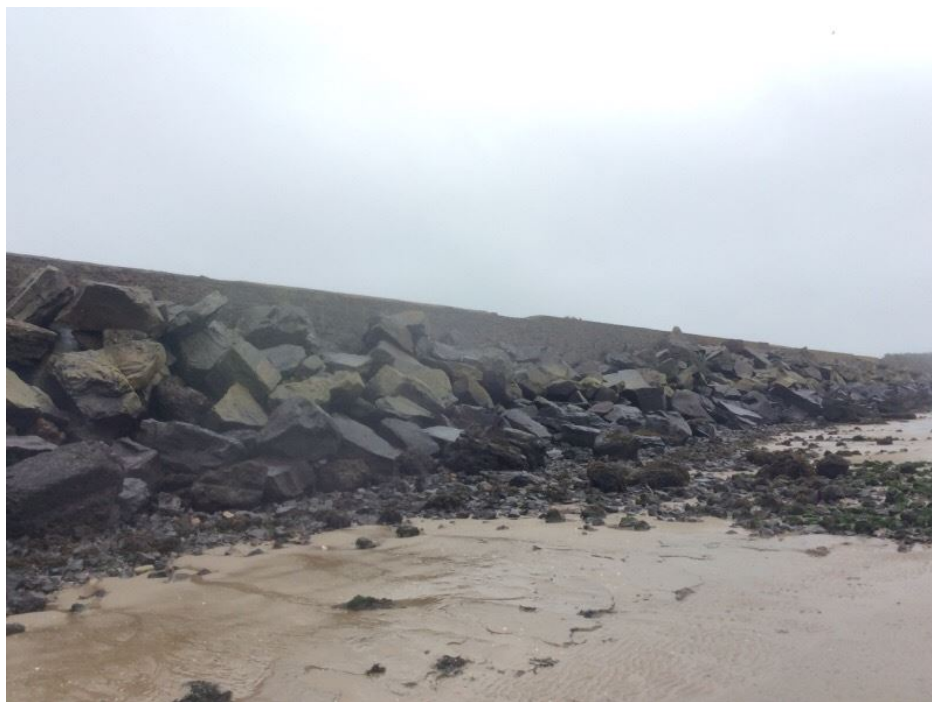
**Section A**  
**Embankment**  
**Armour**  
**Defect Ref: D22**  
**Description:**  
Exposed wall section.  
No change between  
2019 and 2020  
inspections.  
**Photo number: 205**

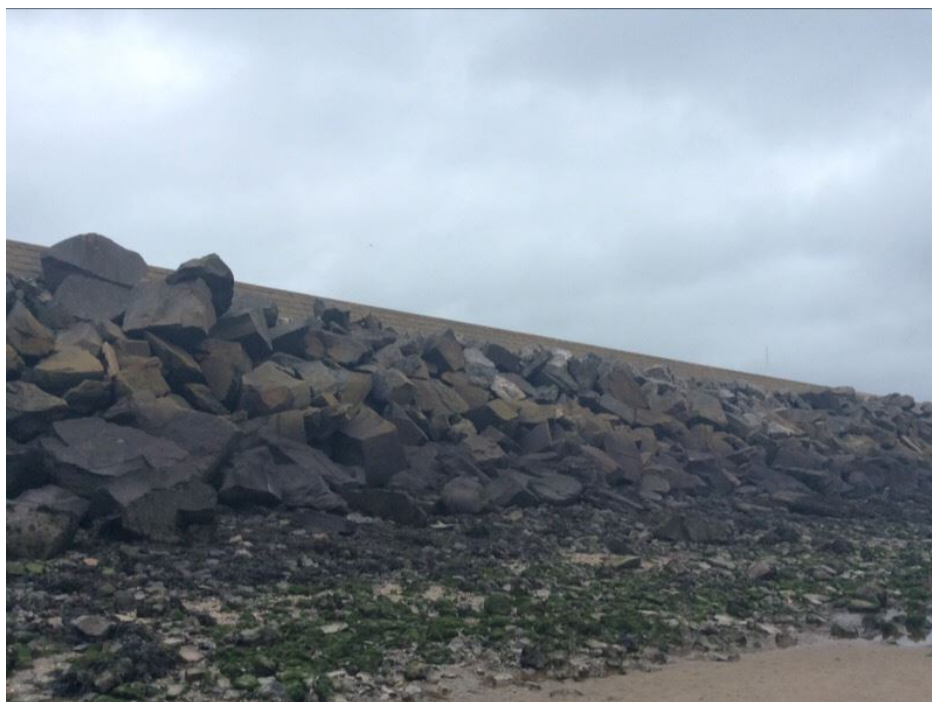
**Section A**  
**Capping Wall**  
**Defect Ref: D23**  
**Description:** Open joints, if left unrepaired further deterioration of the wall is expected. This defect has been repaired between the 2014 and 2020 inspections. However, multiple repointing repairs were found to be broken in 2020.  
**Photo number: 75**

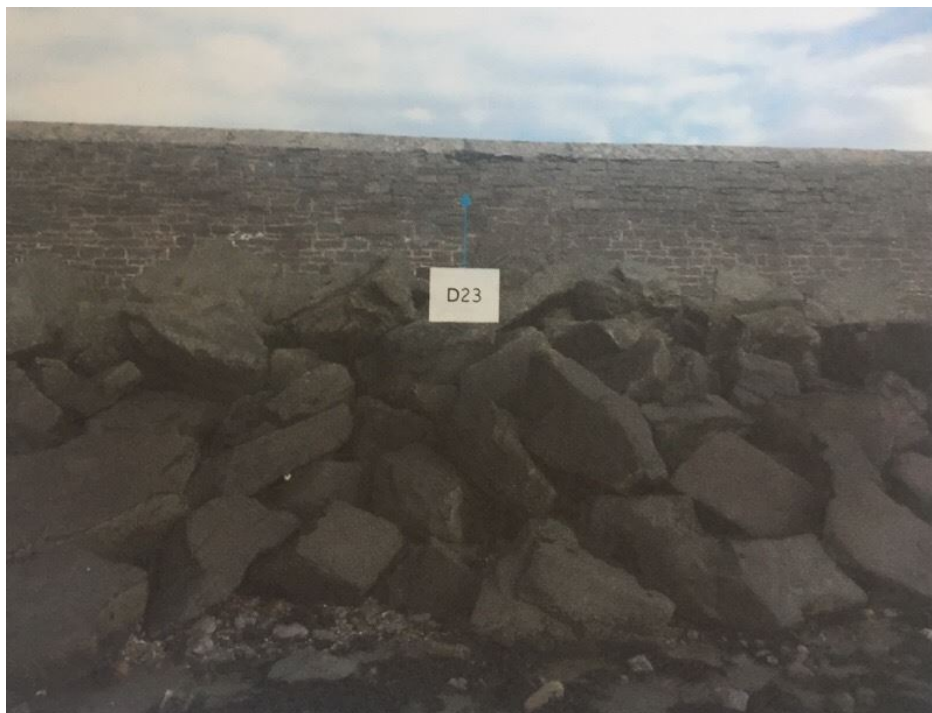
**Section A**  
**Capping Wall**  
**Defect Ref: D23**  
**Description:** Open joints, if left unrepaired further deterioration of the wall is expected. This defect has been repaired between the 2014 and 2020 inspections. However, multiple repointing repairs were found to be broken in 2020.  
**Photo number: 74**

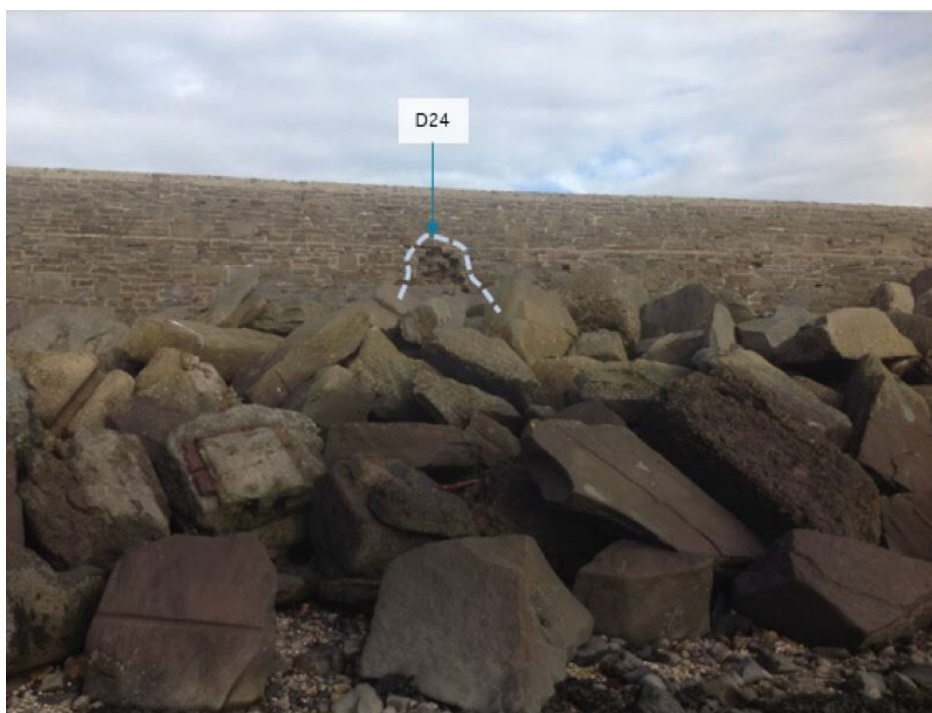
**Section A**  
**Capping Wall**  
**Defect Ref: D24**  
**Description:** Severe damage to wall. Between the 2019 and 2020 inspections, the defect has been repaired.  
**Photo number: 125**

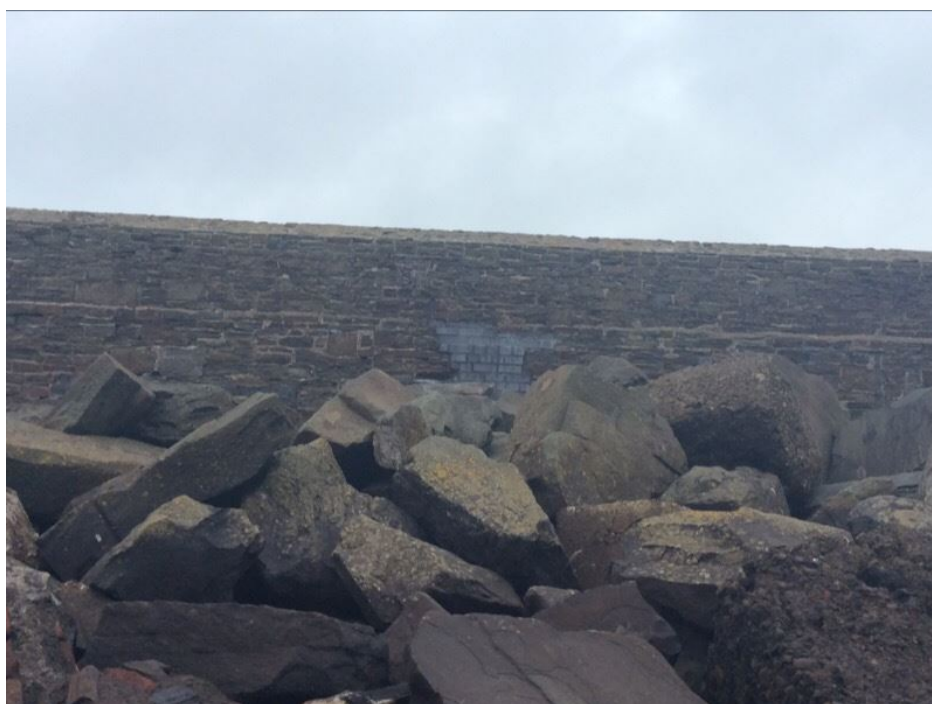
**Section A**  
**Capping Wall**  
**Defect Ref: D25**  
**Description:** This defect has been crudely repaired between 2014 and 2020 inspections with concrete sandbags. The repair is failing.  
**Photo number: 77**

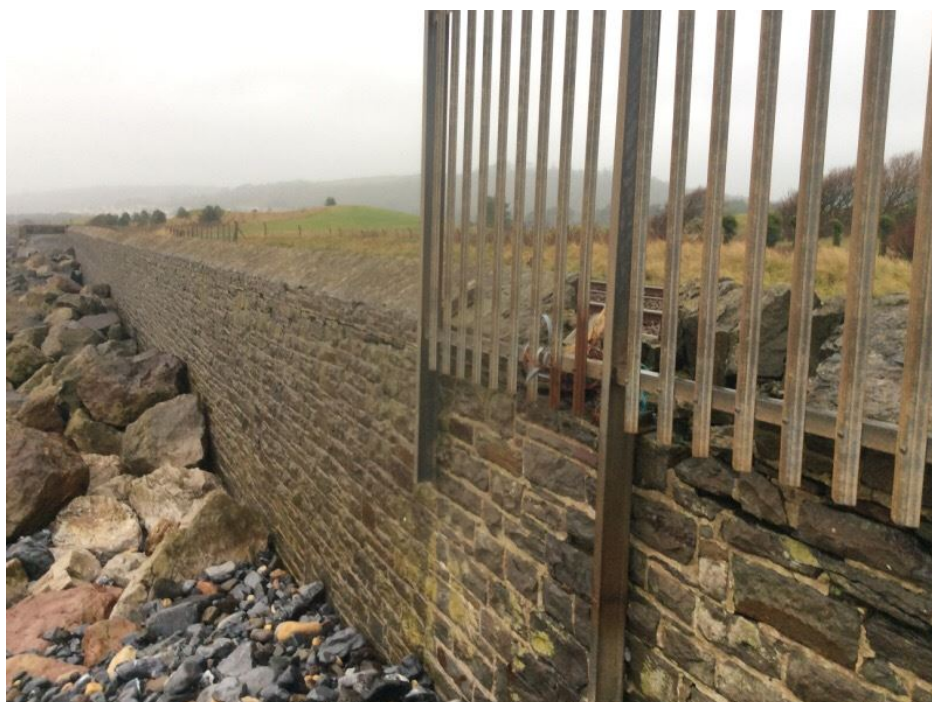
**Section A**  
**Capping Wall**  
**Defect Ref: D26**  
**Description:** Poor defence tie-in. Increased in severity between the 2014 and 2019 inspections, with additional damage to the capping wall. The capping wall has been repaired between the 2019 and 2020 inspections, but there is still a loss of grouting areas.  
**Photo number: 136**

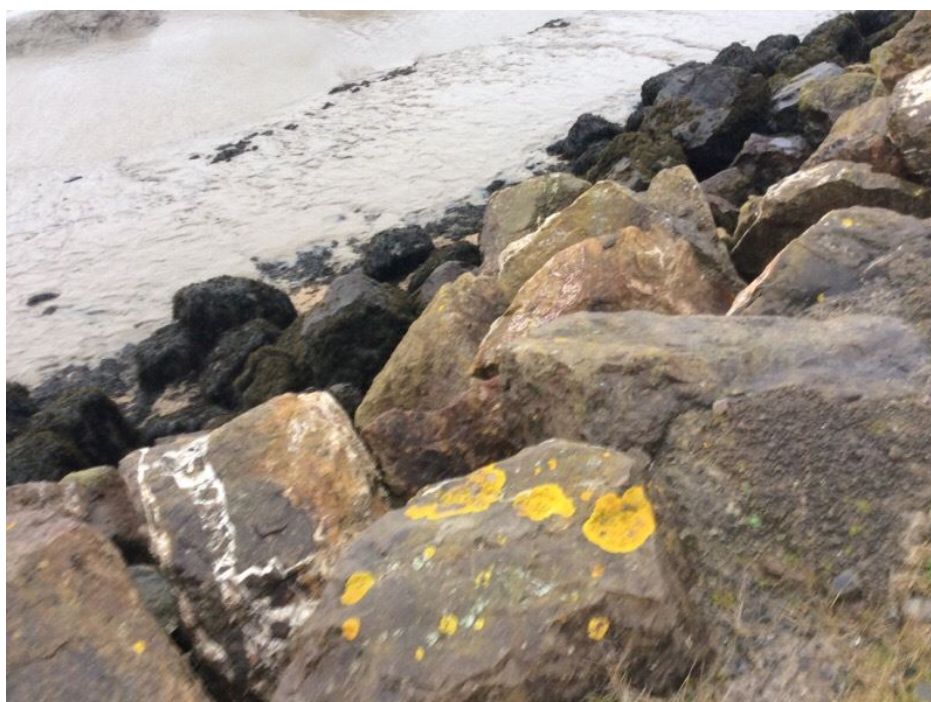
**Section A**  
**Embankment**  
**Armour**  
**Defect Ref: D28**  
**Description:** Poor interlocking between rock armour units. There has been no change between the 2019 and 2020 inspections.  
**Photo number: 118**

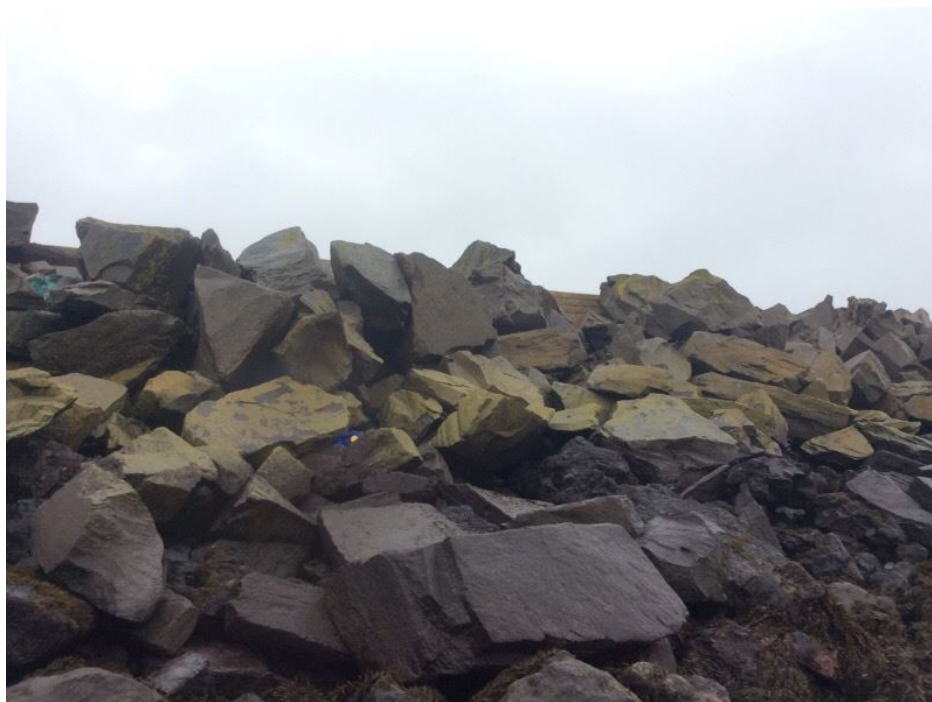
**Section A**  
**Embankment**  
**Armour**  
**Defect Ref: D28**  
**Description:** Poor interlocking between rock armour units. There has been no change between the 2019 and 2020 inspections.  
**Photo number: 119**

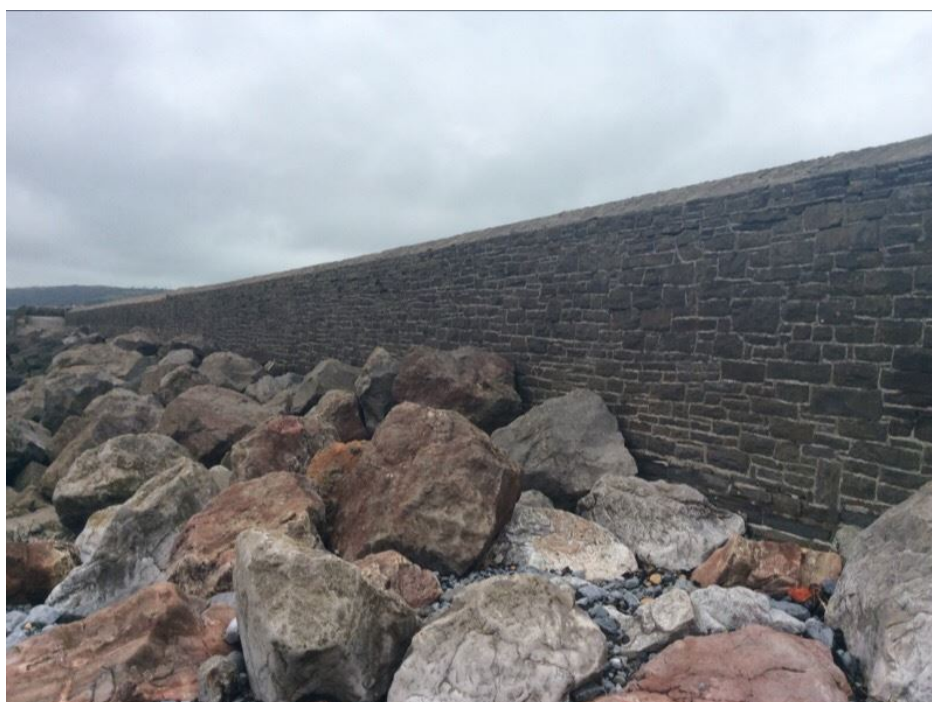
**Section A**  
**Embankment**  
**Armour**  
**Defect Ref: D30**  
**Description:** Wash  
out of ballast  
**Photo number: 143**

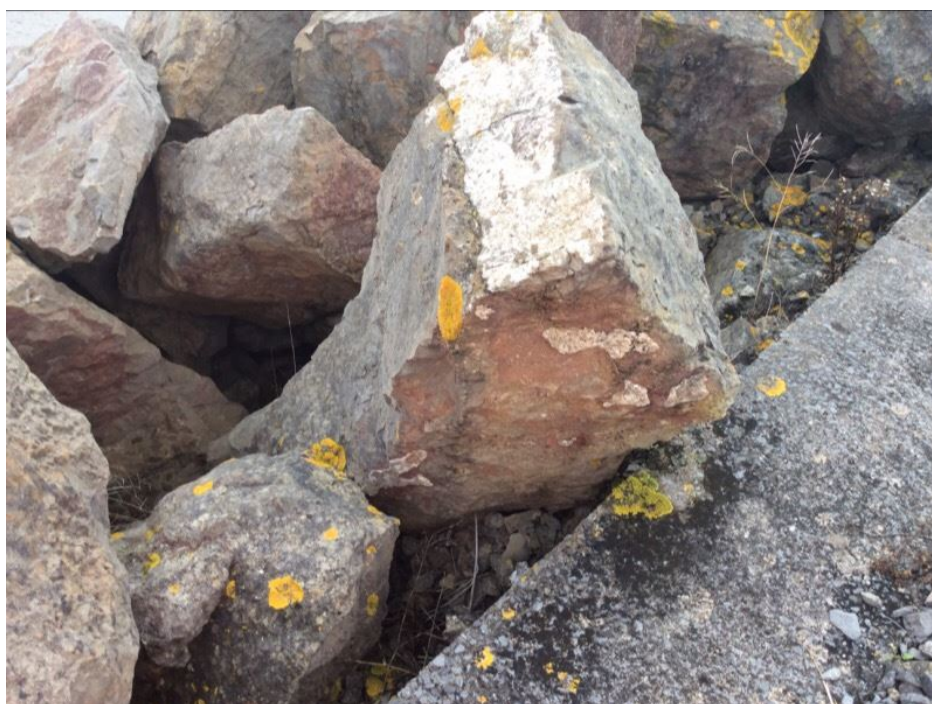
**Section A**  
**Embankment**  
**Armour**  
**Defect Ref: D31**  
**Description:** Voids in rock armour being filled with expelled ballast.  
**Photo number: 147**
