| Location Plan: | | Pwll Sea Wall | |
| | | Structure Reference: | 226 21.5 |

# COASTAL ASSET CONDITION SURVEY REPORT

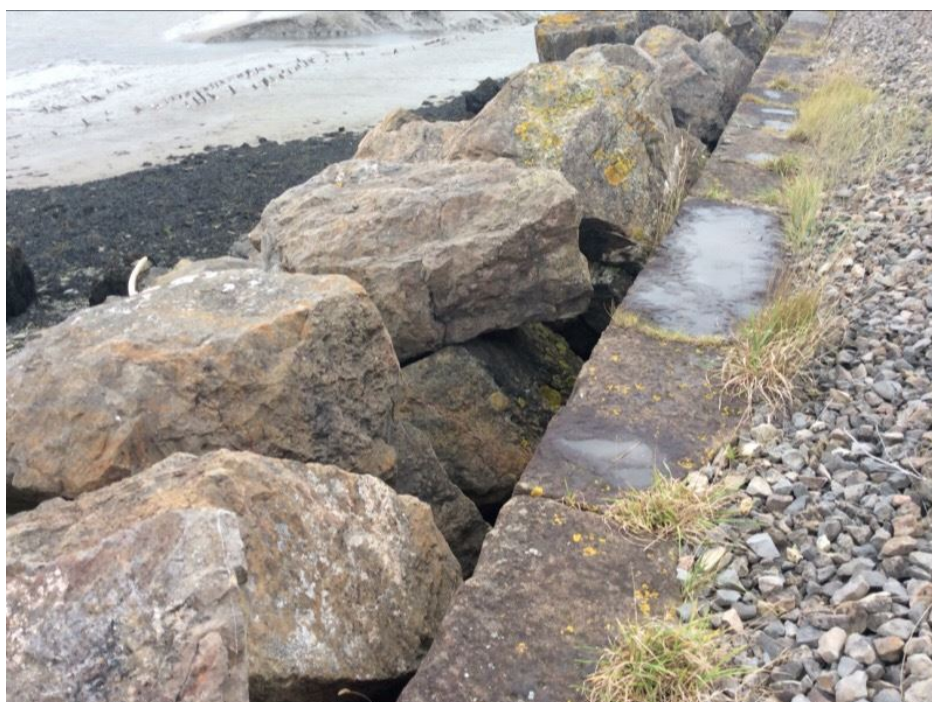
**Section A**  
**Embankment**  
**Armour**  
**Defect Ref: D32**  
**Description:** Large gaps between rock armour and crest of masonry wall.  
**Photo number: 151**

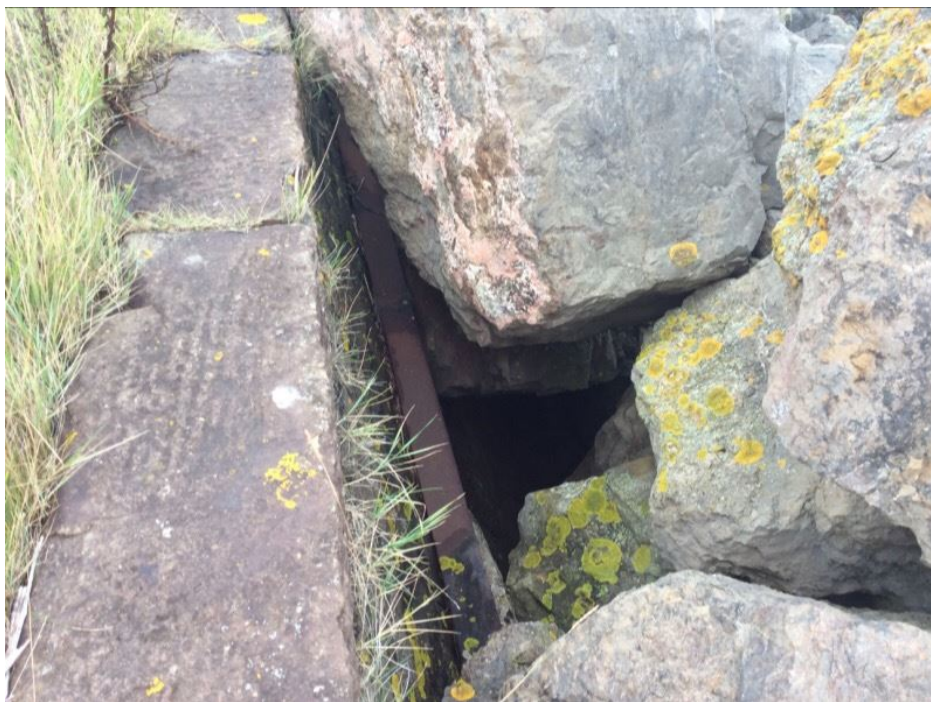
**Section A**  
**Embankment**  
**Armour**  
**Defect Ref: D32**  
**Description:** Large gaps between rock armour and crest of masonry wall.  
**Photo number: 155**

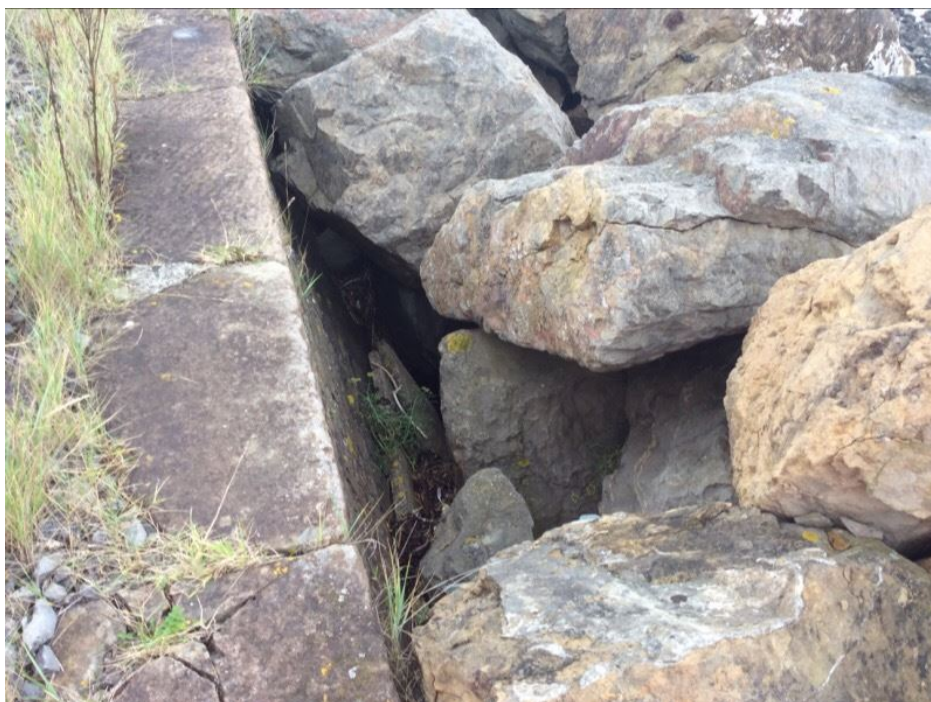
**Section A**  
**Embankment**  
**Armour**  
**Defect Ref: D32**  
**Description:** Large gaps between rock armour and crest of masonry wall.  
**Photo number: 162**

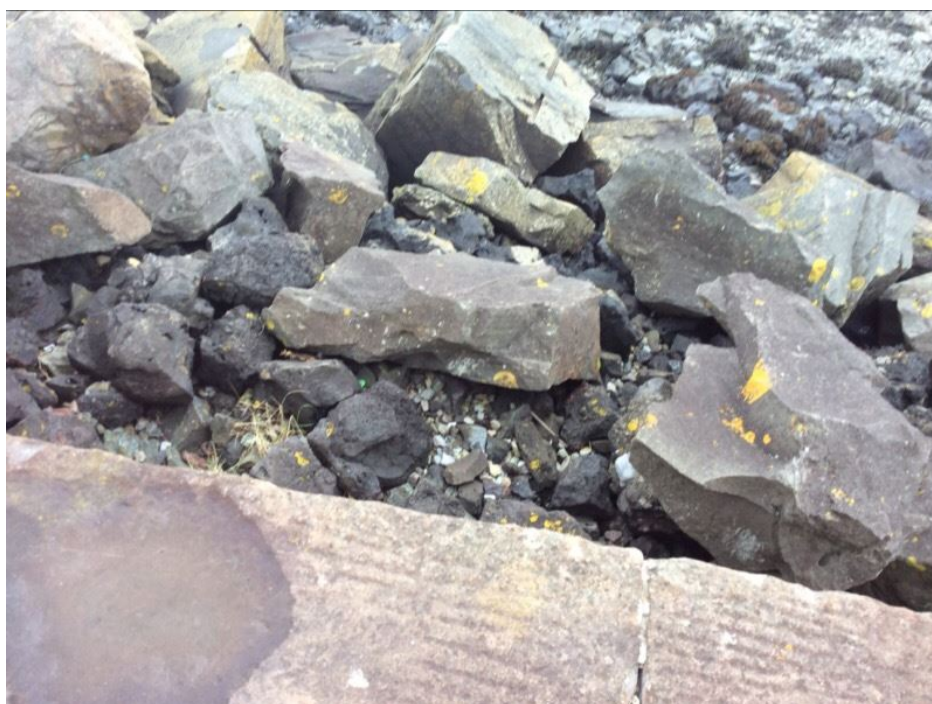
**Section A**  
**Embankment**  
**Armour**  
**Defect Ref: D32**  
**Description:** Large gaps between rock armour and crest of masonry wall.  
**Photo number: 173**

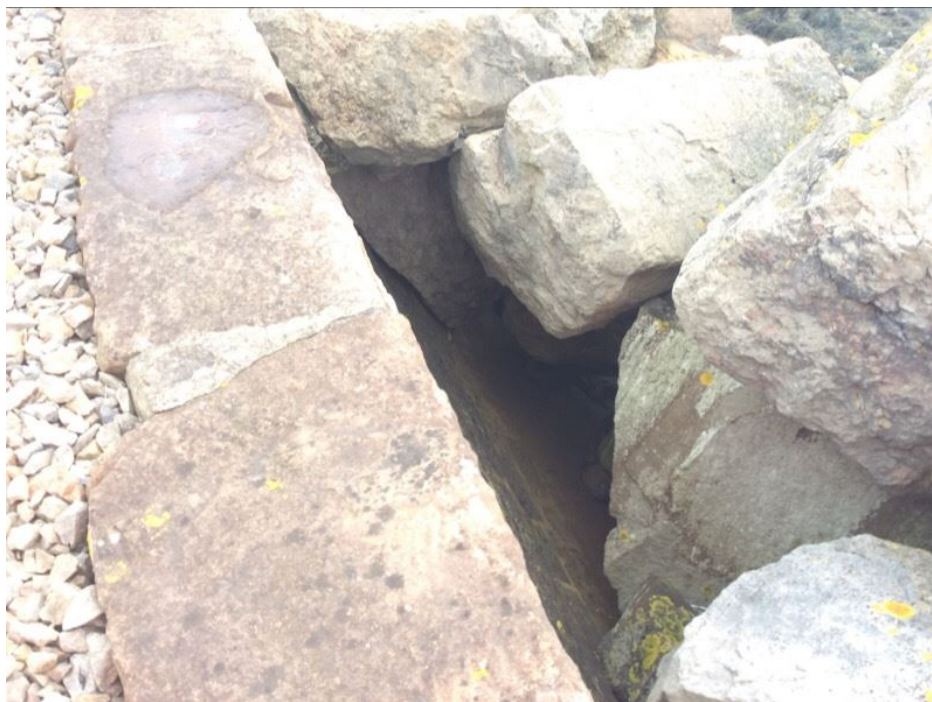
**Section A**  
**Embankment**  
**Armour**  
**Defect Ref: D32**  
**Description:** Large gaps between rock armour and crest of masonry wall.  
**Photo number: 175**

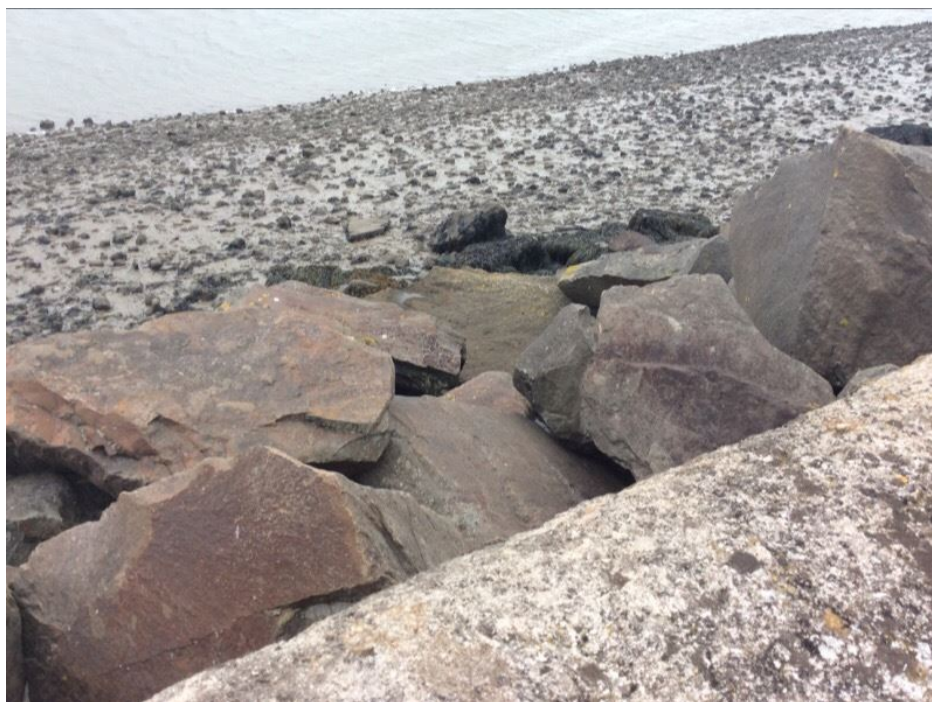
**Section A**  
**Embankment**  
**Armour**  
**Defect Ref: D32**  
**Description:** Large gaps between rock armour and crest of masonry wall.  
**Photo number: 176**

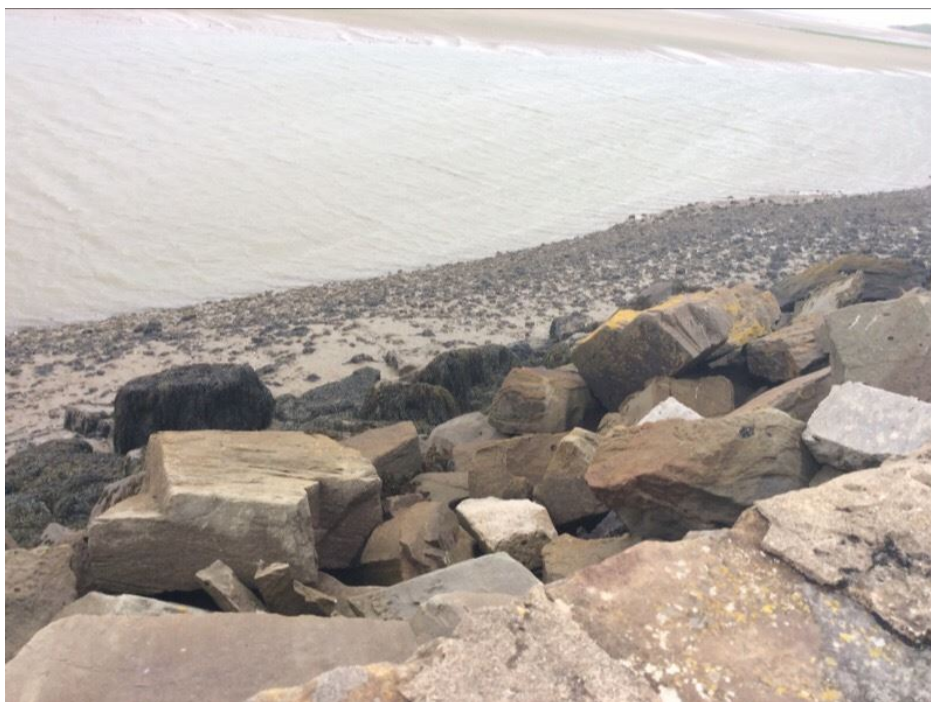
**Section A**  
**Embankment**  
**Armour**  
**Defect Ref: D33**  
**Description:**  
Fracturing in rocks.  
**Photo number: 152**

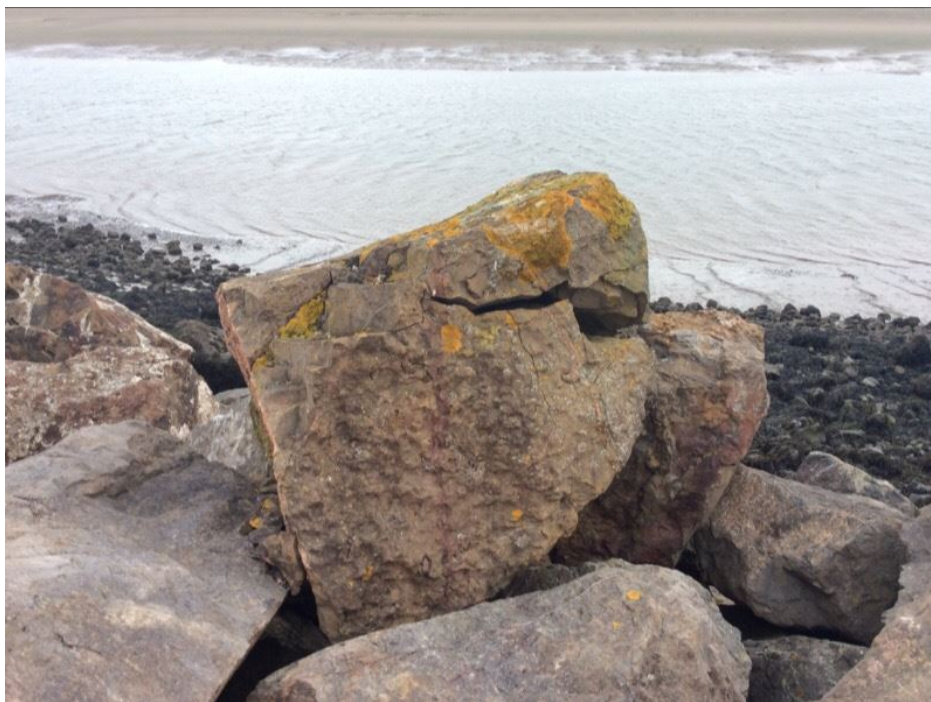
**Section A**  
**Embankment**  
**Armour**  
**Defect Ref: D33**  
**Description:**  
Fracturing in rocks.  
**Photo number: 153**

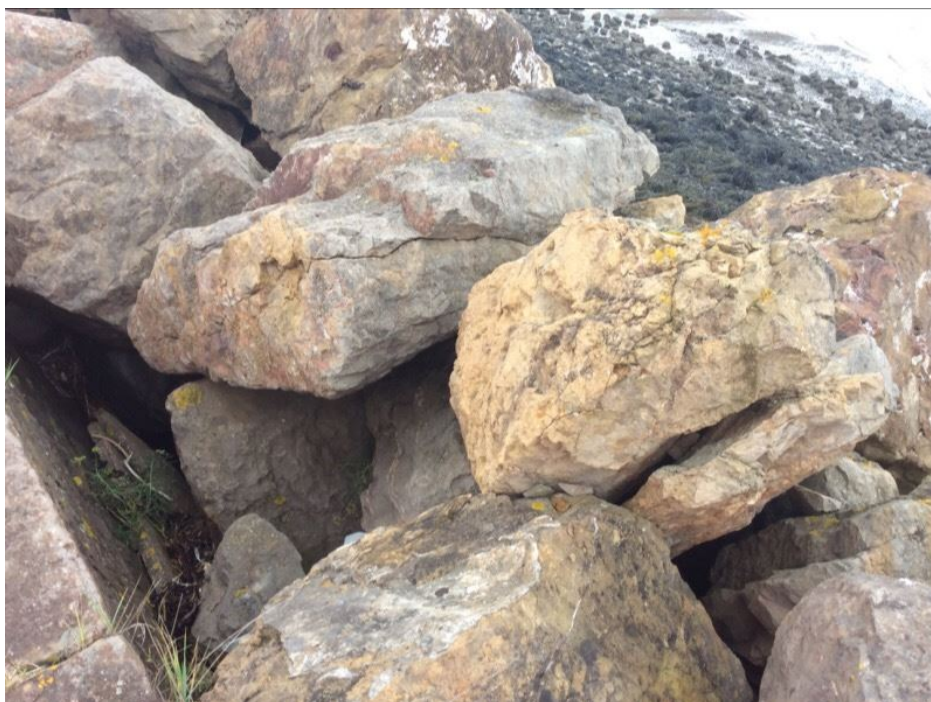
**Section A**  
**Embankment**  
**Armour**  
**Defect Ref: D33**  
**Description:**  
Fracturing in rocks.  
**Photo number: 158**

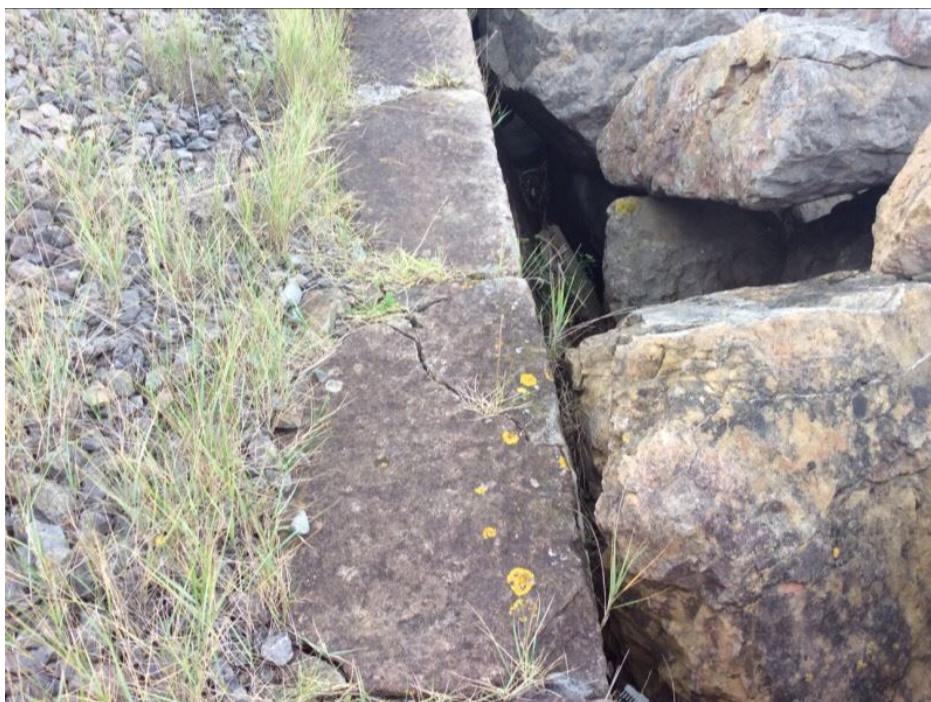
**Section A**  
**Capping Wall**  
**Defect Ref: D35**  
**Description:** Bulging  
wall.  
**Photo number: 177**

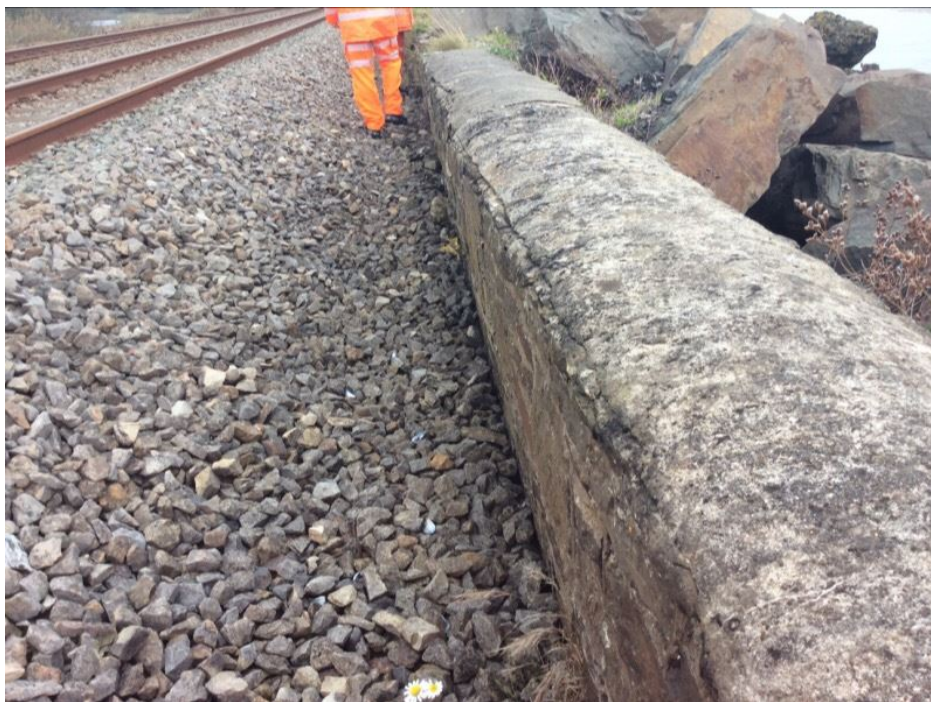
**Section A**  
**Capping Wall**  
**Defect Ref: D35**  
**Description:** Bulging  
wall.  
**Photo number: 178**

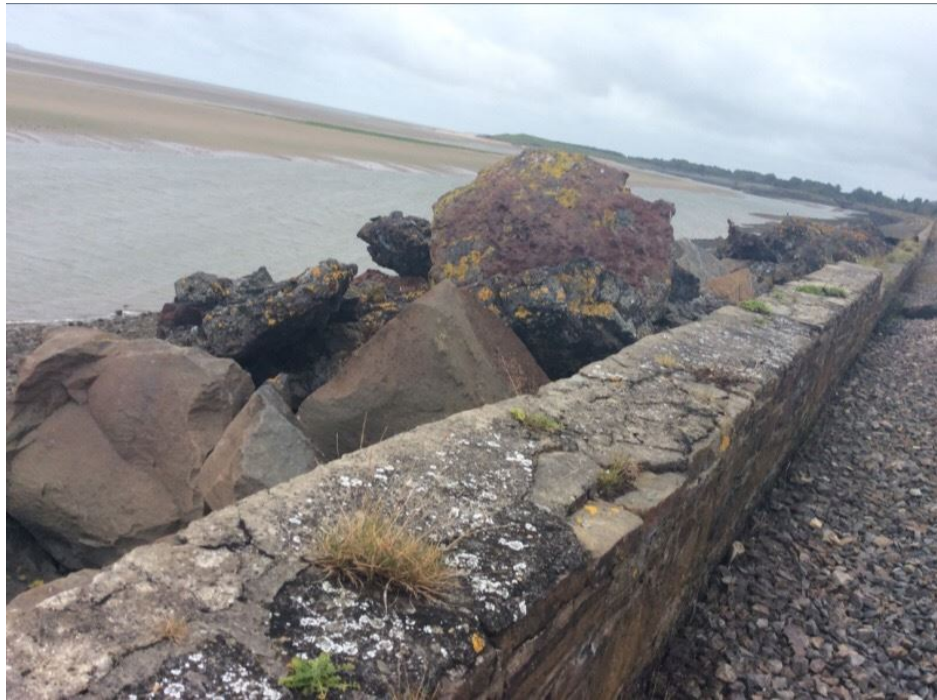
**Section A**  
**Capping Wall**  
**Defect Ref: D37**  
**Description:** Voids in  
crest approx.  
300x300mm  
**Photo number: 184**

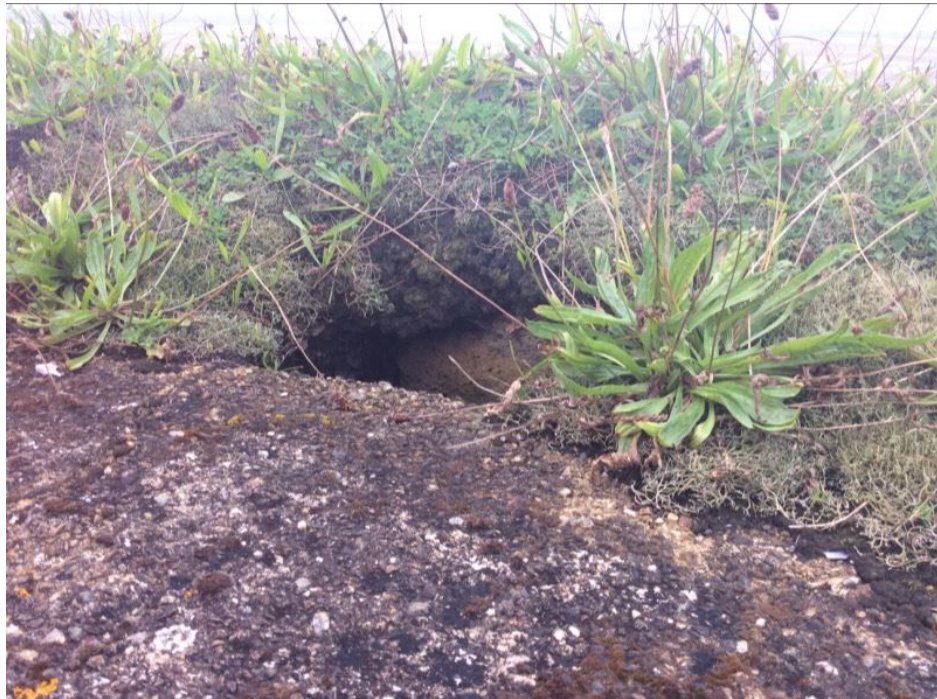
**Section A**  
**Capping Wall**  
**Defect Ref: D37**  
**Description:** Voids in  
crest approx.  
300x300mm  
**Photo number: 185**

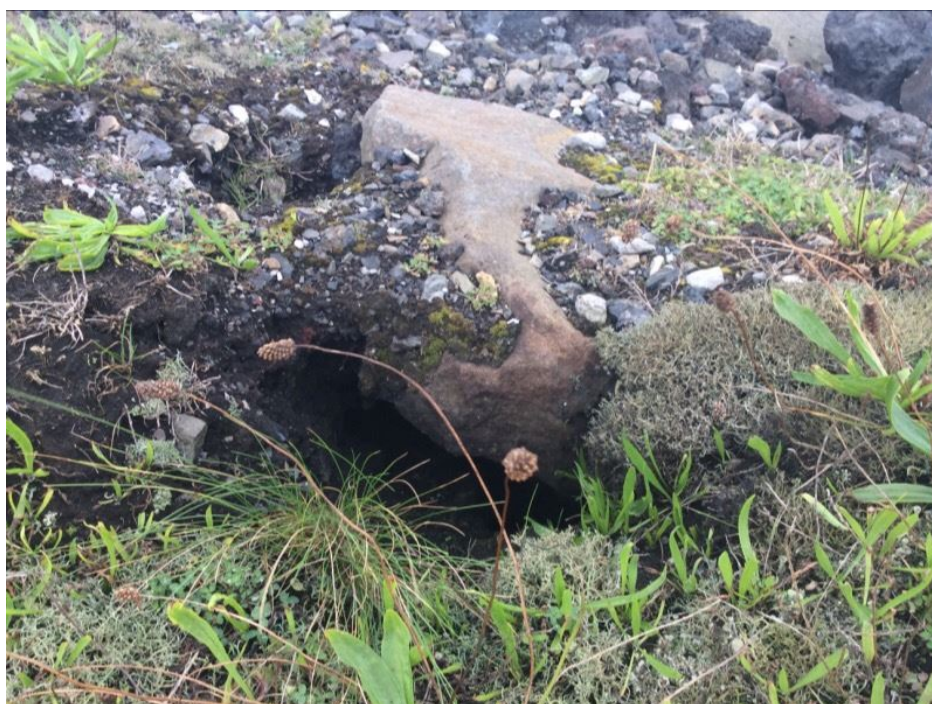
**Section A**  
**Capping Wall**  
**Defect Ref: D37**  
**Description:** Voids in  
crest approx.  
300x300mm  
**Photo number: 187**
