Site Condition Report for Surrender Application EPR/XP3131VK/V002

Deeside Power Station

Deeside Power (UK) Limited

Report No. CRM 343 004 PE R 003

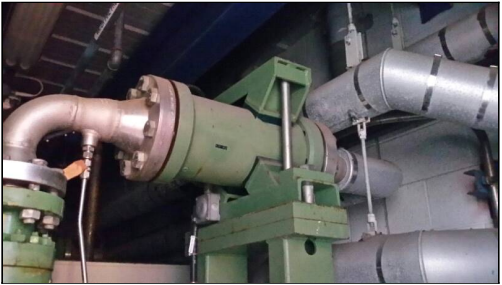
Survey Date:	Lead Surveyor	Survey Type	Floor	Analysis
	16 Feb 2021 to 18 Feb 2021	Adam Yates	Demolition Survey	Ground Floor	Chrysotile (1)
	Building	Room	Item	Quantity	
	Zone 3 - Fuel Oil Pump House	Fuel oil pump house G/01	gasket to pipework flange to pump pipework	4no.	Occasionally likely to be disturbed
	Sample No (S,SP,P,As)	Product Type	Surface Treatment	Condition	
	JW004060 (S)	Asbestos Textiles/Paper (2)	Surface Sealed (1)	Low Damage (1)	
Material Risk Score					
5					
Recommended action		Remove			
Surveyor comments		N/A

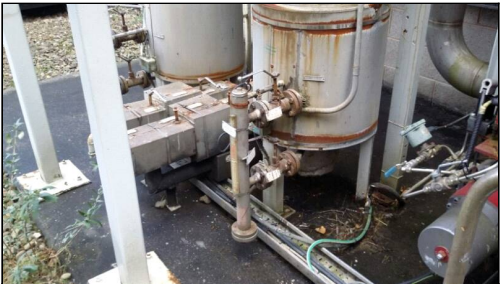
Survey Date:	Lead Surveyor	Survey Type	Floor	Analysis
	16 Feb 2021 to 18 Feb 2021	Adam Yates	Demolition Survey	External	Chrysotile (1)
	Building	Room	Item	Quantity	
	Zone 3 - Gas Compound	Externals E/01	gasket to pipework flange to fuel gat root valve	8no.	Occasionally likely to be disturbed
	Sample No (S,SP,P,As)	Product Type	Surface Treatment	Condition	
	JW004061 (S)	Asbestos Textiles/Paper (2)	Surface Sealed (1)	Low Damage (1)	
Material Risk Score					
5					
Recommended action		Remove			
Surveyor comments		N/A

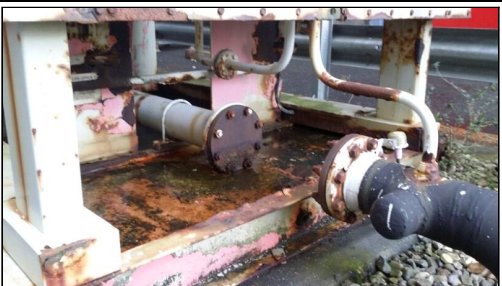
Survey Date:	Lead Surveyor	Survey Type	Floor	Analysis
	16 Feb 2021 to 18 Feb 2021	Adam Yates	Demolition Survey	External	Chrysotile (1)
	Building	Room	Item	Quantity	
	Zone 3 - Gas Compound	Externals E/01	gasket to pipework flange to fuel oil vent valve	2no.	
	Sample No (S,SP,P,As)	Product Type	Surface Treatment	Condition	Accessibility
	JW004062 (S)	Asbestos Textiles/Paper (2)	Surface Sealed (1)	Low Damage (1)	Occasionally likely to be disturbed
Material Risk Score					
5					
Recommended action					
Remove					
Surveyor comments					
N/A

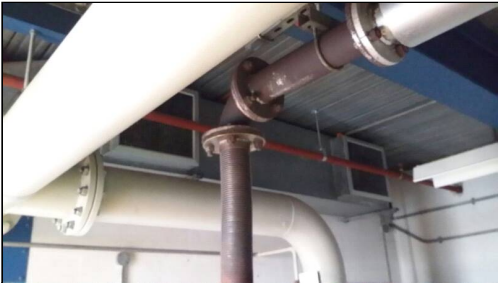
Survey Date:	Lead Surveyor	Survey Type	Floor	Analysis
	17 Feb 2021 to 18 Feb 2021	Adam Yates	Demolition Survey	Ground Floor	Chrysotile (1)
	Building	Room	Item	Quantity	
	Zone 4 - Water Treatment Plant, Waste Collection Area & Demin Tank	Diesel fire pump room G/02	gasket to pipework flange to exhaust pipework	7no.	
	Sample No (S,SP,P,As)	Product Type	Surface Treatment	Condition	Accessibility
	JW004063 (S)	Asbestos Textiles/Paper (2)	Surface Sealed (1)	Low Damage (1)	Occasionally likely to be disturbed
Material Risk Score					
5					
Recommended action	Remove				
Surveyor comments	N/A

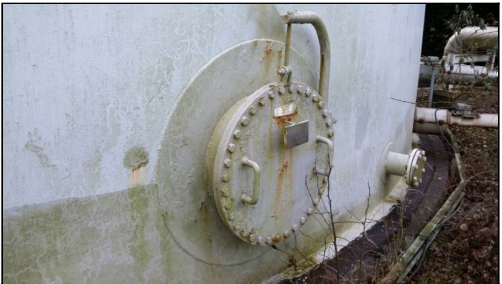
Survey Date:	Lead Surveyor	Survey Type	Floor	Analysis
	17 Feb 2021 to 18 Feb 2021	Adam Yates	Demolition Survey	External	Chrysotile (1)
	Building	Room	Item	Quantity	
	Zone 4 - Water Treatment Plant, Waste Collection Area & Demin Tank	Externals E/01	gasket to tank inspection hatch	1no.	
	Sample No (S,SP,P,As)	Product Type	Surface Treatment	Condition	Accessibility
	JW004069 (S)	Asbestos Textiles/Paper (2)	Surface Sealed (1)	Low Damage (1)	Occasionally likely to be disturbed
Material Risk Score					
5					
Recommended action	Remove				
Surveyor comments	N/A

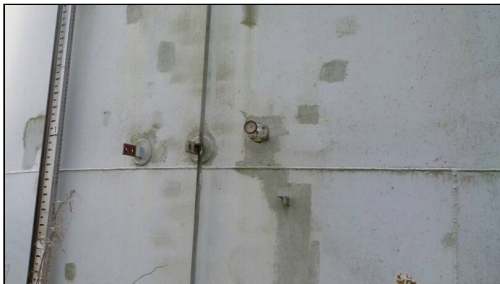
Survey Date:	Lead Surveyor	Survey Type	Floor	Analysis
	17 Feb 2021 to 18 Feb 2021	Adam Yates	Demolition Survey	External	Chrysotile (1)
	Building	Room	Item	Quantity	
	Zone 4 - Water Treatment Plant, Waste Collection Area & Demin Tank	Externals E/01	gasket to pipework flange to pressure gauge pipework	1no.	
	Sample No (S,SP,P,As)	Product Type	Surface Treatment	Condition	Accessibility
	JW004070 (S)	Asbestos Textiles/Paper (2)	Surface Sealed (1)	Low Damage (1)	Occasionally likely to be disturbed
	Material Risk Score				
5					
Recommended action	Remove				
Surveyor comments	N/A

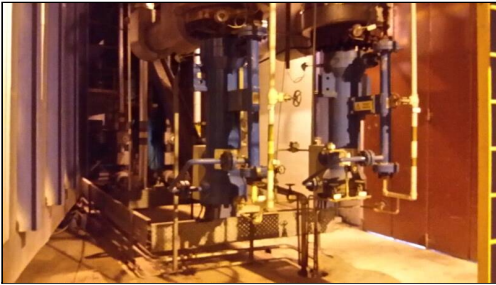
Survey Date:	Lead Surveyor	Survey Type	Floor	Analysis
	18 Feb 2021 to 23 Feb 2021	Adam Yates	Demolition Survey	Ground Floor	Chrysotile (1)
	Building	Room	Item	Quantity	
	Zone 5 - HRSG Building	HRSG building G/01	composite bearings within HRSG 2 glandless motor pump	Unknown	
	Sample No (S,SP,P,As)	Product Type	Surface Treatment	Condition	Accessibility
	Visual (P)	Reinforced Composite (1)	Completely Sealed (0)	Low Damage (1)	Usually inaccessible or unlikely to be disturbed
Material Risk Score					
3					
Recommended action		Remove			
Surveyor comments		Unable to access within machinery for sampling, 2 pumps observed

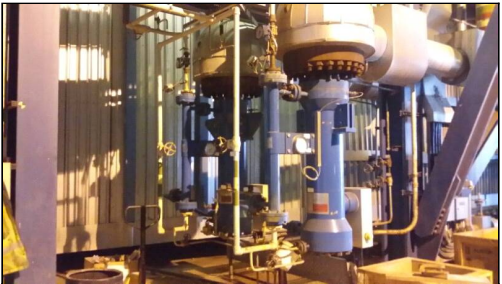
Survey Date:	Lead Surveyor	Survey Type	Floor	Analysis
	18 Feb 2021 to 23 Feb 2021	Adam Yates	Demolition Survey	Ground Floor	Chrysotile (1)
	Building	Room	Item	Quantity	
	Zone 5 - HRSG Building	HRSG building G/01	composite bearings to HRSG 1 glandless motor pump	Unknown	
	Sample No (S,SP,P,As)	Product Type	Surface Treatment	Condition	Accessibility
	Visual (P)	Reinforced Composite (1)	Completely Sealed (0)	Low Damage (1)	Usually inaccessible or unlikely to be disturbed
Material Risk Score					
3					
Recommended action					
Remove					
Surveyor comments					
N/A

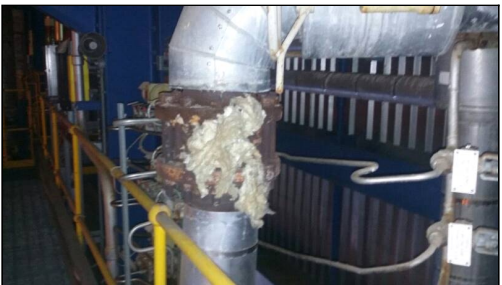
Survey Date:	Lead Surveyor	Survey Type	Floor	Analysis
	18 Feb 2021 to 23 Feb 2021	Adam Yates	Demolition Survey	Ground Floor	Chrysotile (1)
	Building	Room	Item	Quantity	
	Zone 5 - HRSG Building	HRSG building G/01	gasket to pipework flange to high level pump pipework	2no.	
	Sample No (S,SP,P,As)	Product Type	Surface Treatment	Condition	Accessibility
	JW004076 (S)	Asbestos Textiles/Paper (2)	Surface Sealed (1)	Low Damage (1)	Occasionally likely to be disturbed
	Material Risk Score				
Recommended action		Remove			
Surveyor comments		N/A
