## Schedule 5 - Notification

| Permit Number | EPR/FP3232KG |
| Name of operator | Dwr Cymru Cyfyngedig |
| Location of Facility | Cardiff AAD Facility, Tide Fields Road, Rover Way, Tremorfa, Cardiff, CF24 2RX |

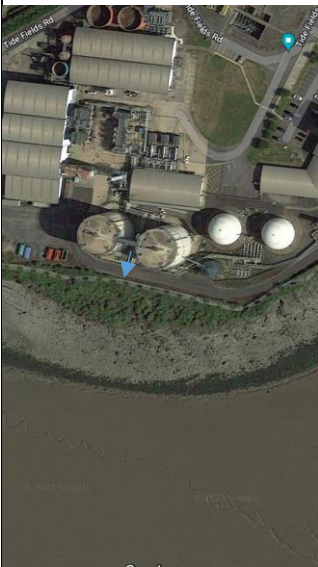
| Reference or description of the location of the event | <p>Previous email contact has been made prior to this schedule 5.</p> <p>Digester foam is entering the limpet box of digester 1. High winds is blowing this foam towards the site boundary fence. Some foam ‘bubbles’ are travelling over the fence and landing on plants and on the public path that runs alongside the fence</p> |

| Description of where any release into the environment took place | <p>Small amounts of foam being blown over boundary fence (area indicated by blue arrow):</p> |
| Description of the failure or accident. | Foam created within the digester, unknown cause at present. |

| Any more accurate information on the matters for notification under Part A. | <p>Event whilst intermittent last until 2<sup>nd</sup> September 2022. The event was caused by a partial blockage of outlet of the digester resulting in the weir box filling with sludge. This raised the level of the digester and when the sludge was sitting in the weir box it would have been naturally degassing but with the absence of mixing causing localised foaming which in the windy conditions at the time, blew away from the box in the prevailing wind. In addition there was overspilling causing the sludge spillage on site but this was all contained on site.</p> <p>An estimated 1000 litres of liquid digested sludge escaped from the digester but was contained within the site, washed back into site drainage and retreated through Cardiff WwTW. Small volumes of sludge foam escaped from site in the windy conditions and coated nearby foliage in black digested sludge. This was later cleaned by our pollution prevention and remediation team.</p> <p>The source of the blockage remains unknown, jetters were called to site to jet the pipework, the blockage was cleared with a combination of jetting and rodding and continued through the treatment process meaning we were unable to see what actually caused the restriction, the levels in the chamber and digester visually started to drop while the crew were jetting so there was certainly a partial blockage or restriction in the pipeline, possibly as a result of the baking effect from the extreme heat on the external pipework or a soft blockage from something that travelled through the digester.</p> |

| Measures taken, or intended to be taken, to stop any emission | <p>Investigation of the cause of the foaming underway, dose antifoam, spray limpet box with water to reduce foam and place screening over boundary fence to reduce amount getting through fence.</p> <p>As well as this DCWW's pollution prevention team has been to site during the morning of 31/08/22 to clean the footpath/planted area where the foam has landed.</p> |

| Measures taken, or intended to be taken, to prevent a recurrence of the incident | <p>Level devices are being investigated on the weir boxes to give early notification of future sludge level rise which may indicate potential blockages before they cause an impact to treatment.</p> <p>A quarterly SAP job card is being created to do a visual inspection of the weir box to check for any partial blockages and also check the sludge level device operation</p> |
