BUILDING SURVEY REPORT

Former Mabey Bridge Facility, Newhouse Farm
Industrial Estate, Chepstow

May 2016

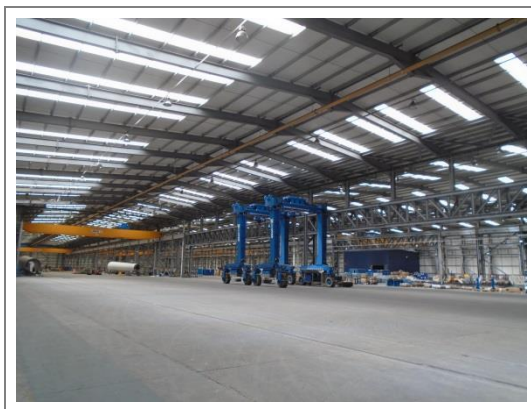
View of structural frame in warehouse

We did not observe any defects suggesting fundamental inadequacies to the structure of the building.

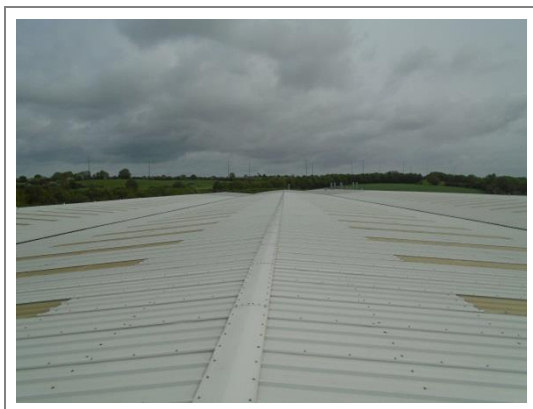
General view of roof coverings

Whilst the overall condition of the roof covering to the original (Phase 1) part of the building is fair to good the roof sheets to this part of the building are beginning to suffer from cut edge corrosion (a process whereby the coloured factory finish begins to peel away from the metal substrate at the bottom edge of the sheets, thus permitting corrosion to the metal substrate over time). Whilst this process is in its infancy we recommend that the cut edges are treated with a proprietary remedial paint system to ensure the longevity of the roof sheets themselves. Given that the roof covering is approximately 8 years of age and that industry standard warranties have a lifespan of 12 years, you may wish to approach the original building contractor and request that they arrange remedial works at their cost. Your solicitors must first check that you can take an assignment of the benefit of the warranty relating to the roof cladding upon purchase. Please note that roofing warranties usually contain wording that states that they will be invalidated if the roof coverings are not regularly cleaned and maintained – given that the roof coverings to this building are covered in a layer of environmental deposits (indicating that they have not been cleaned for a long time) we suspect the contractor will claim the warranty is invalidated and hence the cost of remedial works would devolve to you. We have included a cost for remedial treatment in Appendix A of this report.

As mentioned above the roof coverings were noted to be soiled by environmental deposits. We strongly recommend that all roof coverings are cleaned in the short to medium term as this is likely to extend the life of the factory finish.

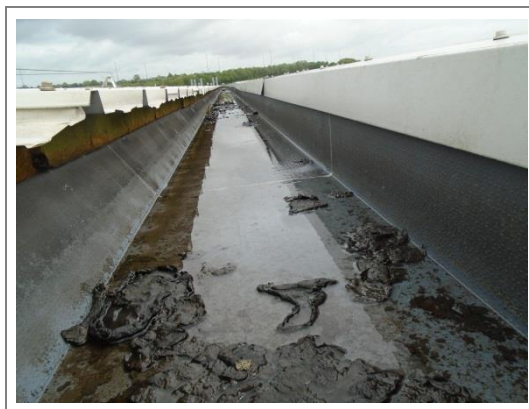
View of a parapet gutter

The gutter linings to the parapet and valley gutters are in good overall condition with no significant defects noted. The gutters contain debris and this should be cleared in the short term to prevent potential blockages to the syphonic drainage system. The maintenance manager commented that the syphonic drainage system operates well and no problems have been experienced since the construction of the building.

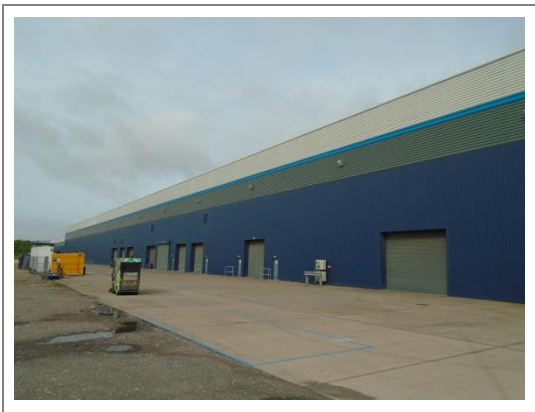
Cladding to south east elevation

The cladding to the warehouse building is in good overall condition with no evidence of cut edge corrosion noted.

The cladding panels were noted to be quite heavily soiled and this is a result of the vendor's business activities as well as environmental deposits. We recommend that the cladding is cleaned in the short term as this will extend the longevity of the surface finishes.

A relatively small number of cladding panels (compared with the size of the building) were noted to be impact damaged at low level and we recommend that these are replaced to maintain the appearance of the building.

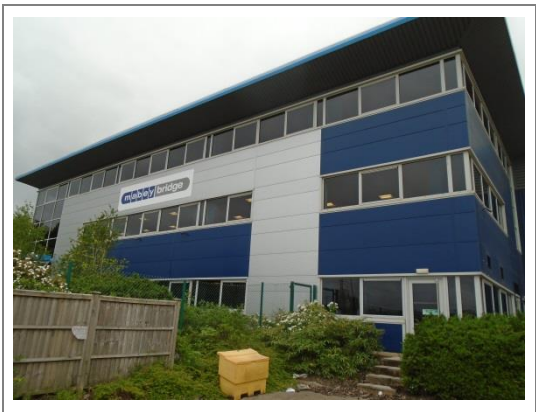
Cladding to accommodation block

The cladding system applied to the accommodation block is in fair overall condition. We noted that a mastic type compound that provides a weatherproof seal between the cladding panels and the vertical trims between panels is leaching out / bubbling. We recommend that the trims are removed and the mastic seals are replaced however we have made no cost allowances for this as we understand that you intend to replace the cladding system completely with a system manufactured by yourselves (which we understand would be undertaken for corporate reasons rather than the presence of disrepair).

We also noted that the cladding panels to the accommodation block appear to have been over-coated with a new paint finish since installation. The reasons for this are unclear, however this is irrelevant given than you plan to re-clad the accommodation block.

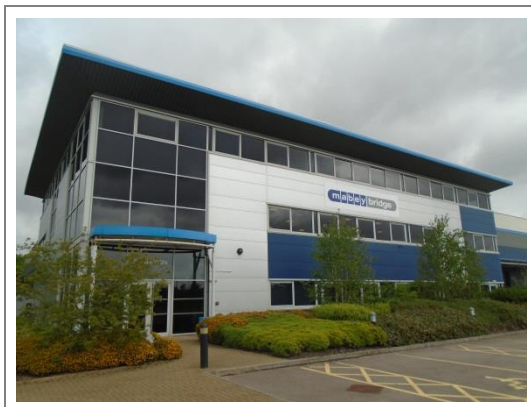
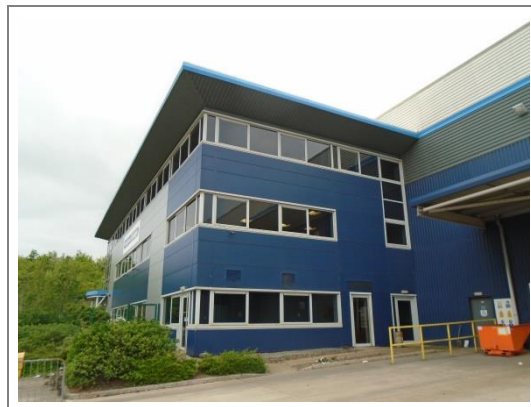
Curtain walling to accommodation block

Windows to accommodation block

The metal framing, glazing and rubber gaskets to the windows and curtain walling were found to be in good condition. The window frames are subject to light soiling and we recommend that these are cleaned to maintain appearance and ensure the longevity of the factory finishes. The windows were found to be stiff to operate and these require lubrication. We understand that you plan to replace the windows and curtain walling for corporate reasons (rather than as a result of defects) and as such we have not allowed costs for remedial works in our report.

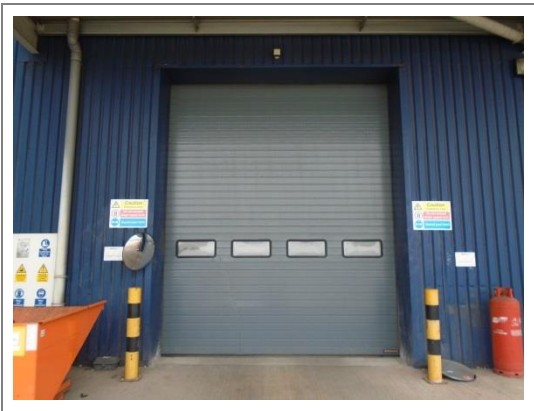
Typical goods delivery door

The goods delivery doors are generally in good condition although these are soiled and require cleaning in the short term. The base sections to a few of the doors were noted to be impact damaged and these should be replaced to ensure smooth operation of the doors.

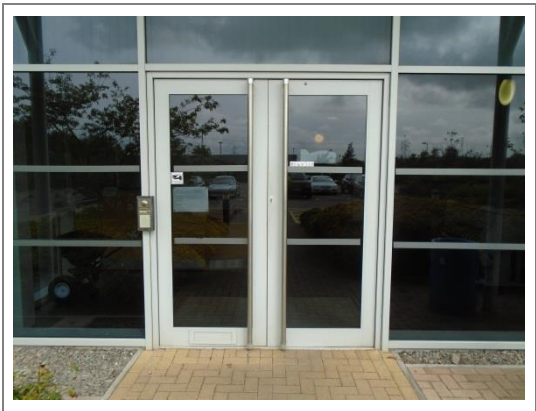
Entrance doors to accommodation block

The entrance doors to the accommodation block were noted to be in good overall condition although these require cleaning in the same way as the other doors.

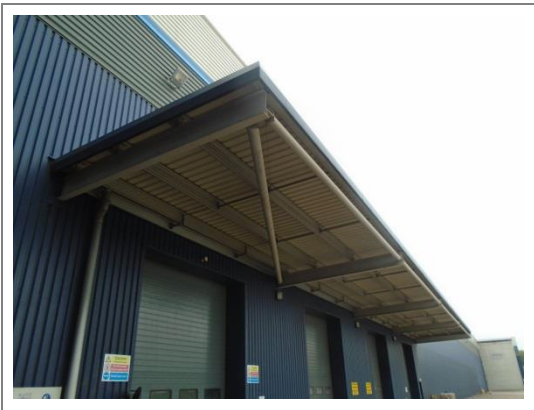
Canopy over goods doors

The canopy above the goods delivery doors is in good overall condition although the structural frame is corroding and requires treating and re-decorating in the short term. The roof cladding is soiled and requires cleaning.

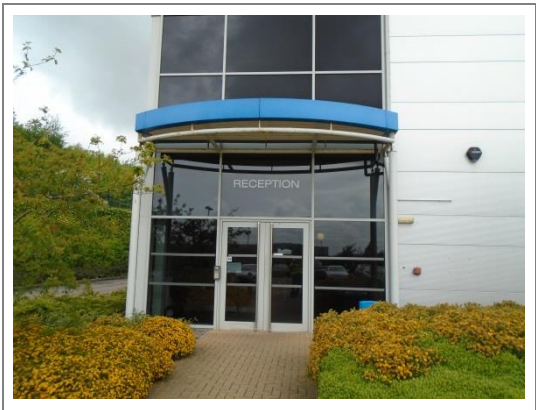
Canopy above entrance doors

The steel structure to the canopy to the accommodation block is corroding and this requires treating and redecorating in the short term.

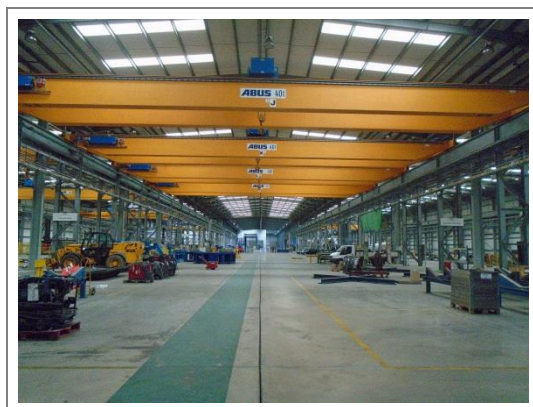
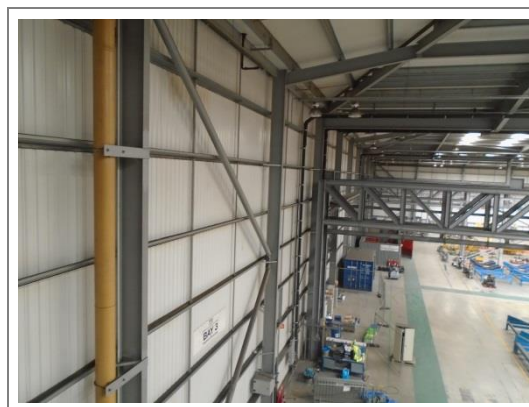
General view of warehouse area

Example view of wall and roof finishes

The profiled metal liner panels to the underside of the roof and to the walls are in good overall condition. The panels are subject to relatively light soiling as a result of the activities of the previous business and cleaning is not considered essential (unless this is necessary for your specific manufacturing activities). We have not allowed for cleaning costs within our report. We have however included an allowance for replacing a small number of wall liner panels that have been subject to notable paint or other staining.

Given that the profiled metal liner panels to the walls extend down to floor slab level it is unsurprising that quite a number of these have been impact damaged. Consideration should be given to replacing these panels so as to maintain the overall condition and appearance of the warehouse area.

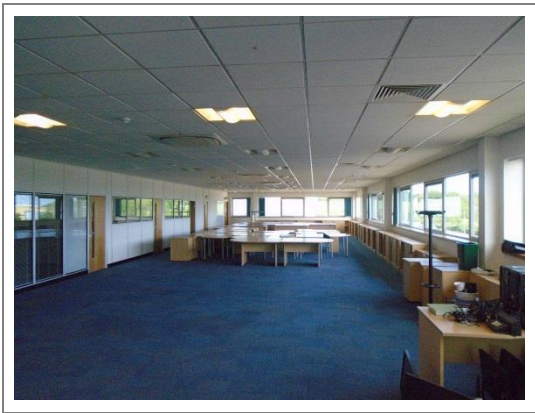
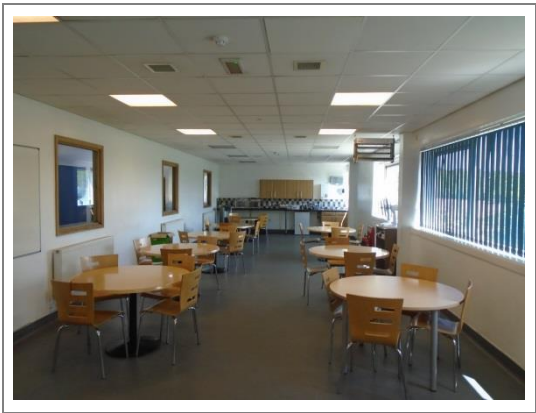
Second floor office accommodation

Ground floor canteen

The suspended ceilings are in fair condition only and we suspect these will require replacement within the next 5 years. Decorations are fairly tired and these would ideally be renewed within the next 1-2 years. Carpet floor finishes are in fairly poor condition in that they are worn and stained - these would ideally be replaced within the next year. Vinyl floor finishes are in fair condition and should continue to provide service for another 5 years. We understand that you propose to make significant alterations to the accommodation block upon purchase of the building which will include wholesale refurbishment. Accordingly, we have not included costs within our report for the cyclical decoration and renewal works we have mentioned in this paragraph.

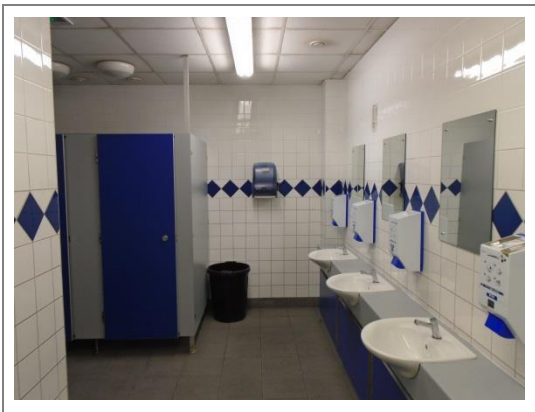
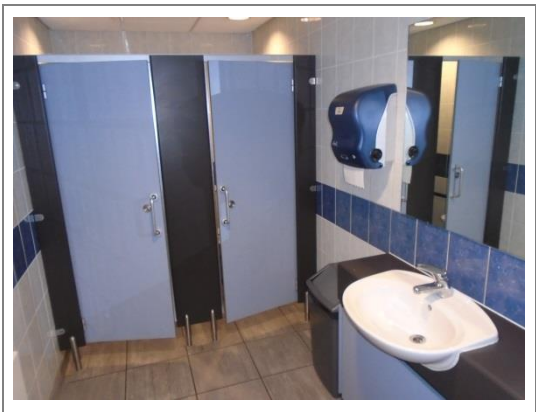
Ground floor Gents Toilet

Typical toilet to upper floors

The toilet facilities are in fair overall condition and should continue to provide service for at least another 5 years. We understand however that you plan to extensively refurbish these rooms prior to your occupation. We have not included costs for refurbishment works.

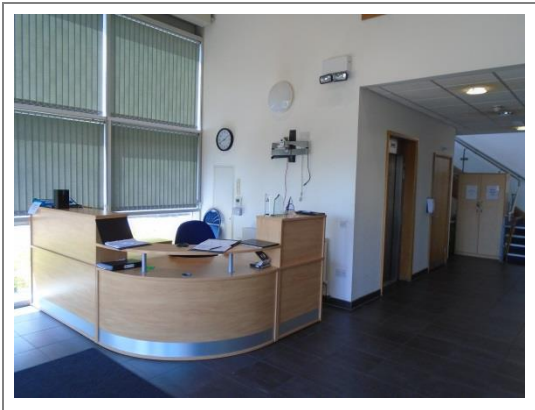
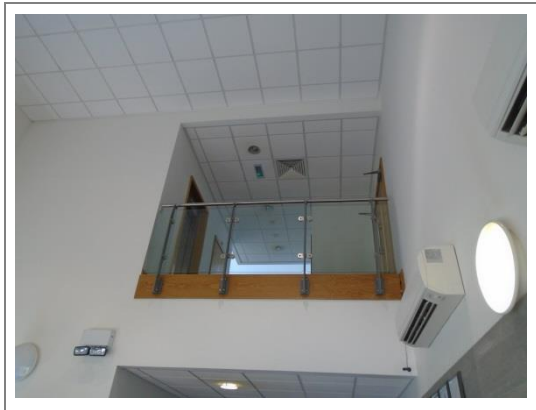
Ground floor reception area

First floor 'gallery' above reception

Surface finishes are in fair to good condition and should provide ongoing service for at least another 5 years. Notwithstanding this we understand that you plan to undertake comprehensive refurbishment works at the beginning of your occupation. We have therefore not included costs for this work.

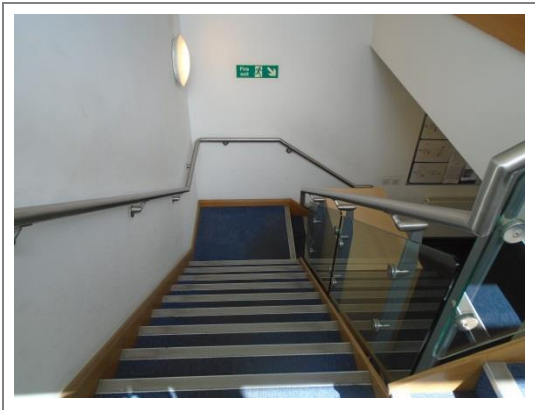
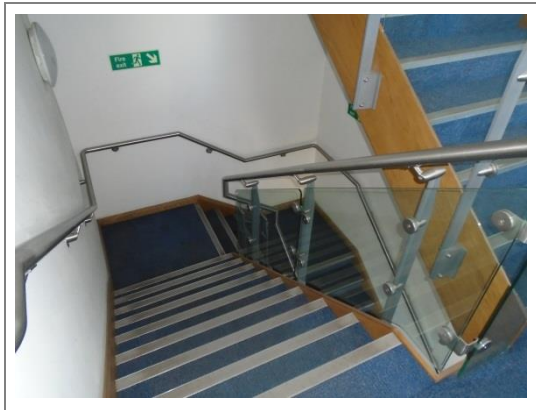
Main staircase

Fire escape staircase

The staircases are in fair overall condition and will require limited attention within the next 5 years. However, we understand that you plan to undertake comprehensive refurbishment works to the accommodation block which will include renewing finishes to the staircases when you occupy the premises. We have not included costs for any refurbishment works.

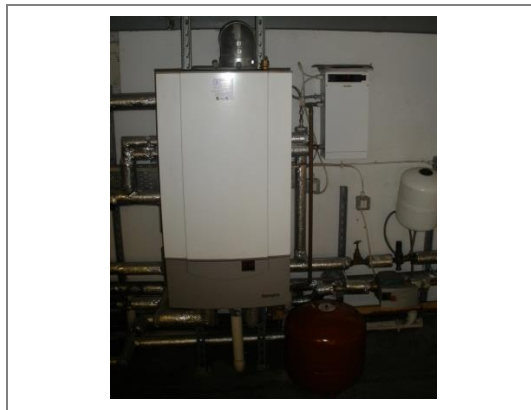
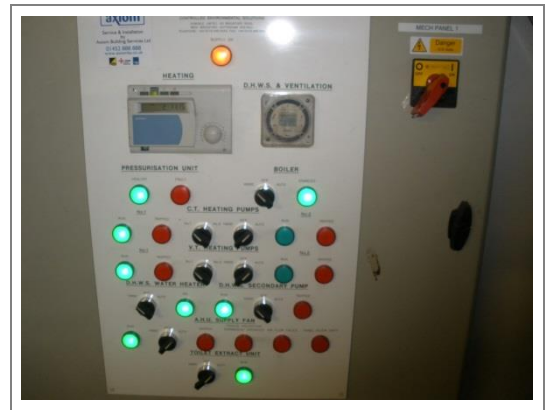
Office Boiler Plant

Heating Control Panel

The heating systems are in a fair and operational condition. No maintenance documentation was available on site.

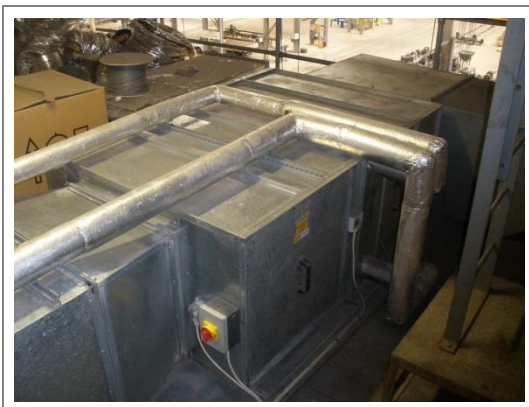
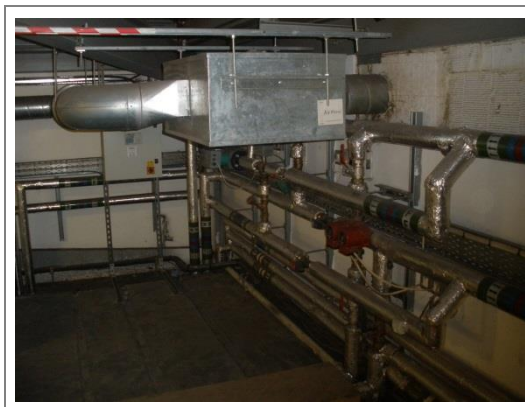
Office Supply AHU

Toilet Extract Fan

The ventilation systems were installed circa 2008 and 2010. The systems are in a fair operational condition.

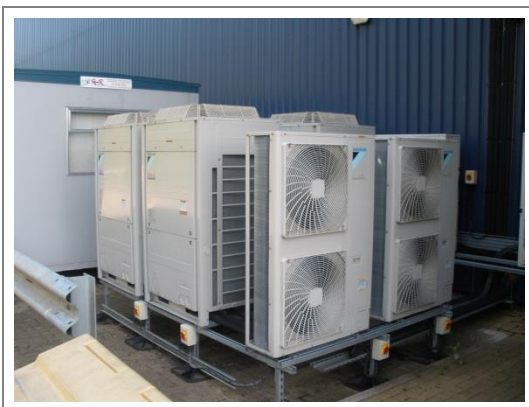
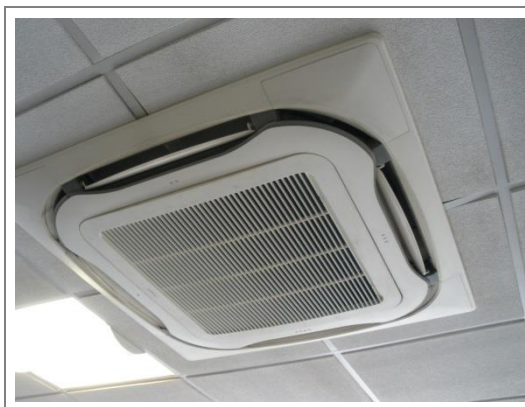
Office VRF Plant

Typical Internal Cassette Unit

The VRF comfort cooling systems were installed circa 2013 and are in a fair operational condition.

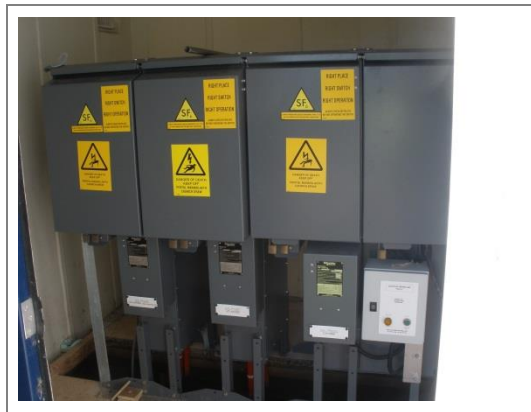
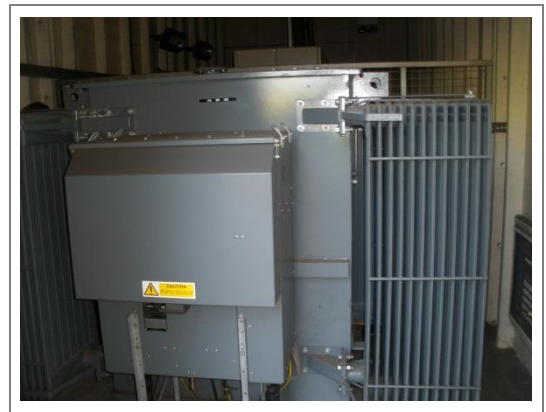
Site HV Switches

Typical Transformer

The incoming electrical supply and infrastructure appears to be in a good operational condition.

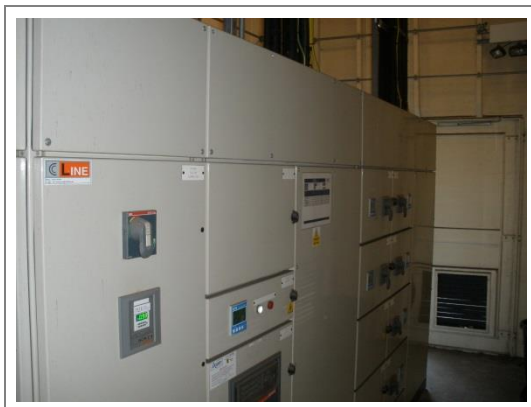
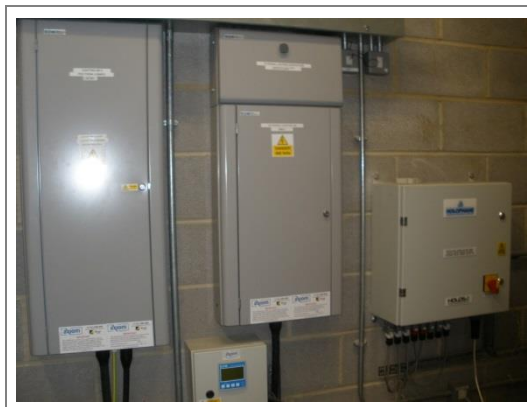
Typical Switchpanel

Typical Distribution Boards

The LV distribution appears to be in a good operational condition. No LV maintenance documentation or fixed wire test was available on site for review. An allowance should be made for a full test and inspection report following the Tenant's vacation.

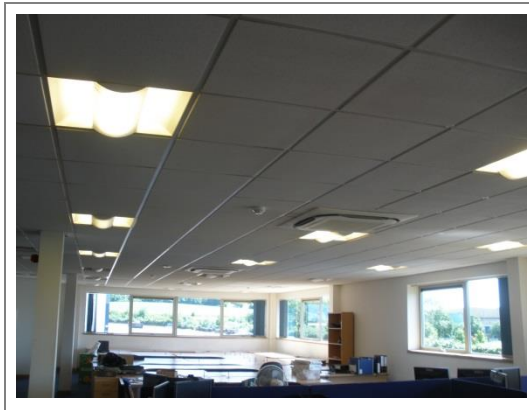
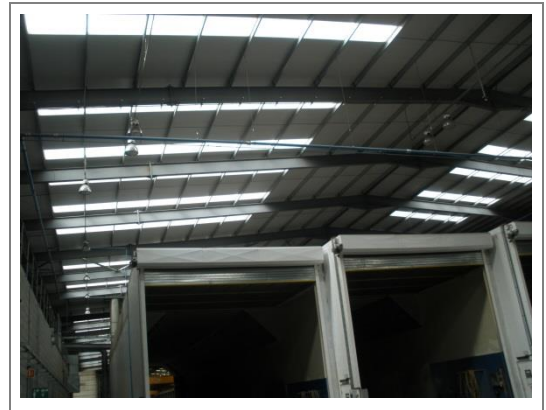
Office Lighting

Warehouse Lighting

The lighting installation appears to be in a fair and operational condition.

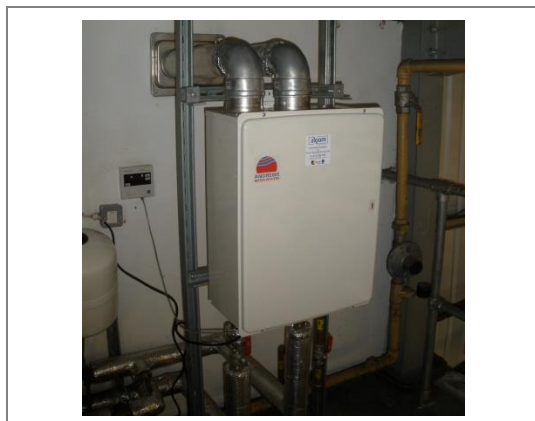
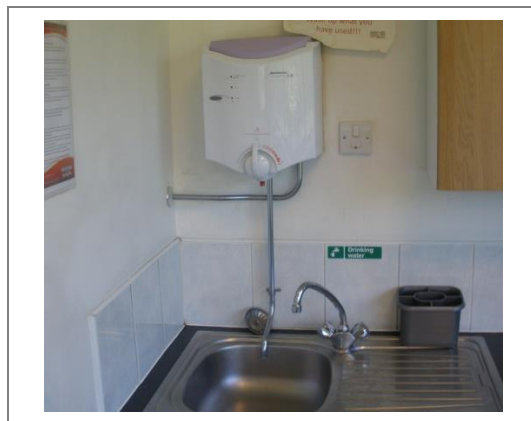
Gas Fired Water Heater

Local Oversink Water Heater

The domestic water installations are in a good operational condition. The gas fired heater was installed in 2016.

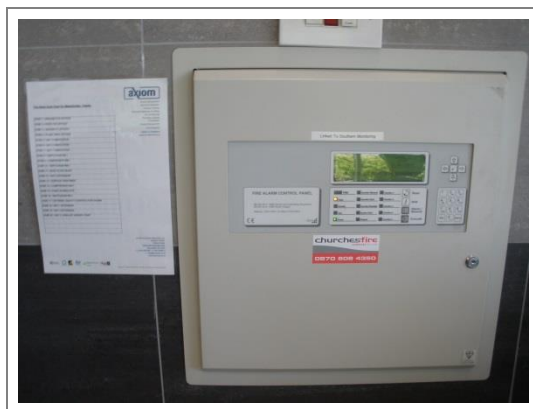
Main Fire Alarm Panel

The fire alarm system appears to be in fair and operational condition. No maintenance documentation was available on site for review. There were two faults on the panel at the time of the survey which should be picked up as part of on-going maintenance. It is assumed any interfaces to plant being removed will also be removed as part of the strip out.

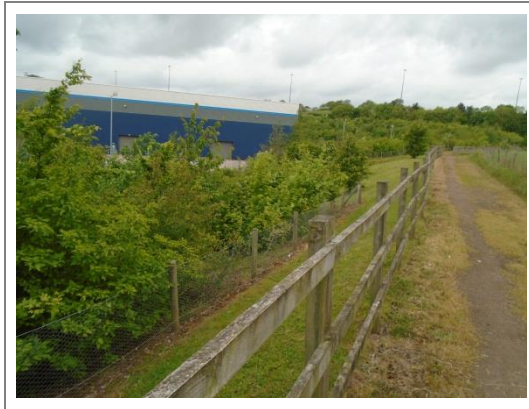
Low level perimeter timber fence

The timber fences are in fair condition although these require treatment with a wood preservative within the next 1-2 years.

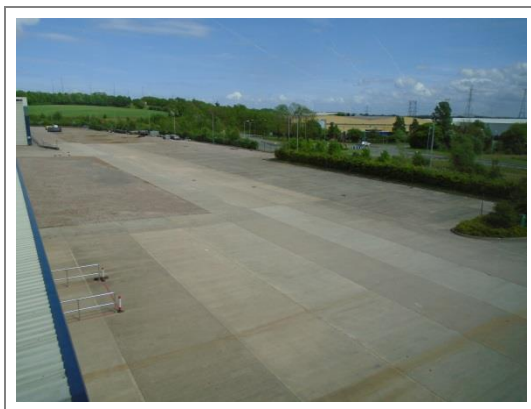
Concrete yard adjacent to south east elevation

The in-situ concrete yard areas are in good overall condition although some slab edges to the yard area to the south east of the building are spalling/breaking up and concrete repairs are required. These repairs should extend along the site entrance for goods vehicles as this area is suffering from the same issue.

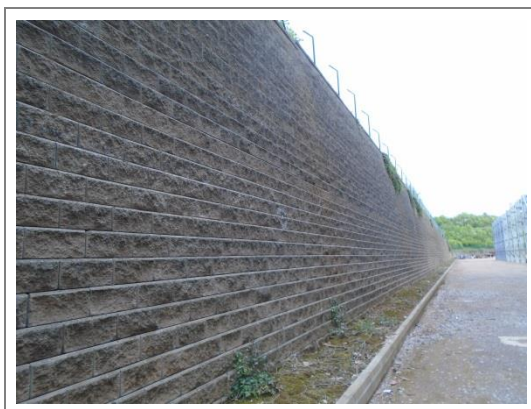
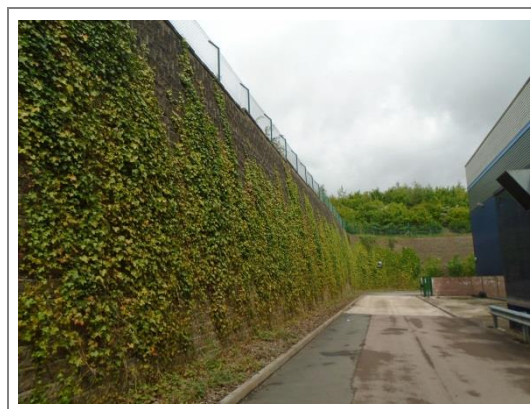
Retaining wall to north west of building

Retaining wall to south west of building

The retaining wall appears to be in good overall condition with no obvious movement or failure noted.

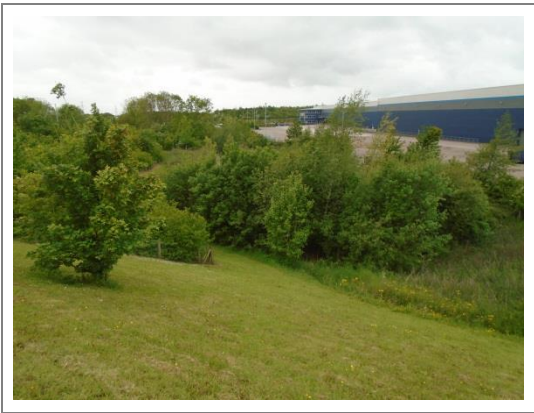
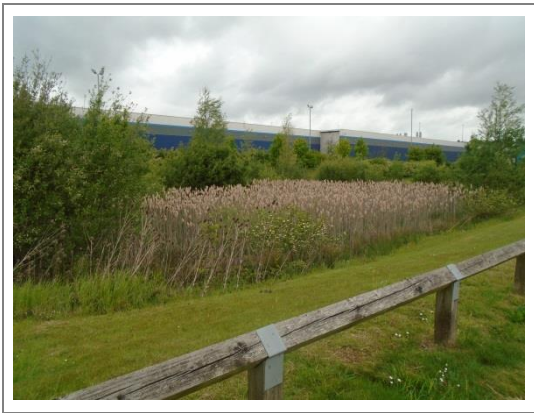
Soft landscaping to north east of site

Soft landscaping to south east of site

The soft landscaping appeared to be well maintained and no significant issues were noted.

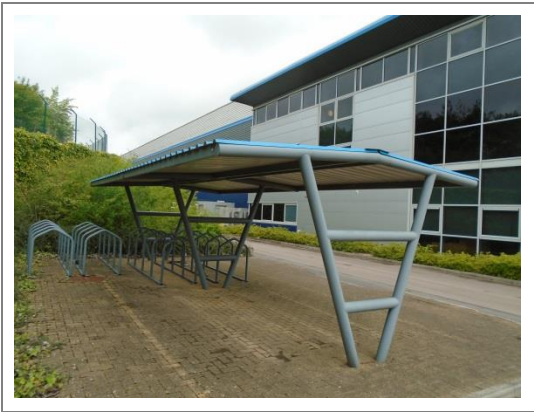
Cycle Shelter

The cycle shelter is in good condition with no significant defects identified
