## Compliance Assessment Report CAR\_NRW0040763

**Permit being assessed:** CG0024001

For: BEDDGELERT WASTE WATER TREATMENT, held by DWR CYMRU CYFYNGEDIG

**Type of assessment carried out:** Audit, Reason: Routine.

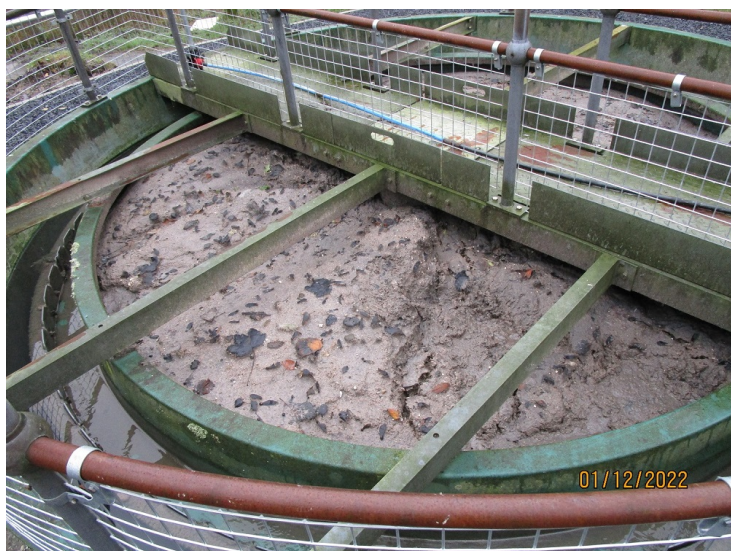
It was explained that the primary tanks were being de-sludged 3 times a week. However, photographs taken of the primary tank showed excessive sludge and organic matter growing within the tanks and outlet, suggesting maintenance of the primary tanks had not been as regular as required. It is recommended that this is looked into.

**Photo of primary tanks with excessive volume of sludge.**

| Criteria | Action needed | Complete by |
|---|---|---|
| WQ-A1 | Improve maintenance and desludge operation of primary settlement tank. | 31/01/2023 |

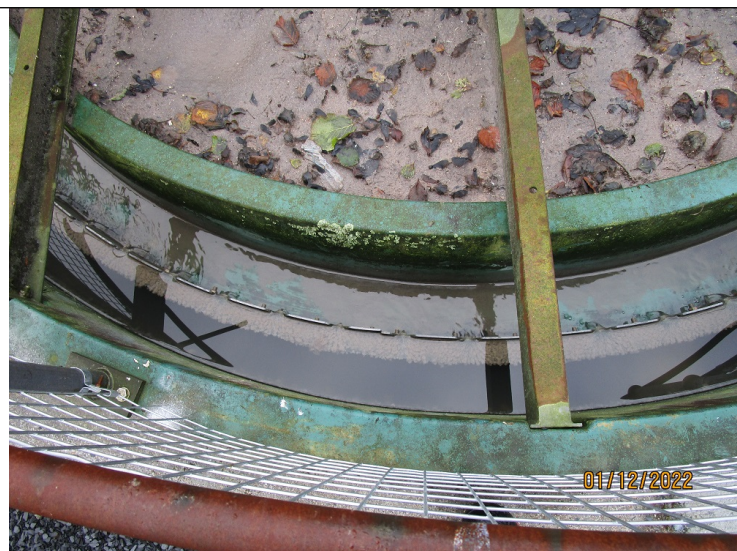
**Photo showing organic matter growth in primary tank.**

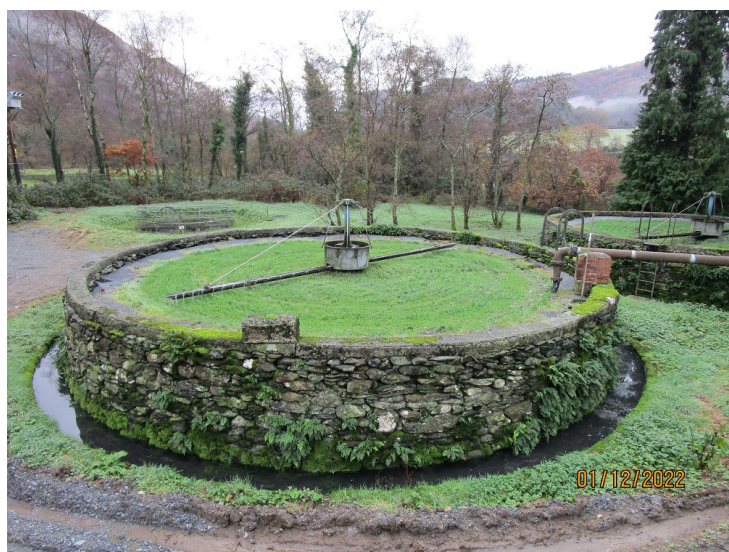
The filter beds on site were operating as normal, however it was noted that there was excessive grass growth on the surface of the filter beds suggesting asset had not received sufficient maintenance recently. It was explained that this was difficult due to the presence of a plastic guard on top of the filter bed.

**Photo of grass growth on surface of filter beds.**

| Criteria | Action needed | Complete by |
|---|---|---|
| WQ-A1 | Improve maintenance of filter beds regarding vegetation growth | 28/02/2023 |

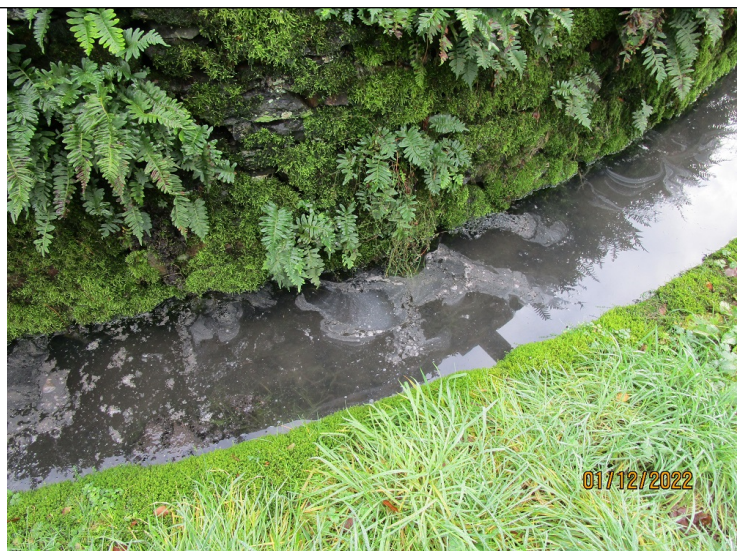
Both filter beds were surrounded by a stagnant effluent 'moat', where there appeared to be little or no flow. It was unclear what was the cause of this, and if a blockage caused by fluvial flooding was causing the system to back up. It did raise the question if the site was being operated as intended, or as effectively as possible?

**Photo of stagnant final effluent 'moat' around filter beds.**

| Criteria | Action needed | Complete by |
|---|---|---|
| WQ-A1 | Improve operations regarding stagnant effluent 'moat' around filter beds | 28/02/2023 |

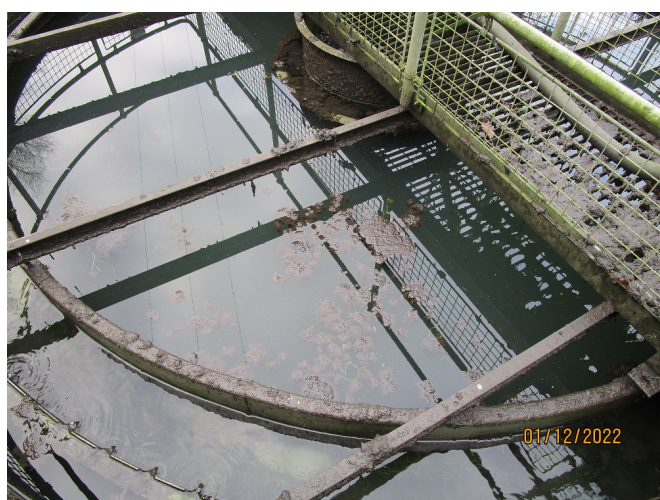
The final effluent tank showed clear impact from recent flooding, with mud deposits surrounding the tank and along the centre walkway. The mud was also present in the final effluent tank, which appeared untidy and in need of maintenance. It is noted that the entire site sits within an area prone to a high risk of flooding, however the site appeared to be unprotected from this risk - there were no bunds protecting the site from flood risk.

**Photo of condition of final effluent tank, with clear signs of mud deposit in and around tank, from fluvial flooding.**

| Criteria | Action needed | Complete by |
|---|---|---|
| WQ-A1 | Improve maintenance of final effluent chamber and investigate if impacts from fluvial flooding can be avoided. | 28/02/2023 |

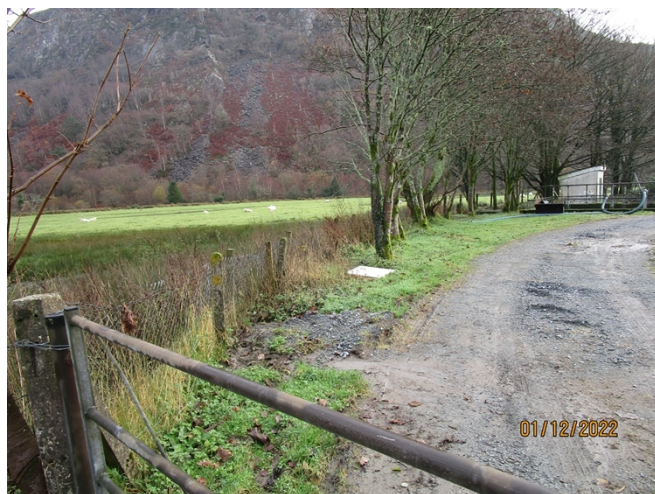
We also note that the site appears to have little protection from any trespass. The site lies

within a 100m from a popular footpath along Afon Glaslyn, yet there was no appropriate security fencing surrounding the site. Although it was stated that no issues had ever occurred with trespass at the site, we would recommend that DCWW review the security provisions at the site in order to avoid any potential accidents or environmental impacts.

**Photo showing STW's perimeter fencing**

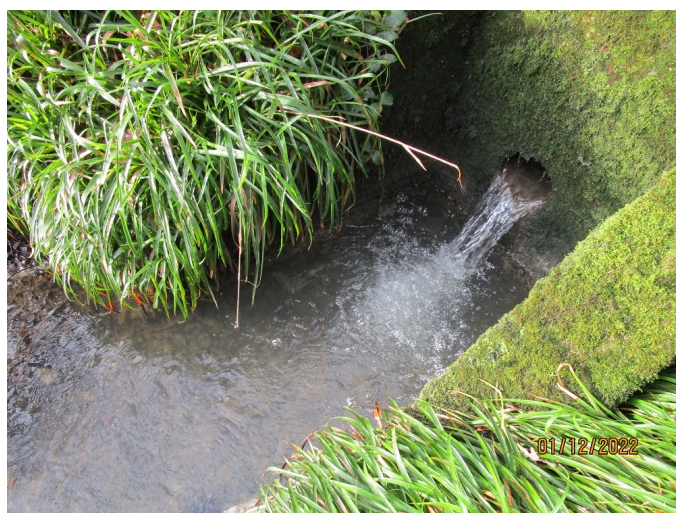
NRW were able to view the outfall pipe into the Glaslyn. It was stated that the final effluent and storm overflow both discharged into the Glaslyn from the same pipe. During the visit there was adequate flow in the river, and the final effluent was seen to be discharging into the Glaslyn, indicating that at the time there were no issues with the river levels causing the final effluent to back up to the works. The final effluent discharge appeared clear, and we detected no odour. We did however see signs of sewage fungus in the watercourse around the outfall. The fungus was seen on vegetation and on branches in the watercourse. We managed to trace evidence of sewage fungus to approximately 20m downstream from the outfall location.

**Photo of final effluent outfall**

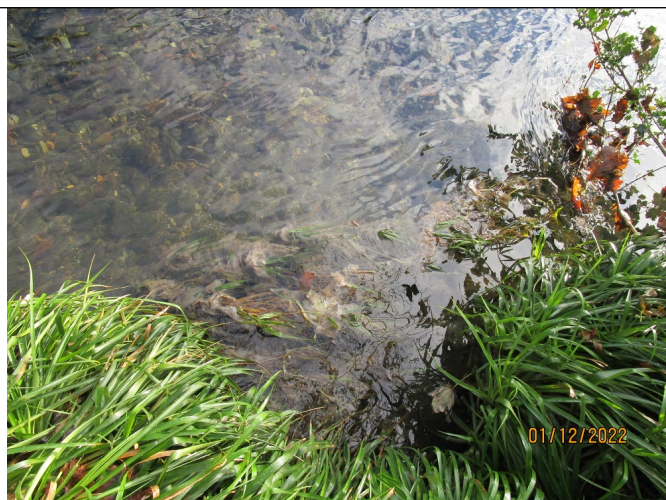
**Photo of sewage fungus downstream of outfall.**

Since any storm overflow should be highly diluted, we question what could be causing this sewage fungus growth around the outfall? Are the treatment works working as effectively as possible, or are there issues with fluvial flooding, stagnant effluent 'moat' and need to de-sludge and maintain the primary tanks causing in-combination impacts to the treatment process at the site?

| Criteria | Action needed | Complete by |
|---|---|---|
| WQ-C1 | Review and improve operating procedures so that discharge is adequately treated and sewage fungus is not present around outfall. | 31/01/2023 |

We would ask that DCWW investigate these matters with some urgency and provide NRW with a report of how the treatment works could be improved to prevent any environmental incidents.
