# Penllergaer weirs

Photo survey for NRW impoundment license

West Wales Rivers Trust

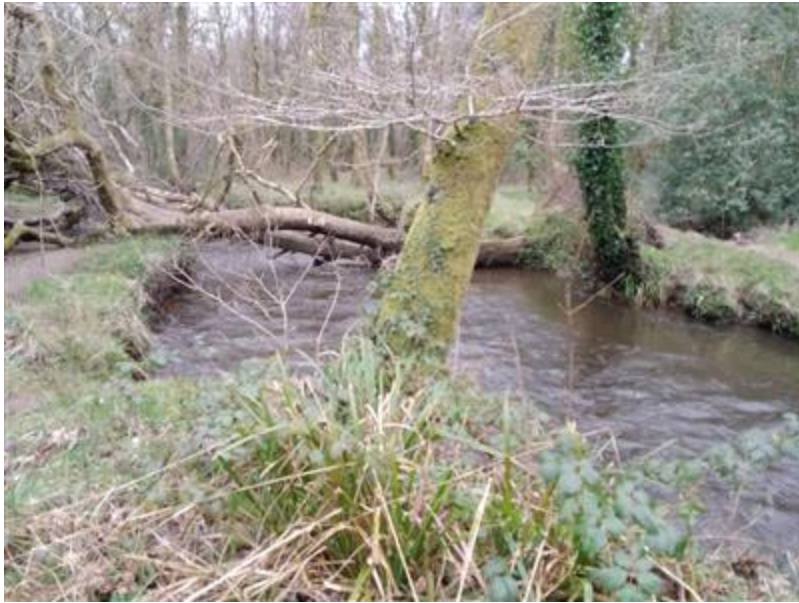
*Figure 1. SS 62448 97780 facing US from RHB.*

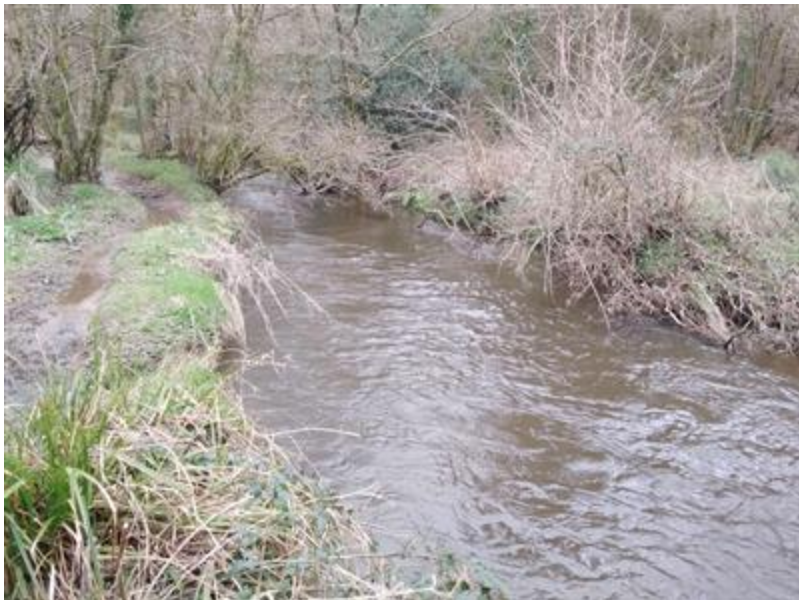
*Figure 2. SS 62444 97737 facing US from RHB.*

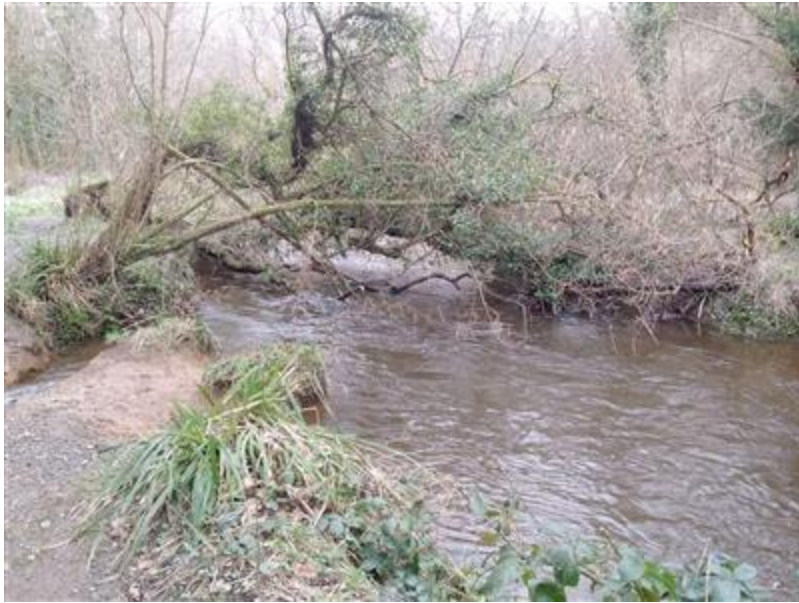
*Figure 3. SS 62444 97732 facing US from RHB.*

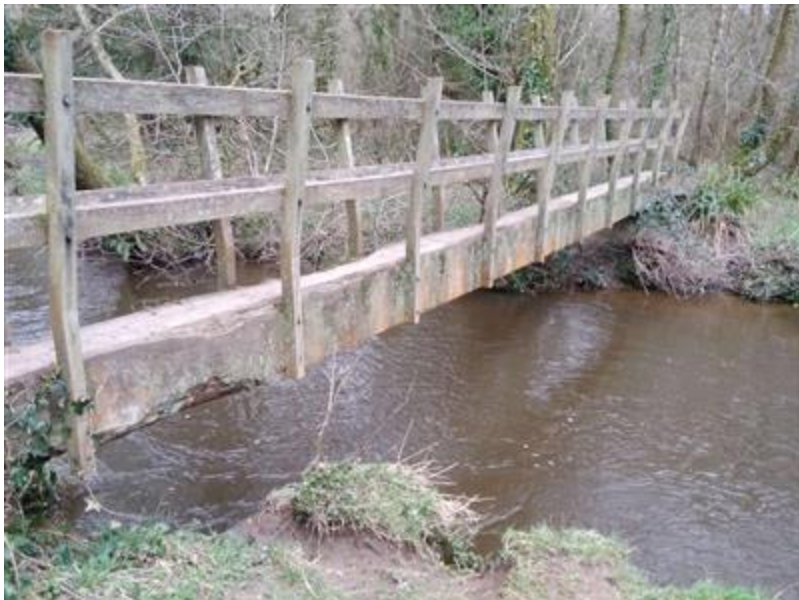
*Figure 4. Footbridge at SS 62451 97729 from RHB at SS 62449 97725.*

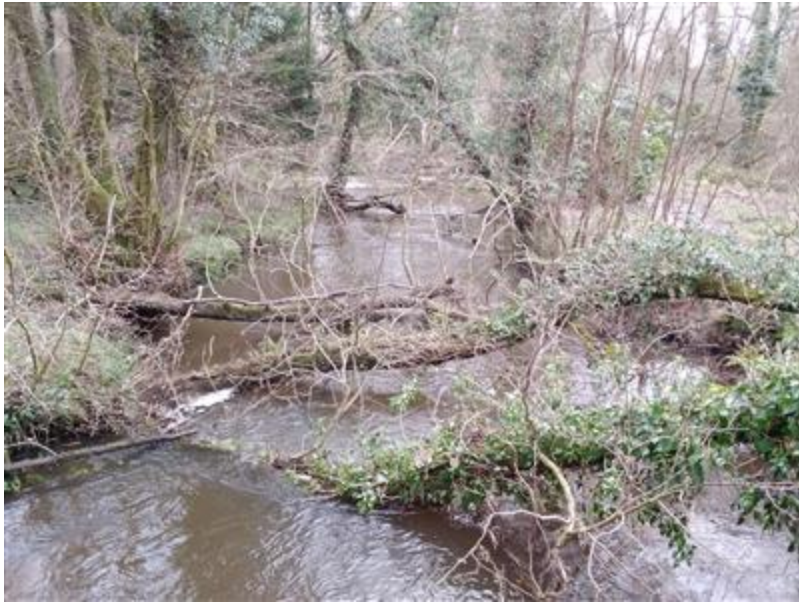
*Figure 5. SS 62471 97703 DS from footbridge.*

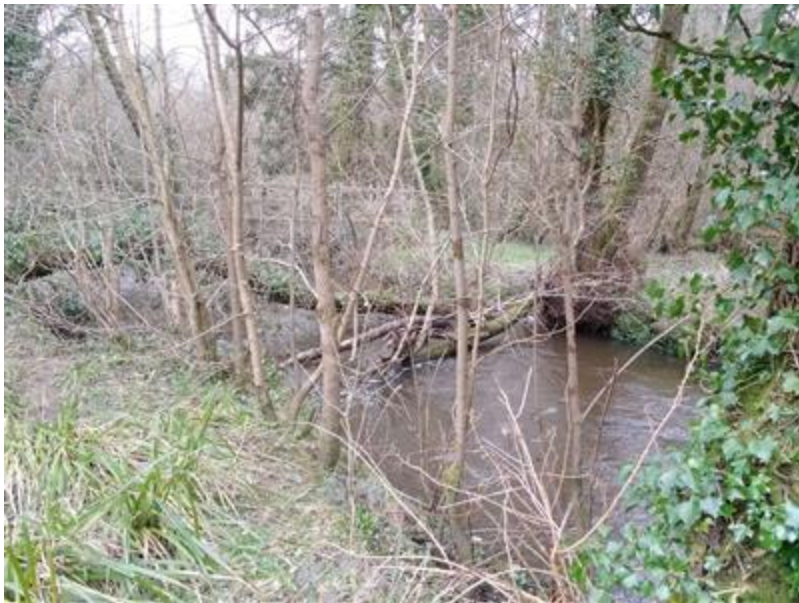
*Figure 6. SS 62448 976996 facing US from RHB.*

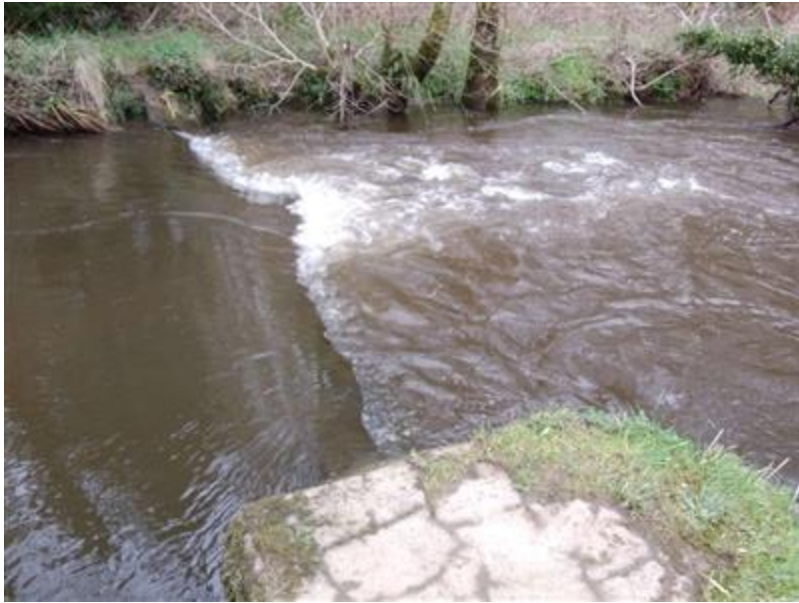
*Figure 7. SS 62454 97699 - photo from RHB pillar facing LHB.*

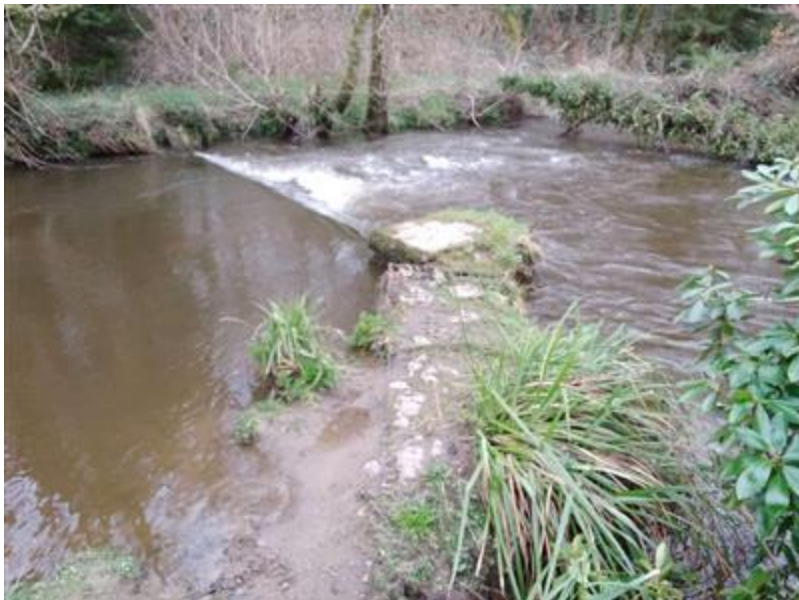
*Figure 8. SS 62450 97698 weir and gabion baskets from RHB.*

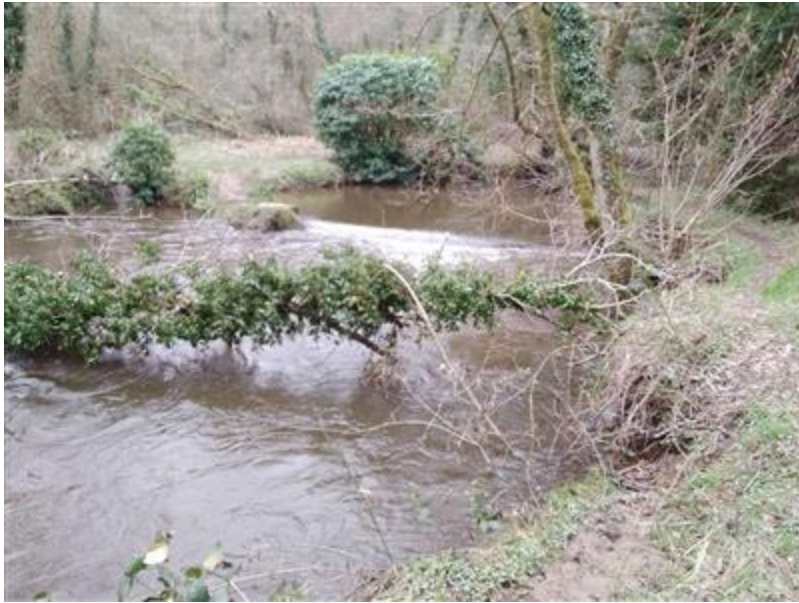
*Figure 9. SS 62469 97686 weir facing US from LHB.*

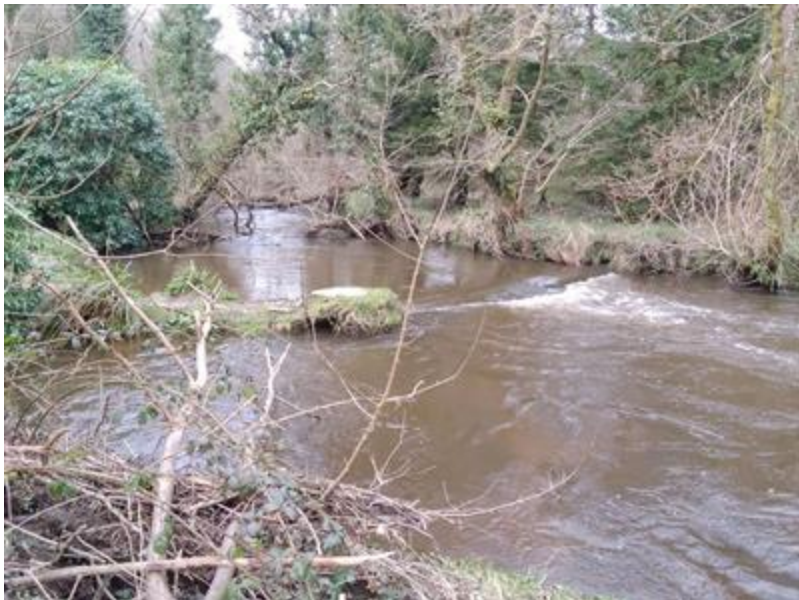
*Figure 10. SS 62457 97695 DS of weir facing US from RHB.*

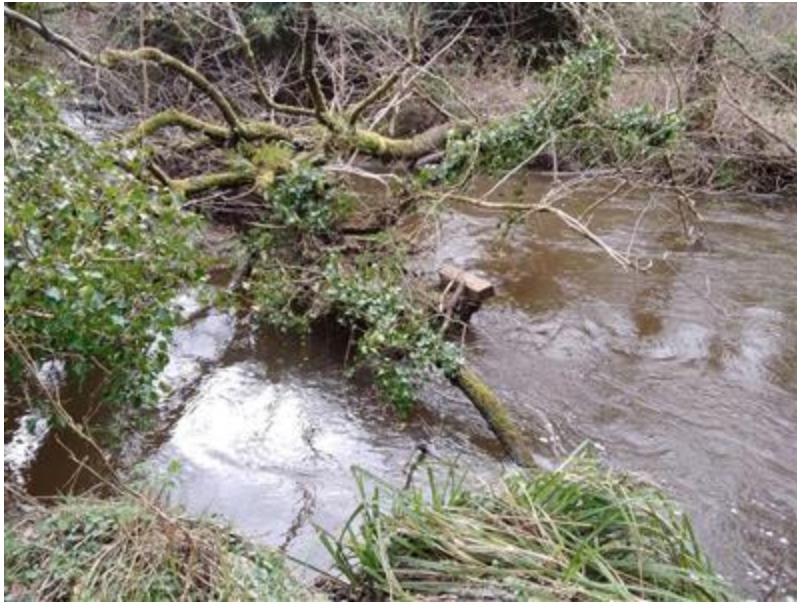
*Figure 11. SS 62465 97669 eddy on LHB - Taken from LHB facing DS.*

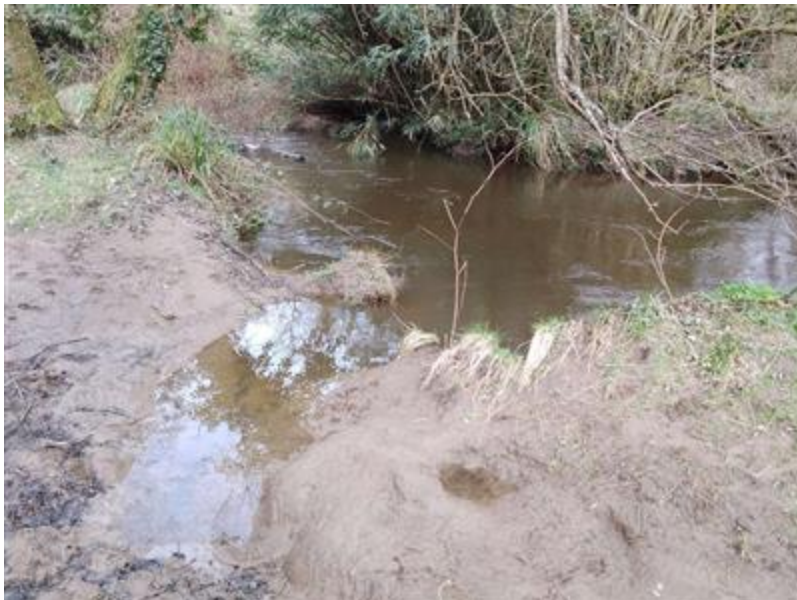
*Figure 12. SS 62428 97641 facing US from RHB vegetated tree lined channel. Some dog erosion.*

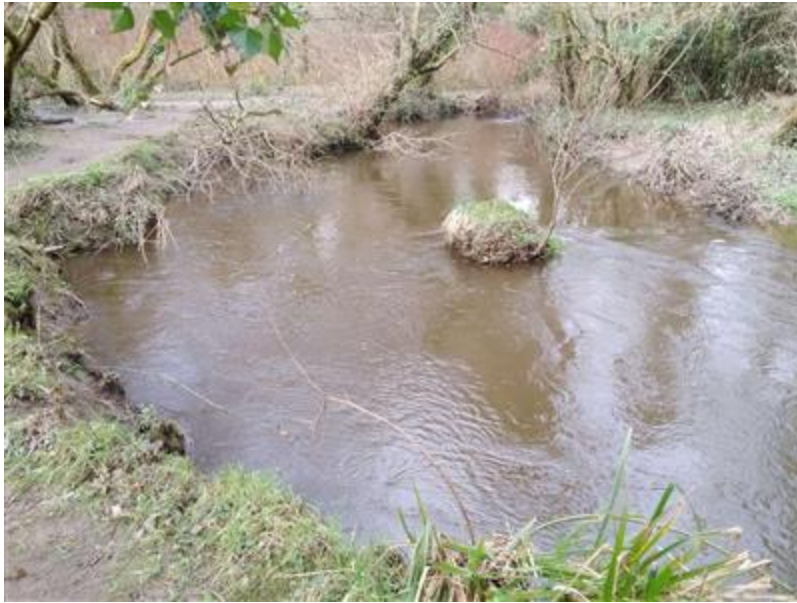
*Figure 13. SS 62456 97615 facing US from the RHB.*

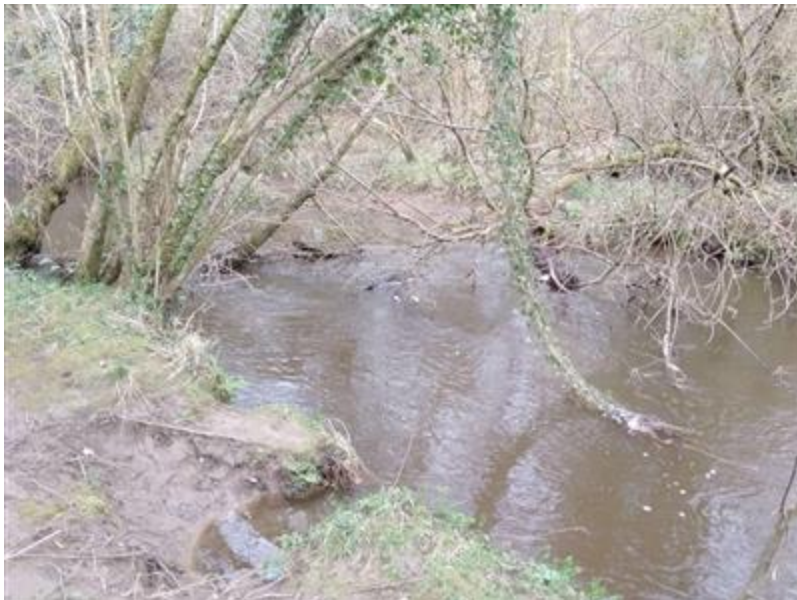
*Figure 14. SS 62448 97587 photo facing US from RHB. Tree lined channel, some erosion from dog access.*

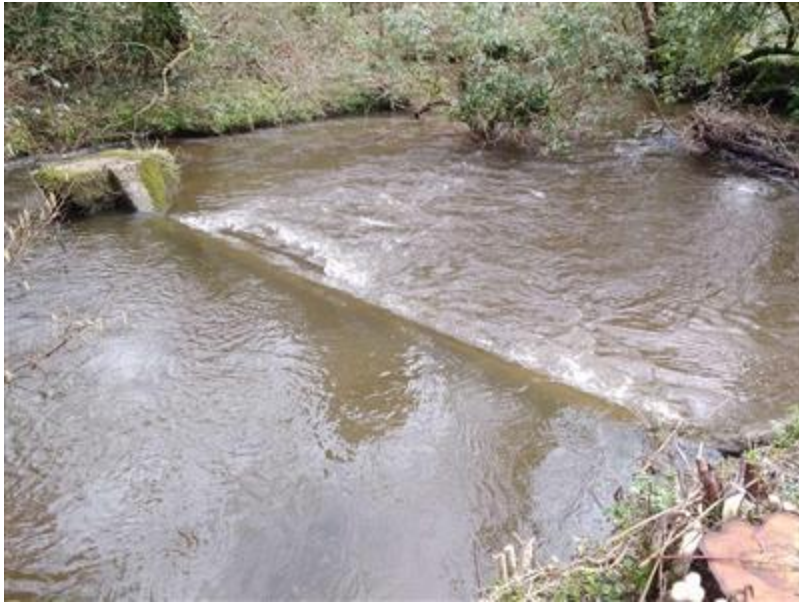
*Figure 15. SS 62443 97565 view from US weir RHB facing DS.*

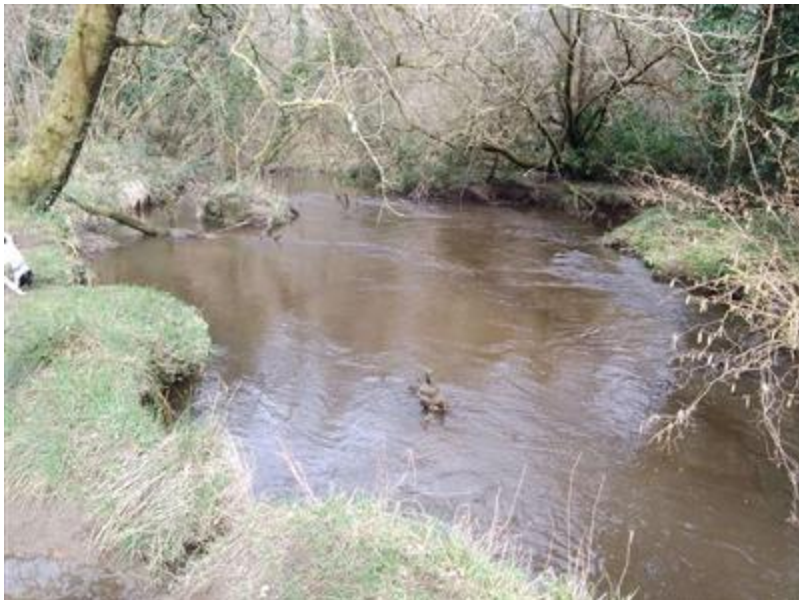
*Figure 16. SS 62445 97576 photo facing US from RHB.*

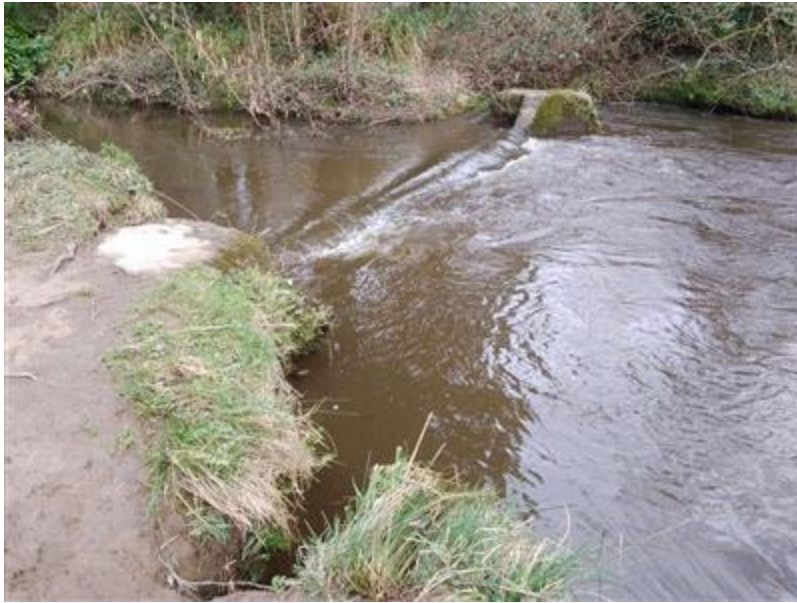
*Figure 17. SS 62442 97559 view from DS weir RHB facing US.*

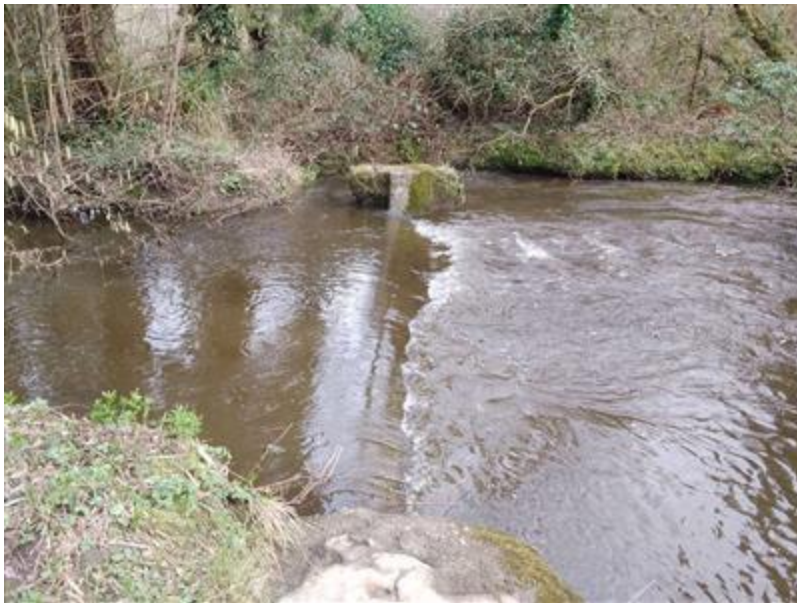
*Figure 18. SS 62440 97566 middle weir from RHB.*

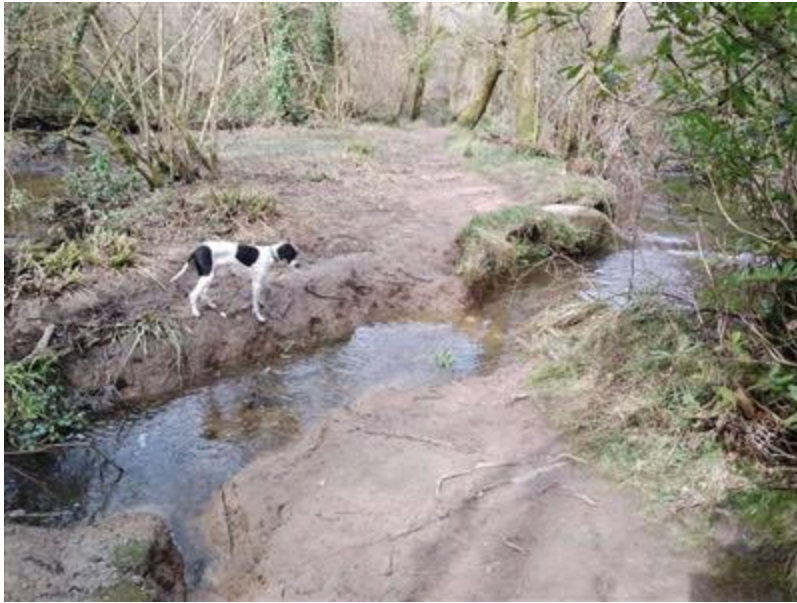
*Figure 19. ss 62447 97535 surface water runoff enters river below weir.*

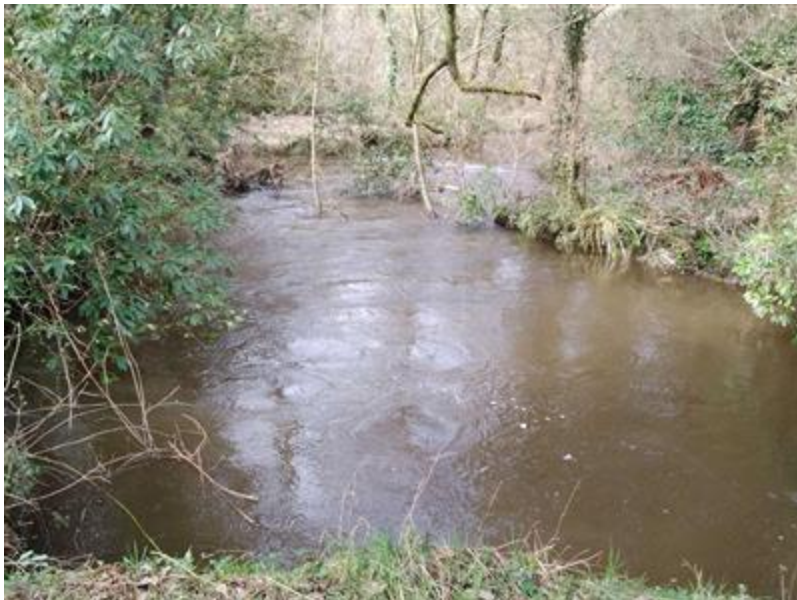
*Figure 20. SS 62452 97525 Facing US from RHB.*

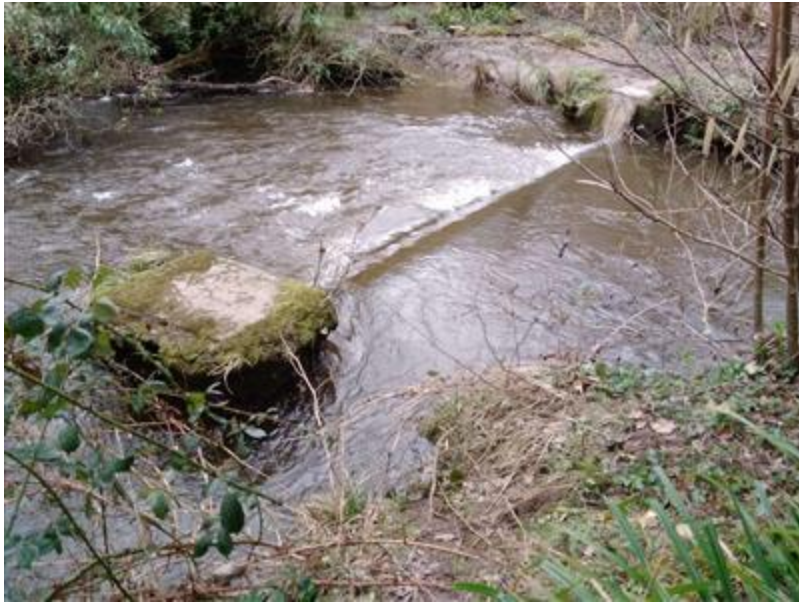
*Figure 21. SS 62440 97559 Weir from LHB facing DS. Note current breach on LHB.*

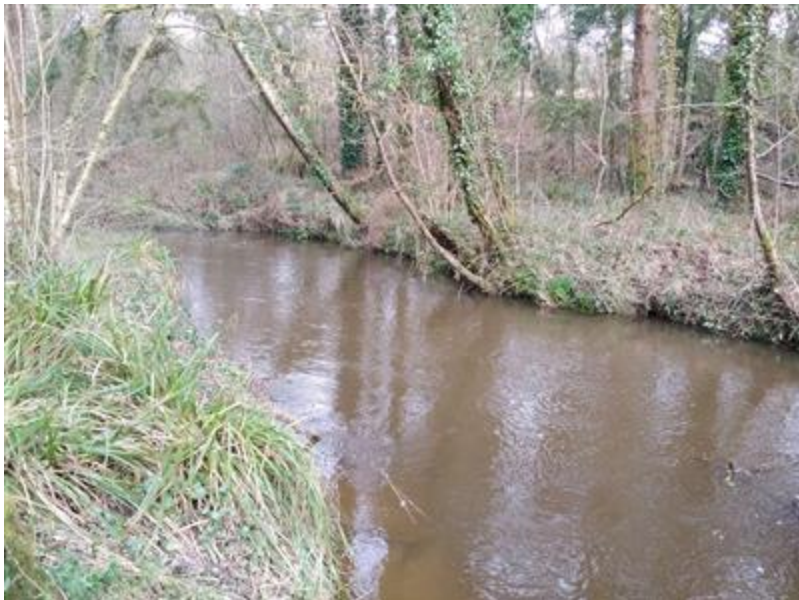
*Figure 22. SS 62451 97523 Facing US from RHB.*

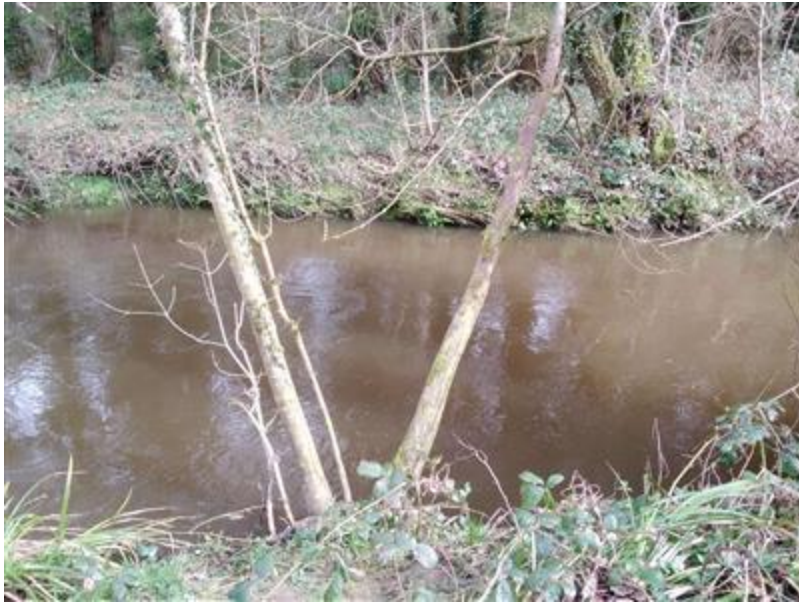
*Figure 23. SS 62450 97518 LHB view from RHB.*

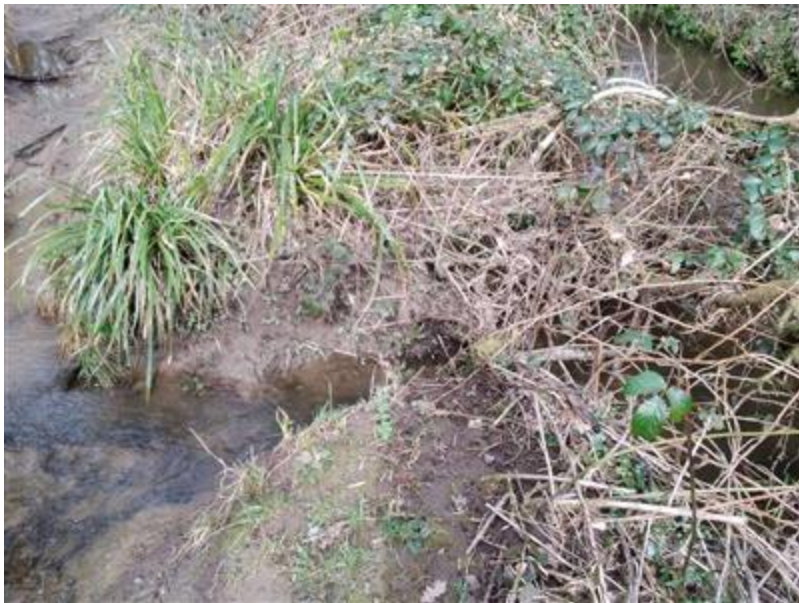
*Figure 24. SS 62447 97500 Flow pathway enters RHB.*

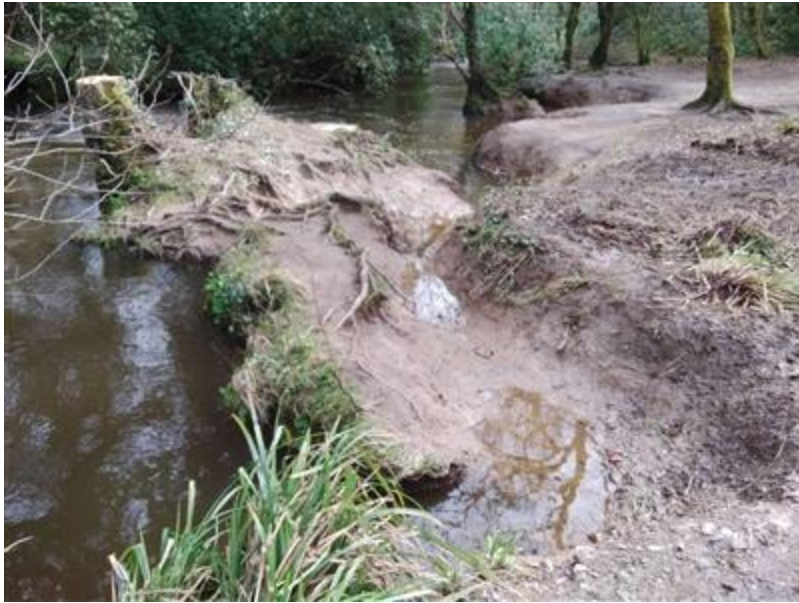
*Figure 25. SS 62450 97495 Erosion on RHB from impounded flows redirecting in high flows.*

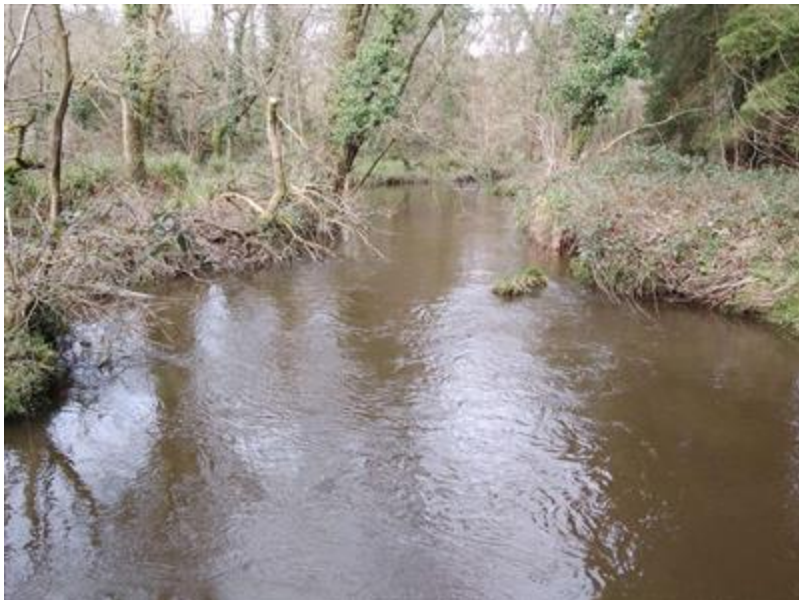
*Figure 26. SS62474 97501 Facing US from RHB.*

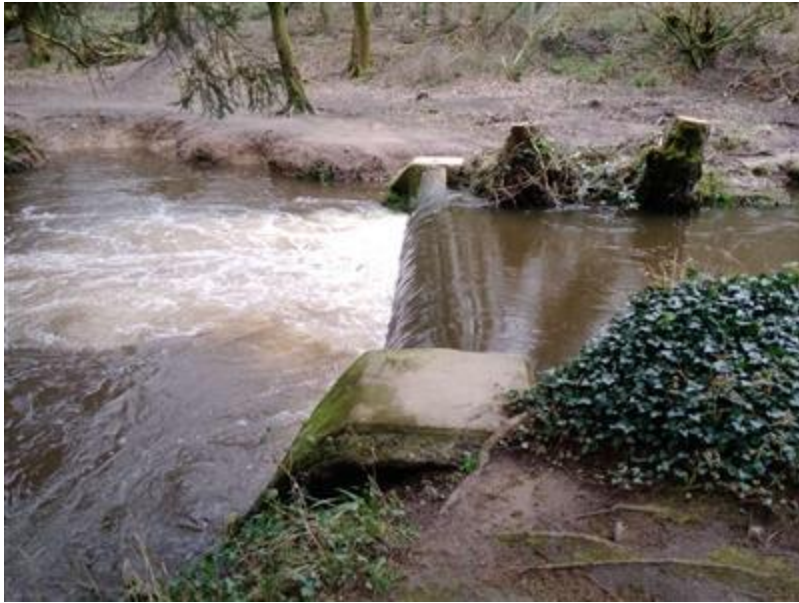
*Figure 27. SS 62458 97486 Weir from LHB.*

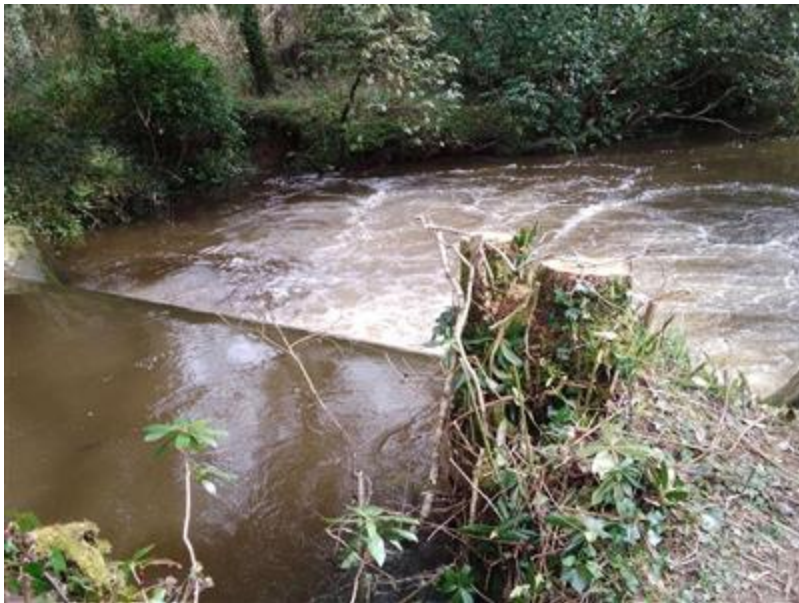
*Figure 28. SS 62454 97493 Immediately US weir from RHB.*

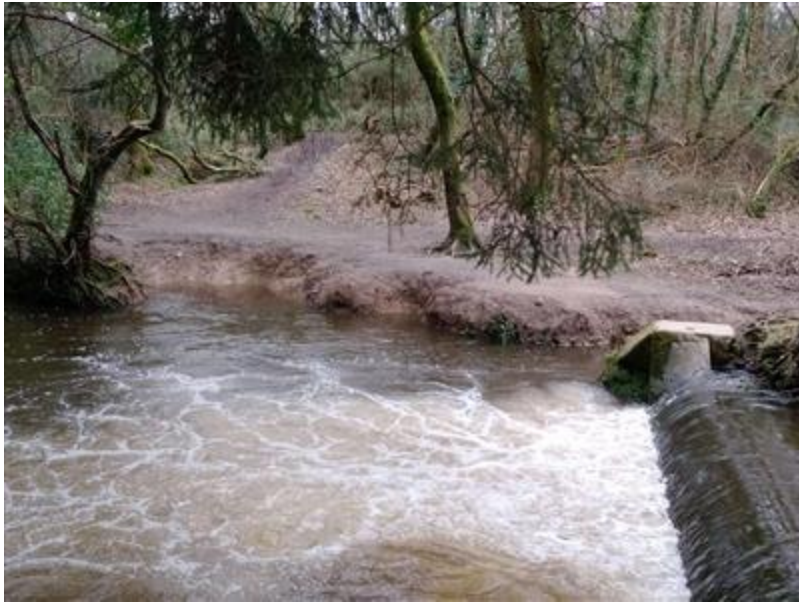
*Figure 29. SS 62458 97491 RHB bank erosion viewed from LHB.*

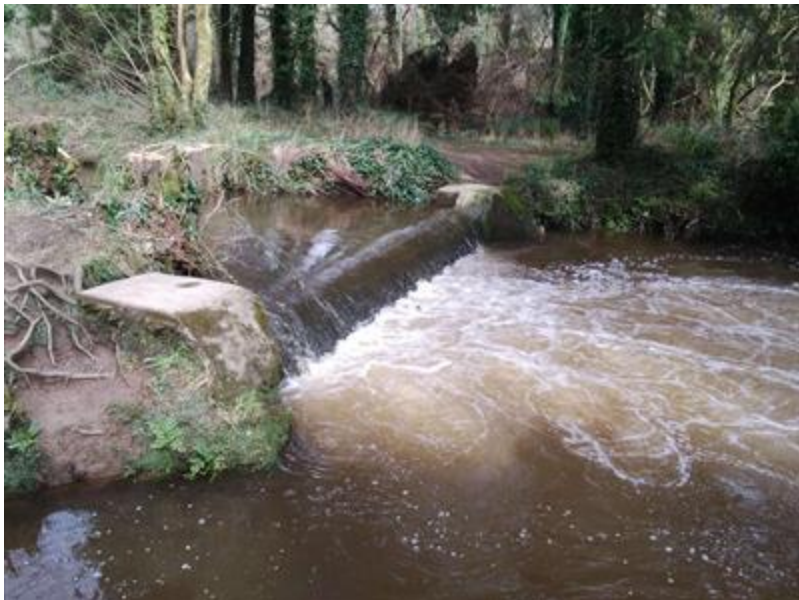
*Figure 30. SS 62460 97491 Immediately DS weir from RHB.*

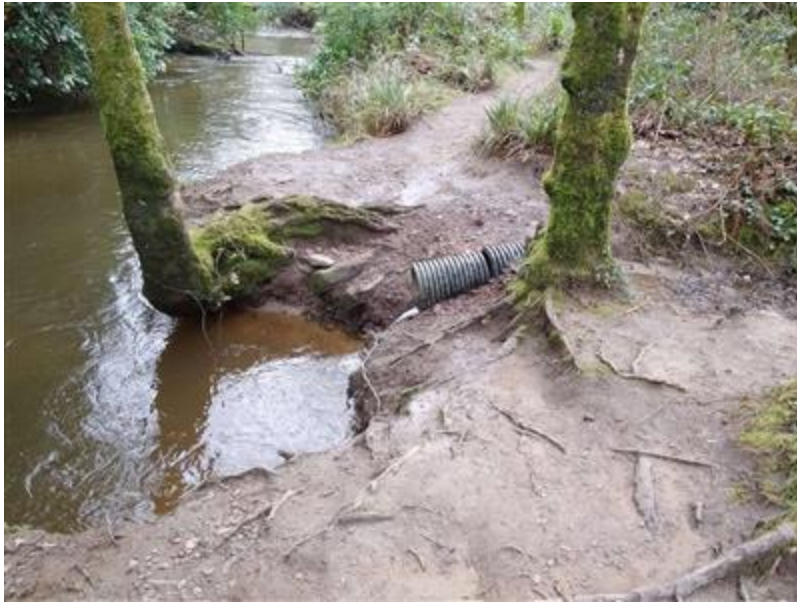
*Figure 31. SS 62466 97477 Bank erosion and surface water inlet (NB. above NGR is photo location, inlet at SS 62457 97473).*

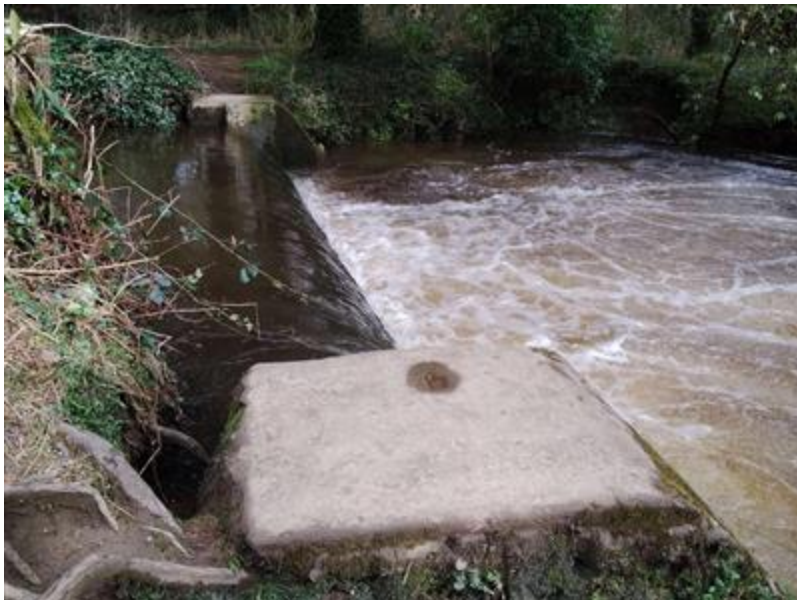
*Figure 32. SS 62452 97478 Weir from RHB.*

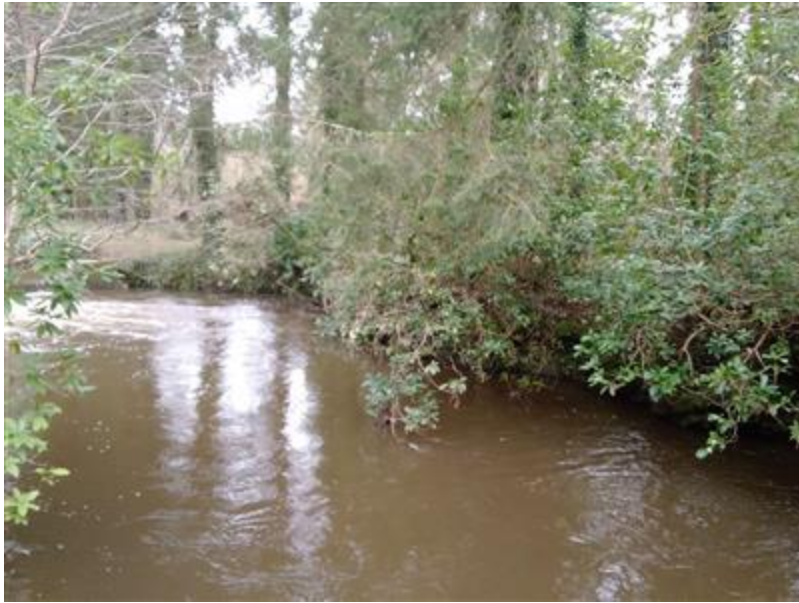
*Figure 33. SS 62451 97482 Tree lined RHB DS of weir.*

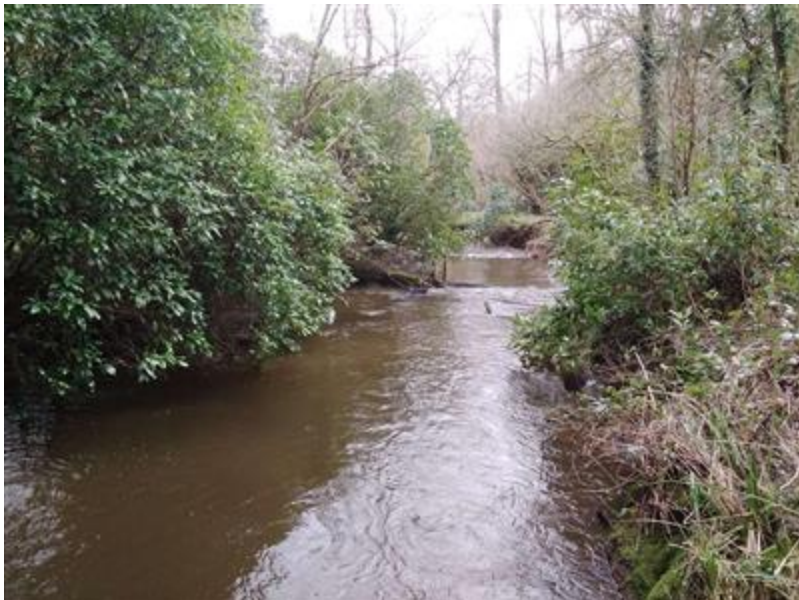
*Figure 34. SS 62457 97471 Channel DS of weir - tree lined either side.*

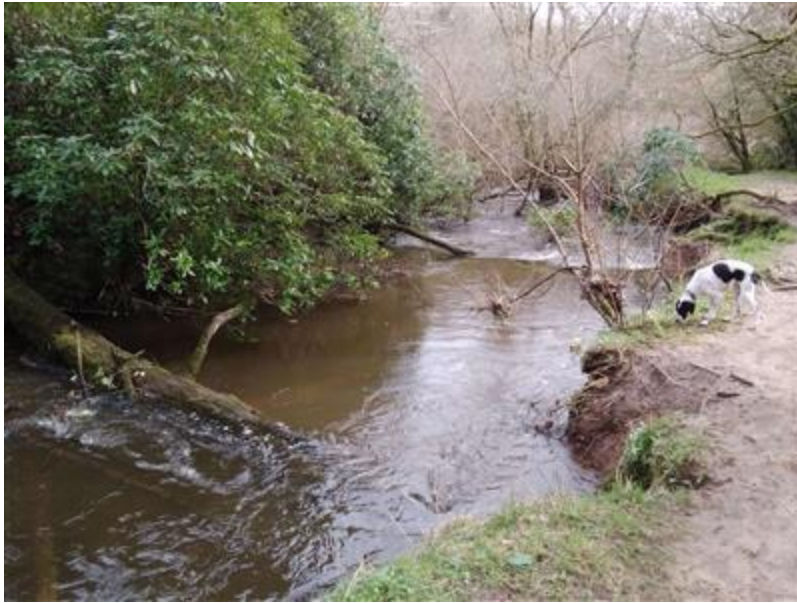
*Figure 35. SS 62479 97443 LWM in channel. Some bank erosion on RHB from dog entry. Photo from RHB.*

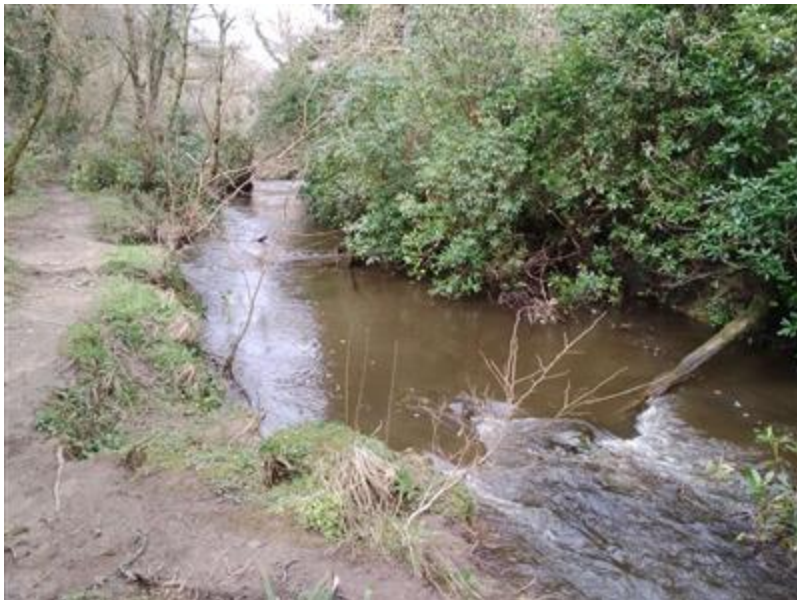
*Figure 36. SS 62476 97440 Facing US from RHB.*

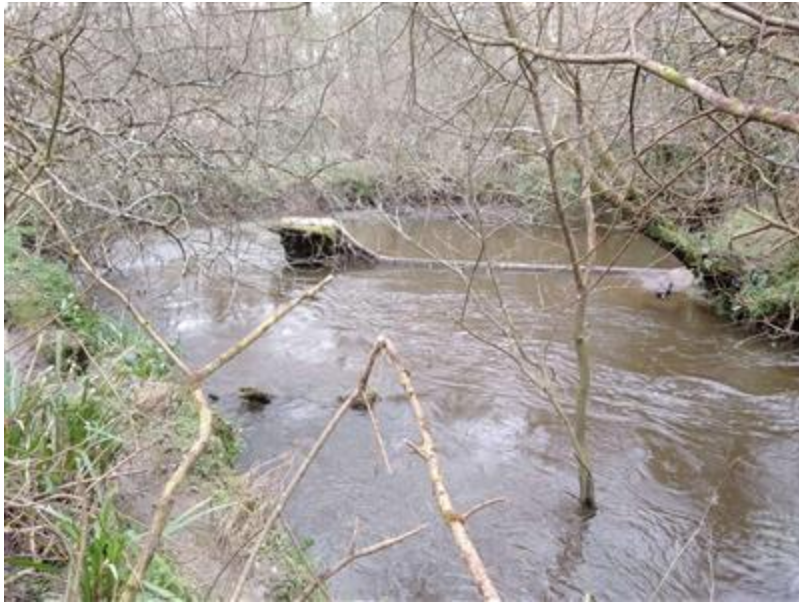
*Figure 37. SS 62459 97475 Weir to be left viewed from LHB facing DS.*

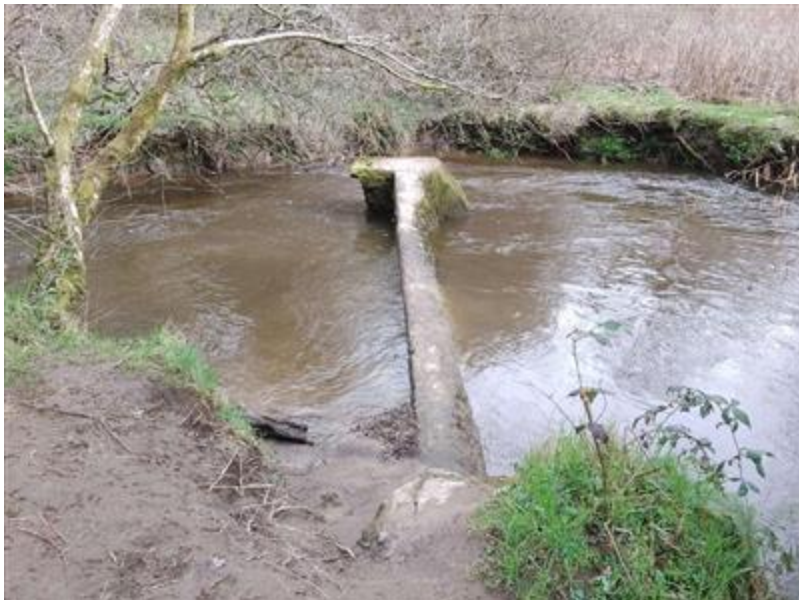
*Figure 38. SS 62495 97436 Further weir breached on LHB. No works being carried out on this weir.*

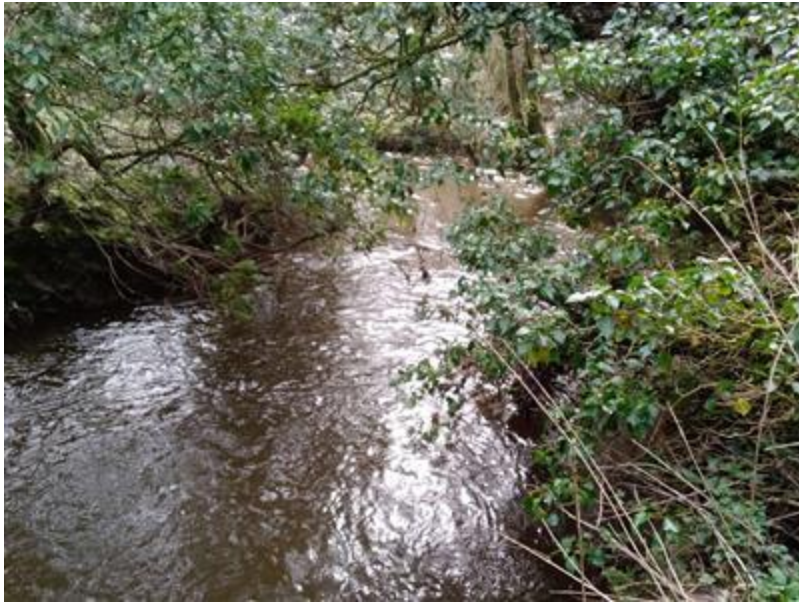
*Figure 39. SS 62475 97417 Both banks vegetated and tree lined.*
