Re: Interim Update on PPC Remediation, Alcoa Manufacturing (GB) Ltd

This letter provides a brief interim update on the current status of the PPC Permit Surrender remedial works at the site. The works have been undertaken by Soilfix Ltd (Soilfix) in general accordance with the Draft PPC Surrender Remediation Action Plan (RAP) Ref.: 64-C12564_1, November 2007. It should be noted that the works are ongoing and as such this update provides only a summary based on currently available information.

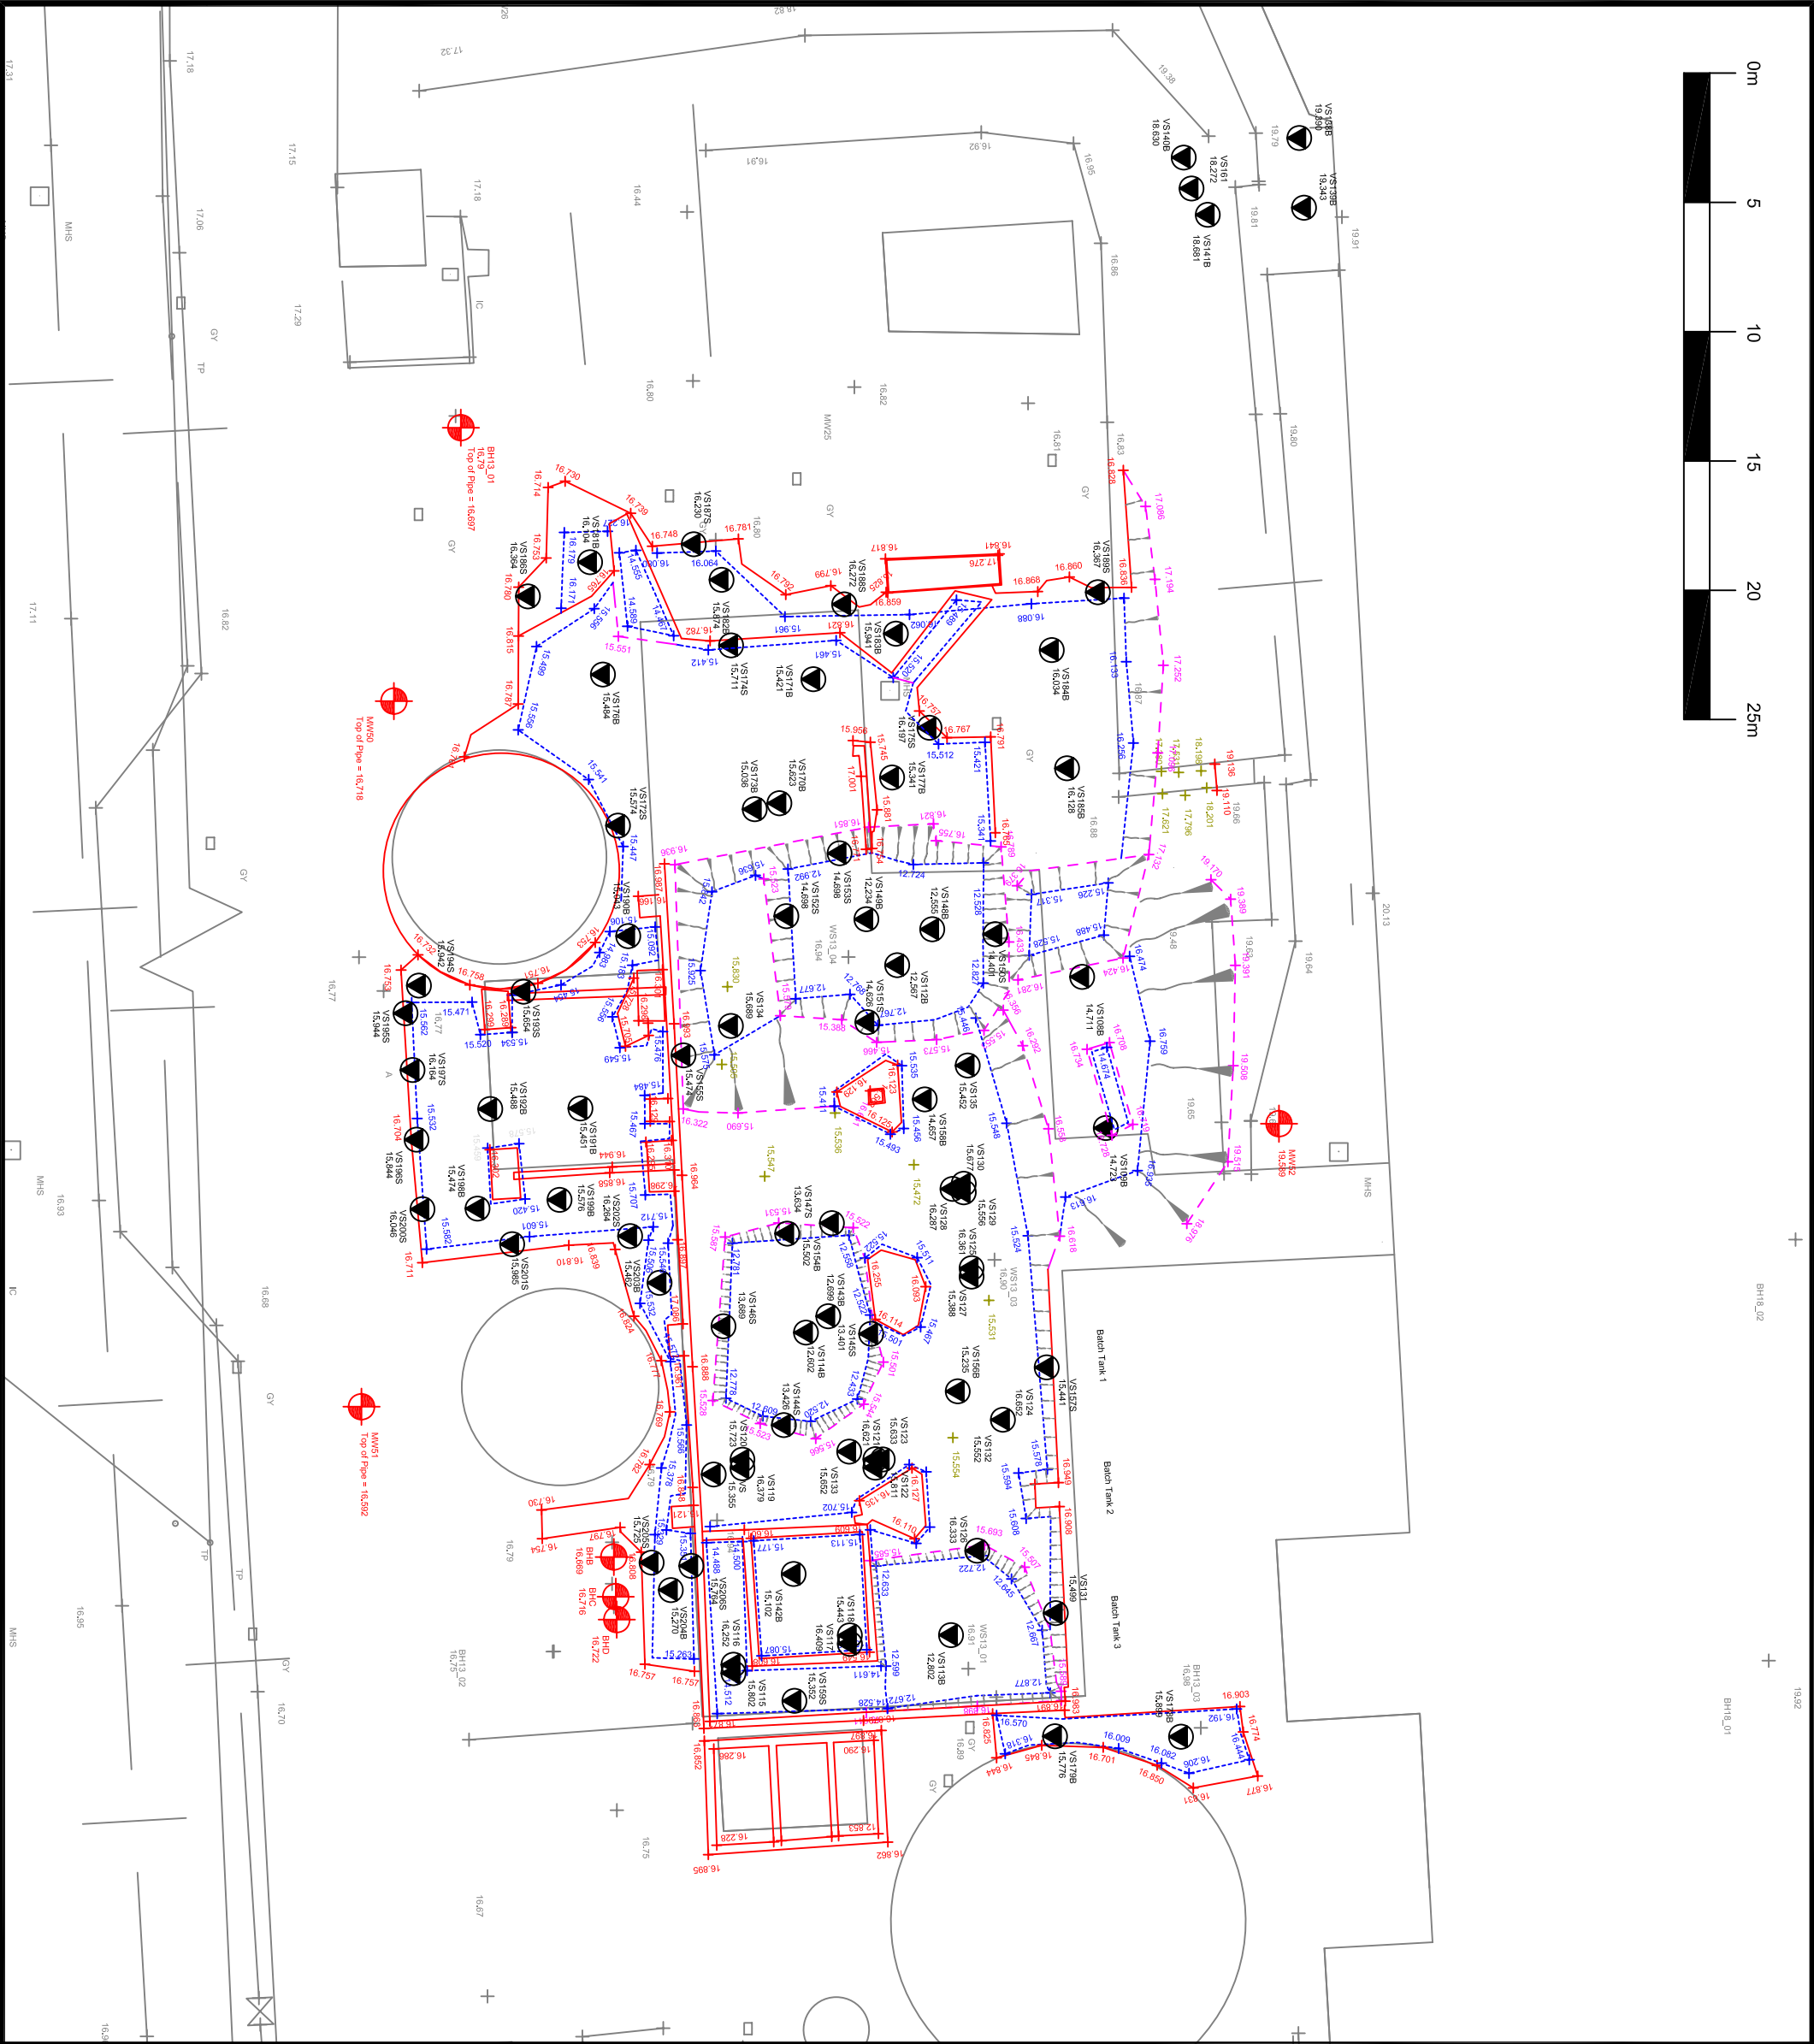
As Dug Survey Effluent Treatment Plant - Zone 13

to remove the free phase hydrocarbons in this area.			2.7m below the existing ground level and the underlying natural clay validated. The excavation was backfilled with imported soil to a level acceptable to Alcoa.
Zone 13 – Effluent Treatment Plant (ETP)	Total and hexavalent chromium in soils underlying the ETP.	Total chromium: 392mg/kg Hexavalent chromium: below MCERTS laboratory reporting limit (<5mg/kg)	Demolition of the ETP building and excavation of contaminated soils underlying and immediately adjacent to the footprint.	The ETP and associated tanks and structures were demolished by Penny Demolition Ltd. Following removal of the floor slab the area was sheeted to prevent rainwater ingress. The chromium contamination was visually identifiable by green staining in the granular Made Ground. By the end of March, approximately 900m ³ of chromium and hexavalent chromium contaminated soils has been excavated and disposed off-site. Excavation works are ongoing and final validation is awaited.

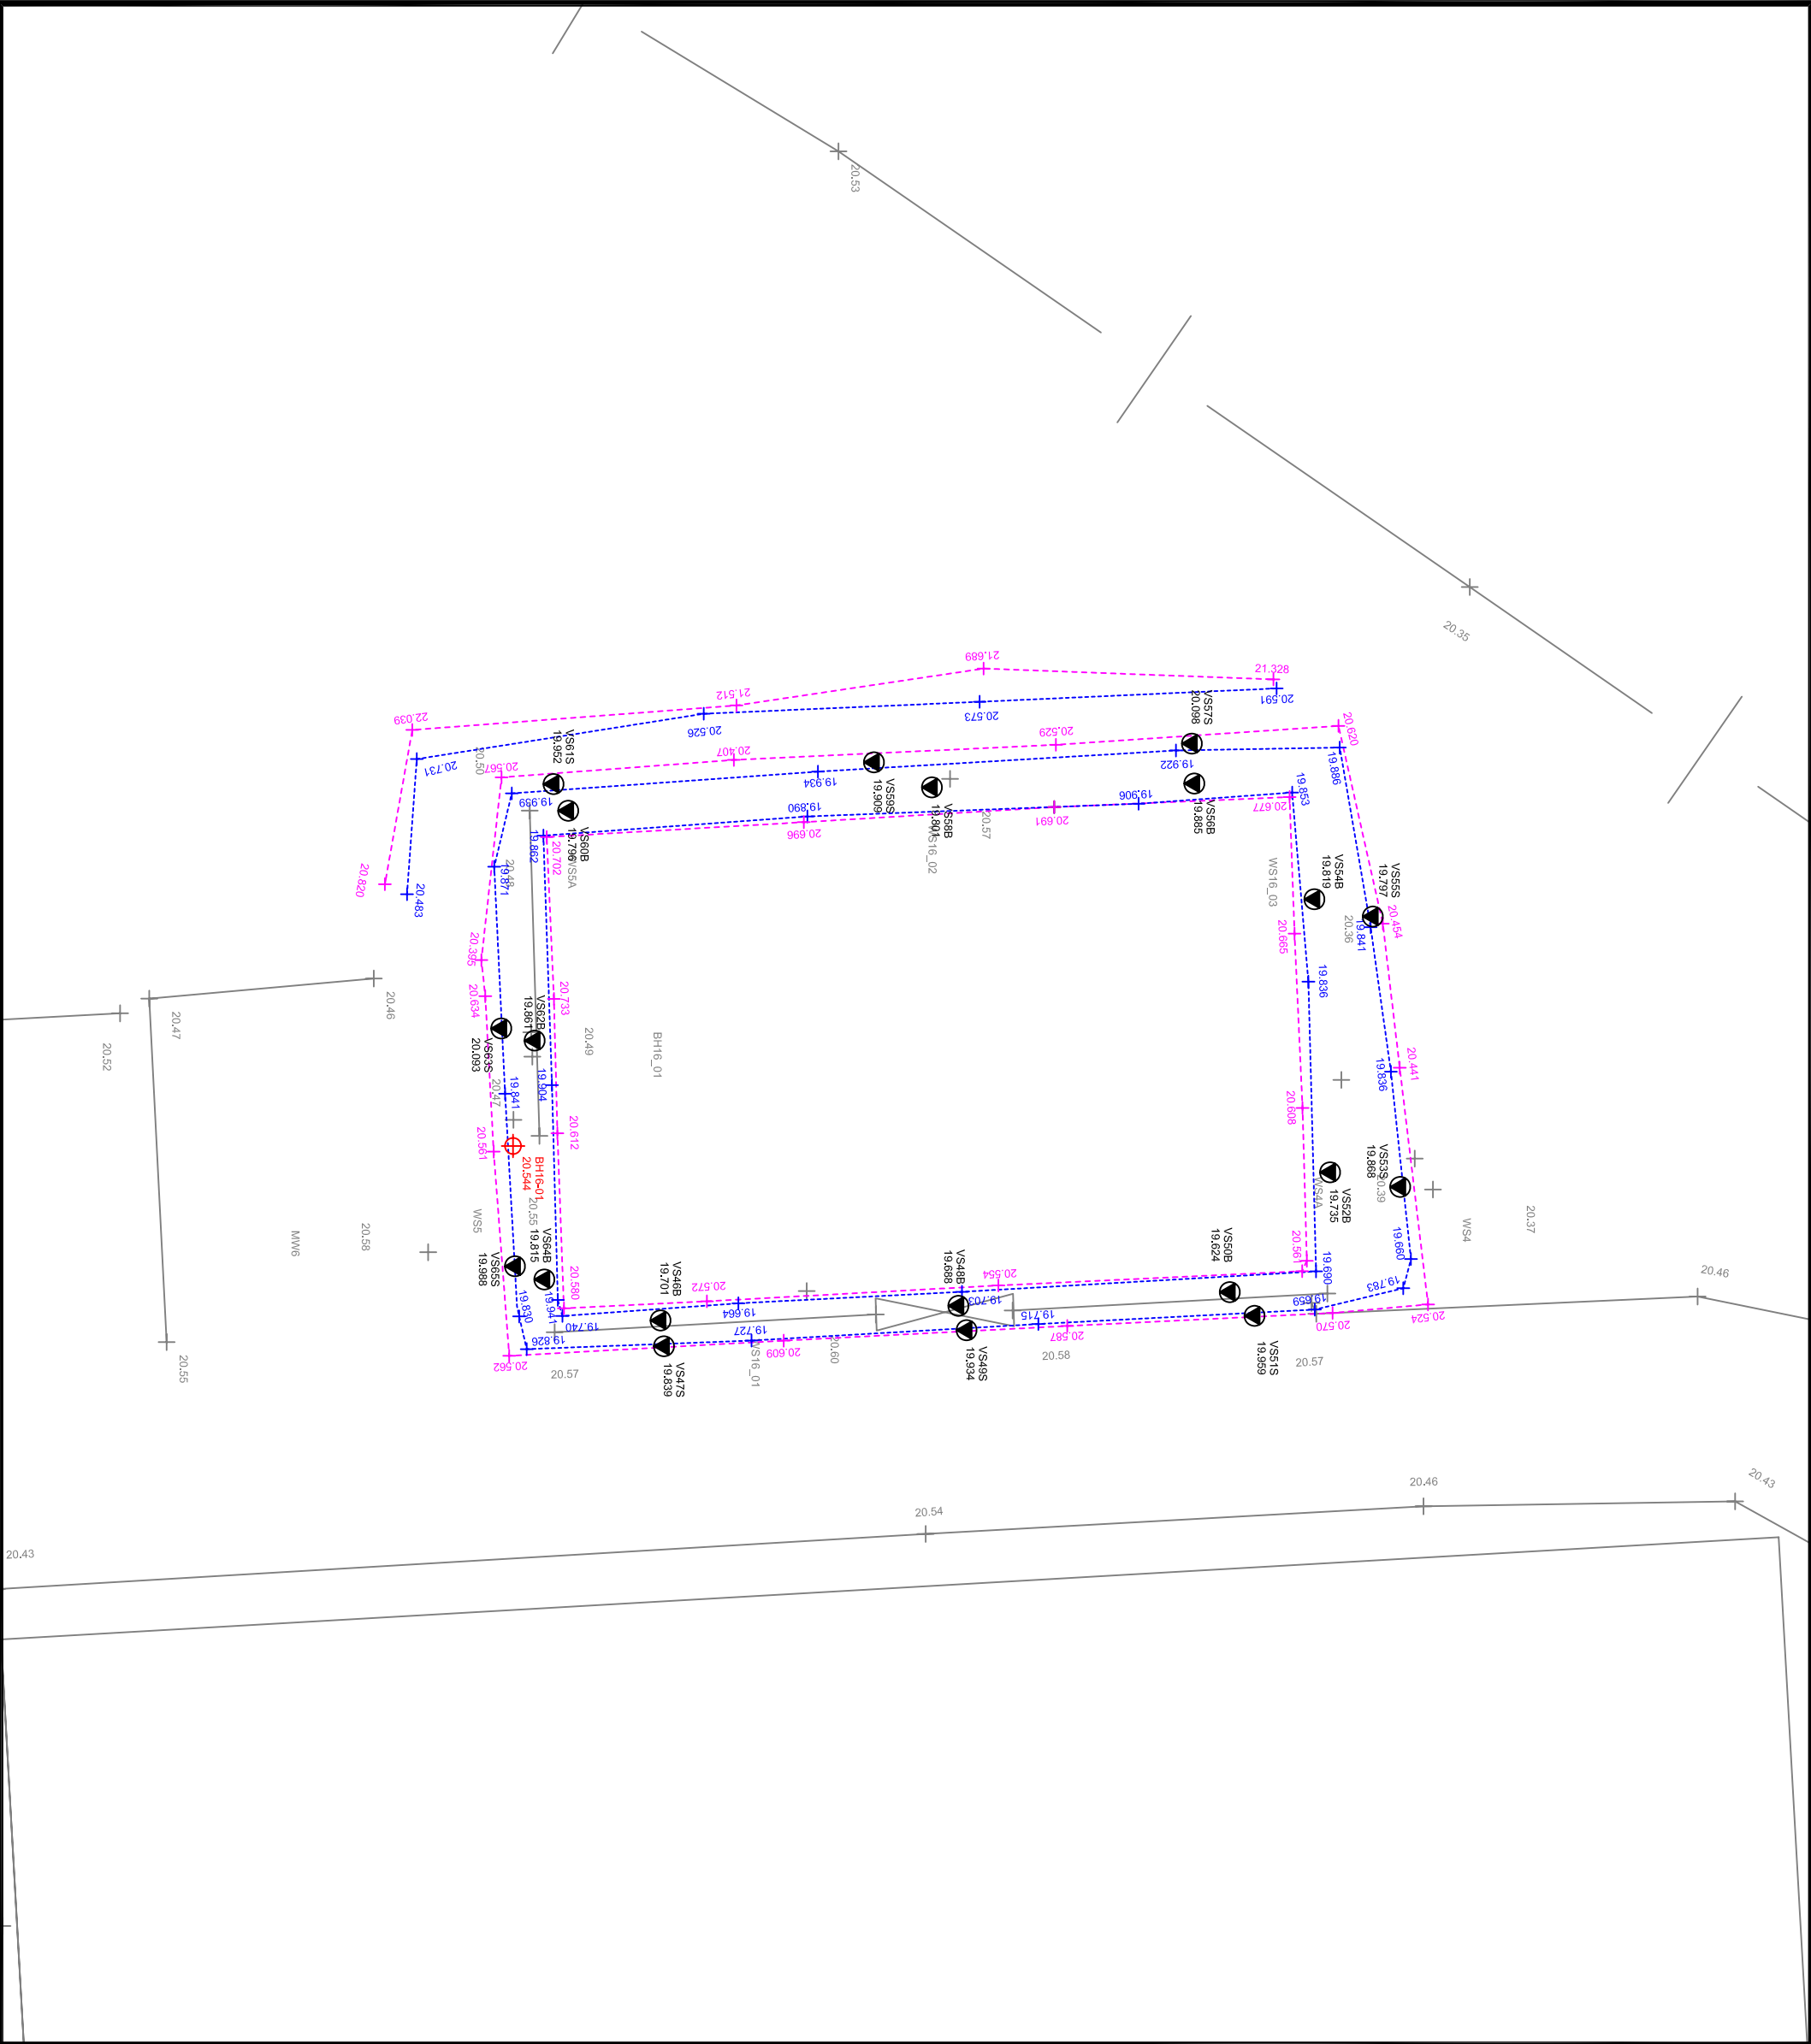
As-Dug Survey Waste Drum Storage Compound - Zone 16

Zone 16 – Waste Drum Storage Compound	Localised hydrocarbon and chlorinated solvent impact in shallow unsurfaced soils around the waste drum storage compound.	Various	Excavation of impacted soils.	The soils around the compound have been excavated in a strip between approximately 1.0m and 2.6m around the waste drum storage compound, to depths of between 0.7m and 0.9m below original ground level. The base and sides of the excavation have been validated to below remedial targets. The excavation has been reinstated to the original ground level with imported soils.
Zone 17 – Disused Cooling Tower Area	Localised hydrocarbon impact in shallow soils	EPH C10-40 7,713mg/kg	Excavation of impacted soils.	Impacted soils were excavated to a depth of approximately 0.6m below the original ground level. The sides and base of the excavation have been validated to below remedial targets. The excavation has been backfilled to original ground level with imported soils.
