Application Site Report
In support of the
Part A2 Environmental Permit
Application for Falcon Steel Ltd

Falcon Steel Ltd
Waunarlwydd Works, Swansea

64-C13317

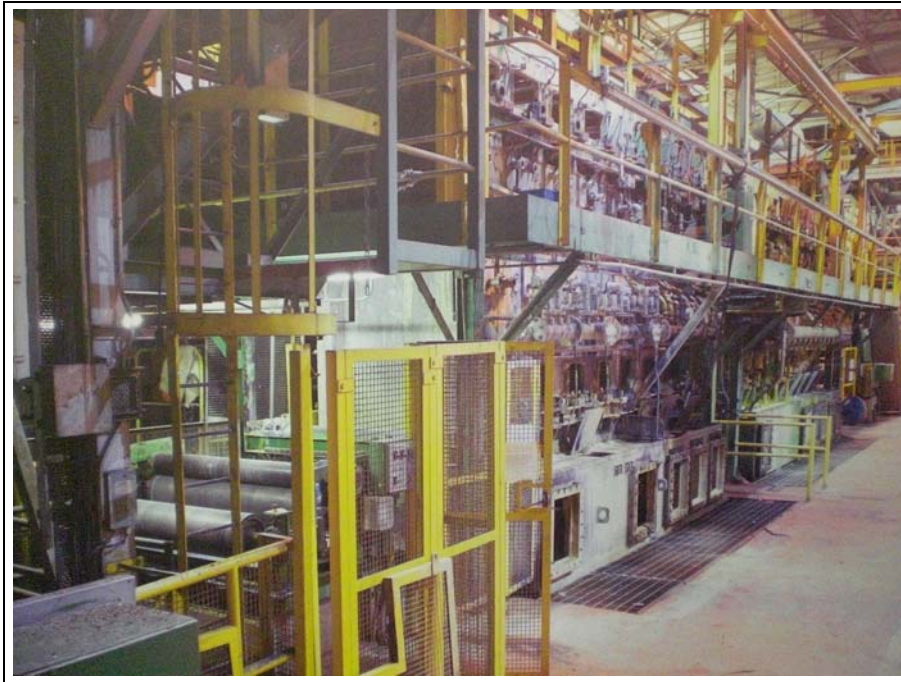
Photo 1: Coil preparation line

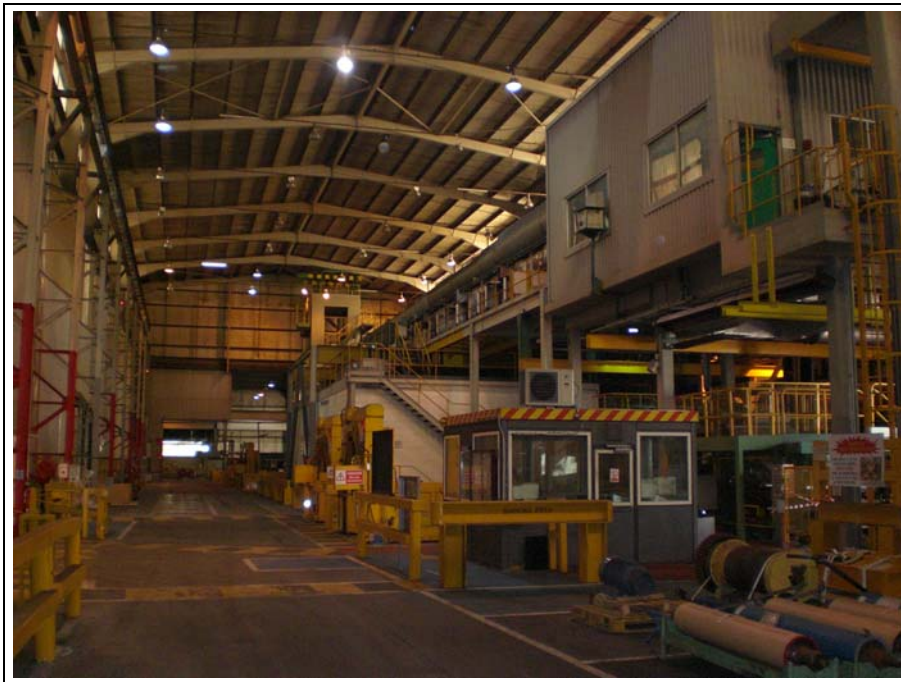
Photo 2: Coil coating line

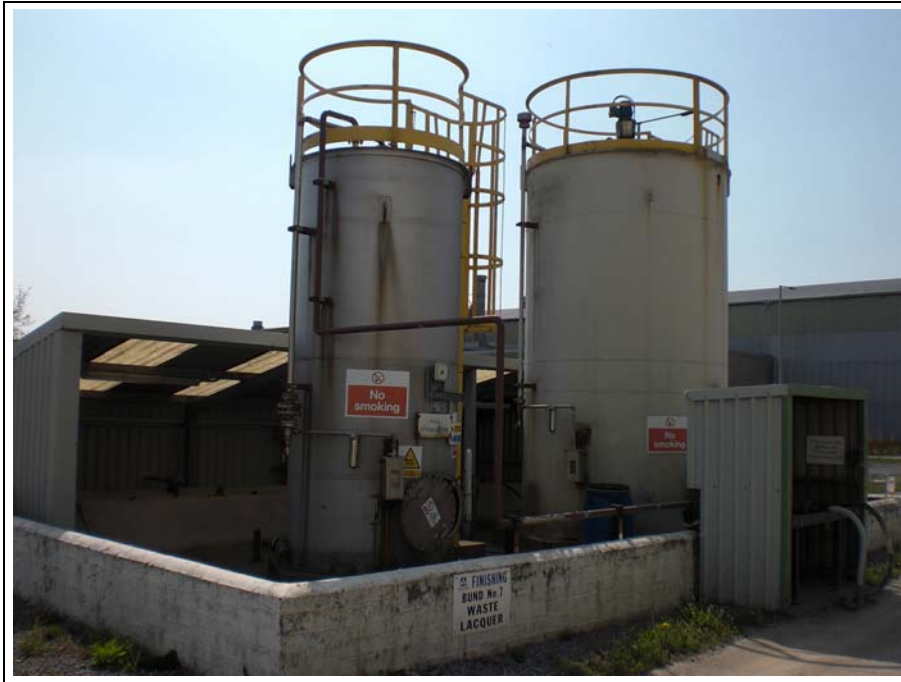
Photo 3: Solvent bulk storage tanks

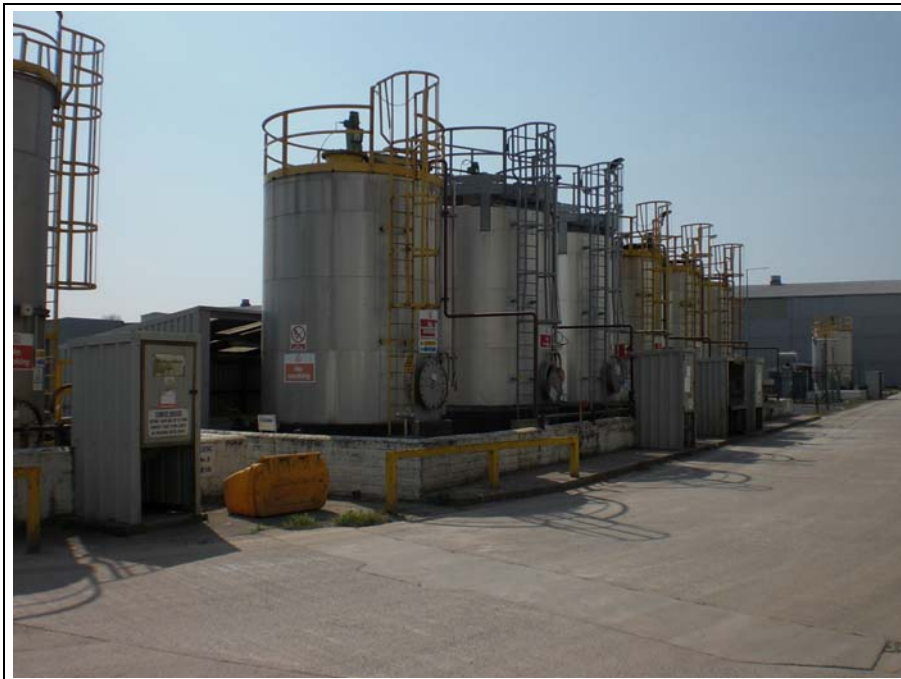
Photo 4: Lacquer bulk storage tanks

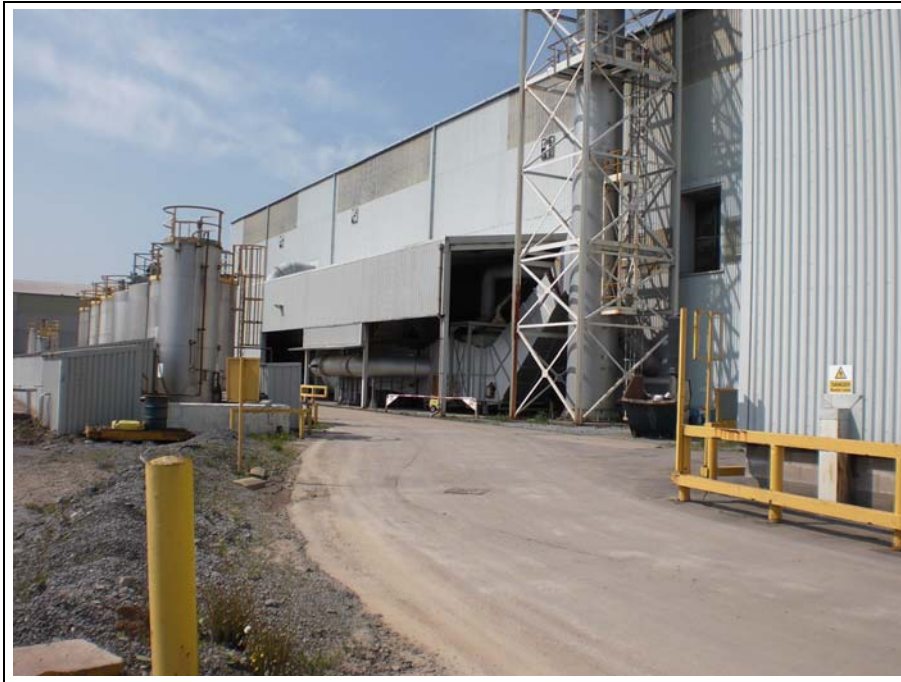
Photo 5: Thermal oxidizer stack

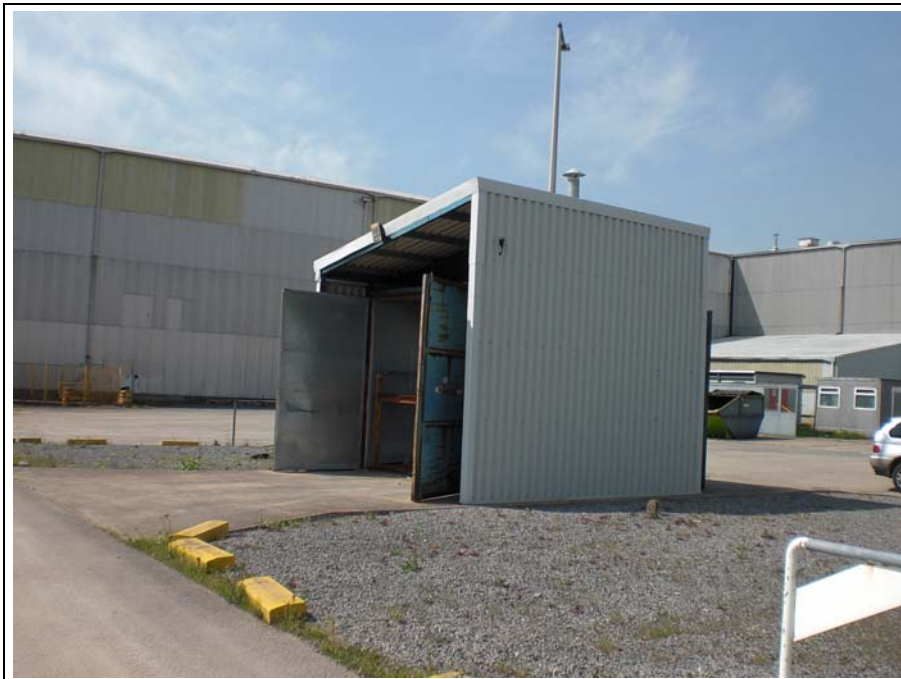
Photo 6: Barrel heater

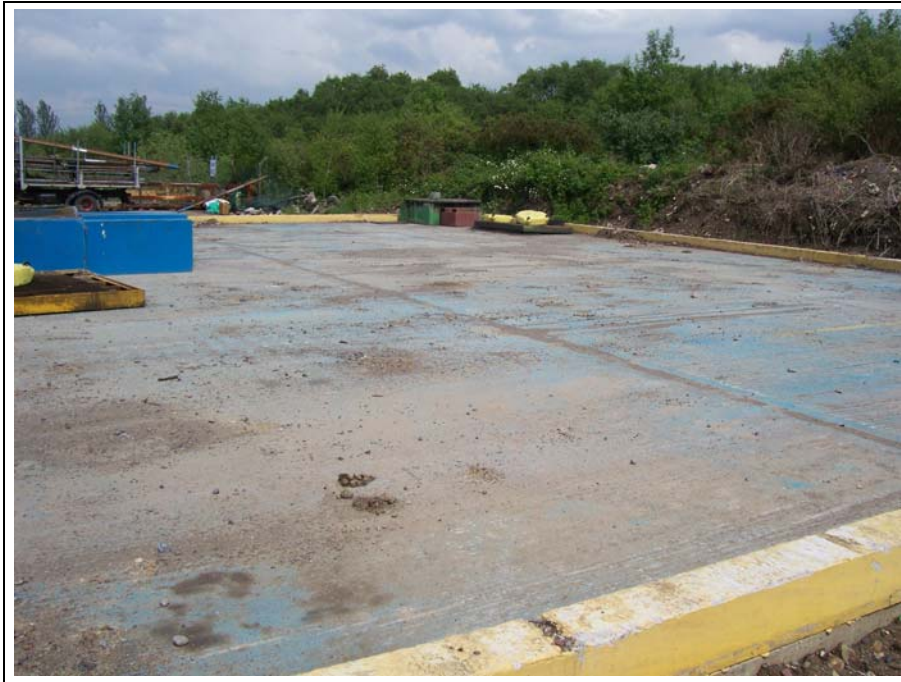
Photo 7: Current view of the barrel storage area

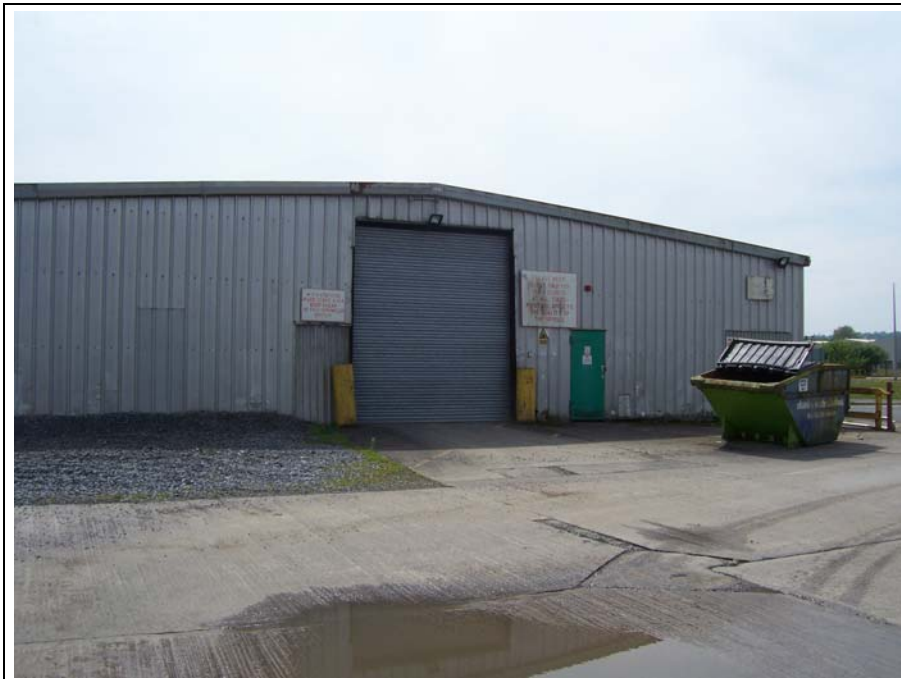
Photo 8: Pallet store

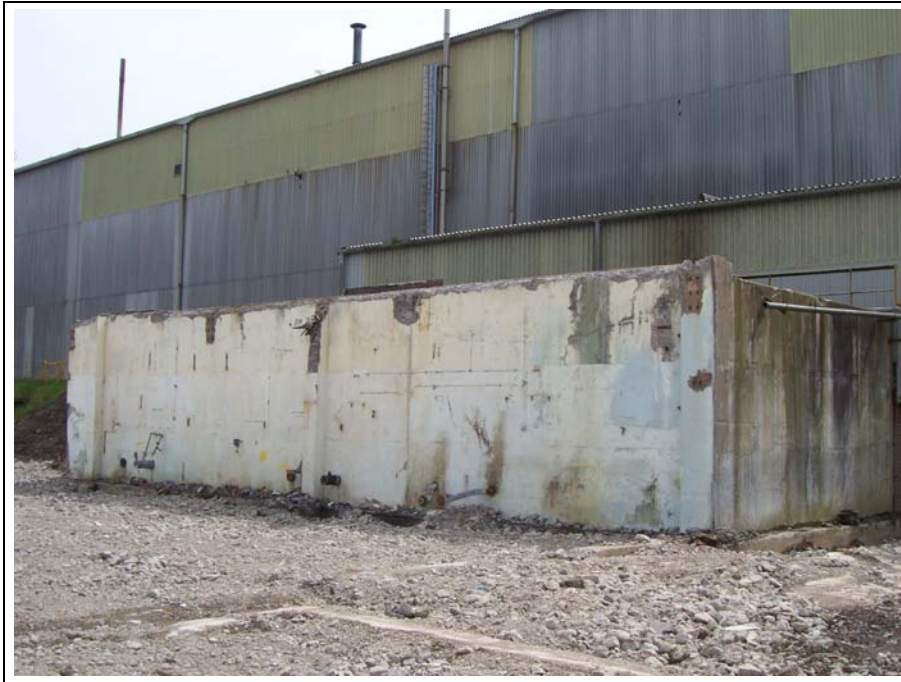
Photo 9: Rear view of the concrete effluent batch tanks. Surrounding area to be concreted.

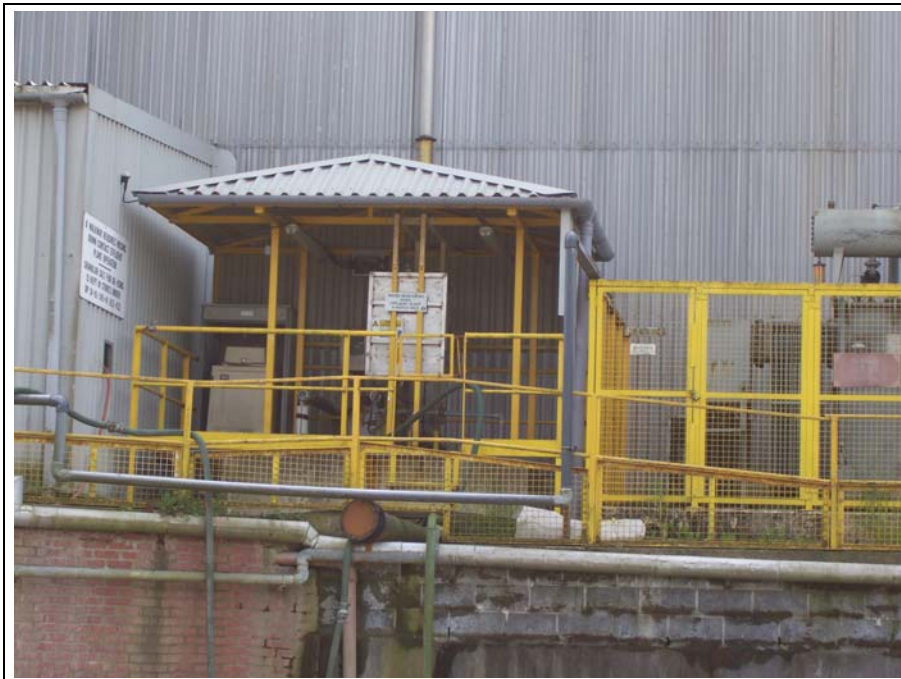
Photo 10: Pumped effluent discharge point to main sewer.
