**SOUTH SIDE
QUEENSWAY WASTE
MANAGEMENT SITE,
LLANWERN STEELWORKS**

**2020 Annual Review of
Environmental
Monitoring**

Report Number 2116r2v1d0221

February 2021

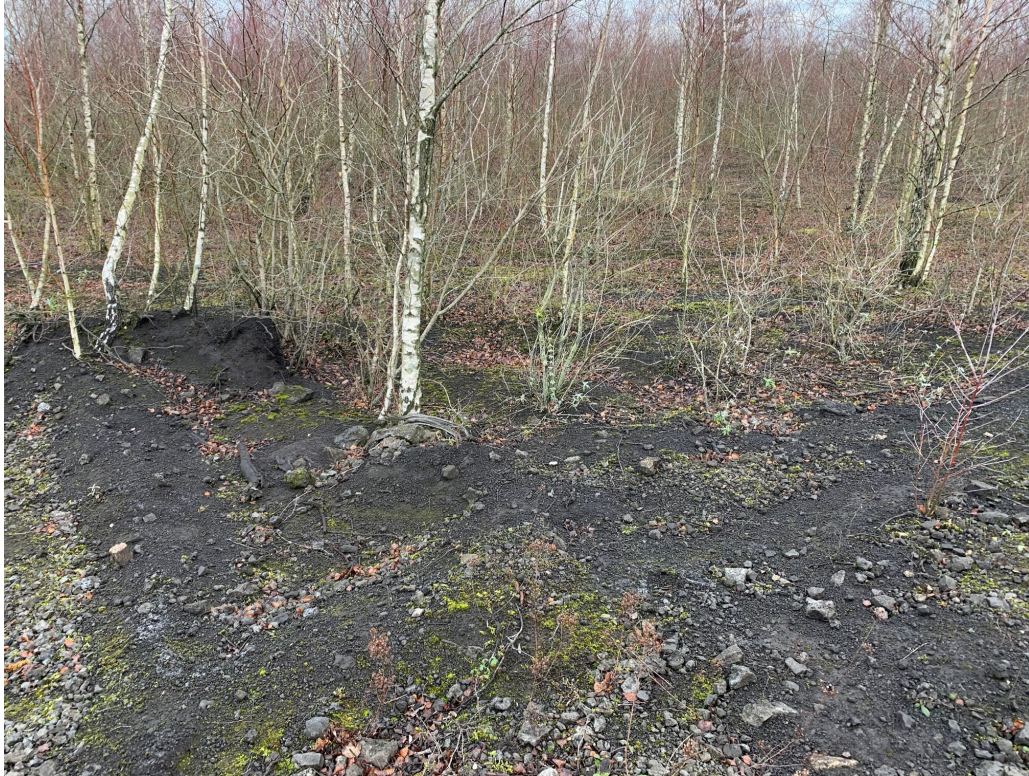
Plate 3-1 Surface of Lagoon 12 in 2020

Lagoons 12 and 25 are very similar in terms of their site position, construction and deposit. Lagoon 12, however, is approximately 20 years old whilst Lagoon 25 is 10 years old. The current condition of the surface of Lagoon 12 is shown in Plate 3-1.

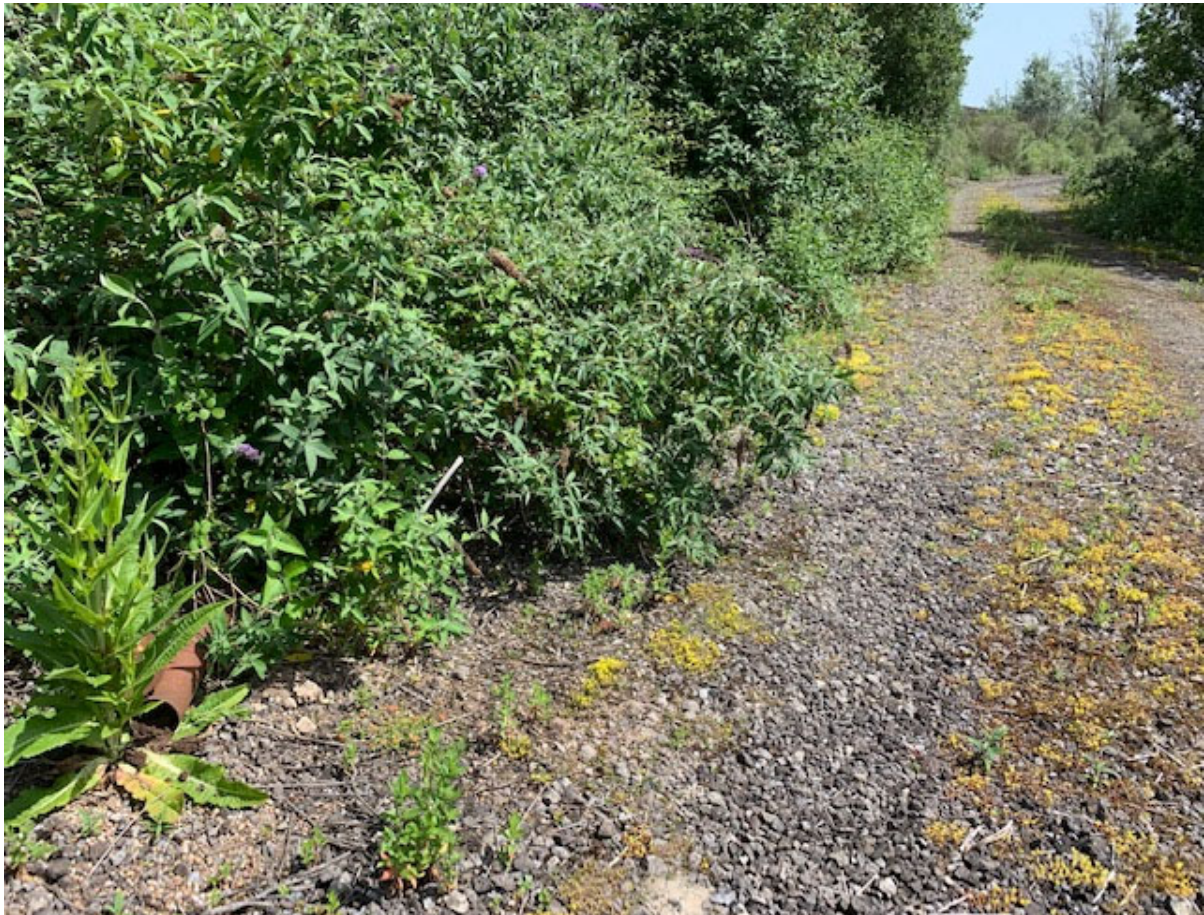
-
- Samples cannot always be collected from the surface water sample monitoring locations due to dense vegetation growth. This was a particular problem during 2019 and during 2020 efforts have been made to maintain access.
 - Buddleia growth along the southern boundary sometimes limits access and monitoring, particularly during the summer months.
 - In 2019, no sample was collected from BH24 as the headworks were found to have been destroyed. During 2020, further investigations located the well and a sample was collected, although the headworks remain damaged and require repair. Other headworks also require maintenance and repair.

Plate 4-1 Overgrown buddleia at BH24
Note headworks on ground in left of picture

Groundwater in the Mercia mudstone is only monitored at BH24, to the south of Lagoon 25. Like the groundwater found in the peat, the groundwater in the bedrock has a circumneutral pH and elevated electrical conductivity (4000-6000 microS/cm in 2017). During 2017, the mineralisation was increasing due, in part, to sustained increases in chloride and ammonia. Since this time, the mineralisation has stabilised within the range of previous observed values but can be spikey between sampling rounds. Some of the variations may be influenced by the significantly damaged headworks.

- Check integrity of the site boundary to ensure members of the public cannot gain access.
- Conduct six monthly walkovers around embankments of Lagoons 12 and 25 to check for leachate breakout.
- Conduct annual walk-over each springtime to look for evidence of shallow translational slips along the embankment of Lagoon 12.
- Improve year-round access to the surface water monitoring positions.
- Locate and expose BH16 and BH18 to assess condition of headworks.
- Manage buddleia growth along the southern boundary as it is limiting access and monitoring.
- Investigate damage to BH24 and take appropriate actions.

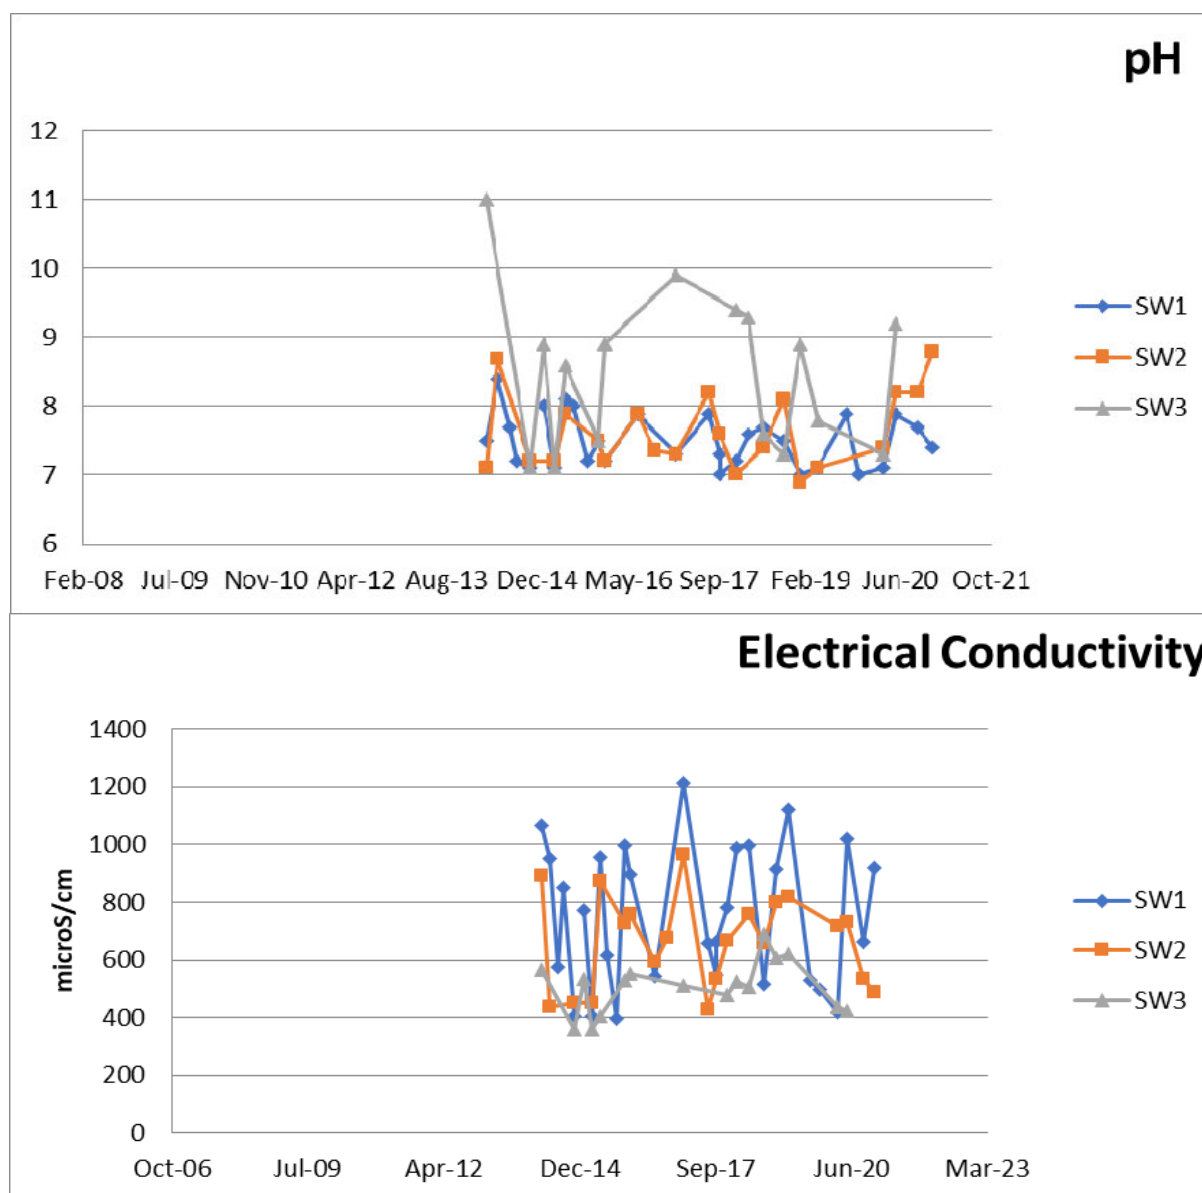
Plate 6-1 Variations in surface water chemistry

Surface water is typically circumneutral, moderately mineralised with low levels of non-hazardous and hazardous substances. As surface water progresses from east to west, the mineralisation decreases from ~ 800 microS/cm to less than 600 microS/cm. The main reason for this change is decreasing alkalinity although most parameters are lower downgradient of SW1.

As shown in Plate 6-1, sample positions SW2 and SW3 were not always accessible in 2019 and 2020 due to dense vegetation growth. This should be routinely cleared or new sample points established with agreement from NRW.

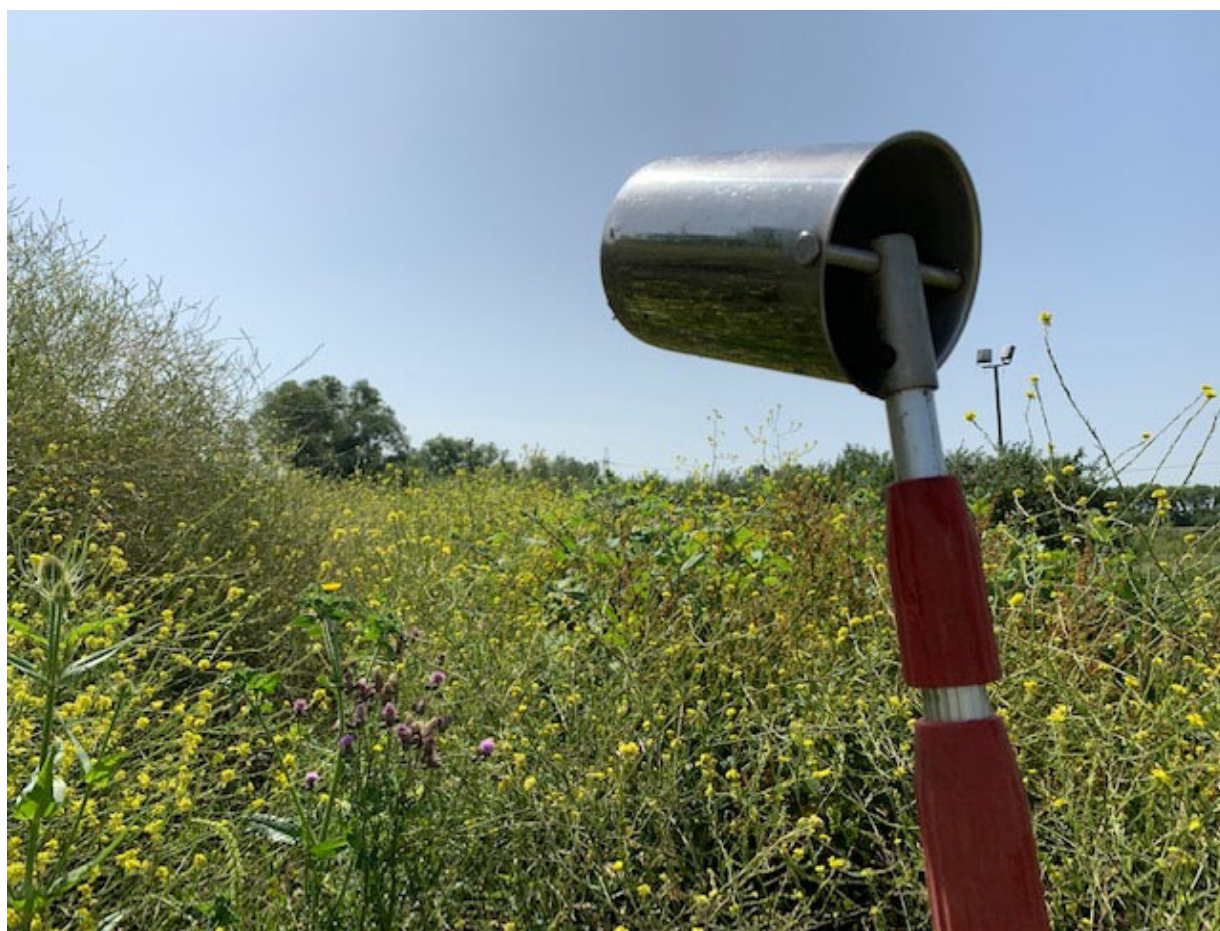
Plate 6-2 Example of dense vegetation approximately 2m high along access route to SW3

- Safe access to the surface water sampling points needs to be improved. Given that vegetation growth is inevitable, routine maintenance and signage would be beneficial. Alternate sample positions could be considered and agreed with NRW, if necessary.
- Several of the headworks are open and not secure. The headworks at monitoring positions BH205, BH16, BH17, BH18, BH19, BH24 and BH201 need particular attention due to inadvertent damage over the years.
- Buddleia growth along the southern boundary is limiting access and monitoring. The vehicular access route and monitoring positions should be routinely maintained.
